Safety Bulletin No. 019
August 15, 2019

Hydraulic Jack Falls During Lift, Causing Injury

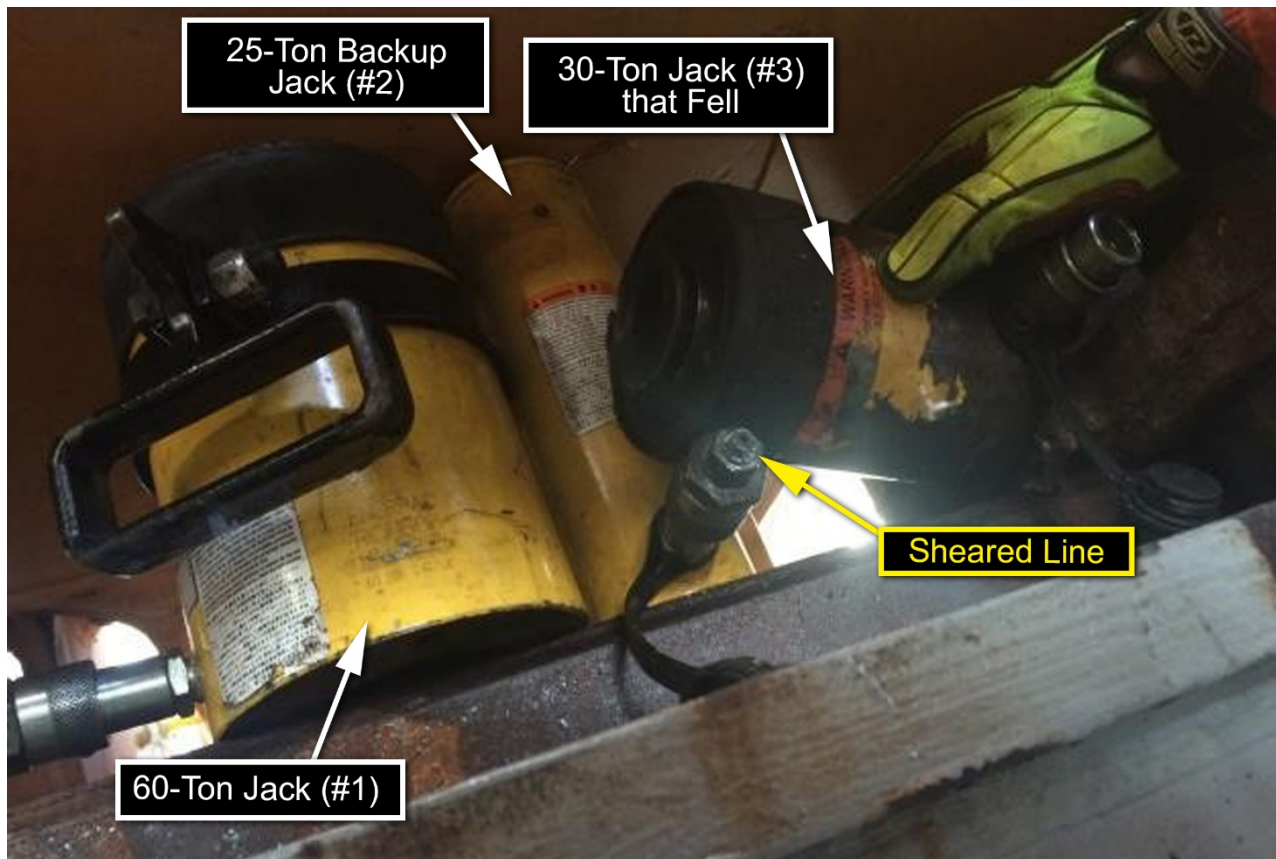
The hydraulic jack at right (#3) was being used to break a Hillman roller free from a mount. The jack fell, shearing the hydraulic line on the backup jack (#2, center).

jack (jack #3) to attempt to free the equipment roller which was stuck to the BOP carrier frame due to corrosion. While pressuring up on the 30-ton hydraulic jack, the 30-ton jack body started to leak hydraulic fluid. The hydraulic mechanic then called “hold up” to another member of the three-person team, but the command was misinterpreted and the 30-ton jack was instead bled off, which caused the 30-ton jack to fall, then strike and shear the hydraulic line fitting on the adjacent 25-ton jack. The hydraulic line on the 25-ton jack broke loose from the fitting and struck the hydraulic mechanic on the right side of his face, causing an injury.

Lifting devices (hydraulic cylinders, cranes, hoists, etc.) should be used as designed, and lifted loads should be supported by solid, stable supports before being approached and before work begins. The personnel involved in this incident supported the load with hydraulic cylinders rather than using rigid supports while working on the supported load.

Lifting devices may be left in place for efficiency’s sake, but should be bled down so that the entire load of the item is supported by the solid, rigid supports. In this incident, the hydraulic mechanic used two hydraulic cylinders to support the load; if the hydraulic pressure supply to the 60-ton jack (jack #1) would have been compromised, additional injuries could have occurred.

If a rigid support was properly used to support the load, the injury would have been prevented because the hydraulic cylinder hoses would have been bled down prior to the incident. In a bled-down condition, the 25-ton hydraulic hose would not have forcefully moved if sheared.

Therefore, BSEE recommends that operators consider the following:

- Install a rigid support system to secure lifted loads, and
- Ensure the Job Safety Analysis includes procedures to be followed during the lifting of a load and that all procedures are communicated with all personnel involved in the task.
