# Final Interpretive Report

## Acoustic Corer™ Survey to Identify Buried Conductors and Geo-Hazards at Mississippi Canyon Block 20 Gulf of Mexico

# Couvillion Group

## RPT-08387-5.0

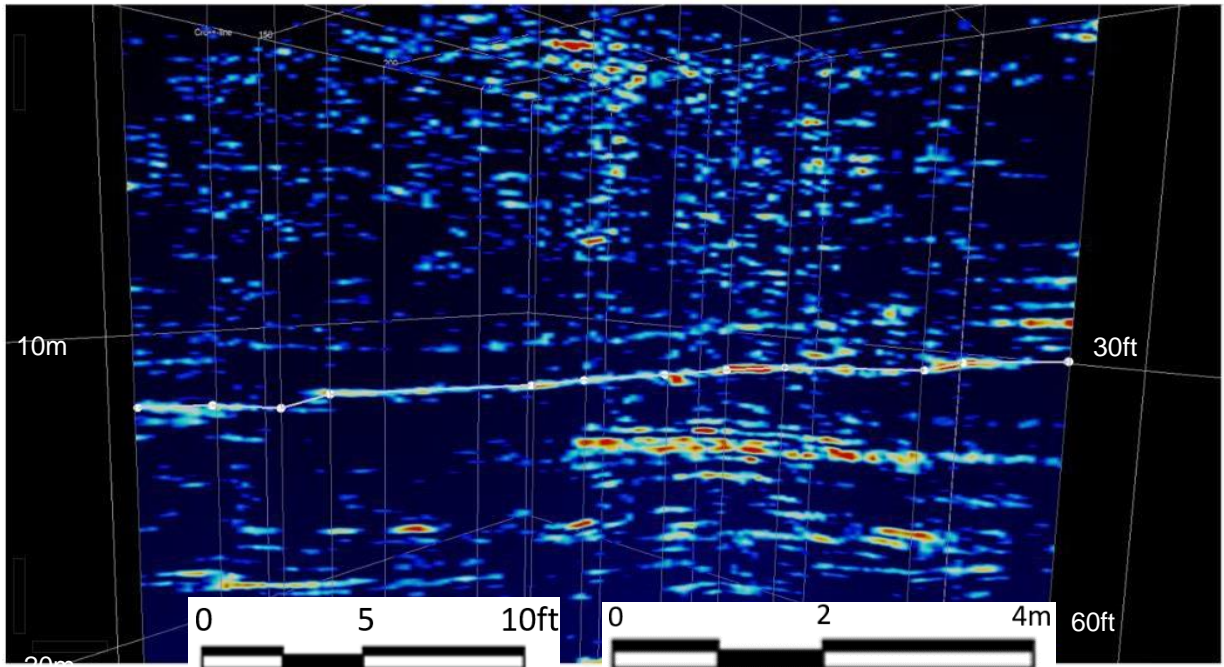
34.6 ft) BML (Figure 19). The B6-HF-C2 feature was interpreted to be of  $9.1 \pm 0.9\text{m}$  ( $30 \pm 3\text{ft}$ ) diameter located at a depth between 13.9-14.6m (45.5 to 47.8ft) (Figure 20 to Figure 22).

Figure 19 - Cross-sectional view of B6-HF-C1. Depths along the side of the section are distances BML

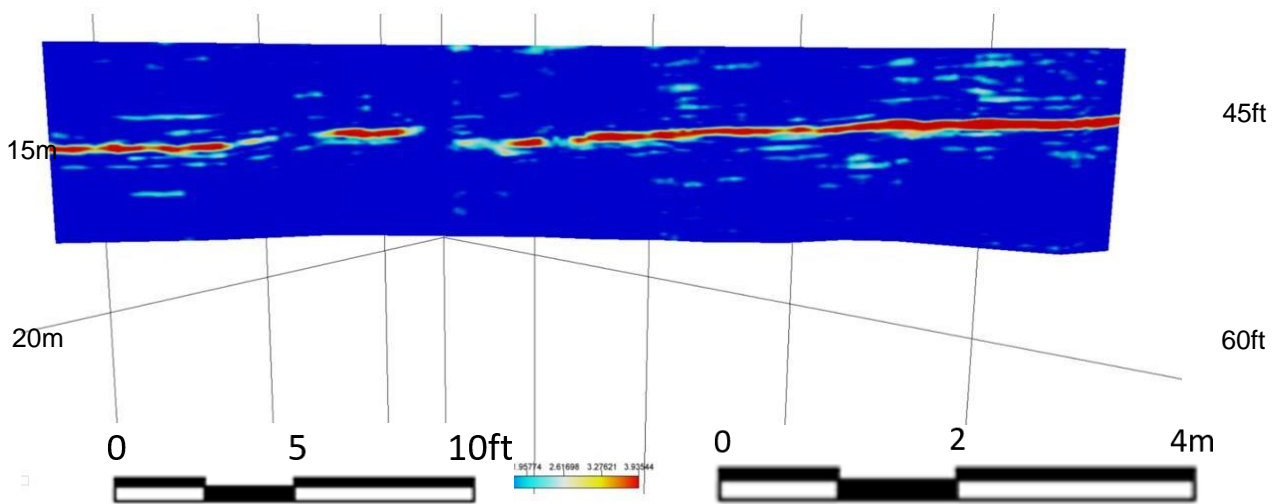
Figure 20 - Side View of B6-HF-C2. Depths along the side of the profile are recorded as BML.

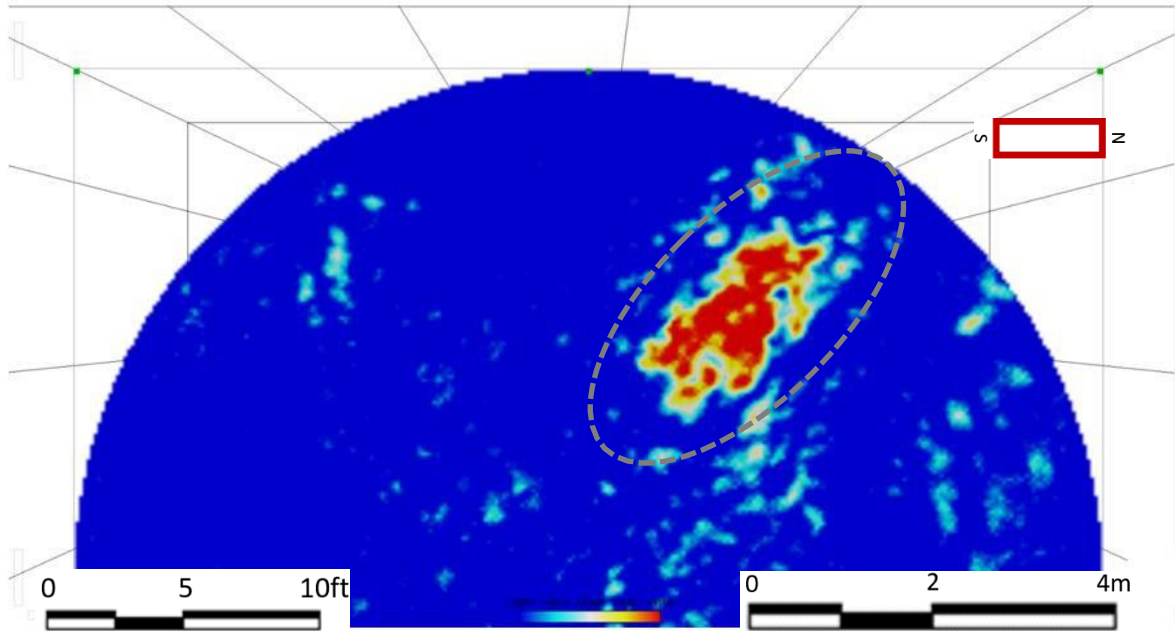
Figure 21 - Plan-View of B6-HF-C2 located at 14.15m BML (46.4ft) showing a portion of the dipping linear feature (dipping towards the NW) through the acoustic core.

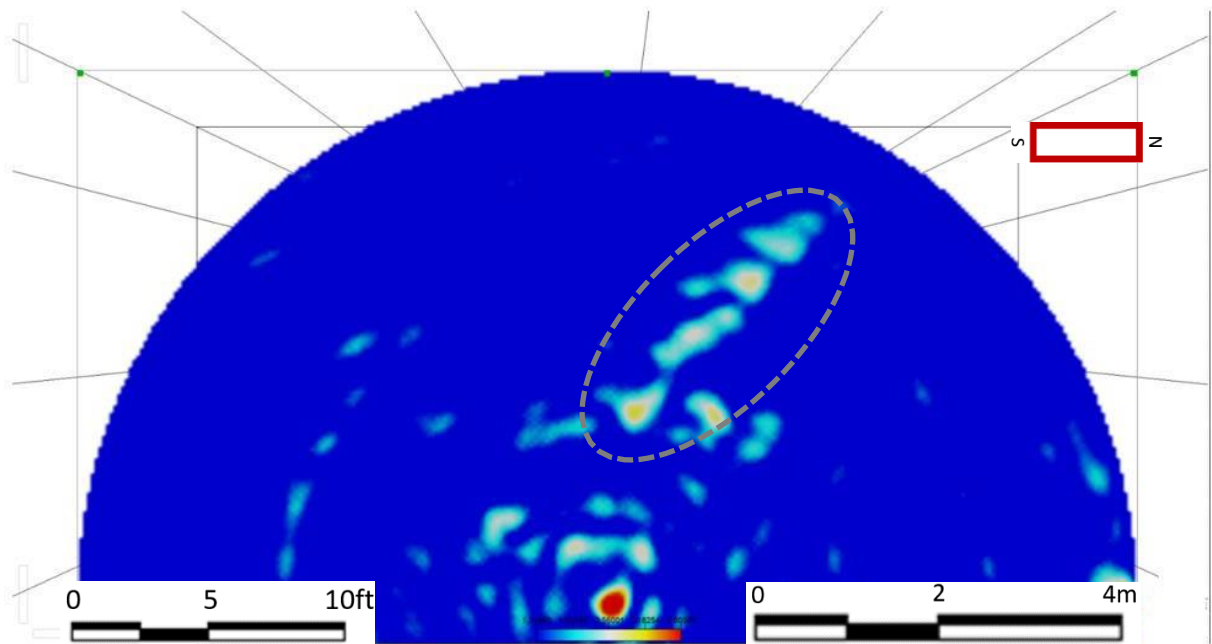
Figure 22 - Plan-View of B6-HF-C2 located at 14.05m BML (46.1ft) using the LF SAS to confirm correlation.

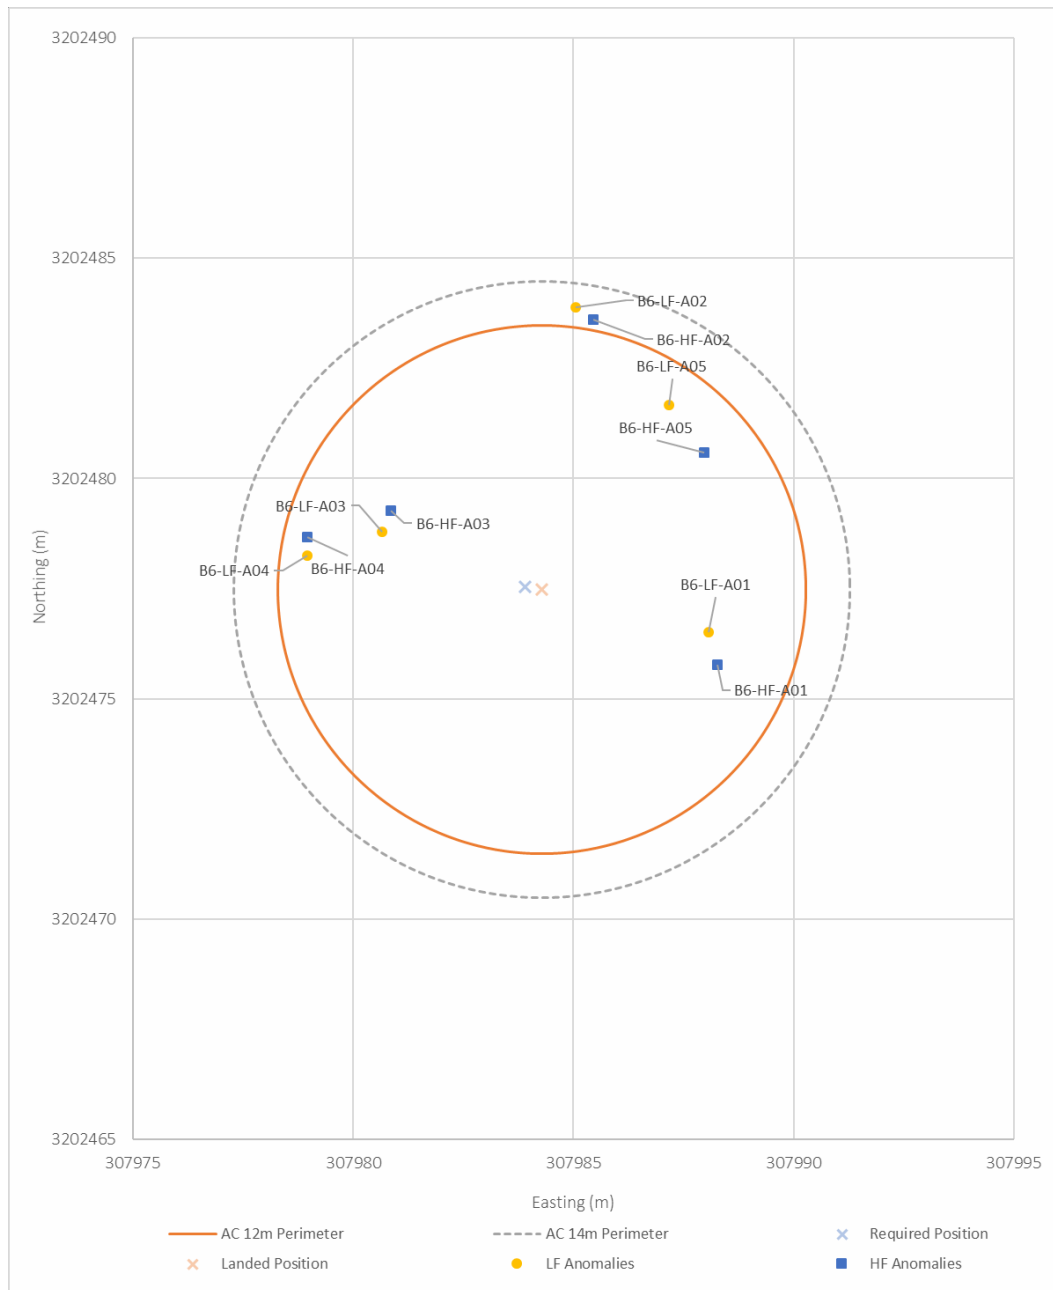
The anomaly analysis result is summarized in Table 16 as well as in plan-view and cross-sectional plots in Figure 23 and Figure 24. A total of 5 anomalies were identified within the HF Core that correlated with 5 anomalies in the LF Core. These anomalies were located between 12-20m BML (39-66ft). Anomalies reported in grey text are in the 12-14m (39.4ft – 45.9ft) annulus of the acoustic core and therefore subject to a greater uncertainty. Sample images of identified anomalies can also be found in Figure 25 and Figure 26 below.

Figure 23 - Plan View Image showing B6 anomalies

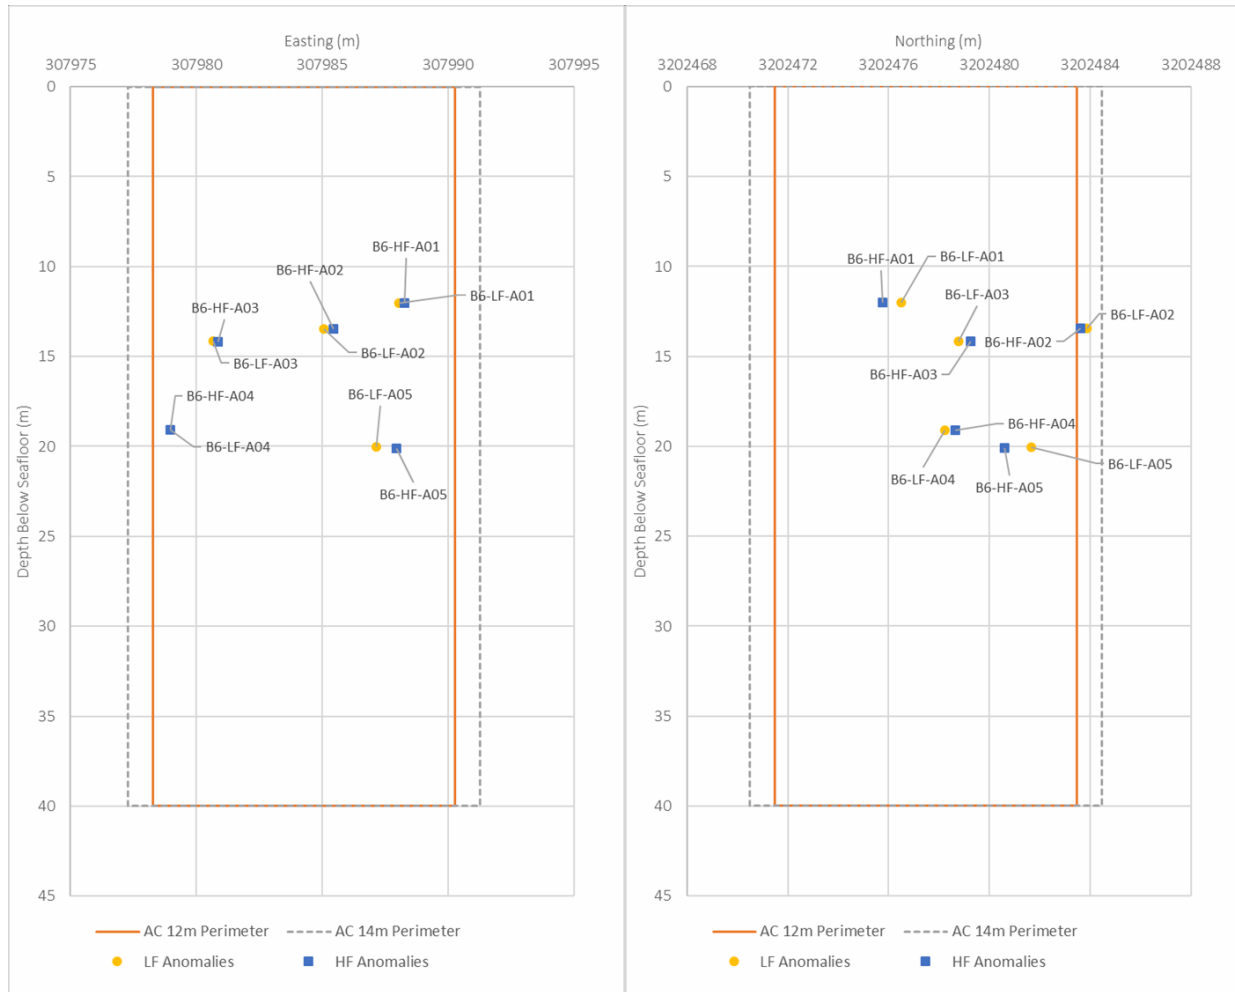
Figure 24 - Cross-Sectional view of the HF and LF acoustic anomalies at Site B6 oriented East-West (left image) and North-South (right image)

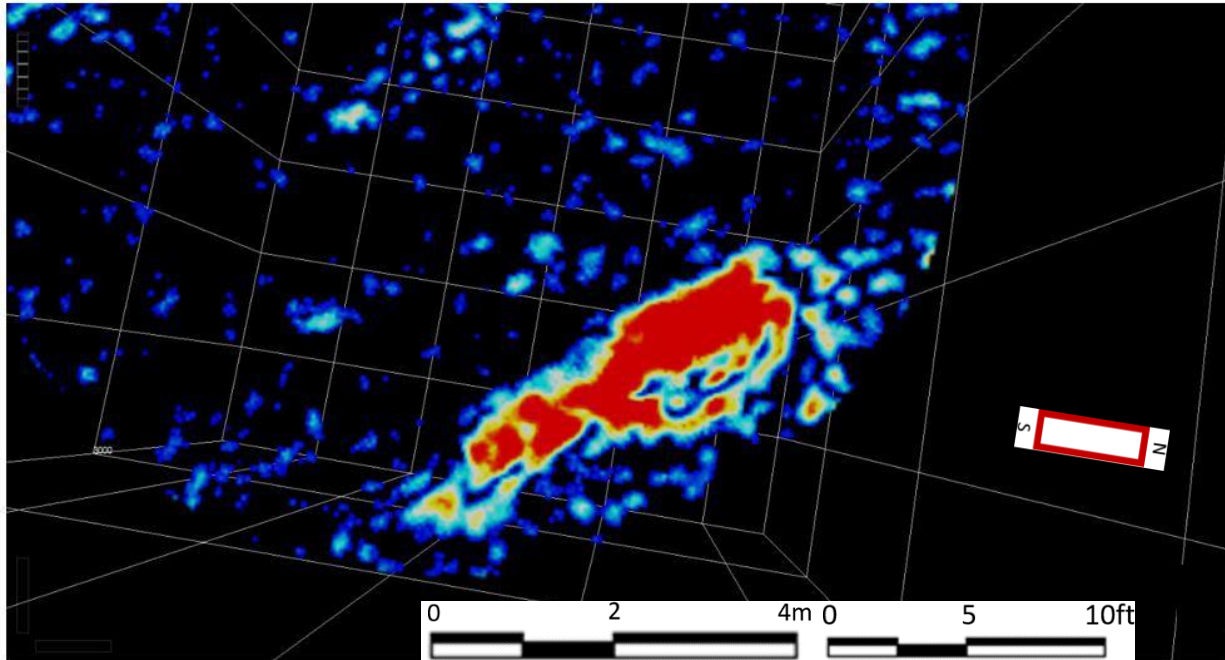
Figure 25 - Sample image showing B6-HF-A05 in plan-view. Depth is 20.09m BML (65.9ft BML). This type of linear feature is indicative of natural gas in the area.

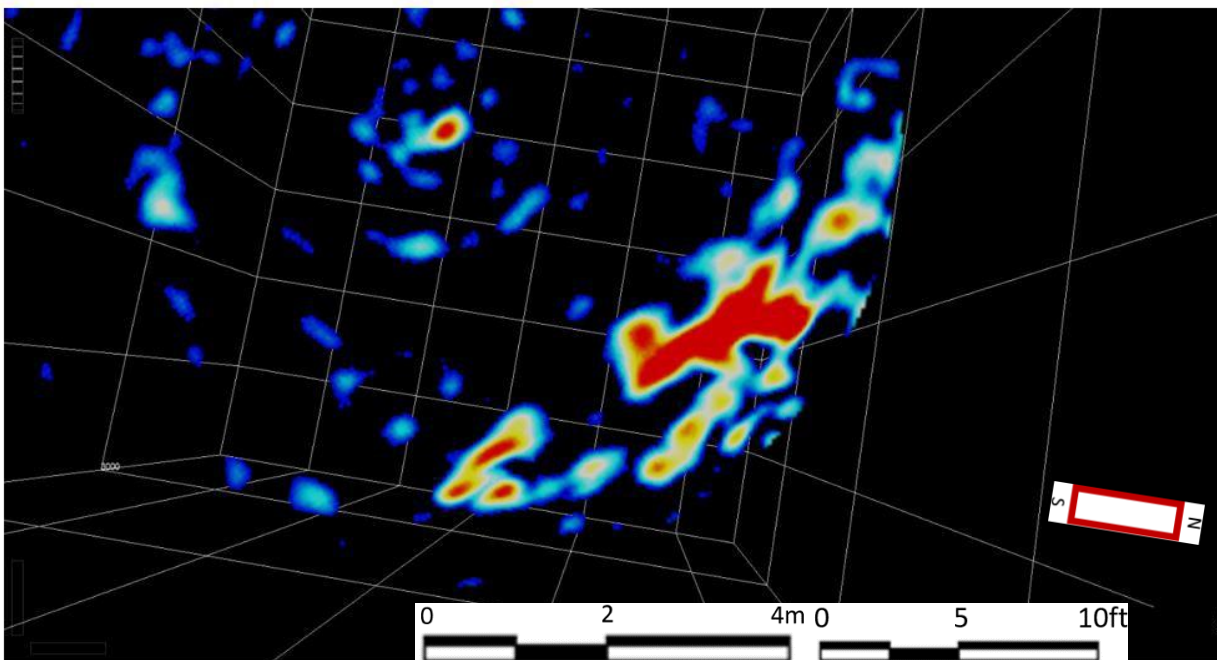
Figure 26 - Sample image showing B6-LF-A05 in plan-view. Depth is 20.03m BML (65.7ft BML). This type of linear feature is indicative of natural gas in the area.

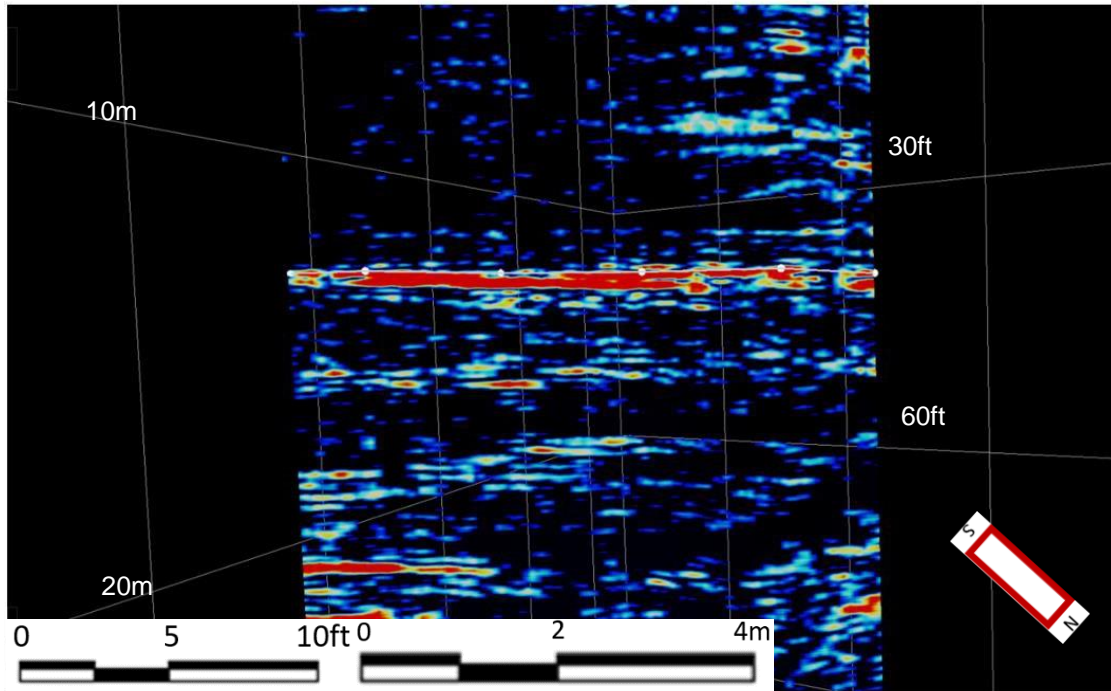
Figure 27 - Cross-section of B3-HF-C4 located between 43-45ft BML

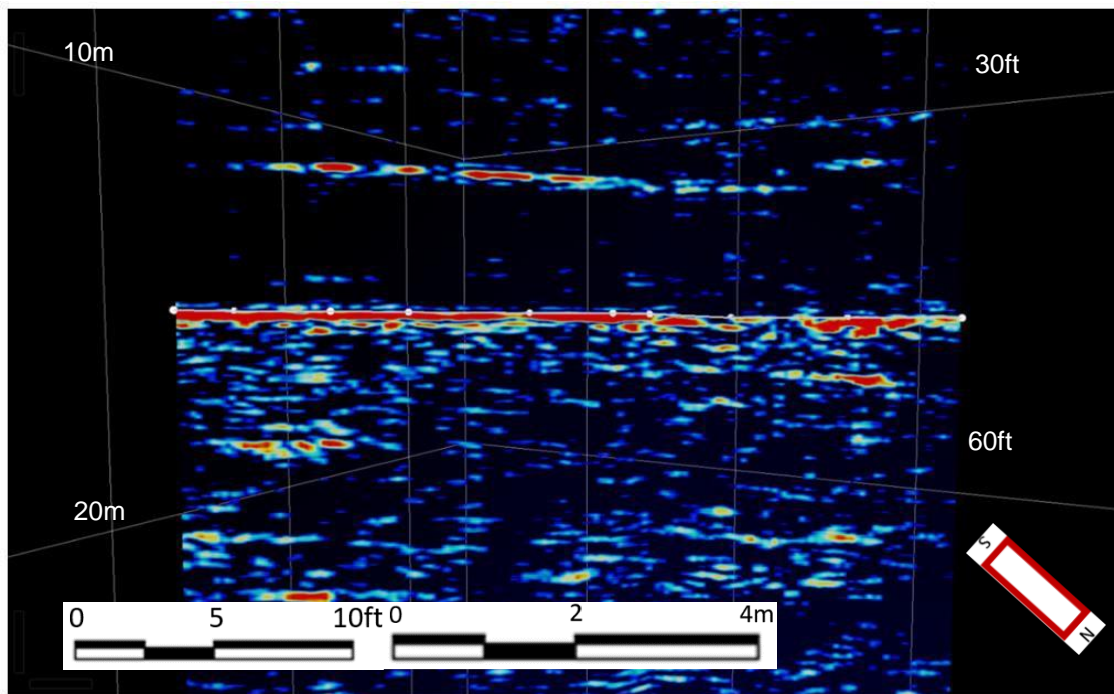
Figure 28 - Side-View of B3-HF-C1 located between 49-51ft BML

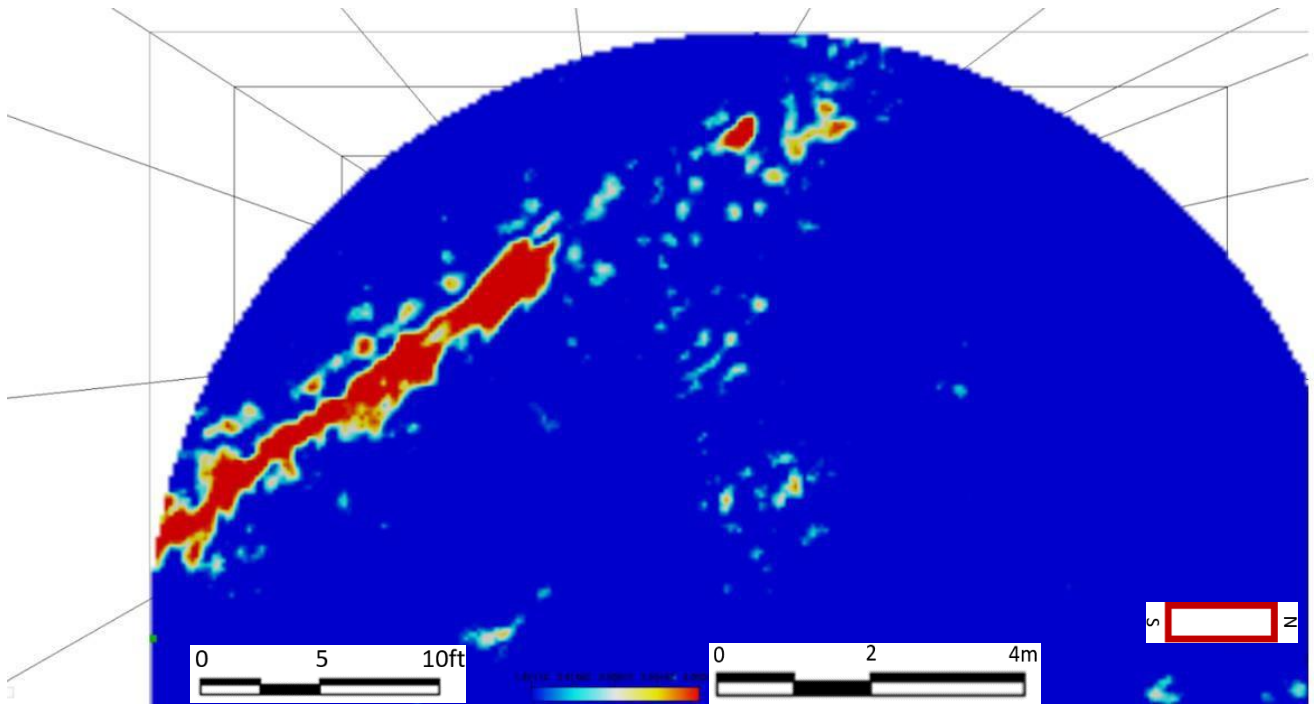
Figure 29 - Plan-view image of B3-C1-HF located at 15.34m BML (50.3ft BML)

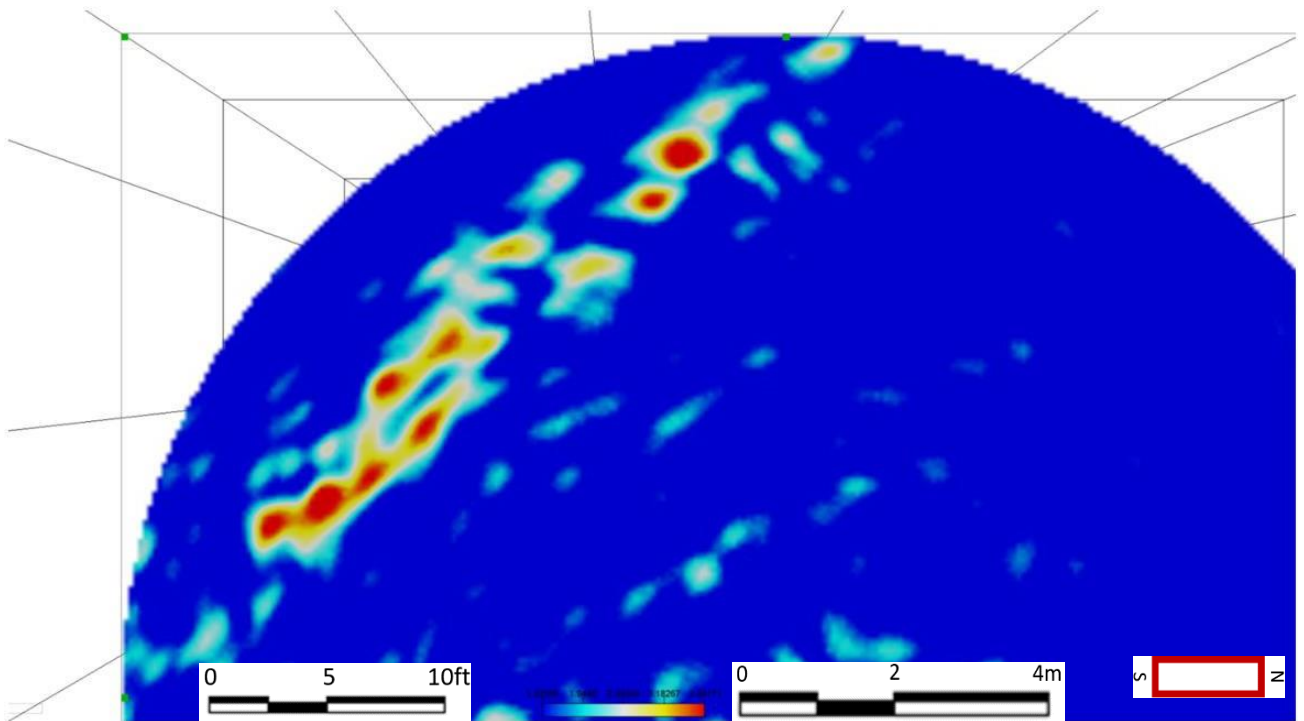
Figure 30 - Plan-view image of B3-C1 in LF SAS located at 15.33m BML (50.3ft BML)

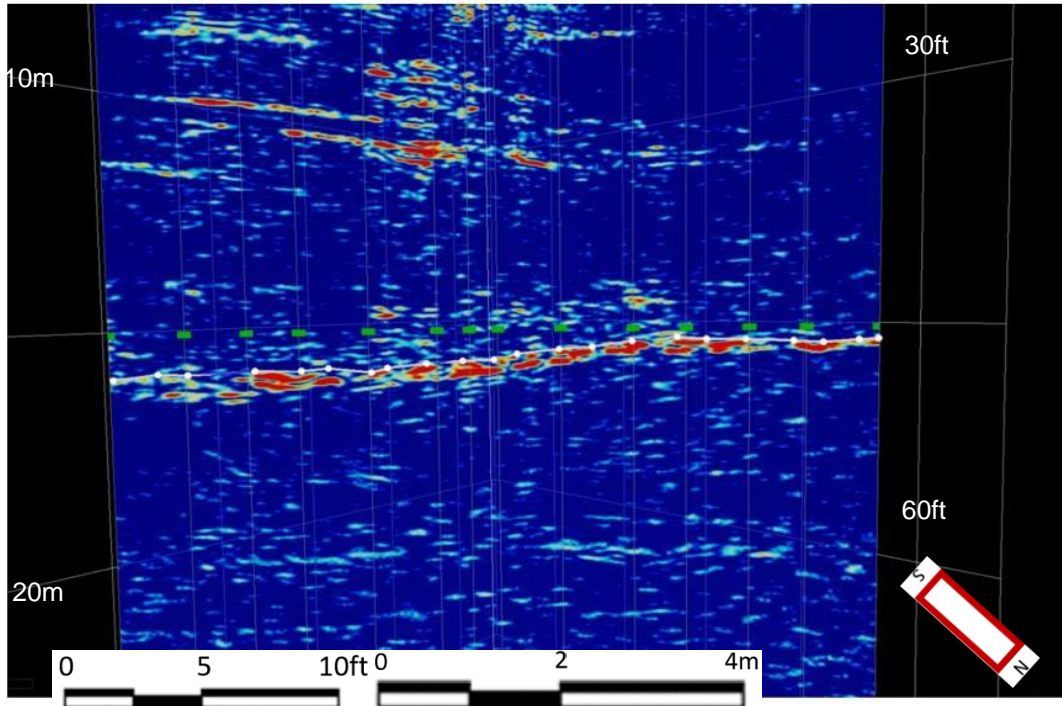
Figure 31 - Side-View of B3-HF-C2 located between 54-55ft BML

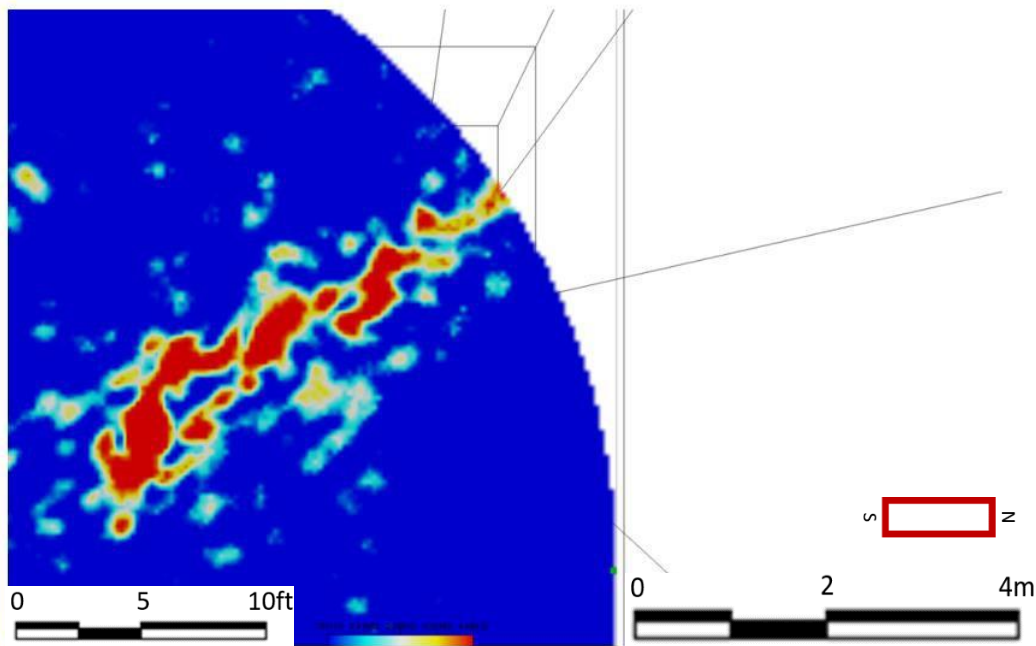
Figure 32 - Plan-View of B3-HF-C3 located at 20.56m BML (67.5ft BML) showing a portion of the dipping linear feature (dipping towards the NW) through the acoustic core. Note orientation in the bottom right of the figure

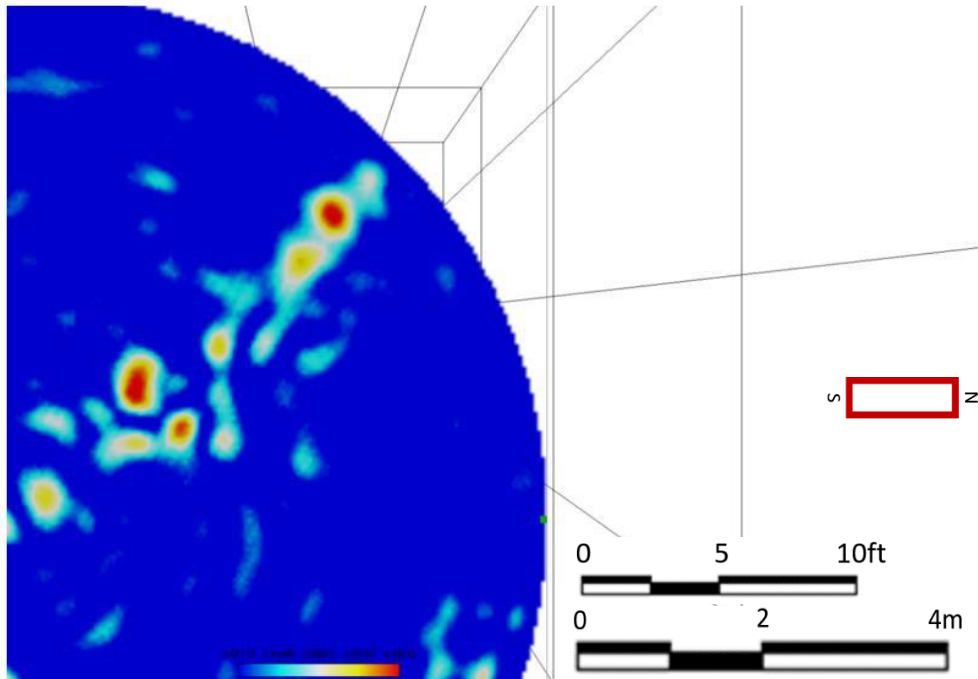
Figure 33 - Plan-View of B3-HF-C3 in LF SAS located at 20.61m BML (67.6ft BML) showing a portion of the dipping linear feature (dipping towards the NW) through the acoustic core. Note orientation in the bottom right of the figure

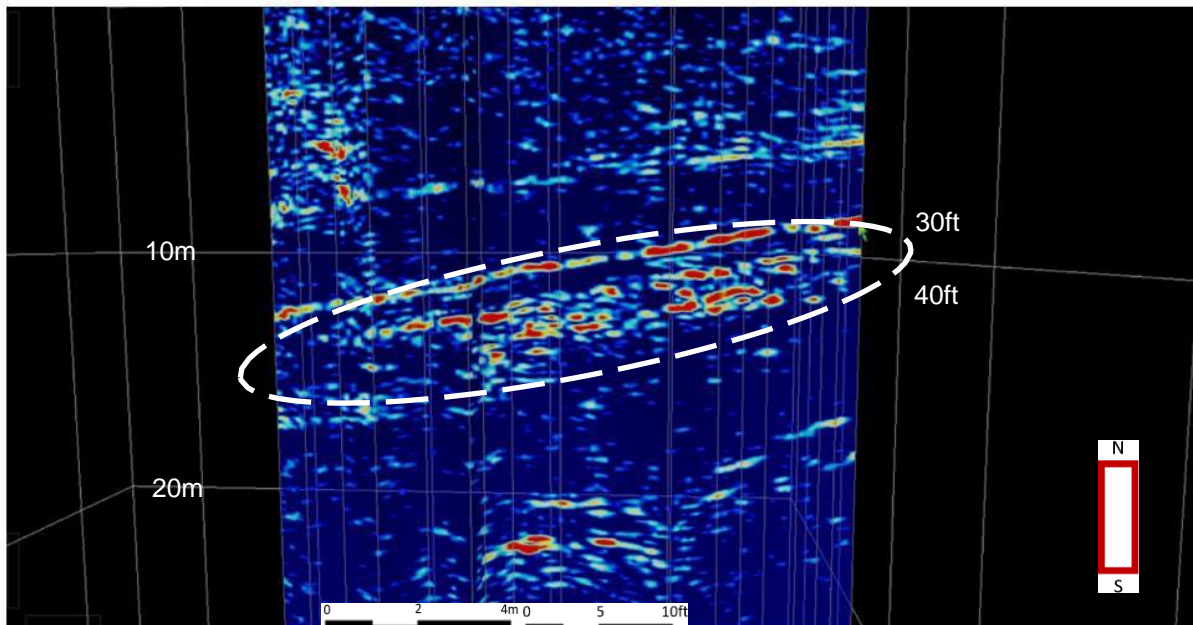
Figure 34 - Dipping layer that extends across the entire length of the acoustic core identified at Site B3. This layer has been interpreted to be a stratigraphic layer. The encircled area shows the layer dipping from west (Right-hand side) to east (Left-hand side) throughout the core. The layer can first be seen at 9.0m BML (29.5ft BML) and is last seen at 12.35m BML (40.5ft).

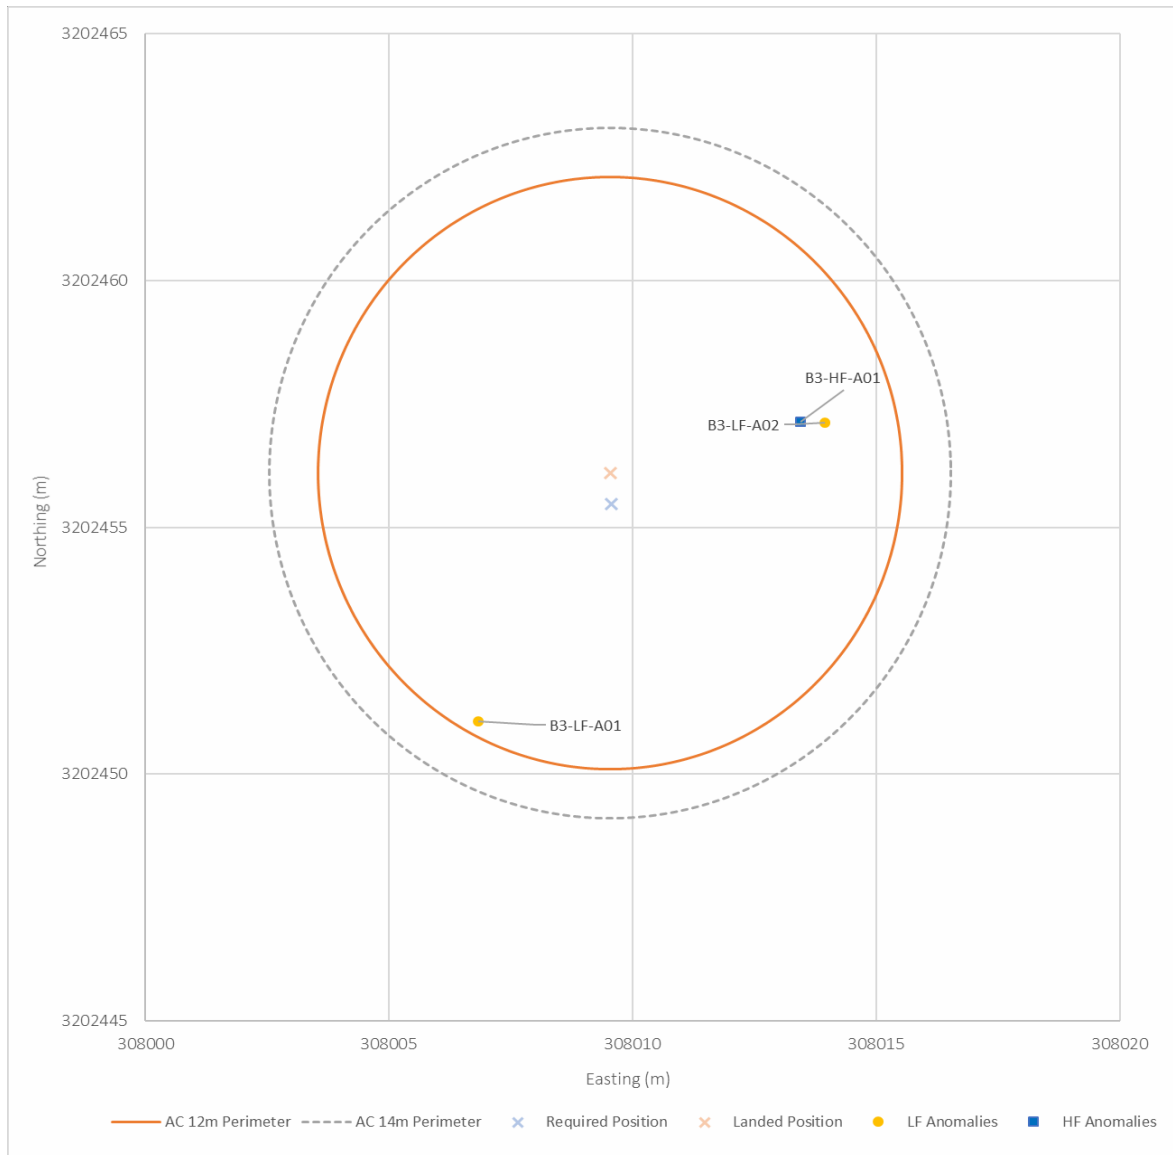
The anomaly analysis result is summarized in Table 18 as well as plan-view and cross-sectional plots in Figure 35 and Figure 36. One anomaly was identified within the HF Core while two anomalies were identified in the LF Core. After further analysis, B3-LF-A01 first identified in the LF core is actually correlated with a dipping section of the linear feature B3-HF-C1. All anomalies were located between 15-26m BML (49-85ft). A sample image of an identified anomaly can also be found in Figure 37 below.

Figure 35 - Plan-View of Anomalies for Site B3

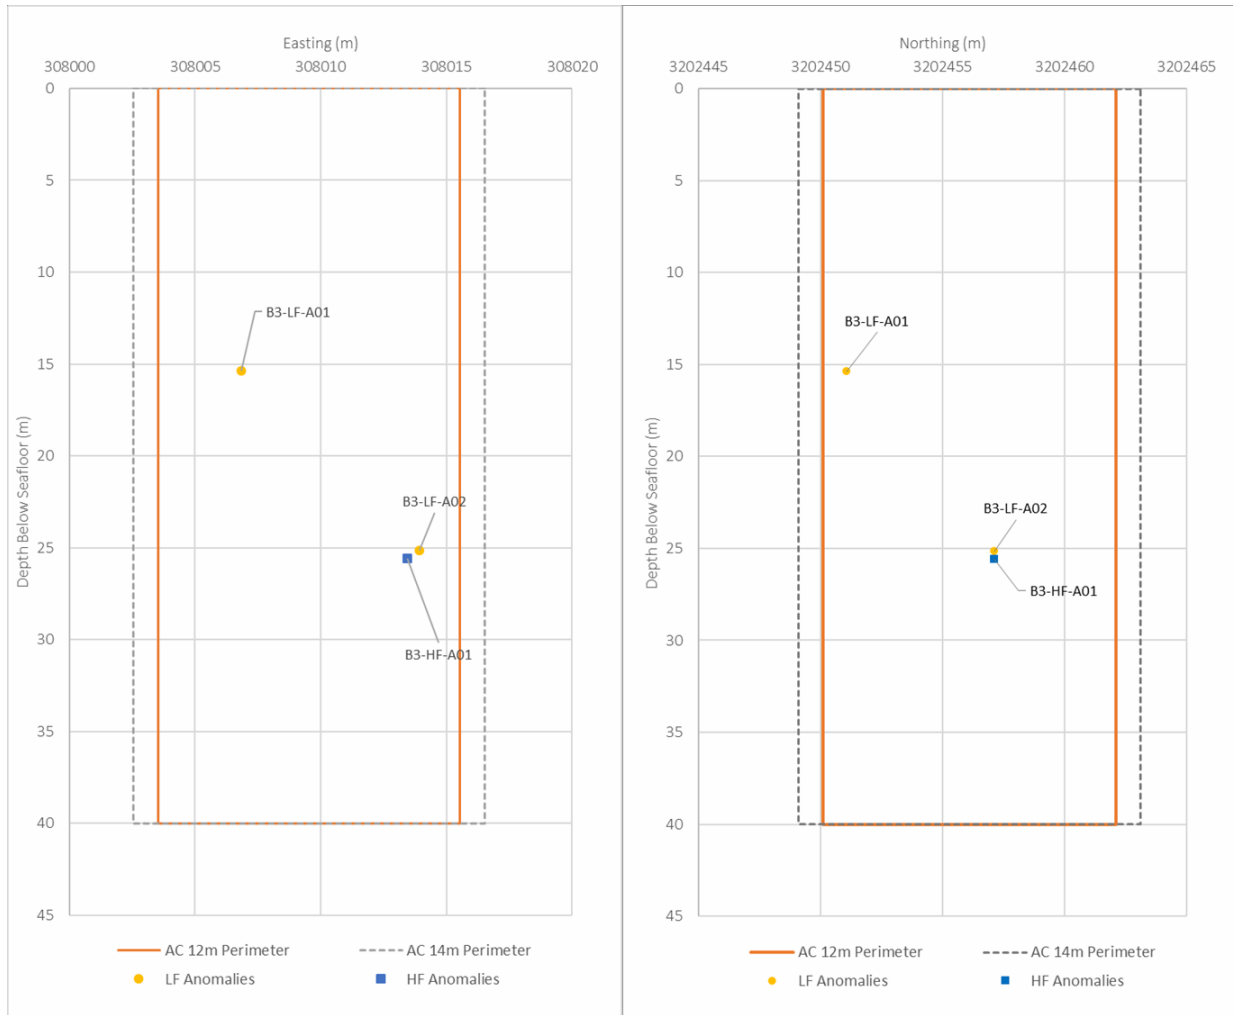
Figure 36 - Cross-Sectional view of the HF and LF acoustic anomalies at Site B3 oriented East-West (left image) and North-South (right image)

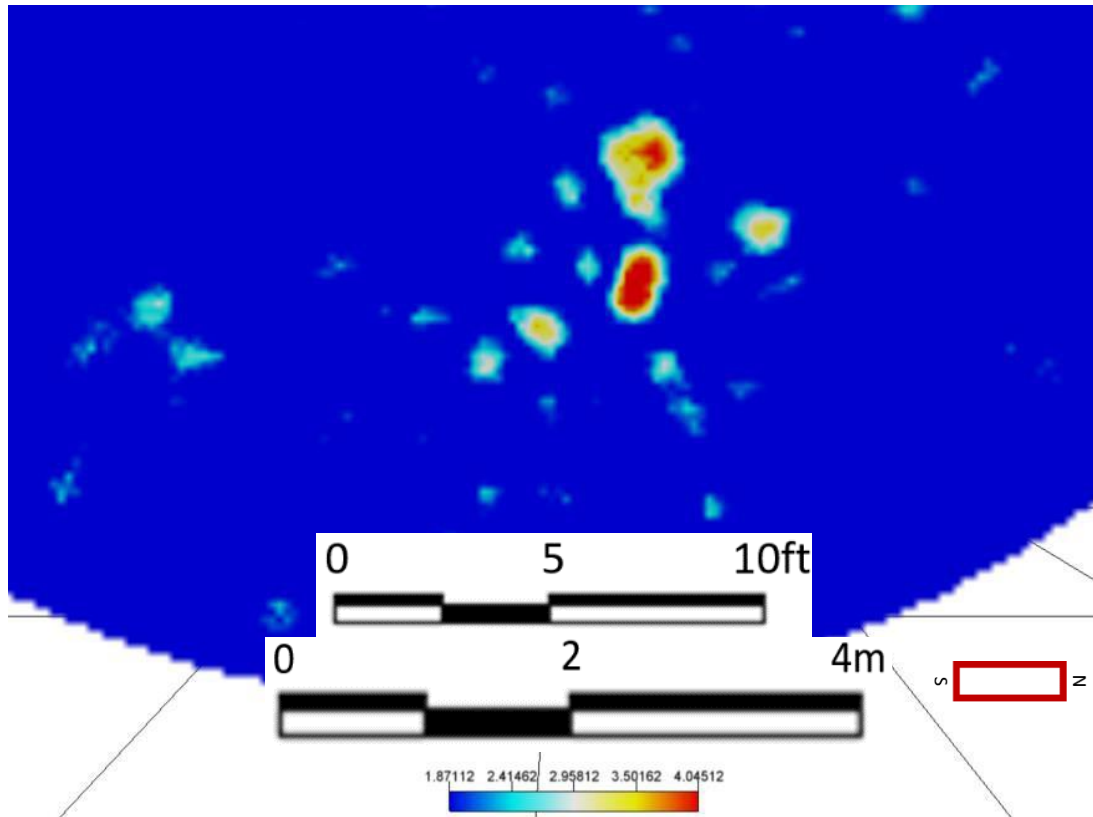
Figure 37 - Plan-view image of B3-HF-A01

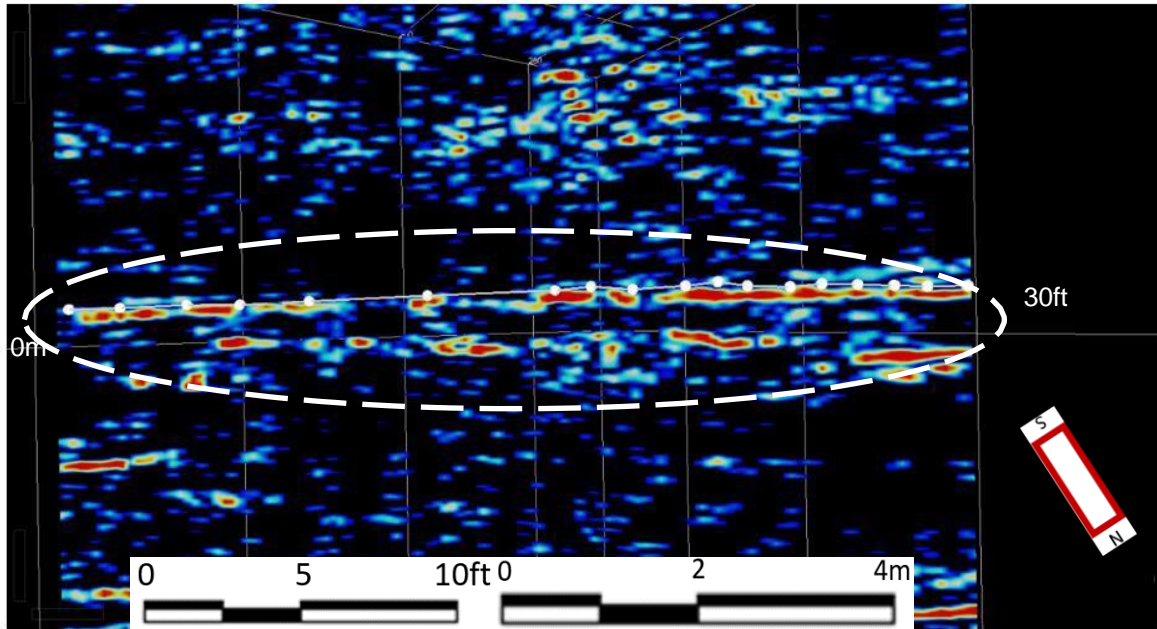
Figure 38 - Side-View image of B9-HF-C1 encircled located between 29-31ft BML

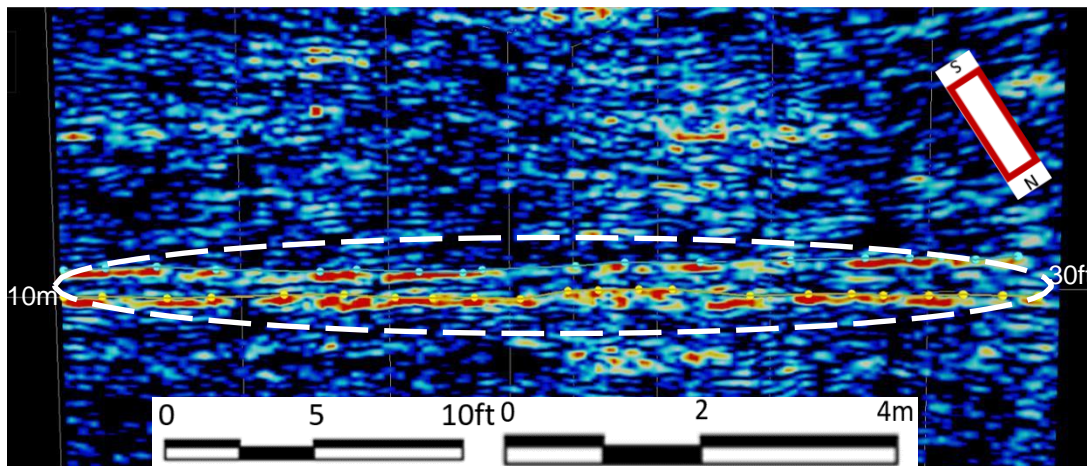
Figure 39 - Side-View image of B9-HF-C5 (Bottom) and B9-HF-C8 (Top). Note that these two linear features are nearly resting on top of one another. These linear features are located between 29-32ft BML

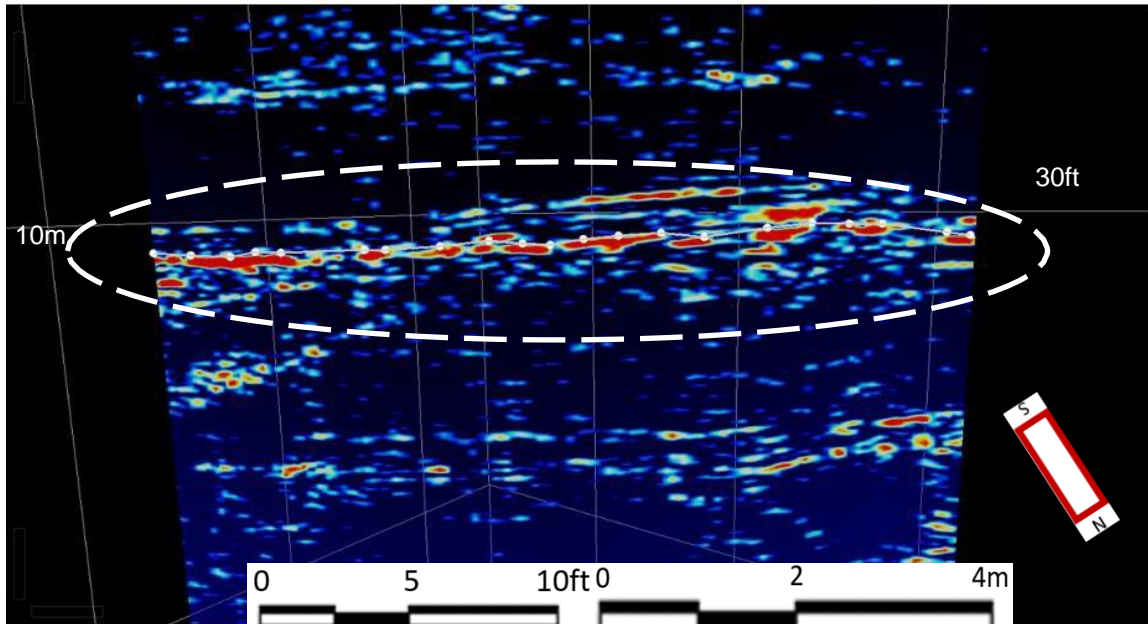
Figure 40 - Side-View image of B9-HF-C4. The feature is located between 33-36ft BML

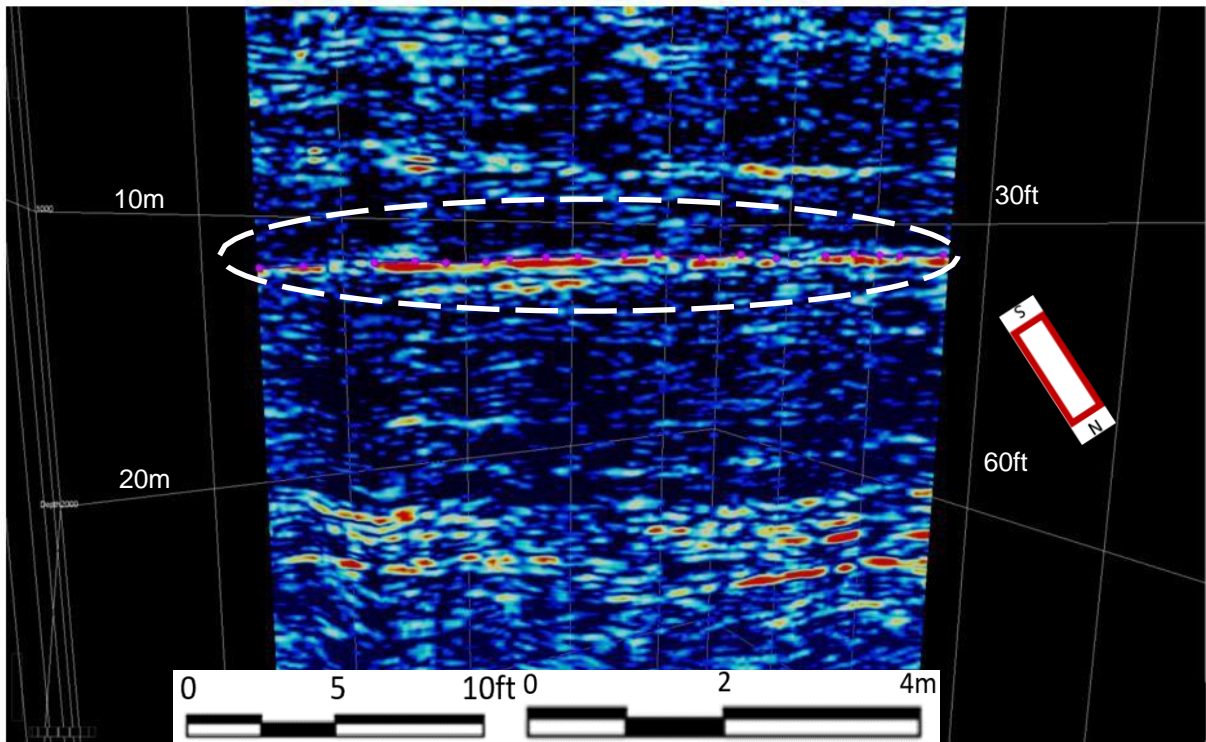
Figure 41 - Side-View image of B9-HF-C2. The feature is located between 35.5-37.5ft BML

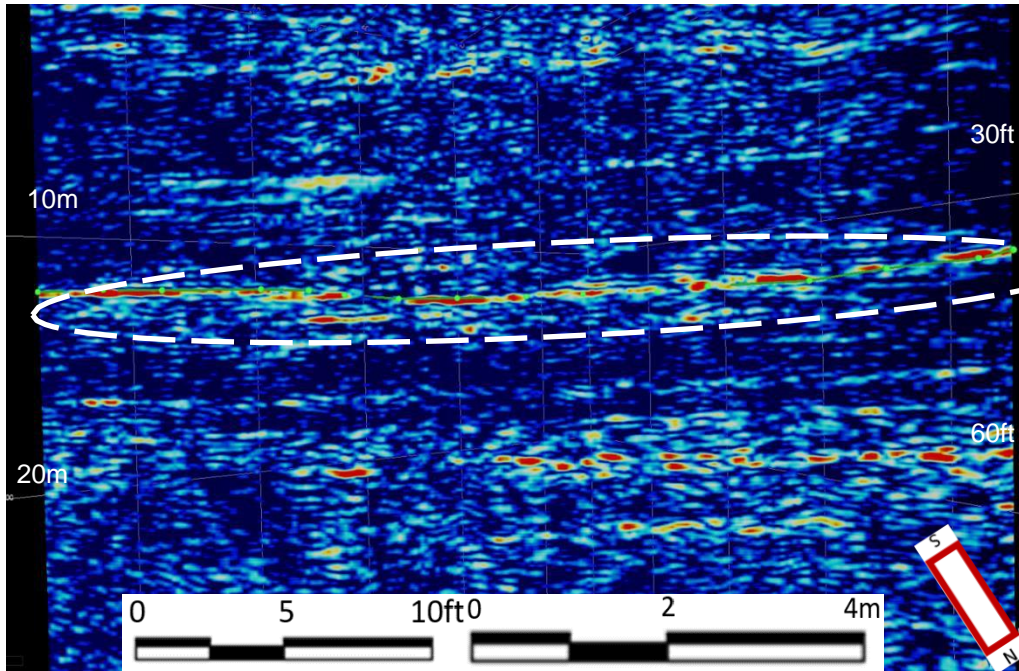
Figure 42 - Side-View image of B9-HF-C6. The feature is located between 39-43ft BML

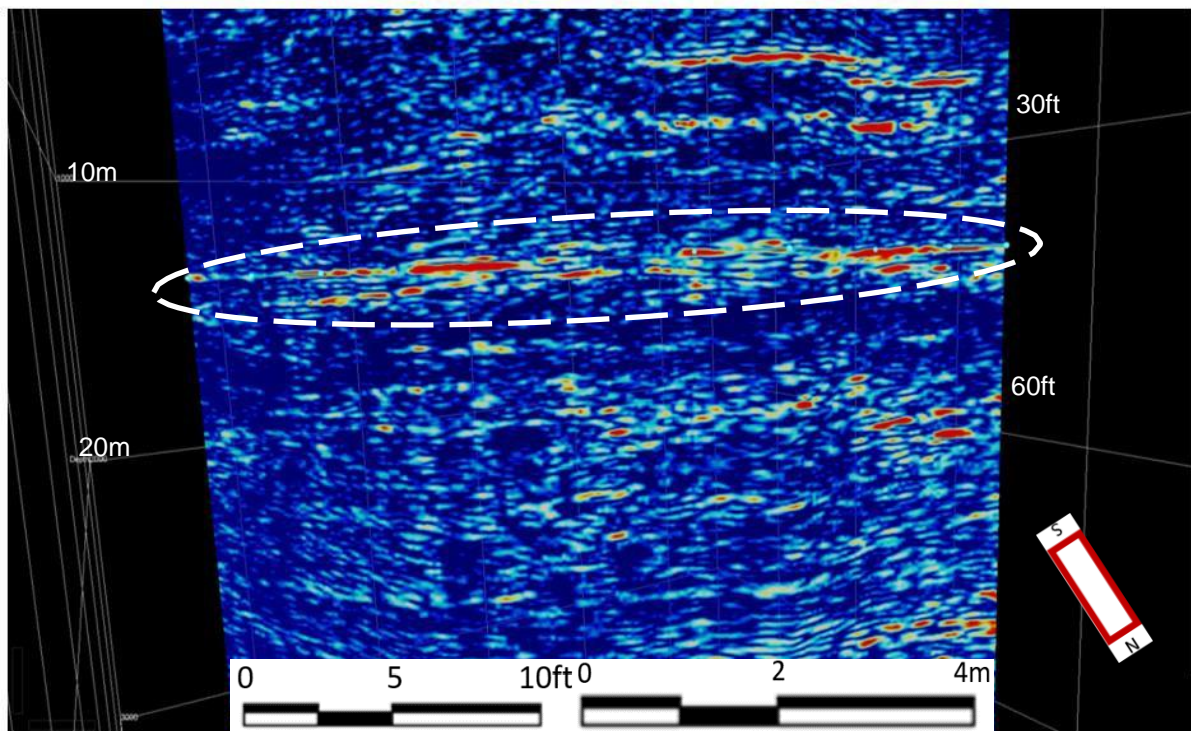
Figure 43 - Side-View image of B9-HF-C3. The feature is located between 42-45ft BML

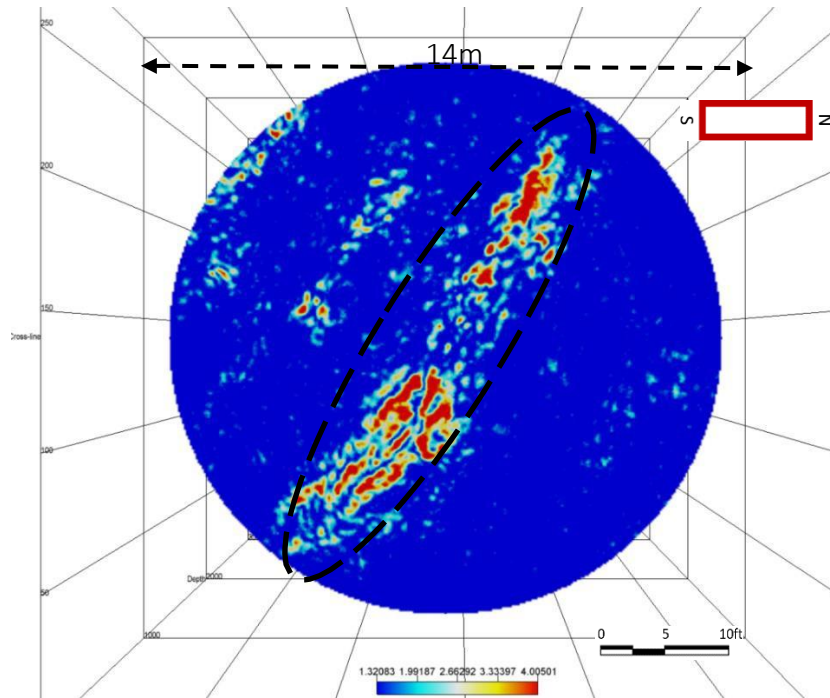
Figure 44 - Plan-view Image of B9-HF-C3. The image displays the full 14m acoustic core. This slice is taken at 13.54m BML (44.4ft BML)
