# Final Interpretive Report

## Acoustic Corer™ Survey to Identify Buried Conductors and Geo-Hazards at Mississippi Canyon Block 20 Gulf of Mexico

# Couvillion Group

## RPT-08387-5.0

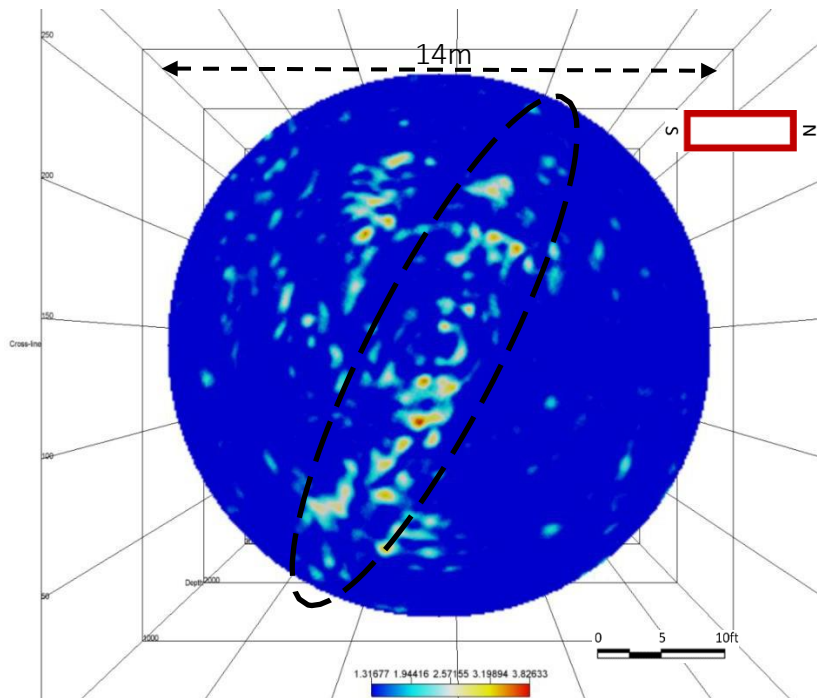
Figure 45 - Plan-view Image of B9-HF-C3 correlated in the LF SAS. The image displays the full 14m acoustic core. This slice is taken at 13.54m BML (44.4ft BML)

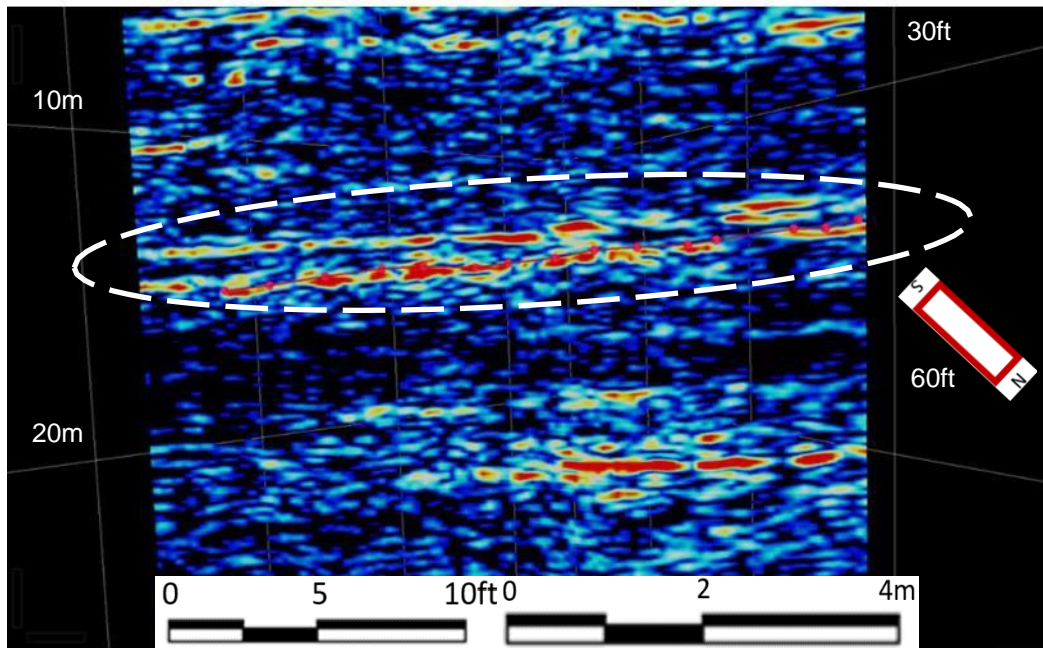
Figure 46 - Side-View image of B9-HF-C7. The feature is located between 46-49ft BML

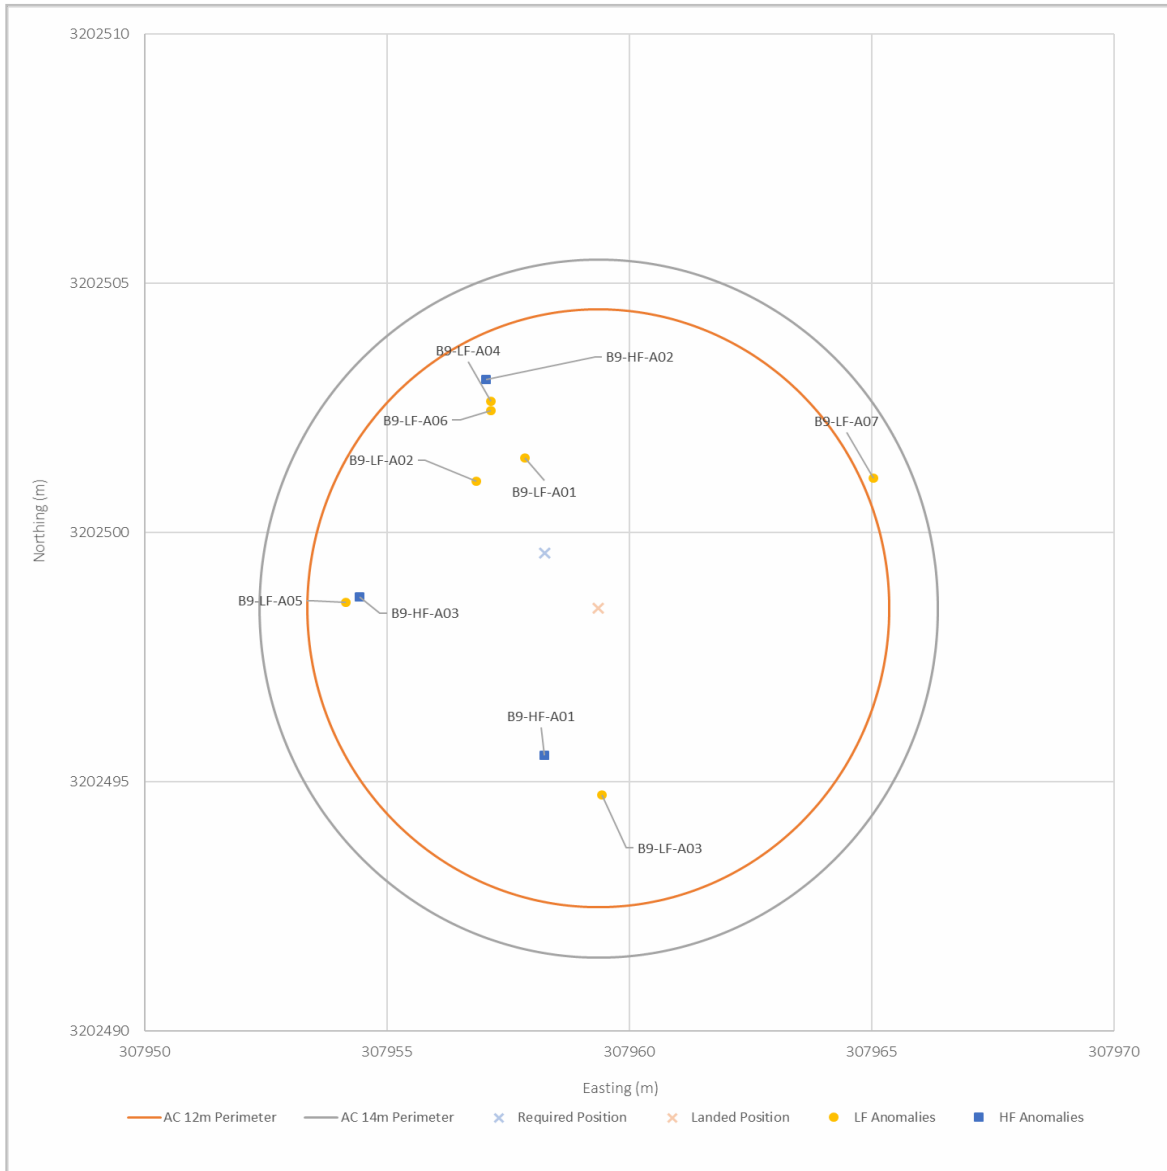
The anomaly analysis result is summarized in Table 20 as well as plan-view and cross-sectional plots in Figure 47 and Figure 48 below. Three anomalies were identified within the HF Core while 7 anomalies were identified in the LF Core. After further analysis, B9-LF-A01 and B9-LF-A02 first identified in the LF core were actually correlated with a dipping section of the linear feature B9-HF-C2 and B9-HF-C6 respectively. All anomalies were located between 10-27m BML (32-88ft). Sample images of identified anomalies can also be found in Figure 49 and Figure 50 below.

Figure 47 - Plan-View Image of Anomalies at Site B9

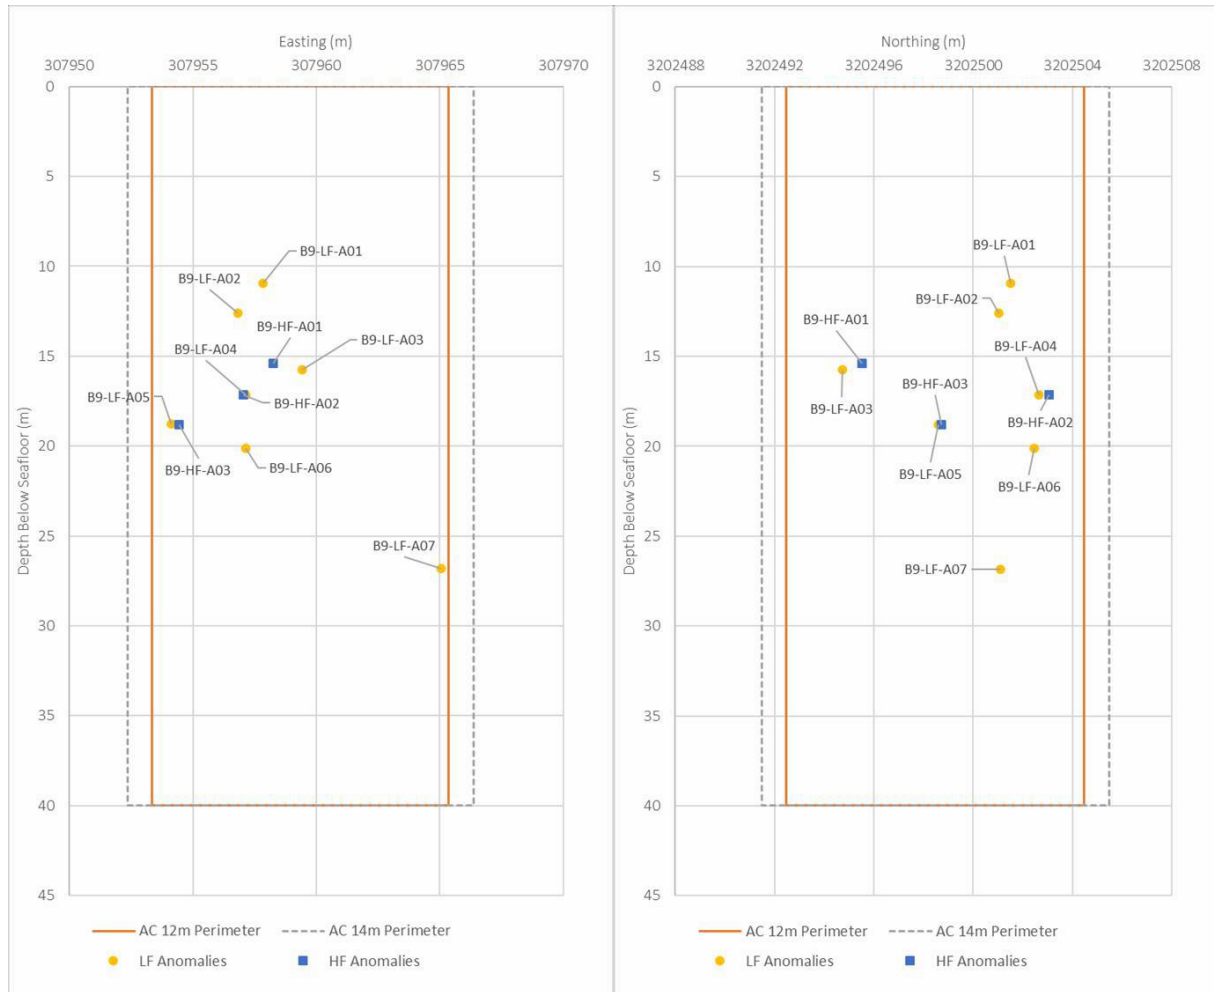
Figure 48 - Cross-Sectional view of the HF and LF acoustic anomalies at Site B9 oriented East-West (left image) and North-South (right image)

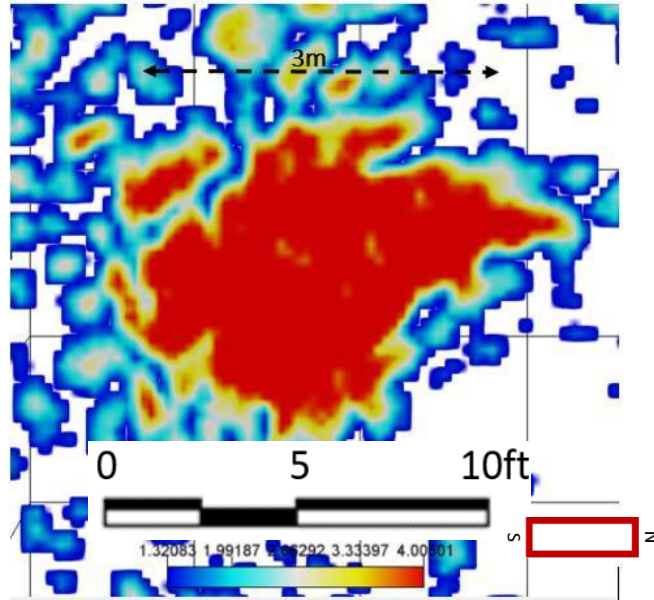
Figure 49 - Plan-view Image of B9-HF-A01.

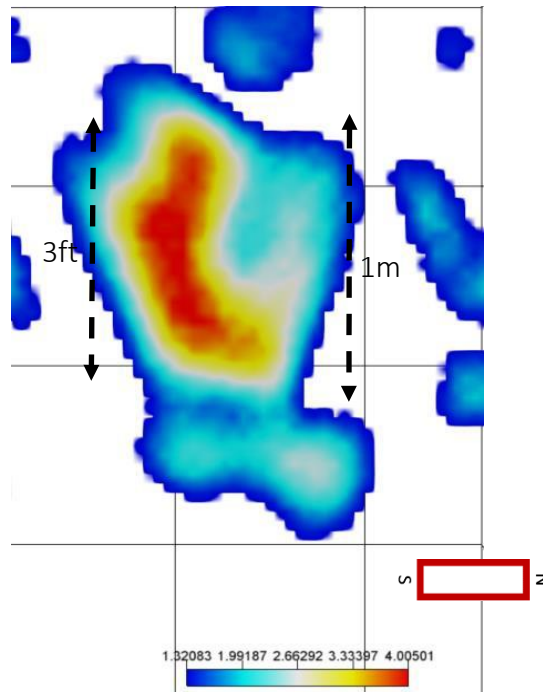
Figure 50 - Plan-view Image of B9-LF-A06

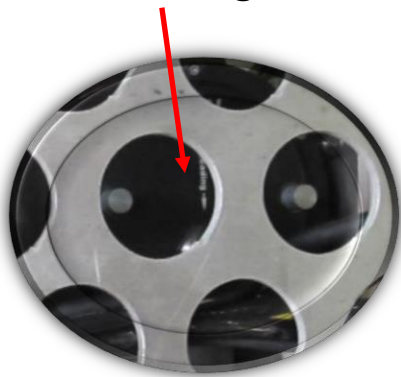
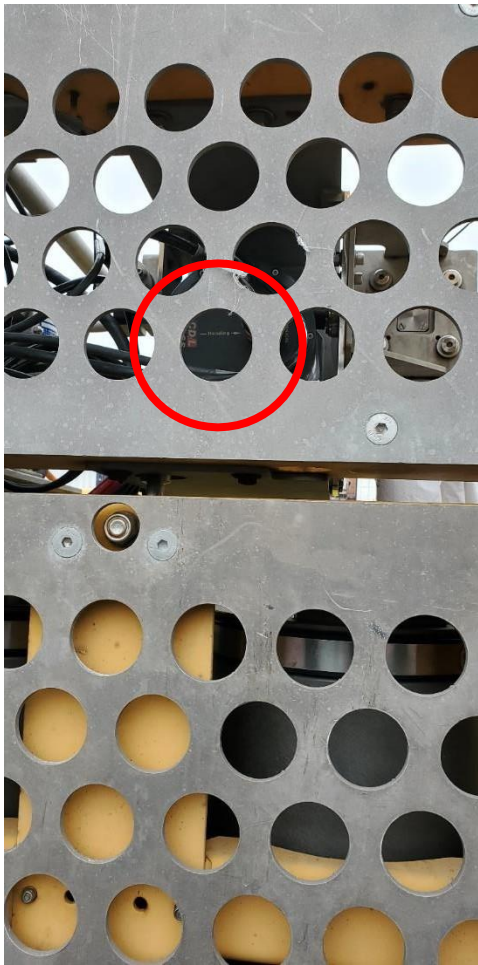
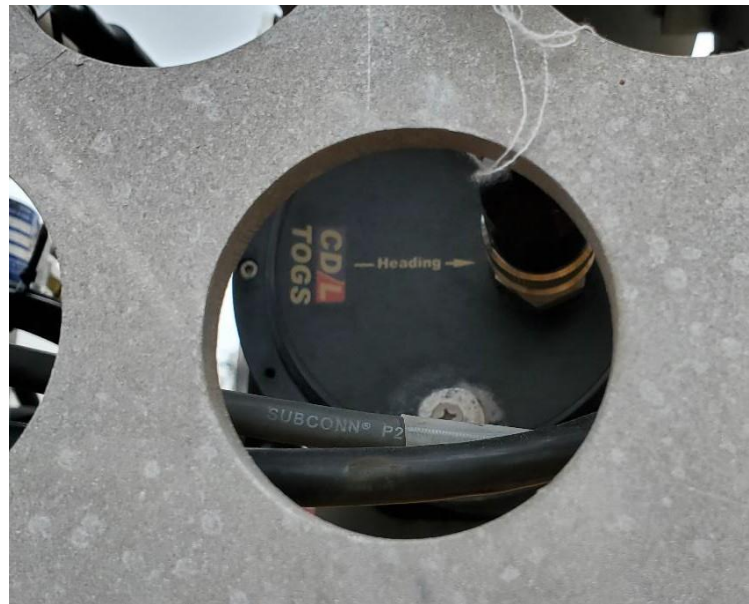
During the change to the **REDACTED** system, the team failed to identify unintended consequences of changes to established Pangeo procedures and checks.

The “heading arrow” on the TOGS Gyro system should point toward the rear of the AC as per PanGeo engineering drawings. (Alignment Notch in direction of Boom Extensions). Prior to the MC 20 project the AC underwent a complete refurbishment. During the final stages of reassembly, PanGeo’s lead mechanical expert was absent due to personal reasons. The QC audit revealed that the onsite lead responsible for the AC maintenance program recalled orienting the arrow on the TOGS mounting flange to point toward Boom 1. This offset would cause a 90-degree shift in the heading reading.

Pangeo engineered drawing displays the heading arrow to be pointing to the rear of the AC. On MC 20 the arrow was aligned wards Boom 1 causing the +90-degree misalignment to the correct installation as per the AC’s engineering documentation. This resulted in an apparent 90-degree rotation in the AC data set.

Figure: Image showing incorrect orientation of TOGS, Mississippi Canyon Campaign 2019
