**Investigation of Loss of Well Control and Fire  
South Timbalier Area Block 220, Well No. A-3  
OCS-G 24980  
23 July 2013**

**Gulf of Mexico  
Off the Louisiana Coast**

David Trocquet – Chair  
Jack Williams  
Marty Rinaudo  
James Richard  
Charles Arnold  
Michael Idziorek  
Michael Pittman  
Matthew Capon - USCG

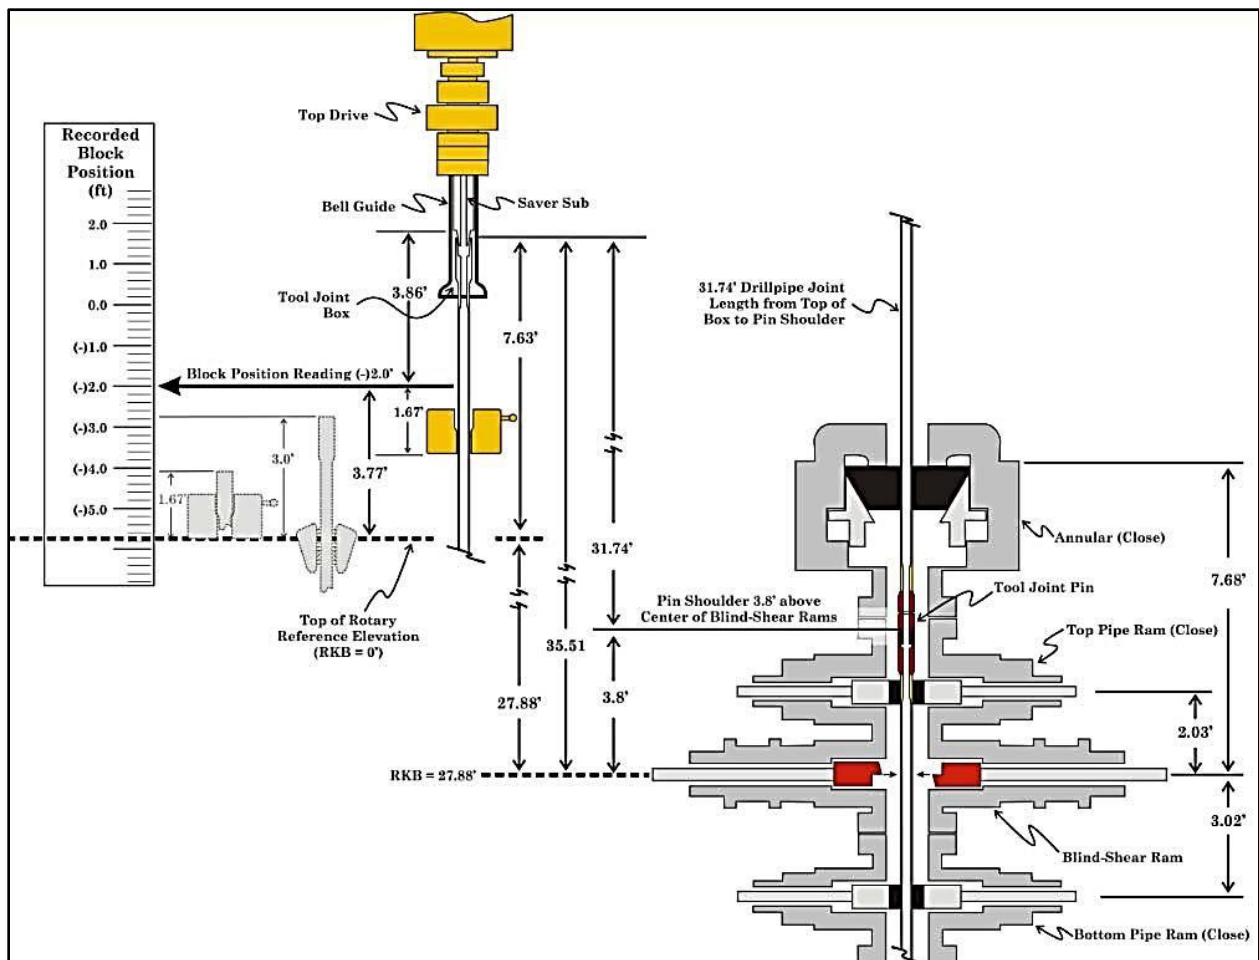
**Figure 21:** Estimated position of tool joint and top drive bell guide preventing installation of safety valve (from SME Committee Report)

Statements from the Driller and Derrickhand indicated that they first attempted to direct the Floorhands to install the safety valve into the drill string as per the Hercules procedure. Statements indicated that the force of the ejecting fluid was pushing the pipe out of the hole and the weight of the drill pipe string remaining in the hole was apparently insufficient to pull the string down to a position where the valve could be installed. It was noted that this proved impossible because the connection of the drill string was about 8-ft above the rig-floor, pushed up inside of the top drive bell guide (*see figure 21*). In that position, the Floorhands could not access the box end to position the safety valve. .

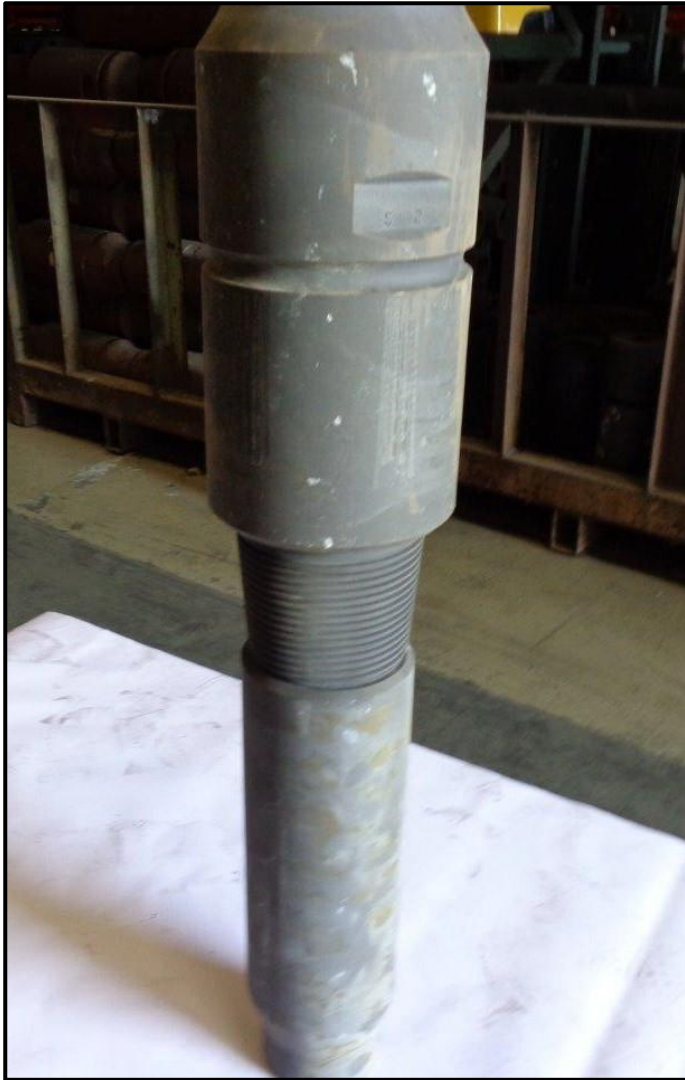
**Figure 22:** Top drive 5-in pin above 3 ½-in box

Statements were also received that the top drive pin connection had not been changed from 5-in to 3 ½-in

pressure of the Well, operating on the end of the drillpipe and packer, was already forcing the pipe out of the hole up into the top drive bell guide making it impossible to position the pipe so that the safety valve could be stabbed. So he then closed the annular. It remains unknown if closing the annular early contributed to the inability to stab the safety valve.

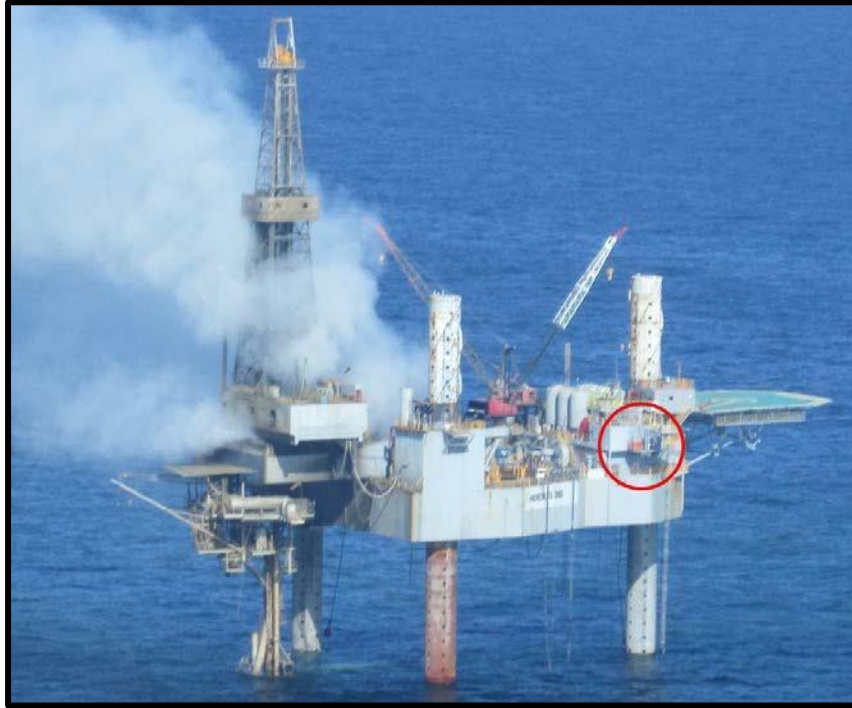
**Figure 28:** Hercules 265 capsule No. 2 location – after deployment

When the #2 life-capsule (*see location, figure 28*) reached the waterline it briefly became caught on the starboard escape ladder. The motormen used the vessel's engine and rudder controls in combination with the sea swells to free the life-capsule. Once free the life -capsule moved safely away.

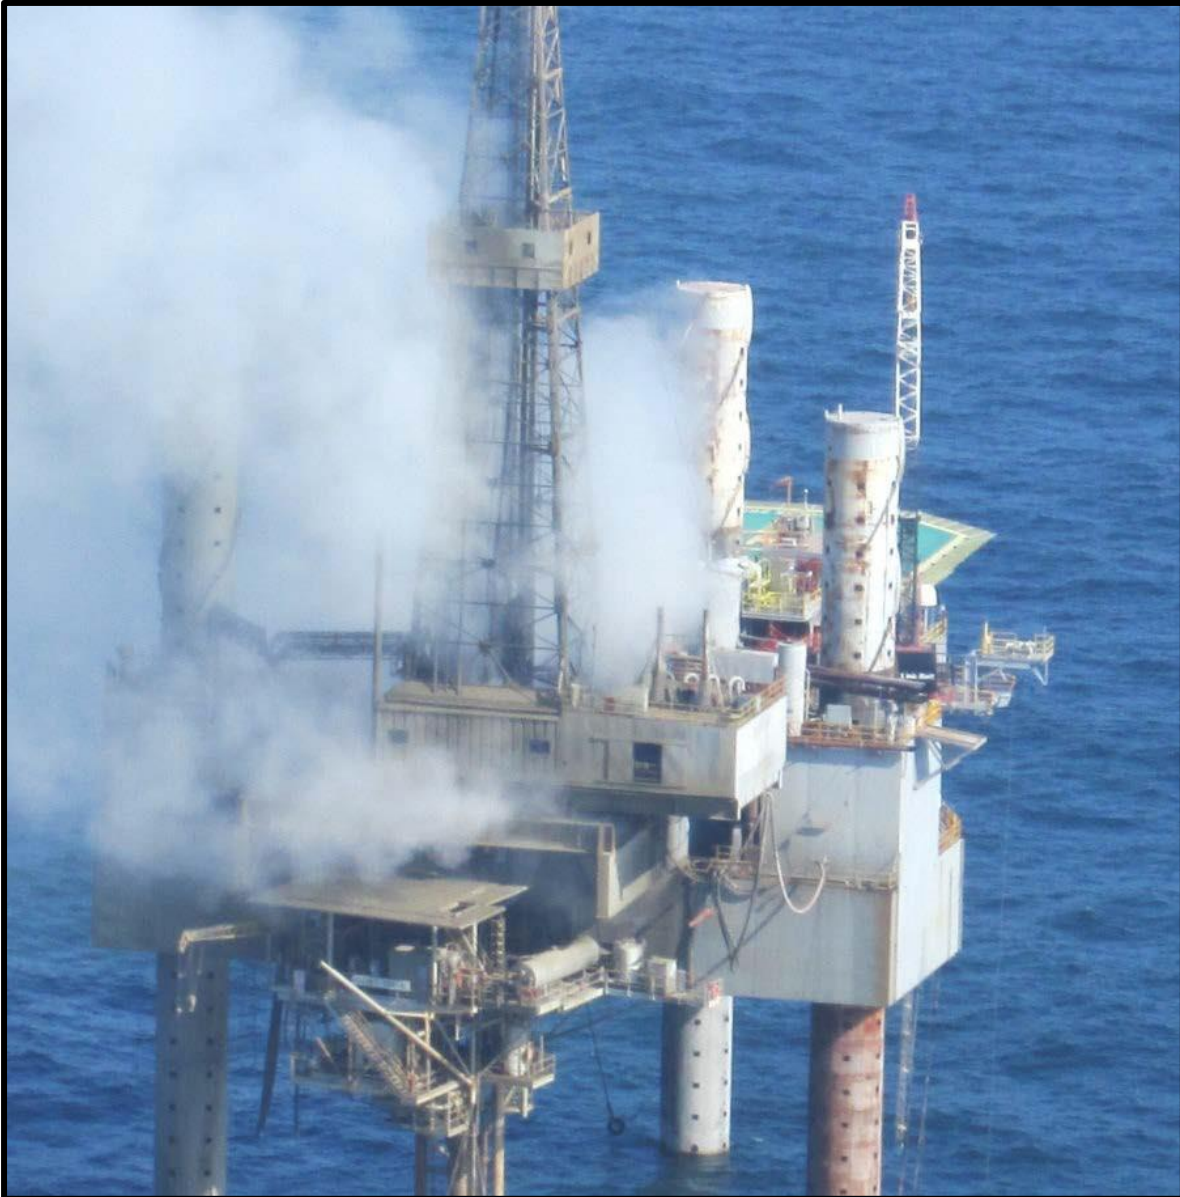
**Figure 29:** *Rig and Platform after abandonment and loss of control*

After the Rig was abandoned, the uncontrolled flow from the Well continued to strengthen. The SME Committee Report stated their opinion that leakage through all BOP stack components became obvious by approximately 0900 hrs “as high velocity sand began eroding the blind shear ram seals...”

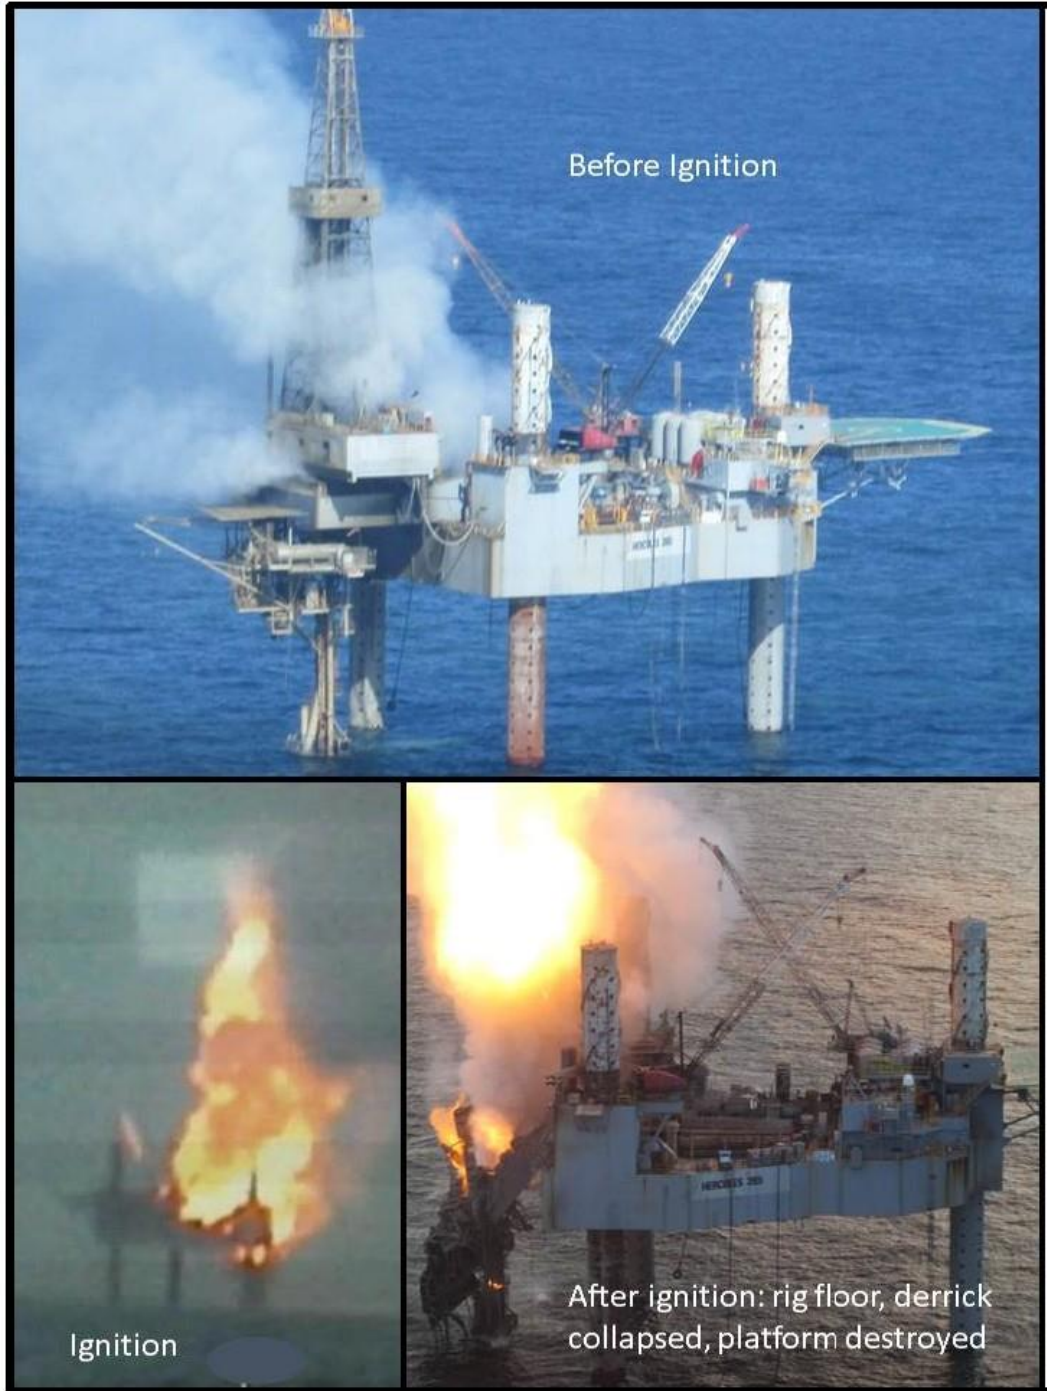
*Figure 30: Rig, Platform, and Well prior to and after ignition*

of production of some formation water suddenly caused the Well to bridge naturally at 2145 hrs, 26 July 2013. The bridging extinguished the fire except for an occasional small residual flame and some continued burning of combustibles on the remains of the Platform and Rig.

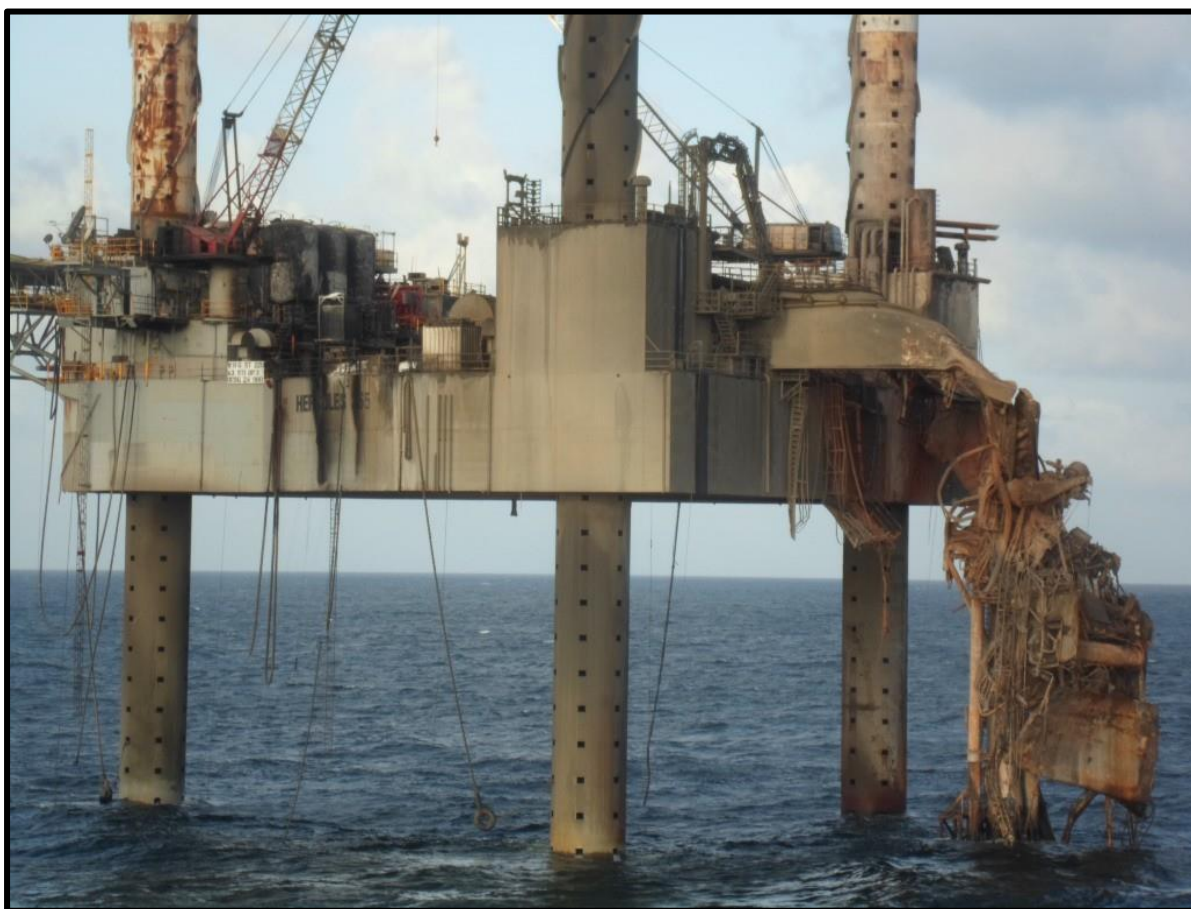
**Figure 33:** *MODU and Platform, after Well bridged*

**26 July 2013:** The Well bridged over and remained in that status for the duration of the response (*see figures 33-36*).

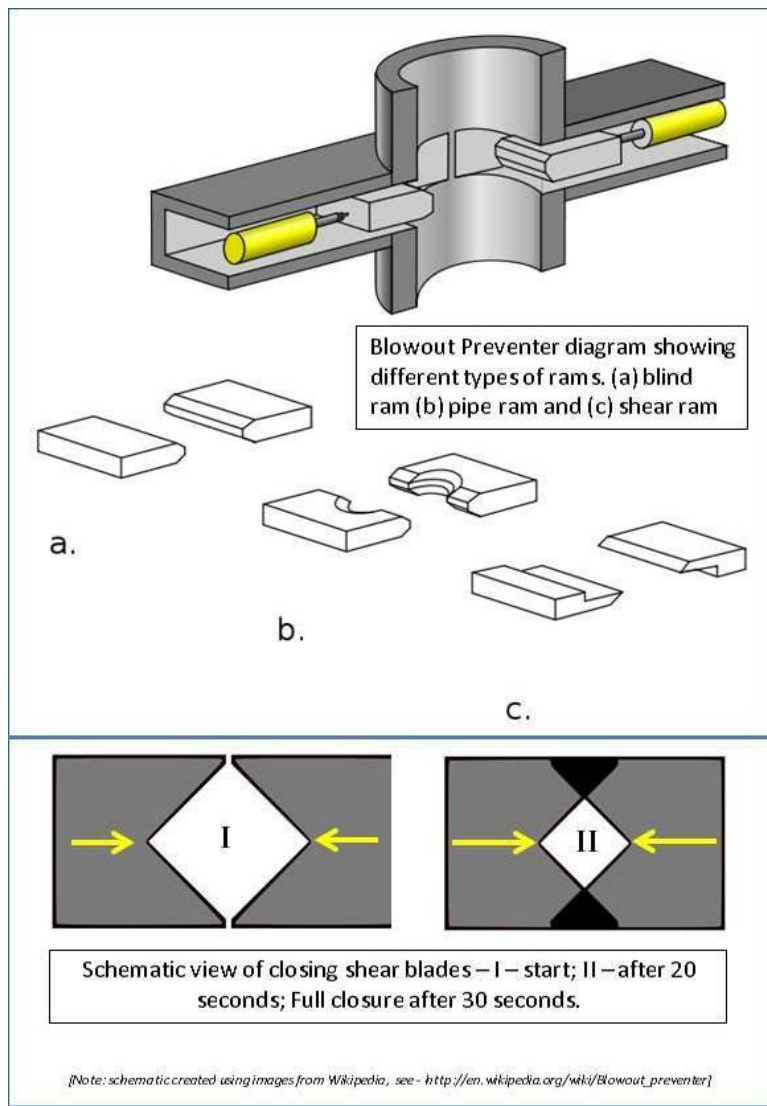
**Figure 48:** Why blind shear rams create production choke conditions

*“...Further, it is believed that this high pressure in the well and a loss of hydraulic closing pressure would have allowed the blind shear rams to begin to leak continuously at a high pressure if they had successfully sealed. Gas moving through a small opening at sonic velocity and carrying sand is known to cause very high erosion rates that can cut through steel in a short period of time...” (emphasis added).*
