**MANAGEMENT OF HUMAN ERROR
IN
OPERATIONS OF MARINE SYSTEMS**

**A GORDIAN KNOT:
INTO WHICH SAILED
THE *EXXON VALDEZ***

**Karlene H. Roberts
&
William H. Moore**

**Report No. HOE-92-1
January, 1992**

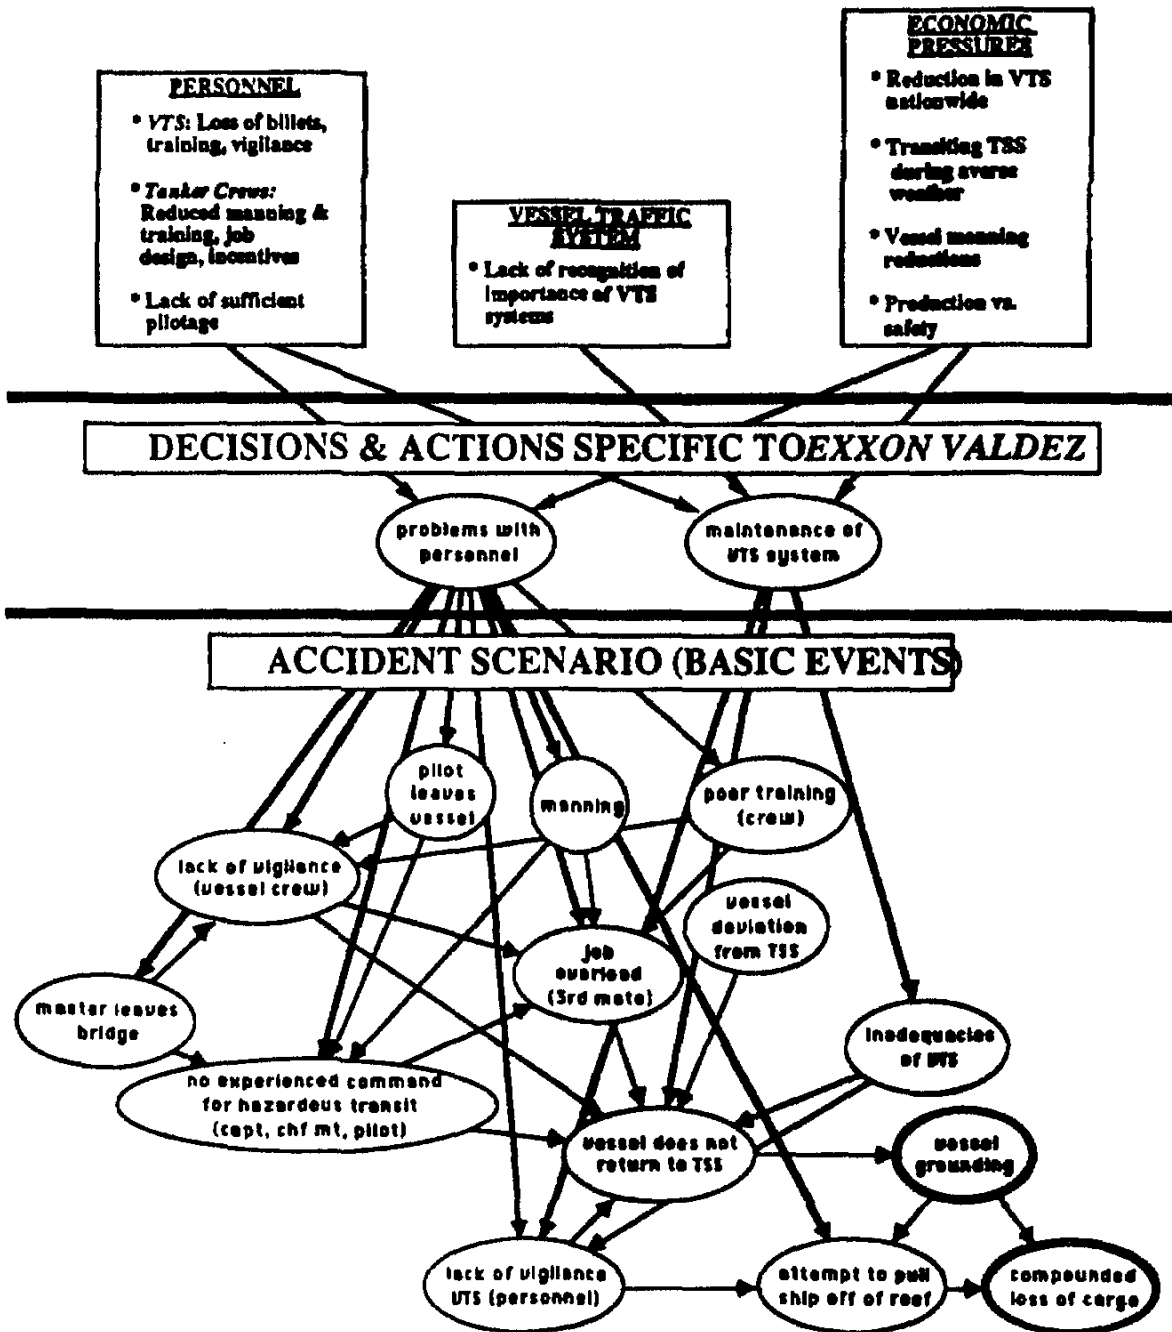
Figure 2: Dependencies among events of accident scenarios, decisions and actions specific to the grounding of the tankship Exxon Valdez and organizational factors

All in all the Valdez Coast Guard looks like an organization of deteriorating resources, suffering from downsizing, and lack of appropriate training. Figure 2 shows the organizational factors between both *Exxon* and the Coast Guard which led to the *Exxon Valdez* grounding. This figure demonstrates the personnel and economic pressures were observed in both organizations which were critical to the events leading to the grounding.
