Post Mortem Failure Assessment of Jack-up MODUs During

Hurricanes Katrina & Rita

August 2005 & September 2005

Minerals Management Service

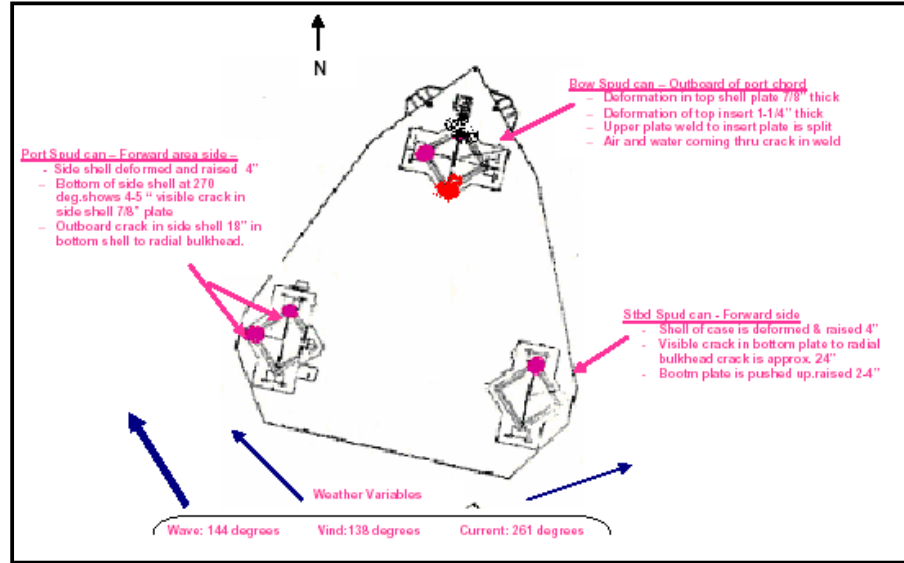
Figure 8.1.1: Spud Can Damage Locations. The rig is shown at 13 degrees heading, the maximum winds came from 138 degrees, the waves from 144 degrees. The damage to the spud cans is noted.

The Spud can damage pattern confirms it is as a result of the storm/hurricane.

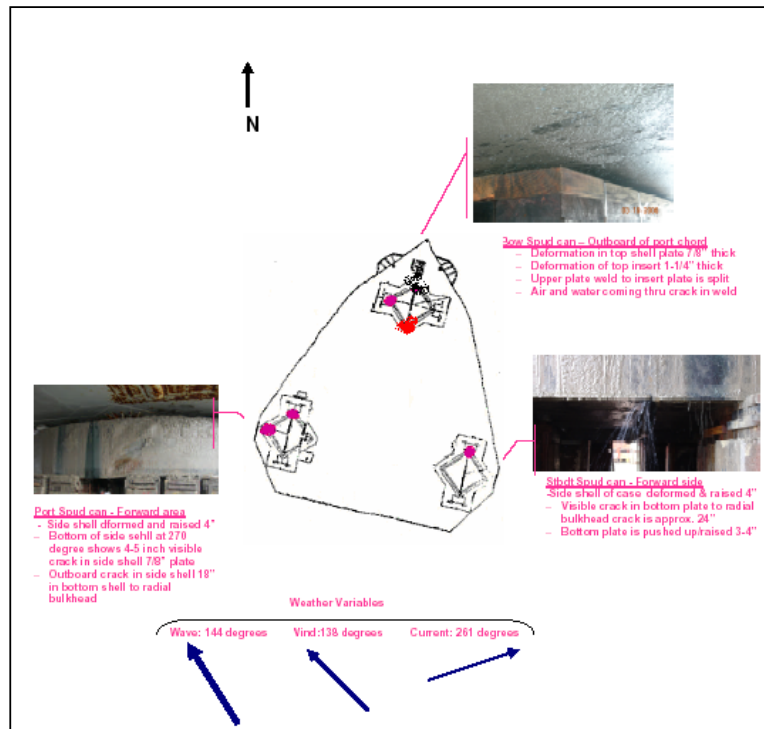
Figure 8.1.2: Spud Can Damage Locations. 1 photo from each spud can is shown superimposed on the Figure 8.1.1.

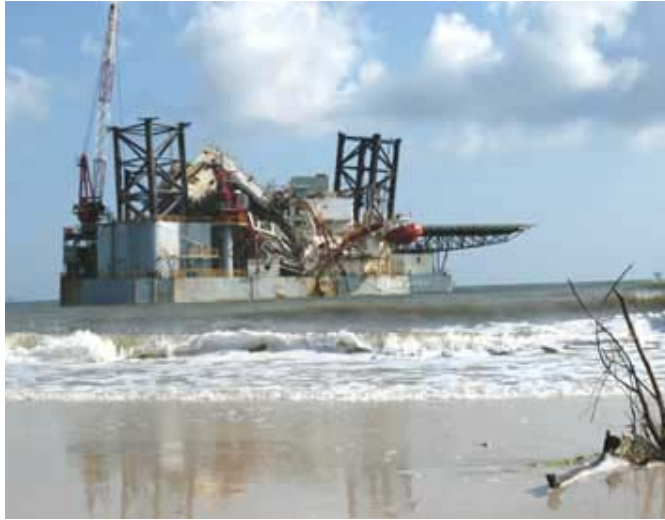
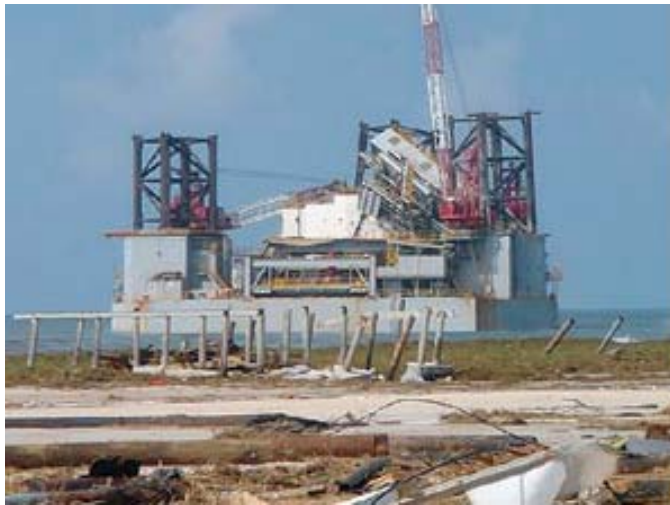
All 3 legs failed and the rig floated off location and beaching at Dauphin Island. The derrick fell on the quarters and all legs were damaged below the guides, with further damage in the upper legs. The rig was declared a total constructive loss.

Photos 8.3.2 The Ocean Warwick as seen from Dauphin Island.

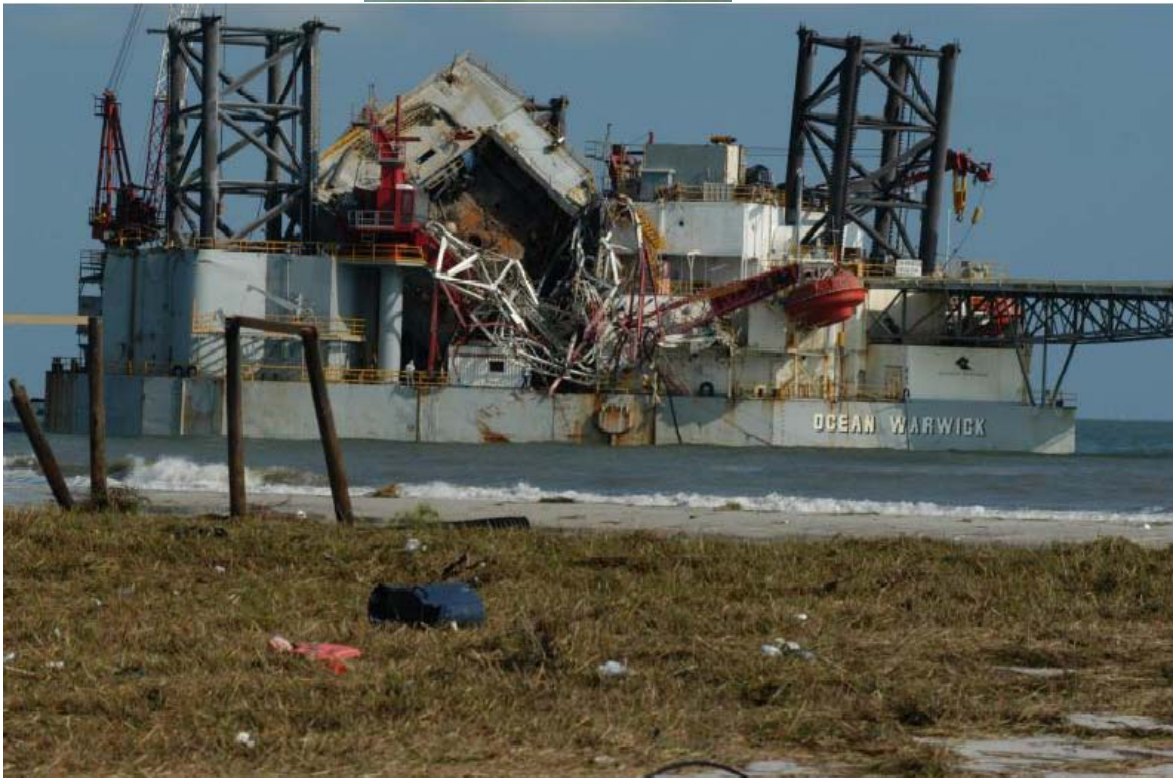
Photos 8.3.3: Different perspectives of Ocean Warwick, on the beach.

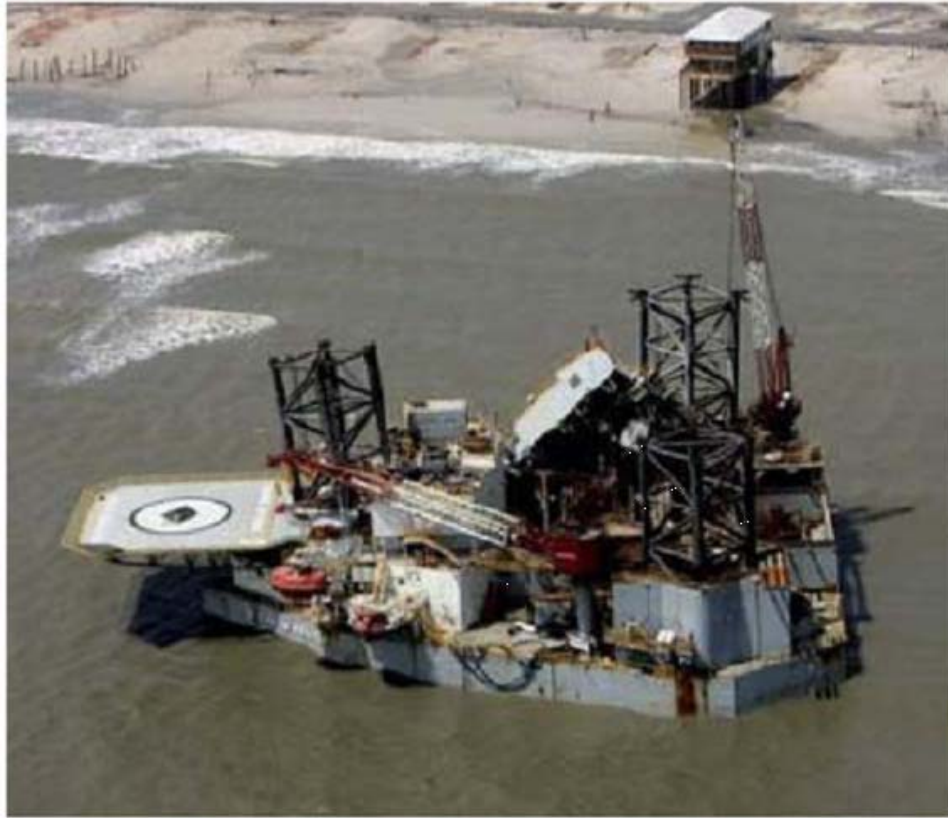
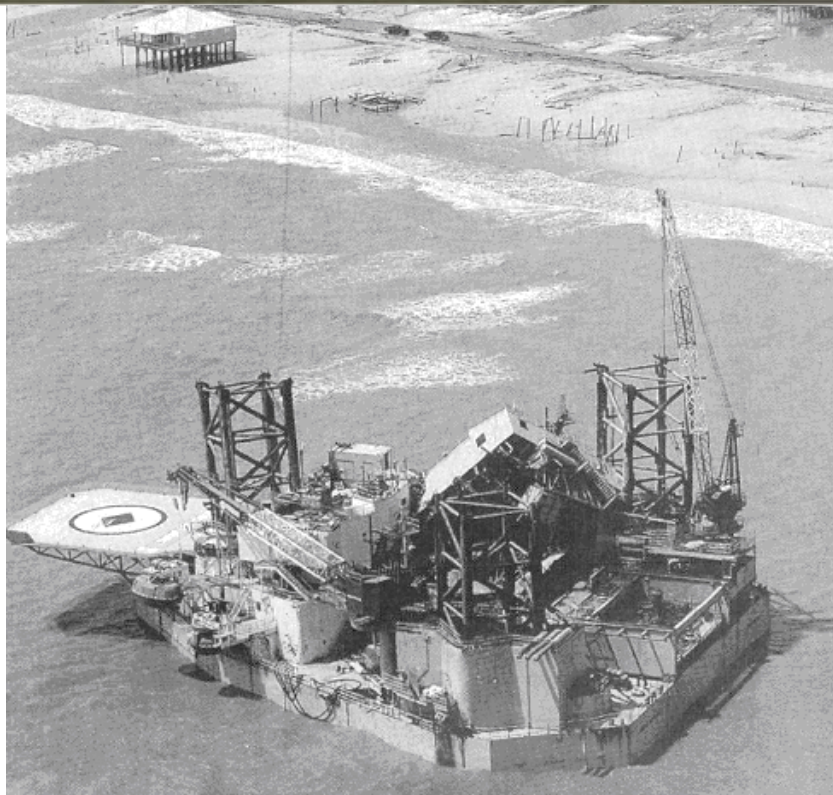
Photos8.3.4: Ocean Warwick in Color and in Black and White to provide better detailing.

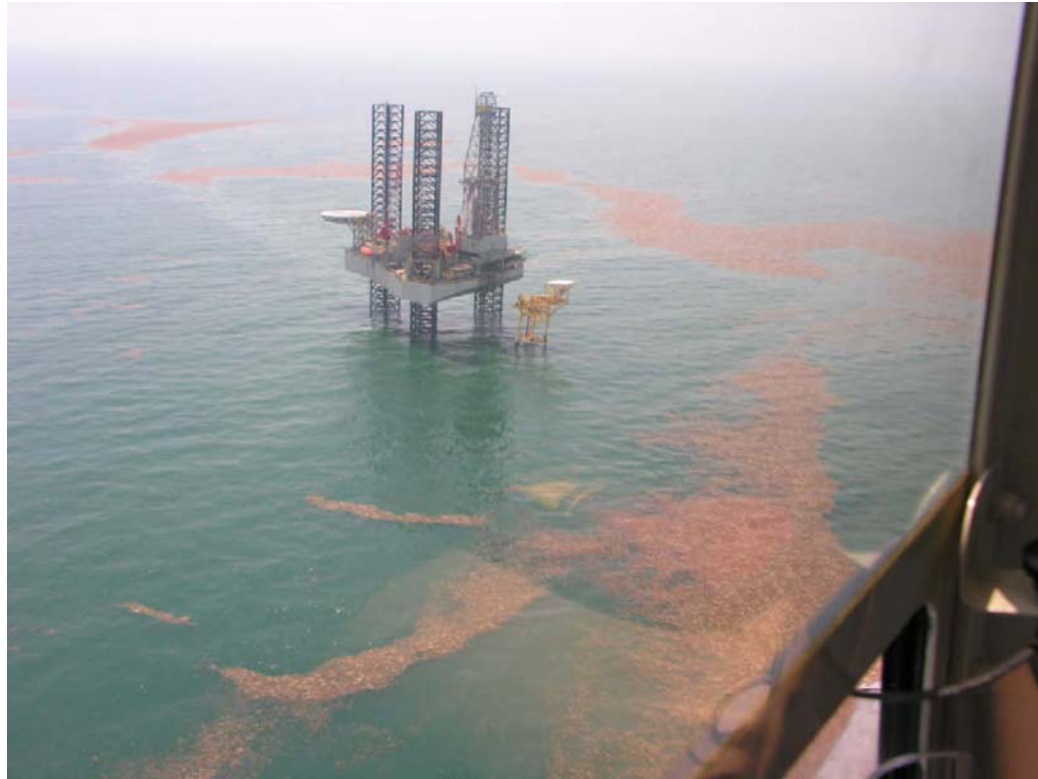
Photo 8.4.2: Ensco 74 on location after Hurricane Katrina
(Courtesy of Dominion)

As a result of Hurricane Katrina the starboard leg of the Ensco 74 penetrated an additional 1 ft. There was some jacking system (7 final drive units, 1 gear box) damage, minor bottom shell damage (two bottom shell plates 28A, 29A local damage), and a few cracks in welds at the gear unit brace beams' back-up structure at main deck. There were 5 lights and minor wiring in derrick damaged, and 2 deepwells grounded. The rig was repaired on location and returned to service. The main damage is believed to have been caused by the waves contacting the hull bottom.

photos. It was not relocated prior to or after the storm. The jacket was pulled straight with a crane and tugs then the damaged jacket leg was repaired.

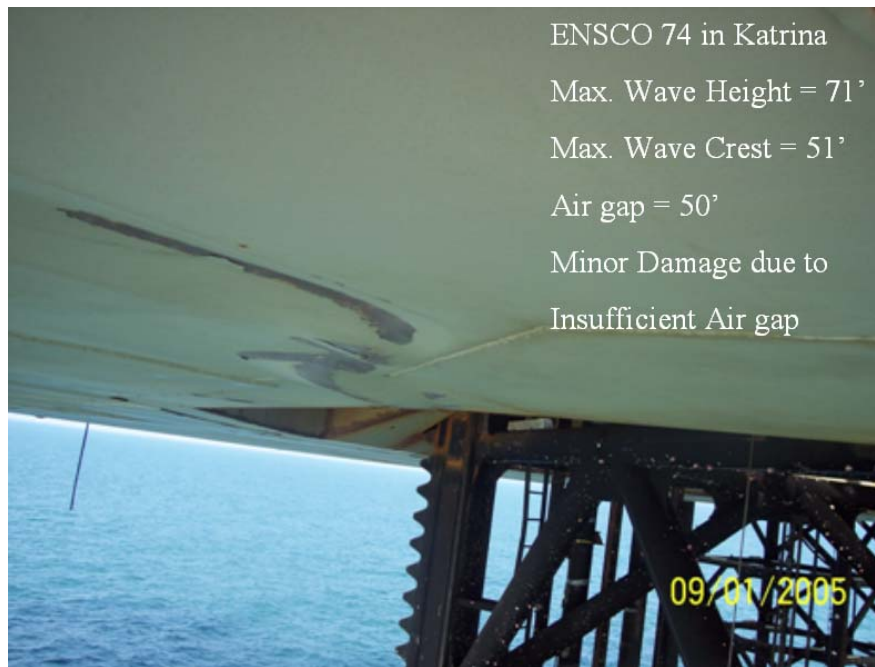
Photo 8.4.5: Bottom of Hull showing Damage from Wave hitting underside of Hull (Ref 12).

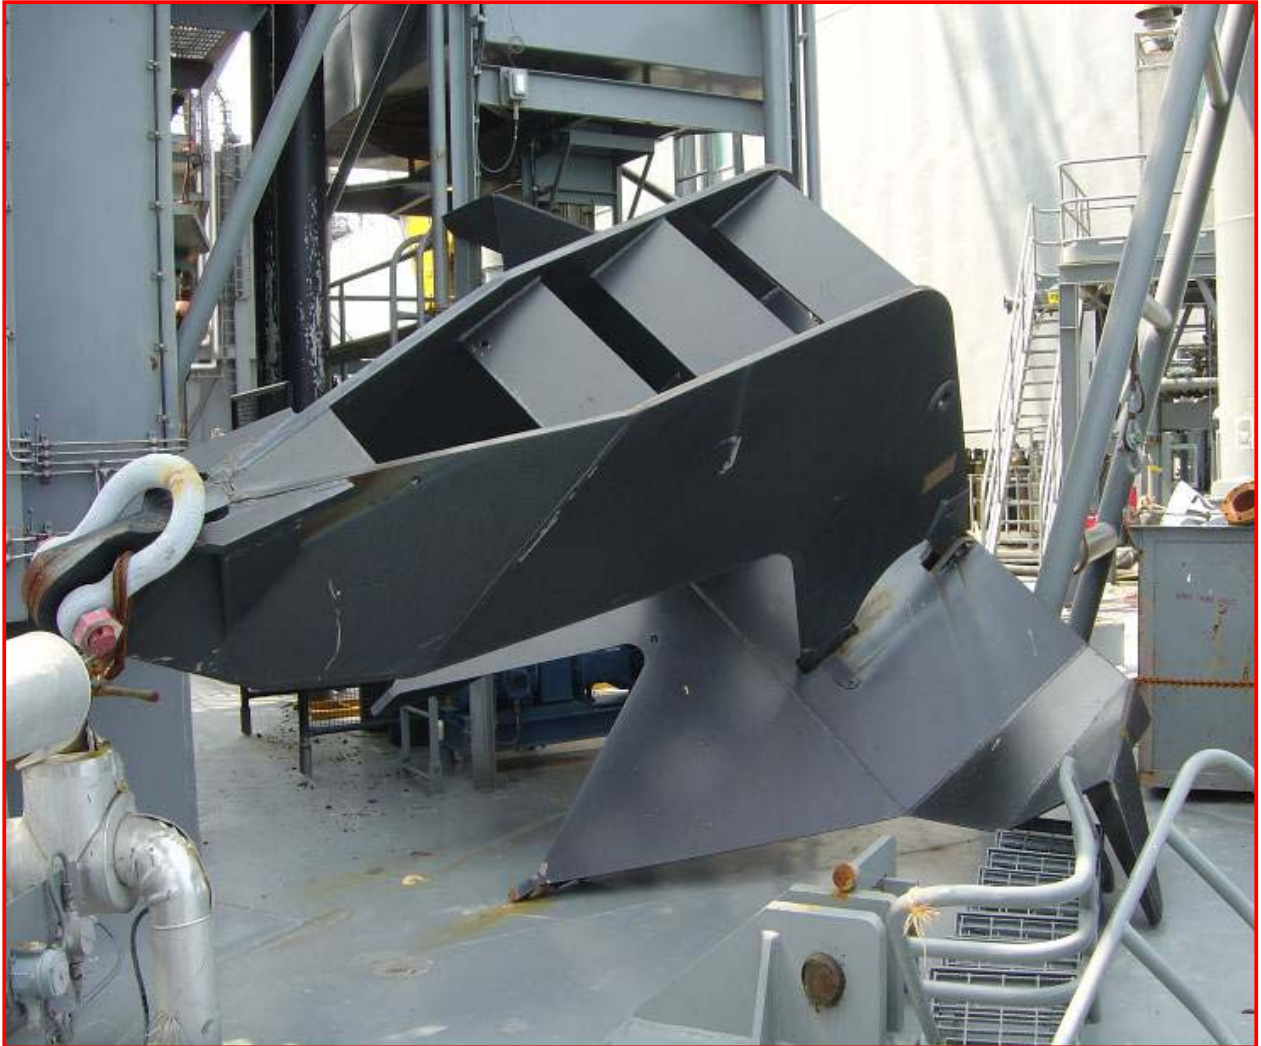
Figure 8.13.1: 5-ton anchor was racked on the exterior of the hull 50 feet above the sea before the storm

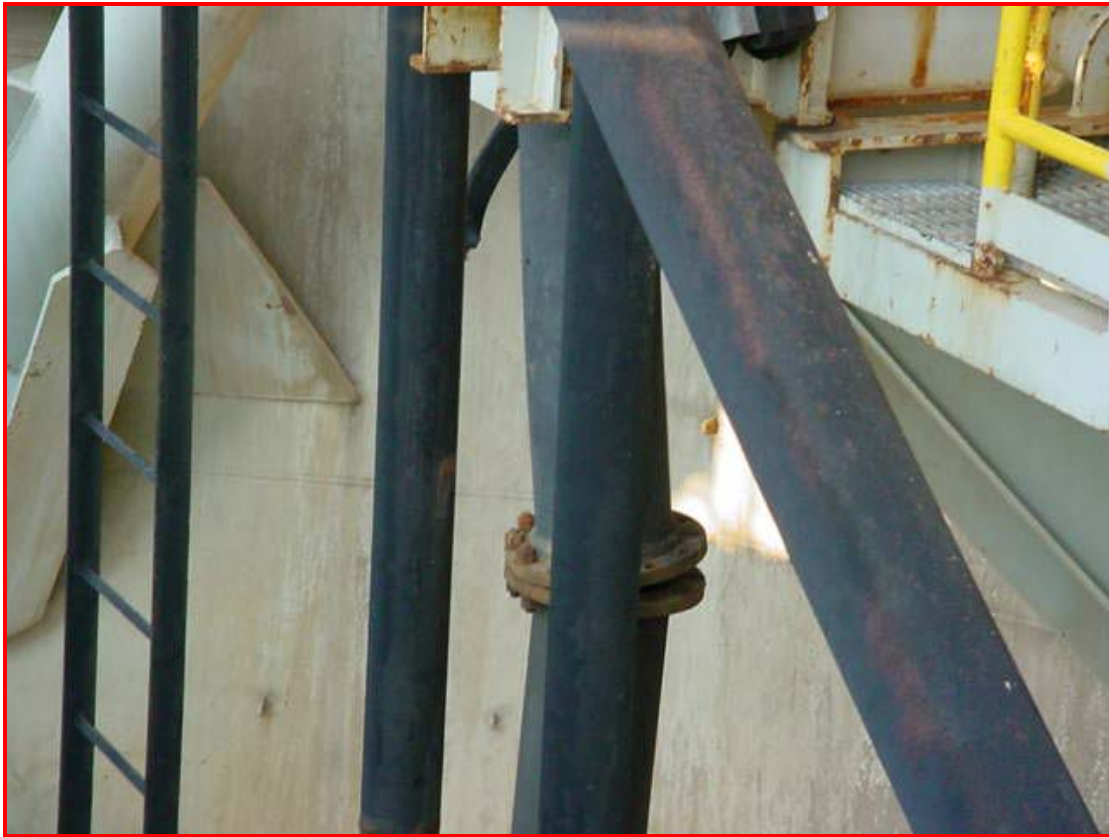
Photo 9.13.1 showing the deepwell pipe damage on the ENSCO 105.

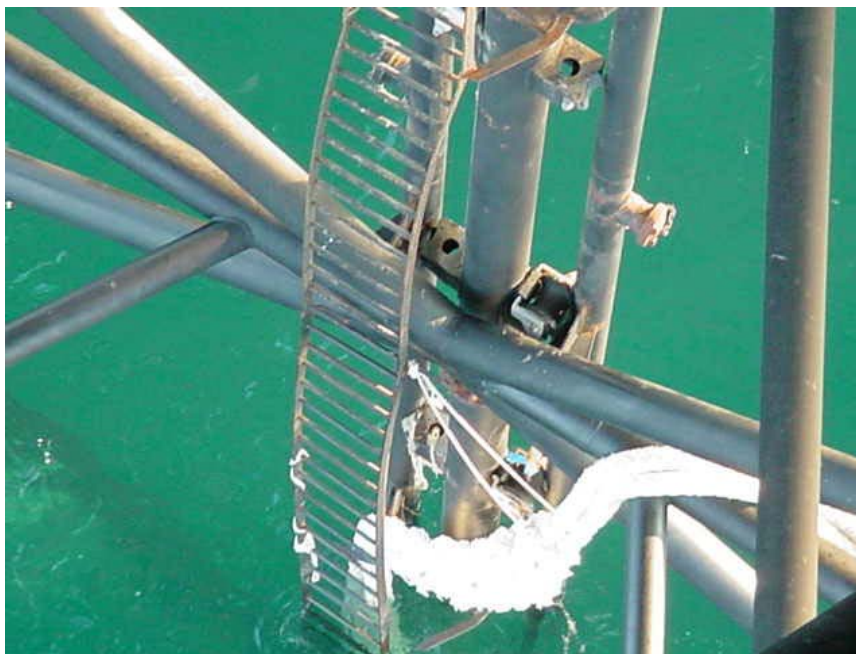
Photo 9.13.2 showing leg ladder damage on ENSCO

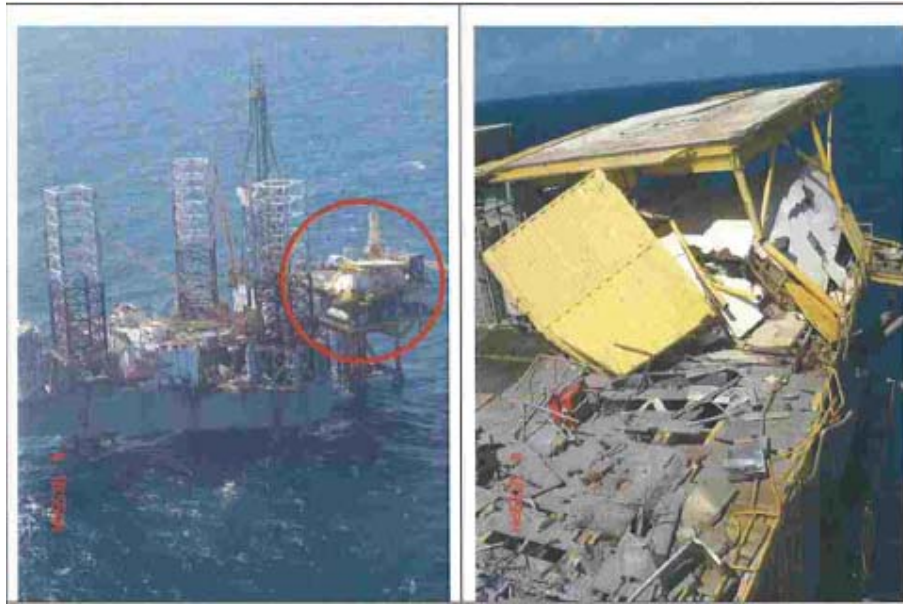
Photos 9.14.1 – Rig/Platform interface after the Hurricane Rita

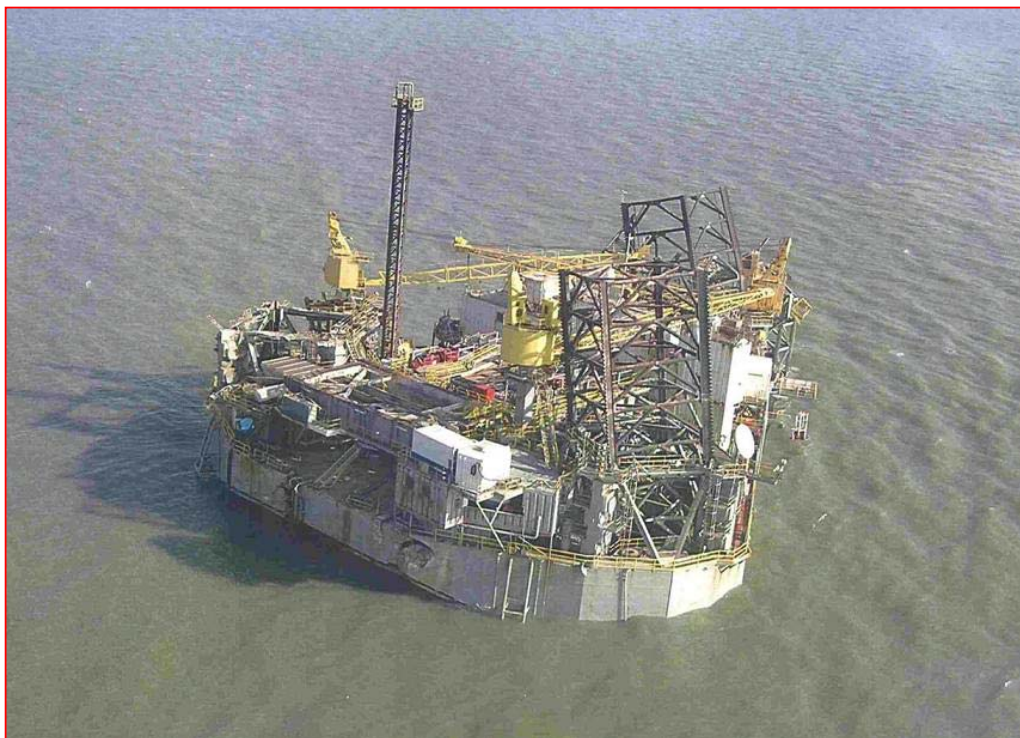
Photo 9.15.4: GSF Adriatic VII Note: Drilling package is missing and the holes in the aft end facing the reader.

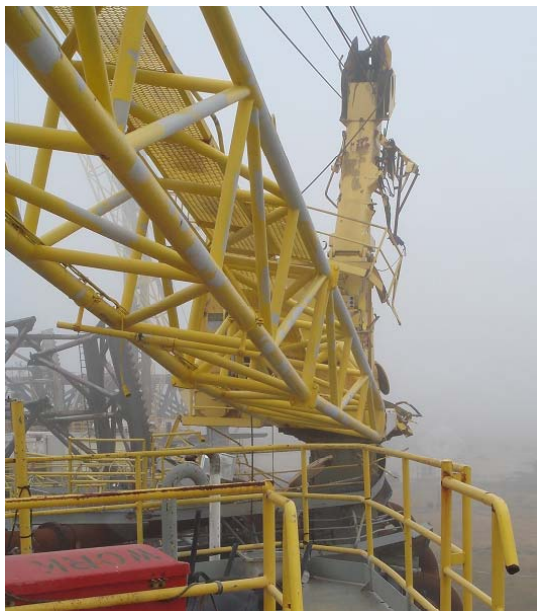
Photo 9.15.9: Crane damage to boom

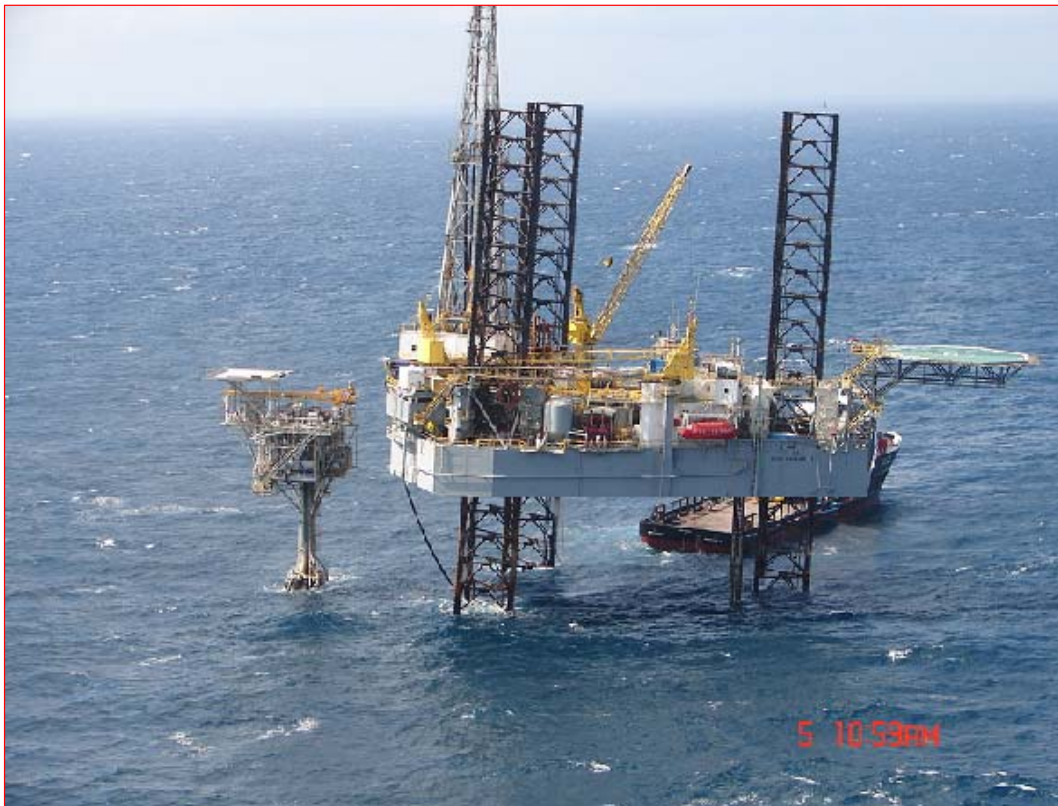
Photo: 9.17.2 When attempts were made to jack the rig down, extreme loads were imparted to the legs at the transition to the hull/leg guides using further leg cracks.

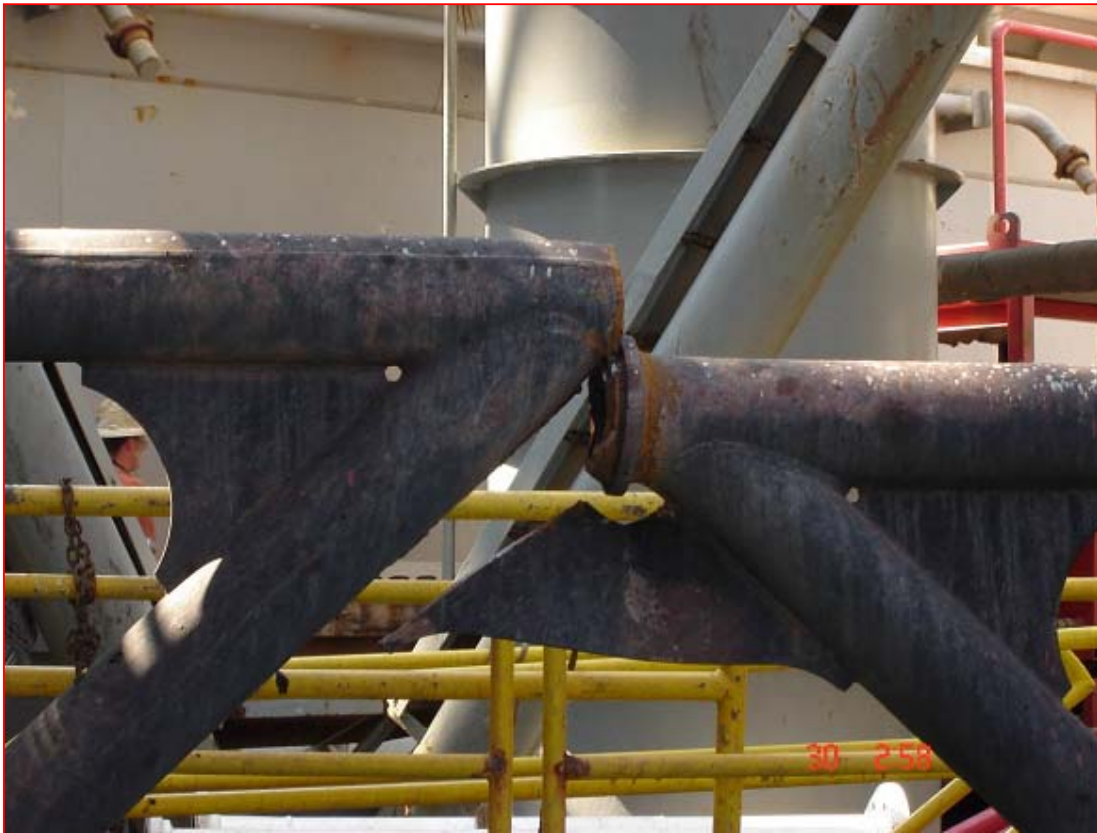
Photos 9.17.4 Some of the leg chords were bent and many of the K-braces have been overstressed. Damage was reported inside the spud cans where they interface with the legs.

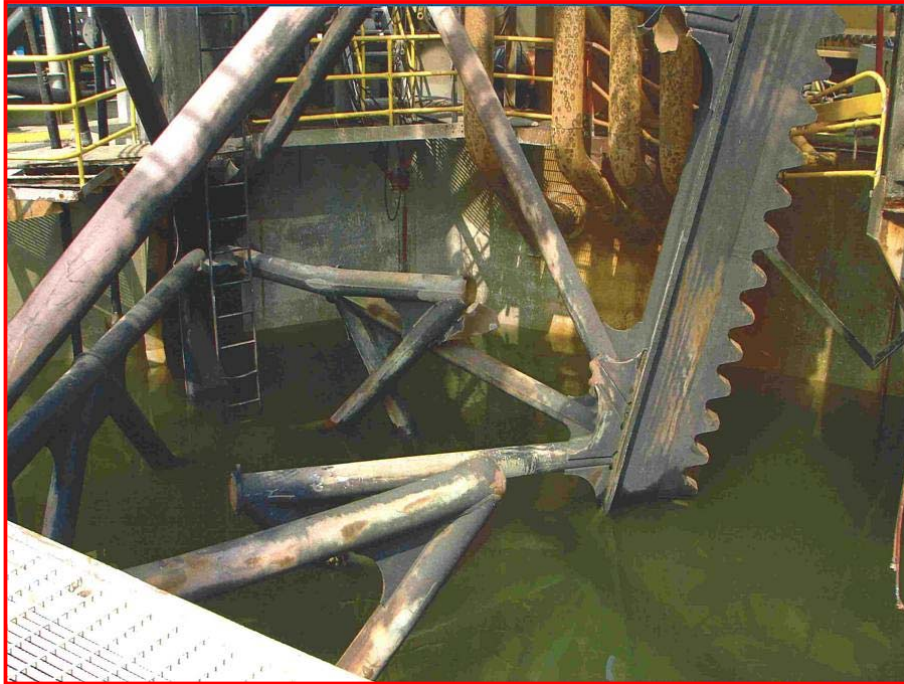
Photo 9.18.6: Showing extent of leg damage

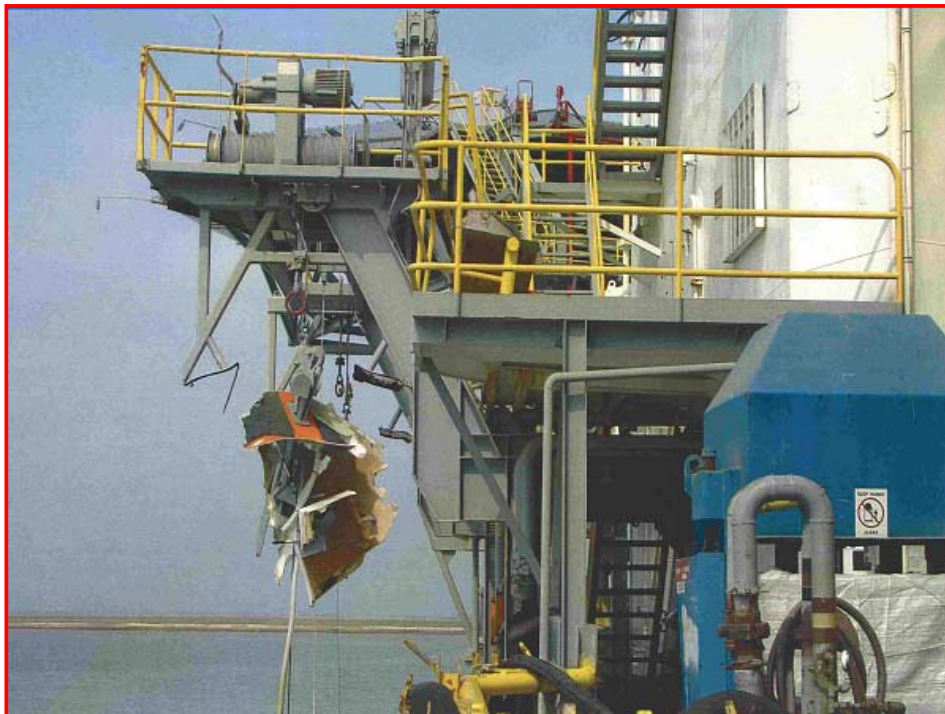
Photo 9.18.7: Lifecraft had been impacted by the storm (hanging from the davit)

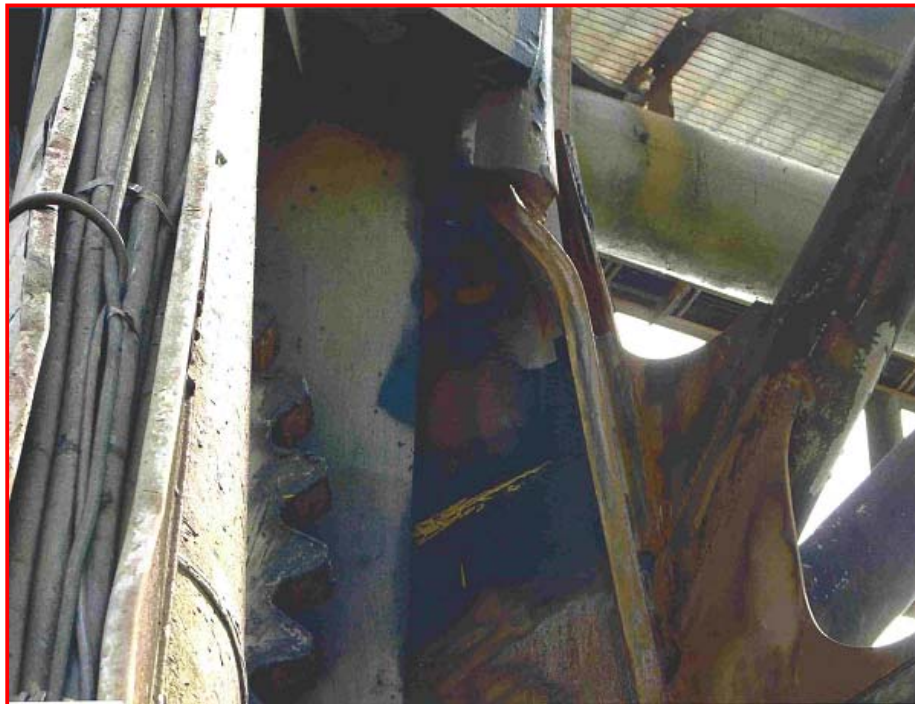
Photo 9.18.8: Damage to leg close to lower leg guide.

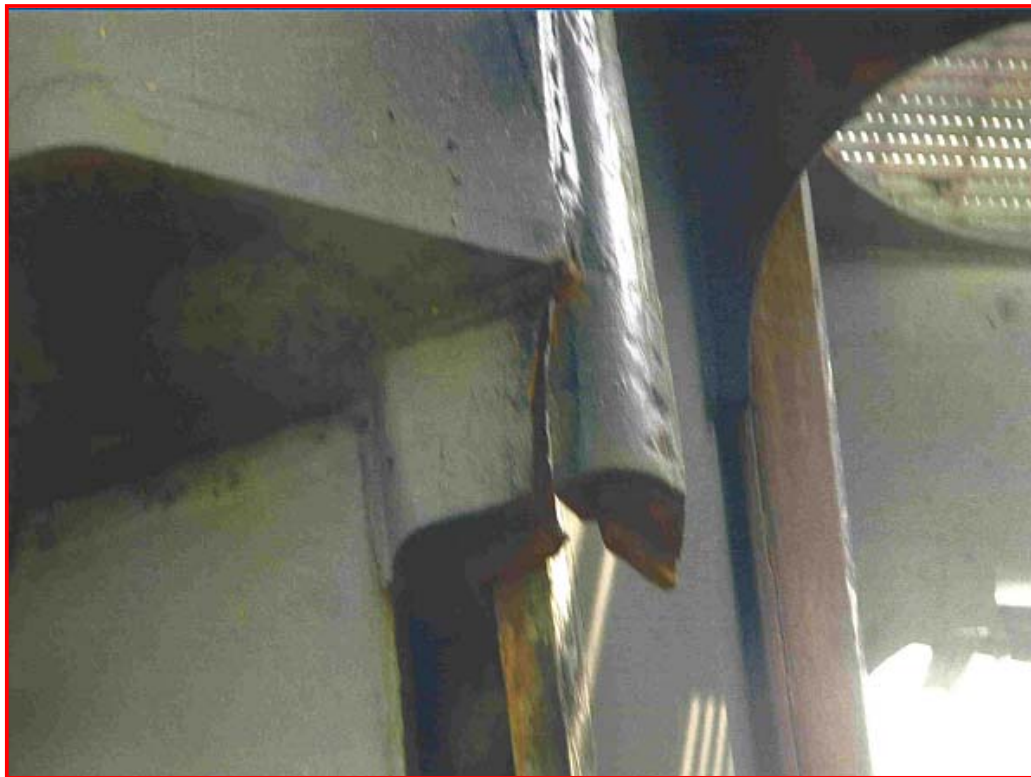
Photo 9.18.9: Lower leg guide cracked.

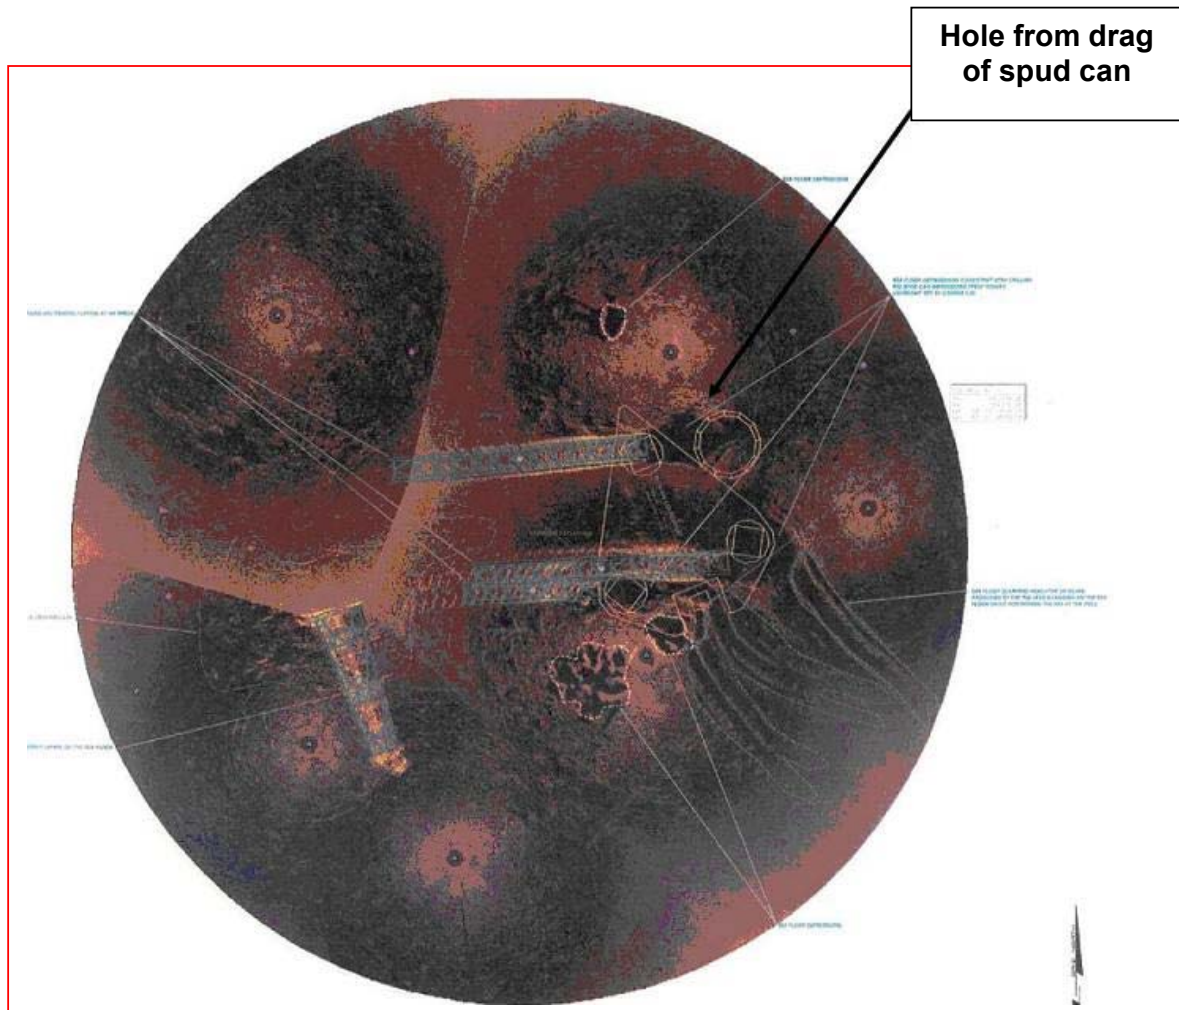
Figure 9.38.2 shows a hole made by the spud can being dragged as the Rowan Louisiana collapsed, and the hull floated off. (Ref 28).
