Damage and Critical Analysis of Accidents to Assist in Avoiding Accidents on Offshore Wind Farms on the OCS

May 2010

Project No. 633, Contract M09PC00015

This document is the Report on Damage and Critical Review of Accidents: documentation of significant damages relevant to wind farms for which appropriate information is available together with analyses of the causes when available.

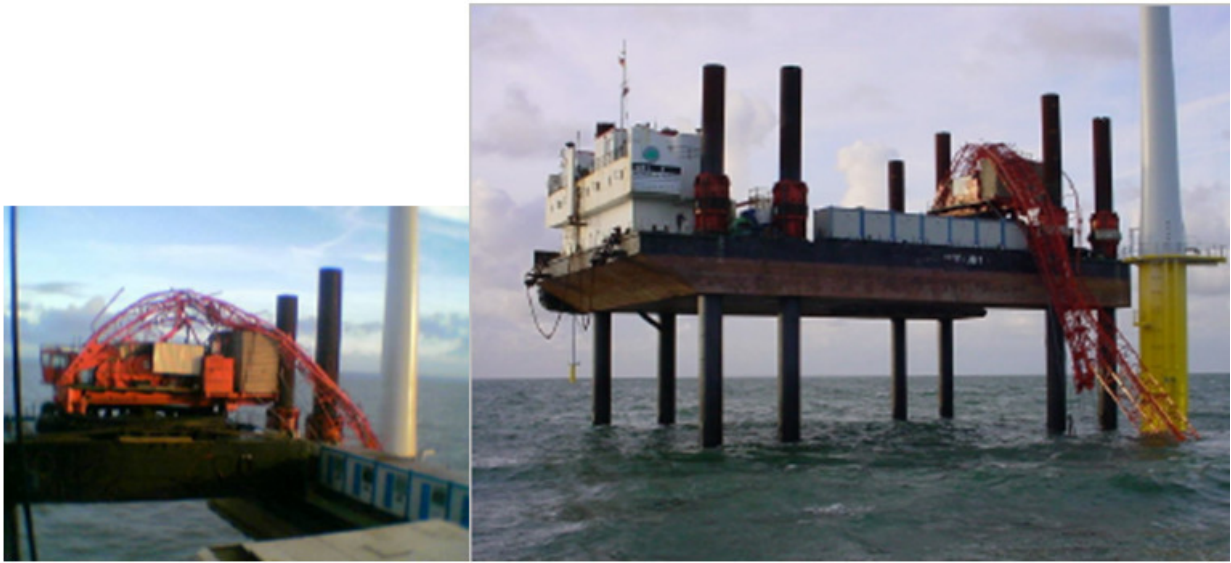
Figure 4: MEG-JB1 at North Hoyle

5	MEG-JB1	Crane collapse	North Hoyle	2003
	Name	Summary	Location	Year

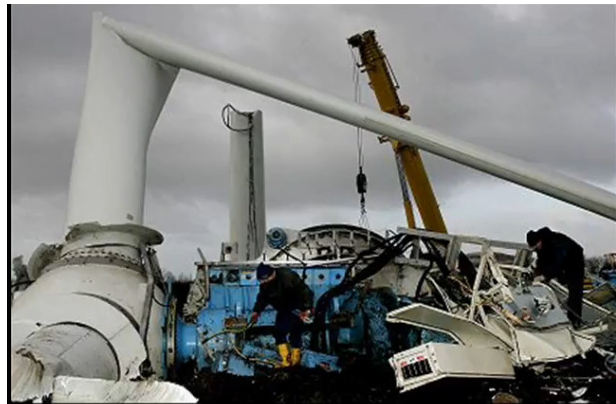
For Global Wind Energy, which contributes to IMIA, some 20% of their claims were from gearbox issues. A photo in their presentation is given below showing a collapsed turbine, though the date and details are not noted:

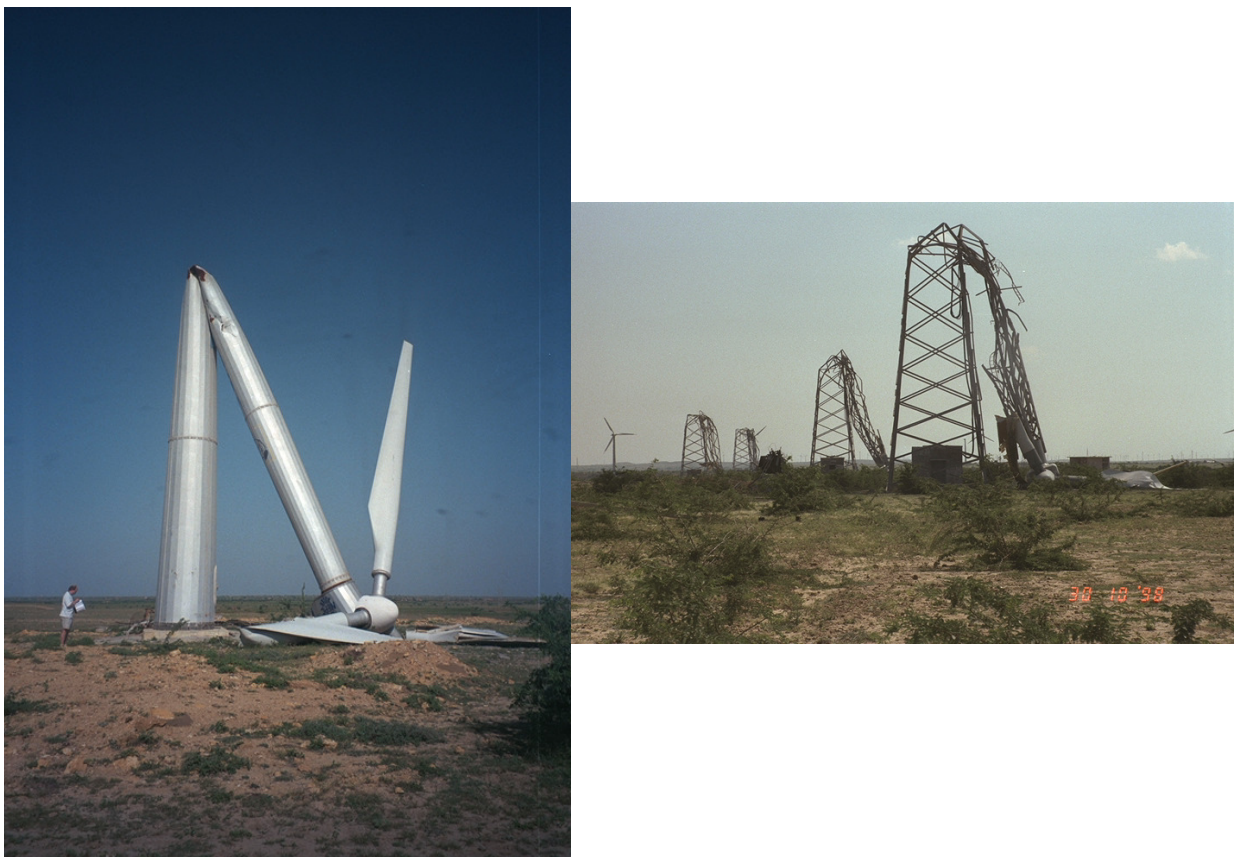
Figure 12: Gujarat, India 1998

In 1998 Tropical Cyclone 03/A destroyed 129 or 40% of the 315 wind turbines at a wind farm in India.

Approx. 40 MW was damaged during the cyclone of May 1998.

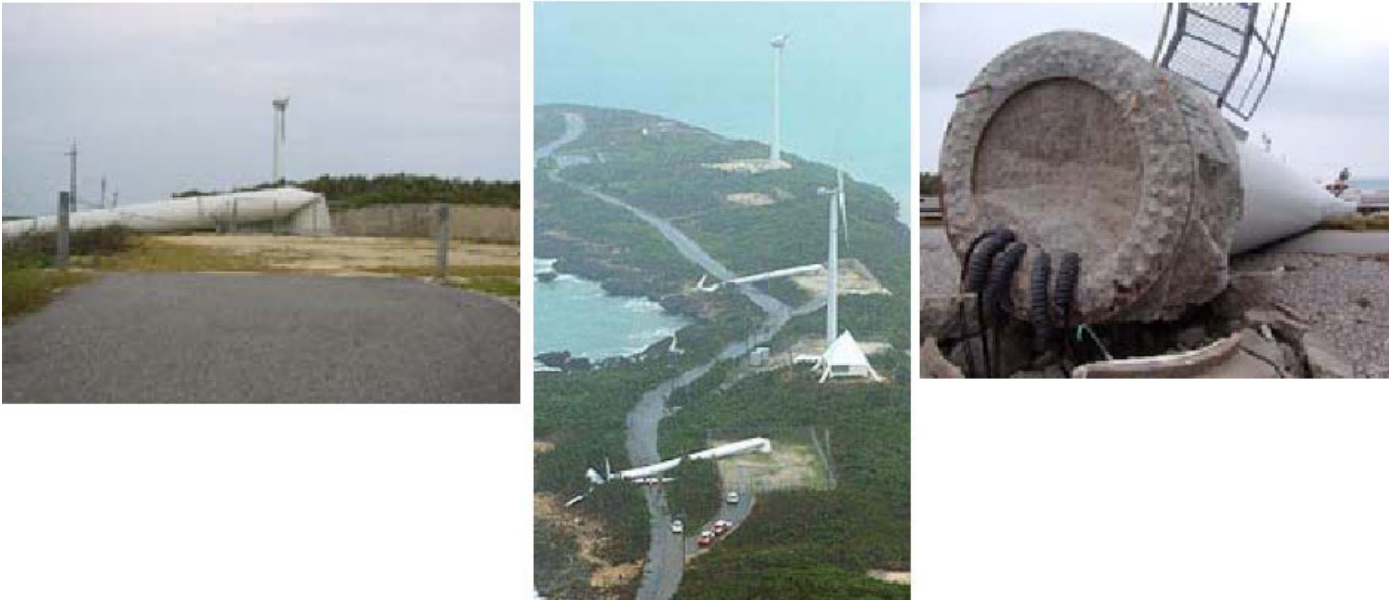
Figure 13: Failure of 7 Turbines in Japan in Typhoon Maemi (2003)

Miyako region – All 7 turbines failed in typhoon Maemi(2003) (Gust 74.1 m/s)

- Turbine failure rate in Japan is 3 times that of Denmark
- Gust winds experienced about 7 times larger than IEC guidelines.
- Source: Suguro (MHI) [Ref. 29, Ref. 30, Ref. 31]

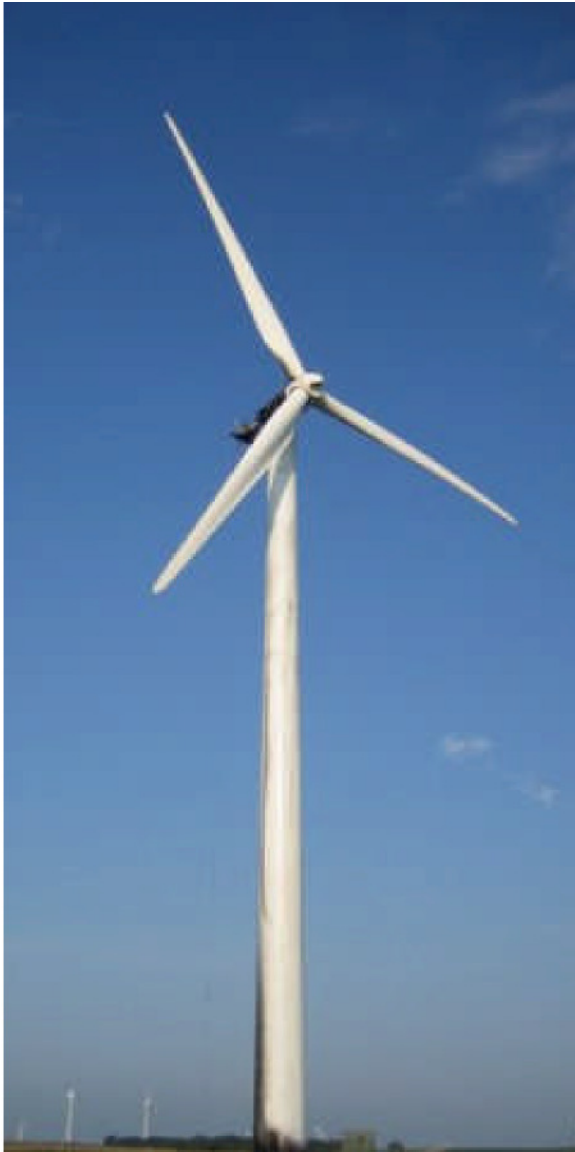
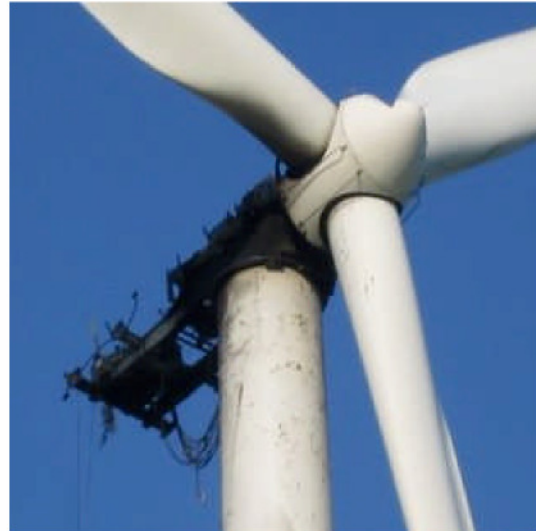
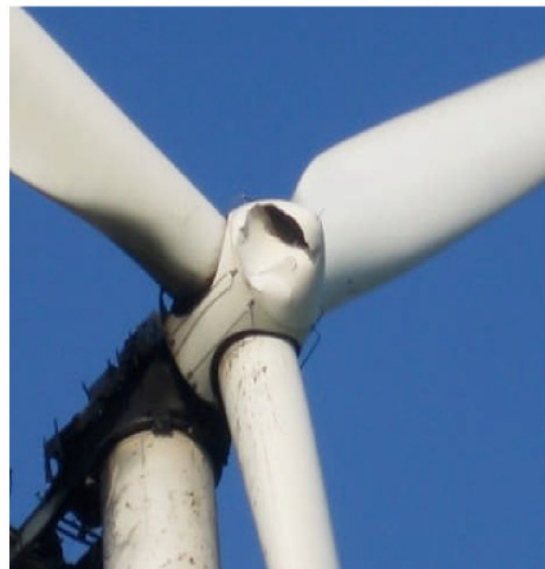
Estimated costs. 800.000 Euro. Plus business interruption.

The burned nacelle.

Notice the nosecone. Due to the overspeed an implosion have occurred.

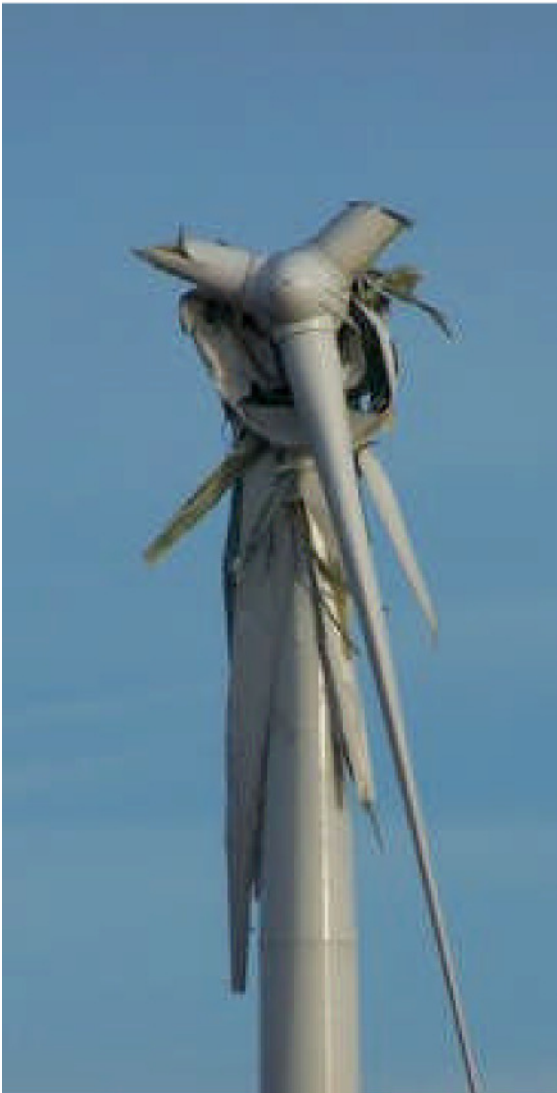
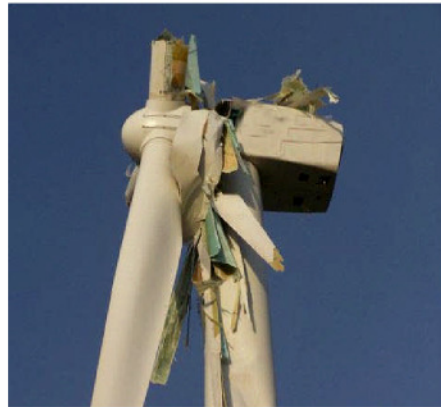
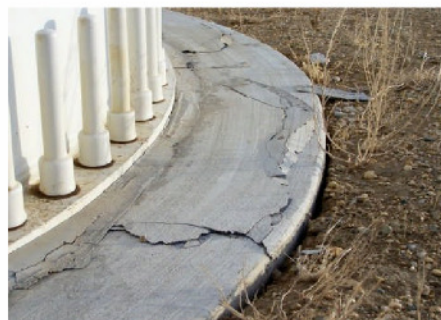
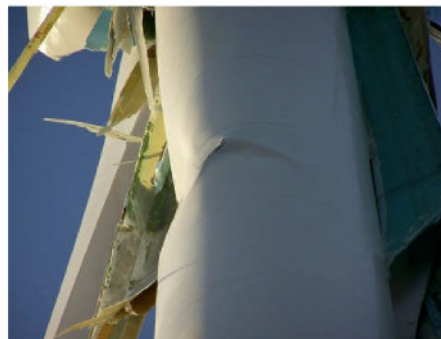
Due to problems with the control system of the pitch system the turbine went overspeed. *Damaged parts.* Nacelle (repairable), 3 blades, upper section of the tower, foundation *Estimated costs.* 600.000 Euro. Plus business interruption.

The damaged turbine.

Notice the cracks in the foundation and damaged upper tower section.

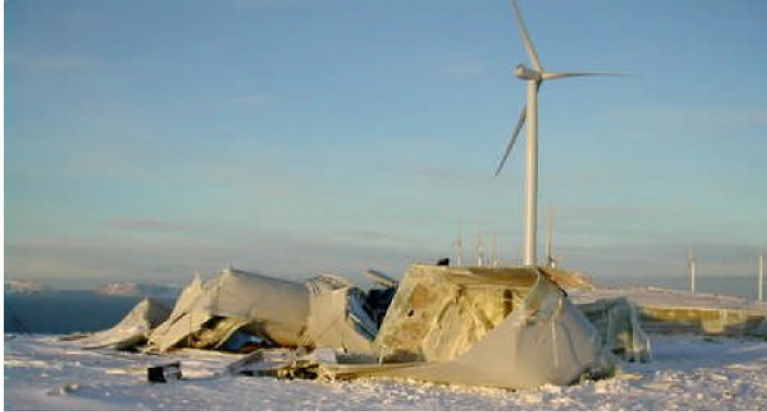
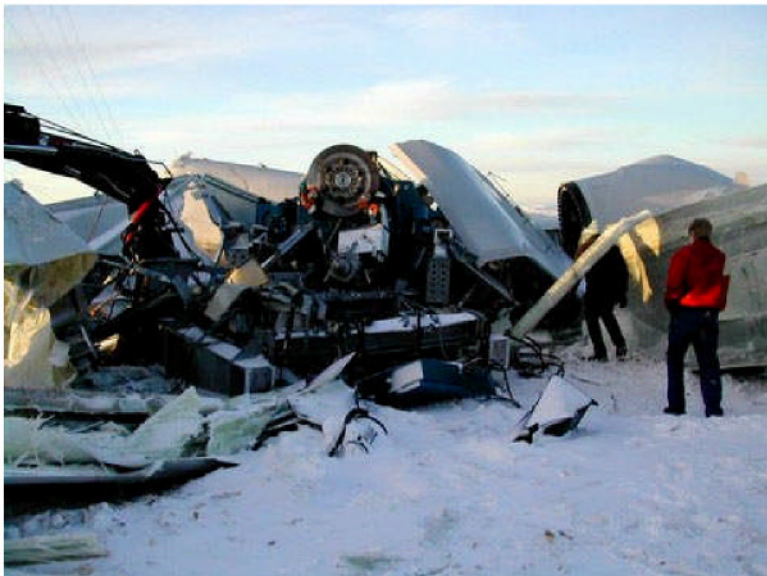
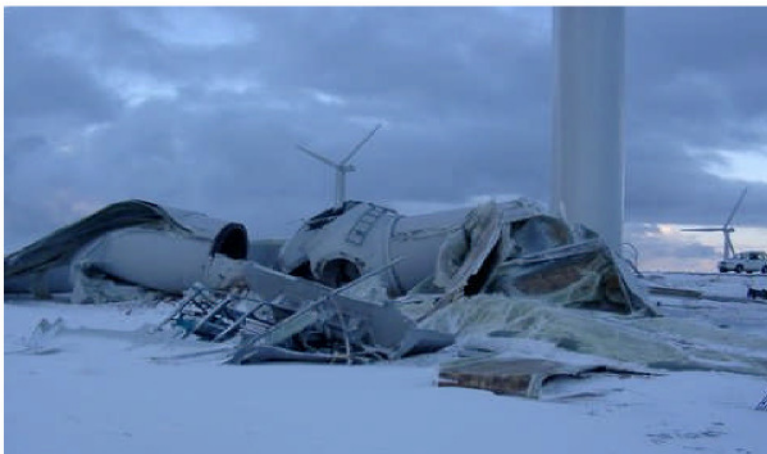
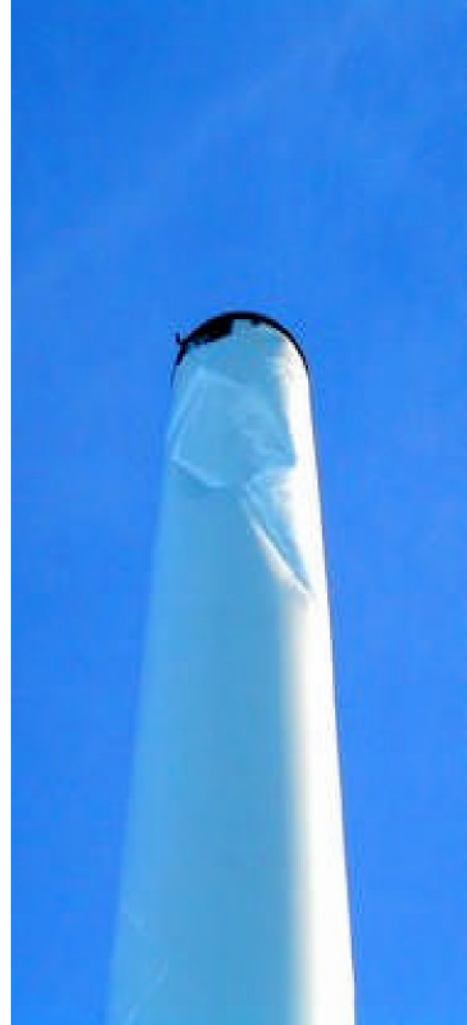
Estimated costs. 1.300.000 Euro. Plus business interruption.

The damaged turbine. Notice the marks on the tower from one of the blades. When the nacelle crashed to the ground it was totally destroyed.

Gearbox. Bearing and gearwheel damages.

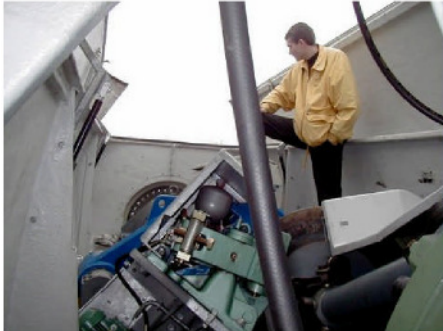
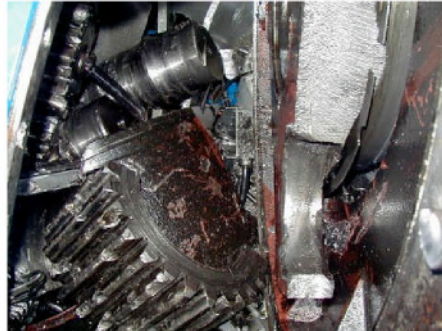
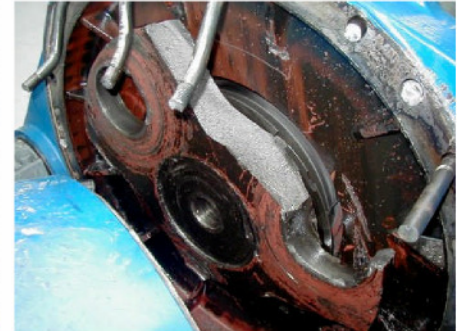
Damaged parts. All parts of the gearbox. Bearings, shafts and gear mesh both in the planetary and the helical stage. Though pitting/wear of the bearings in the planetary stage are most common. *Estimated costs.* Up to 270.000 Euro. Plus business interruption. At the moment the lead-time can be up to 15 month both on gearboxes and on the big components such as the low speed gearwheel.

Damages gearbox in a 750 kW turbine, resulting in damage of the generator, hydraulic system and the control system. Of some reasons the turbine was not stopped at time and the planetary stage locked resulting in server damages not only on the gearbox but also on the other components in the nacelle.

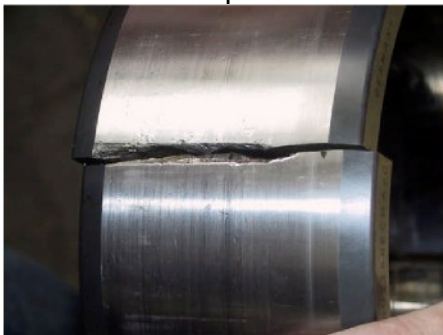
Broken bearing from one of the two helical gears

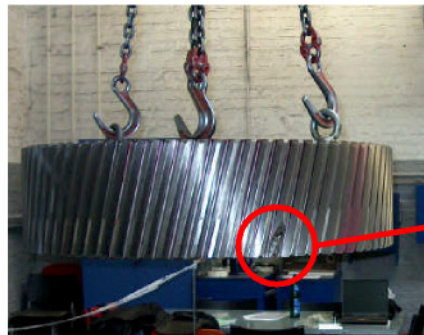
Broken tooth on the low speed gearwheel in a 2 MW gearbox

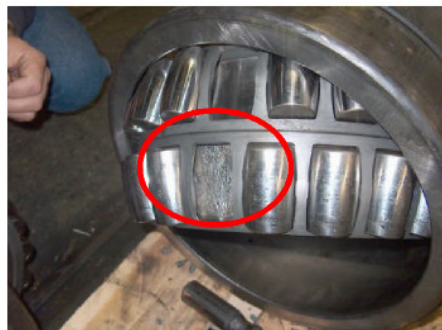
Pitting (wear) on one of 6 bearings from the planetary stage

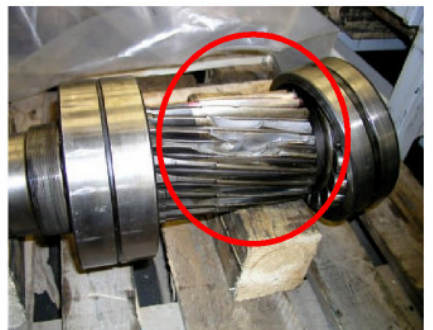
Broken tooth on the pinion in a 750kW gearbox

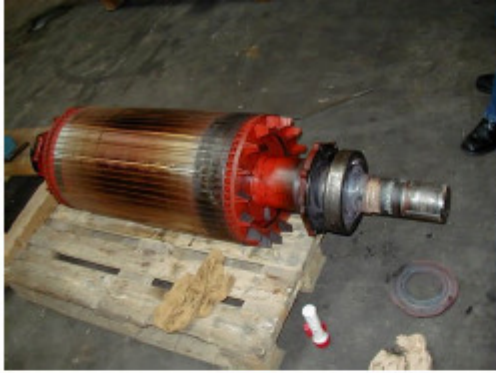
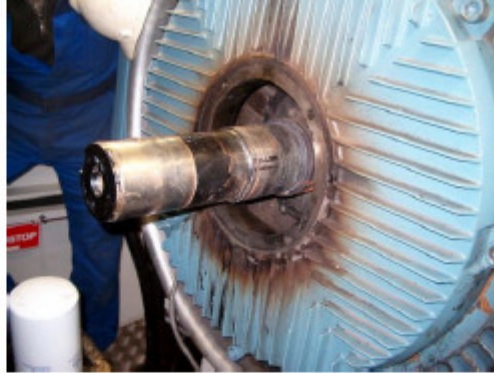
Hot bearing from a 1 MW generator. Root cause could among others be lack of grease, unsuitable grease or loose connection between bearing and shaft.

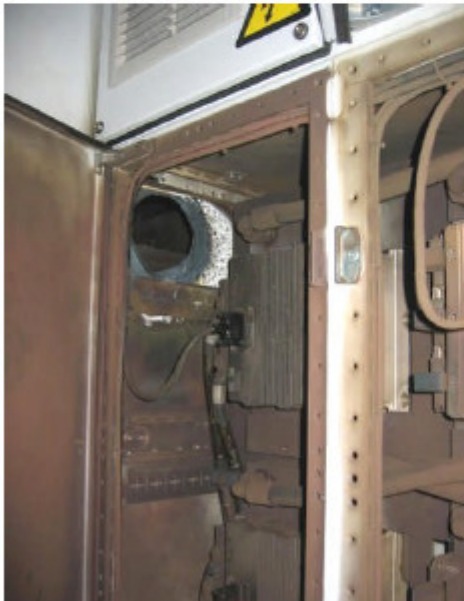
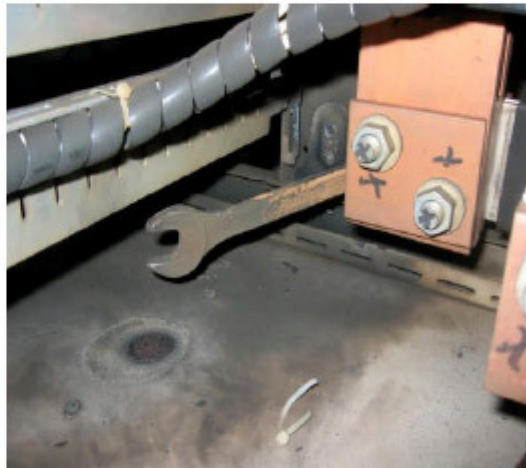
Short circuit in a power panel. Root cause was a forgotten tool. It was traced back to the manufacturer.

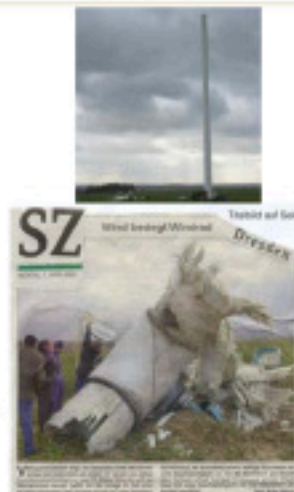
20030406.1.bmp

Crash of nacelle in Siebenlehn,
April 6, 2003

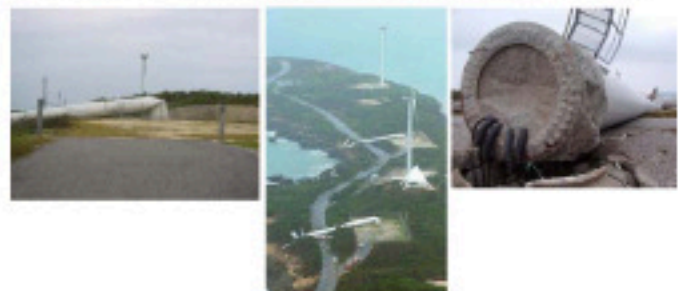
20030911.1.bmp

Miyako region – All 7 turbines failed in typhoon Maemi(2003) (Gust 74.1 m/s)

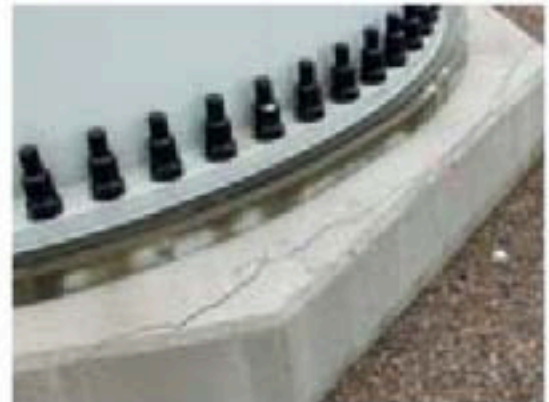
20079999.7.jpg

Cracks in the concrete left no alternative but to remove the foundations and rebuild them.

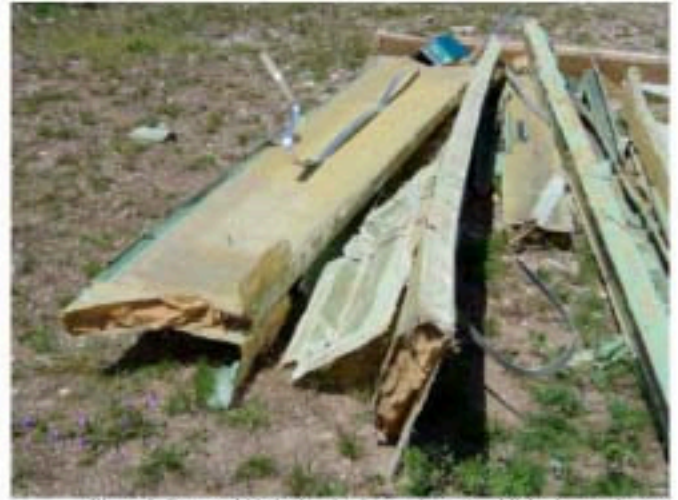
20080306.2a.bmp

Figure 2: Damaged blade showing internal spars and lightning conductors

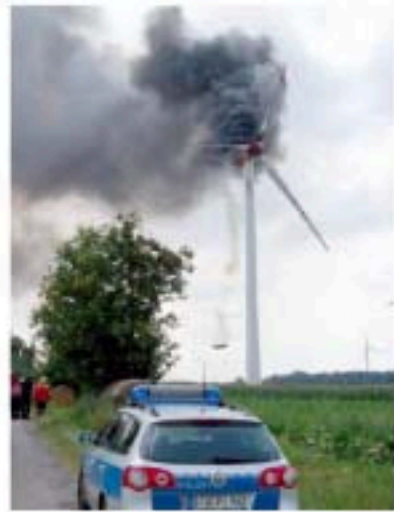
20080926.1a.bmp

Fig. 20: Debris falling from burning wind turbine, Germany, 2008.

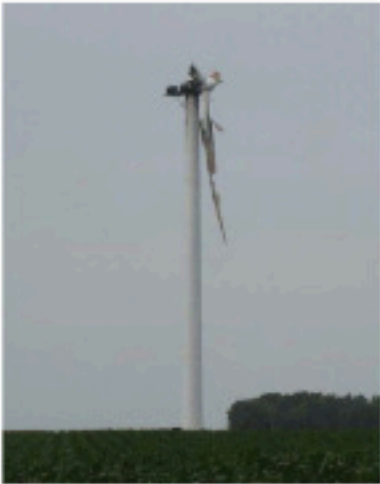
99999999.37.bmp

Fig. 7: Lightning strike damage on a wind turbine operated by Neel Energy in southern Minnesota resulted in destruction of the nacelle and the rotor blades.

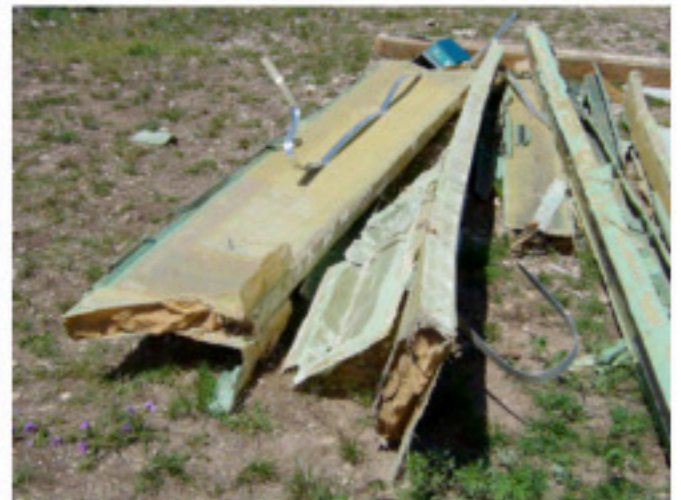
99999999.3a.bmp

Figure 2: Damaged blade showing internal spars and lightning conductors

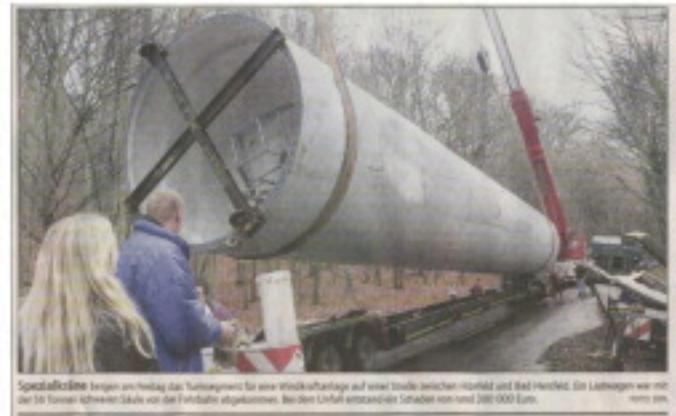
C20021115.1.jpg

Spezialzelle bringen am Freitag die Turbinen für eine Windkraftanlage auf einer Straße zwischen Moorfeld und Bad Moorfeld. Ein Lastwagen wie mit der 16 Tonnen schweren Säule vor der Fortfahrt abgekommen. Bei dem Unfall entstanden Schäden von rund 200.000 Euro.

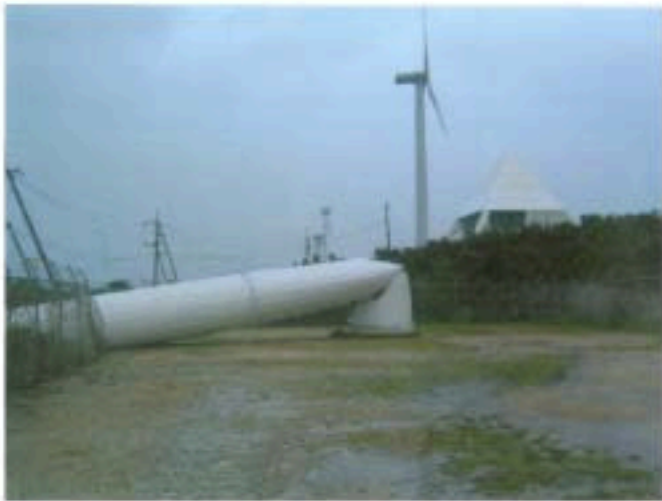
Fig. 1 Buckling Failure of a Wind Turbine Due to Typhoon
C20030911.1f.psd

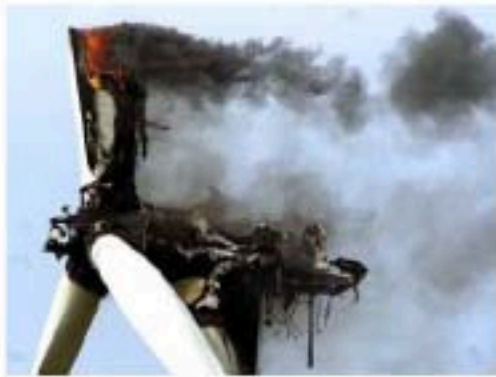
C20040609.1.bmp

Fire caused by a short circuit, frictional overheating or lightning in 2004 in a Germany. Source: Der Spiegel, DPA.
