## EROSIONAL/CORROSIONAL TESTING FOR MULTIPHASE FLOW LINES

FINAL REPORT  
SwRI Project No. 04-6461

For  
Minerals Management Service  
U.S. Department of the Interior  
Reston, Virginia

April 1995

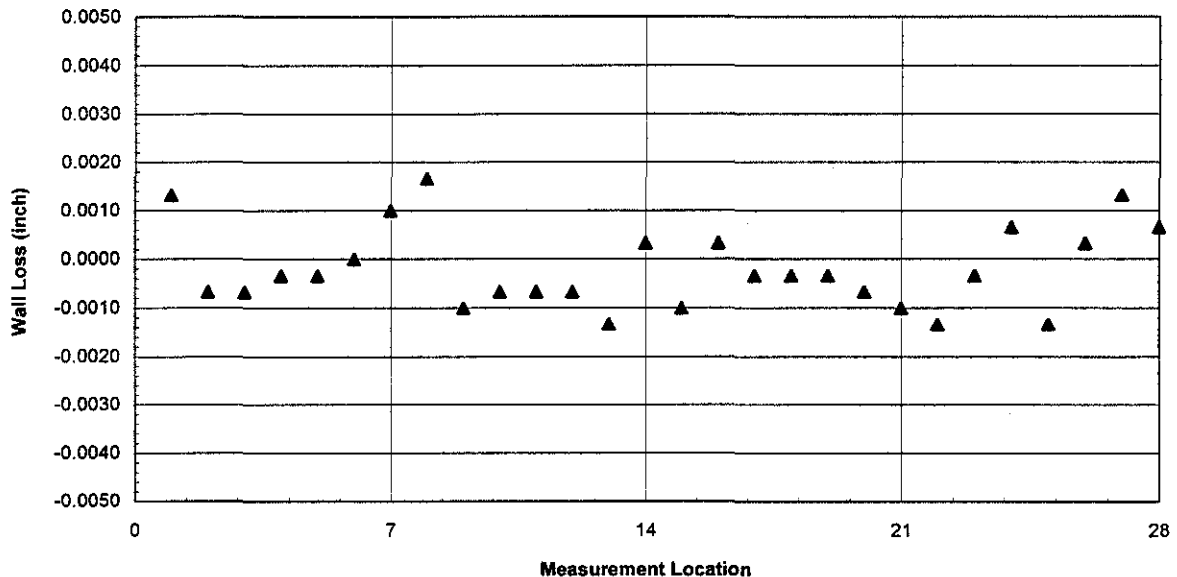
**Figure 3.3. Wall Loss Measured in the Elbows During Test 7. Seven measurements were made in each of the four elbows.**

*Test 7* was conducted with a gas superficial velocity of 15 ft/sec and a liquid superficial velocity of 0.8 ft/sec. The flow was in the slug flow regime. The test ran for a period of 35 days. The ultrasonic wall thickness measurements taken during the test showed no general wall loss during the test. No pitting or general wear was found in the straight sections of pipe. One of the test fittings did not have any pitting, but the other three had some pitting. One of the fittings had a number of small pits located along the outside bend of the elbow between 40° and 60° from the elbow inlet (inlet plane is 0° and exit plane is 90° degrees) and located in a 1 in. diameter region that was centered slightly above the centerline of the pipe. The pits were very shallow and irregularly shaped. The pit diameters were typically about 0.01 in., and the pit depth was about 0.005 inch. The second elbow experienced pitting in a 0.4-in.-diameter region located 60° from the elbow inlet and centered 0.3 in. above the pipe centerline. The largest pit was about 0.07 in. in diameter and 0.008 in. deep. The second largest pit was 0.01 in. in diameter, but deeper (0.020 in.). The third elbow had a rough surface texture in a 0.4-in.-diameter region located 55° degrees from the elbow inlet and centered slightly below the centerline of the pipe. The attack was very shallow (less than 0.005 in. deep) and appeared more like a removal of the corrosion product film (leaving islands where the film remained) than pitting.

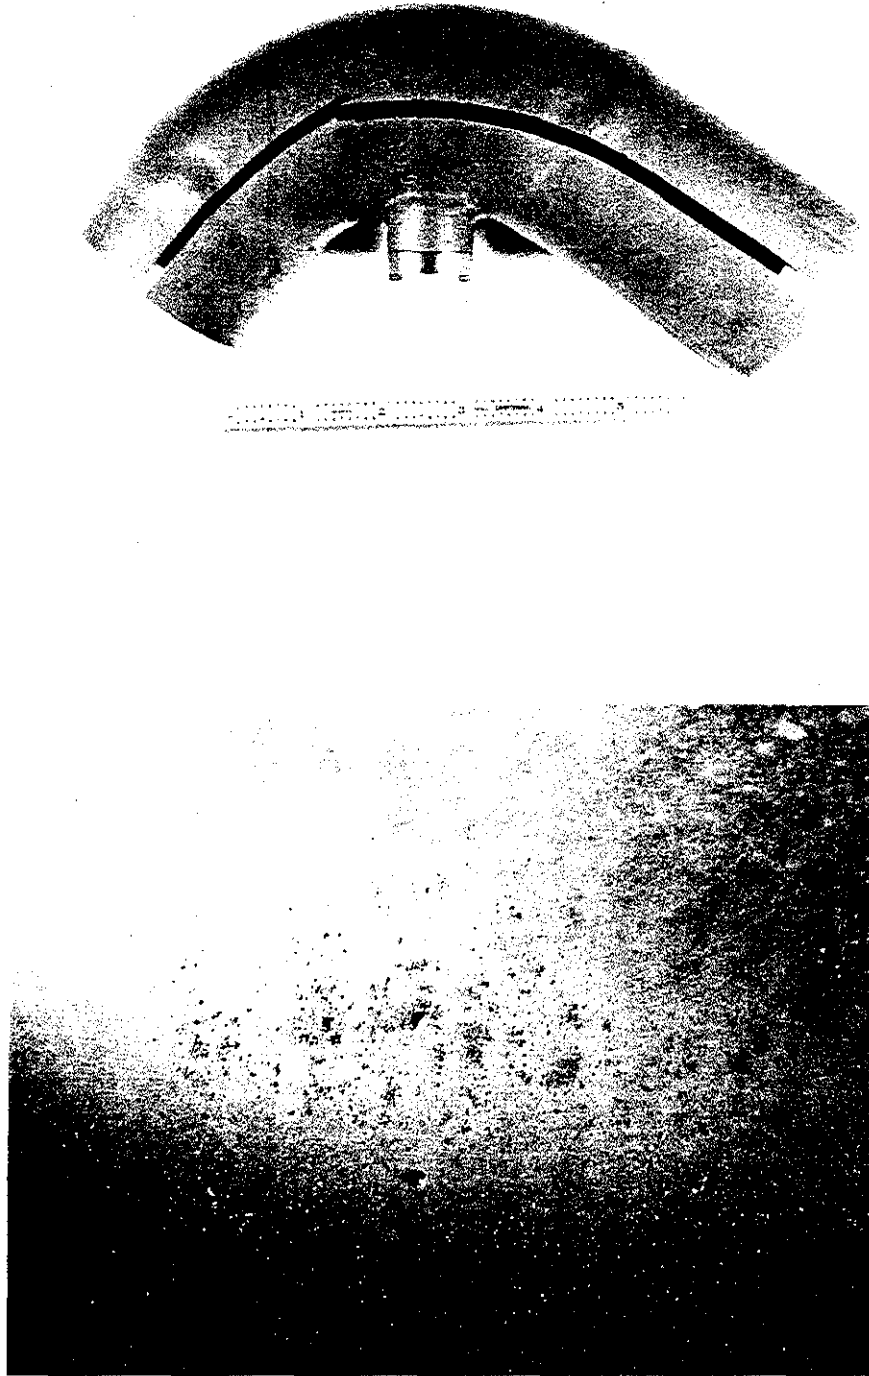
**Figure 3.6. Photographs of Test Fitting. The top figure shows the test fitting cut open for inspection. The bottom figure shows the pitting wear experienced during Test 9. The view is of the inside surface of the elbow near the three flaws that were machined into the elbow.**

*Test 9* was conducted with a gas superficial velocity of 36 ft/sec and a liquid superficial velocity of 0.36 ft/sec. These test conditions resulted in stratified wavy two-phase flow. The test ran for 36 days. The ultrasonic wall thickness measurement showed that no general wall loss occurred during the test. Inspection of the test fittings after completion of the test showed no localized pitting wear in the straight sections of pipe and no pitting wear in three of the four test fittings (the long radius 90° elbows). One of the fittings showed some pitting located in the upper half of the elbow at the location where drops flowing straight down the pipe would impinge on the surface of the elbow. The largest pit was 0.024 in. in diameter and 0.015 in. deep. The second largest pit was 0.020 in. diameter and 0.012 in. deep. The rest of the pits were less than 0.010 in. in diameter.

Most of the corrosion pits appeared to be passivated (no longer actively growing). The exceptions were the two largest pits, which appeared to be active. The bottoms of these pits were not covered with a protective corrosion product film. Since some of the fittings experienced pitting and some did not, it appears the test may have been conducted near the upper limit of an acceptable operating velocity.

<b>LARGEST PITS FOR EROSION/CORROSION TEST 9</b>		
<b>Test Fitting</b>	<b>Pit Diameter (mils)</b>	<b>Pit Depth (mils)</b>
Elbow #1	24	15
Elbow #2	None	
Elbow #3	None	
Elbow #4	None
