2005 Hurricane Preparedness

Shell's Experience with Hurricane Ivan

API – 2005 Hurricane Readiness and Recovery Conference

Virgo Platform (Viosca Knoll 823) Hurricane Ivan Impact & Recovery

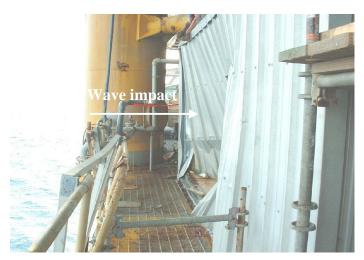
Damage Assessments – MC 194

- ➤ Evidence of Green Water in the deck, 45 feet above the water line; platform 100 miles from the eye of the storm.
- ➤ Platform damage consisted of:
 - Missing Grating and Handrails
 - Minor Facilities equipment
 - ❖Gaugers Shack

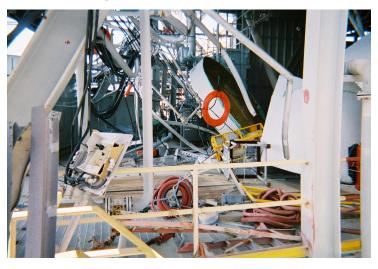
Damage Assessments – MP 252

- ➤ Evidence of Green Water in the deck, 50 feet above the water line. Platform was near the eye of the storm.
- ➤ Estimated wave height 65 70 ft which corresponds to the maximum design wave of 72 feet.
- ➤ Platform damaged consisted of:
 - Missing Grating and Handrails (100 % at boatlanding to 20 % on lower deck)
 - Facilities equipment, cable tray and mostly support utilities

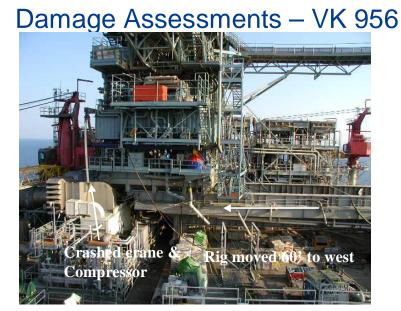
- ➤ Evidence of Green Water in the deck, 90 feet above the water line. Platform near the eye of the storm.
- ➤ Estimated wave height at this location is around 100 ft. Design wave was around 87 ft.
- ➤ Platform damaged consisted of:
 - Drilling rig moved off location
 - ❖FGC 2 exhaust
 - Missing Grating and Handrails (100 % at boatlanding to 20 % on lower deck)
 - ❖Facilities equipment, cable tray and mostly support utilities

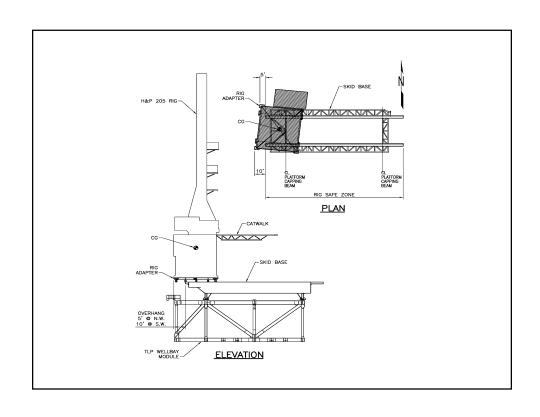
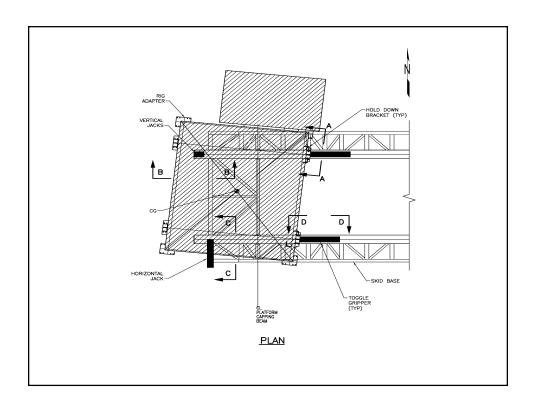
VK 956 A – Drilling Rig Recovery

- ➤ Rig was located in potentially unstable position.
- ➤ Rig had to be secured to prevent further damage.
- ➤ 2500 ton rig to be a) lifted vertically then slid back into position or b) disassembled and then reassembled.
- ➤ Option a) was selected

- -Strategy
 - ➤ Secure rig using hold down brackets.
 - ➤ Hold down brackets designed for additional hurricane force conditions.
 - ➤ Use a system of strategically placed jacks, cylinders and grippers to recover rig.

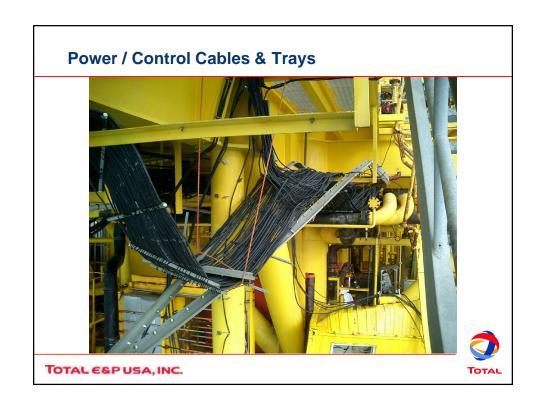
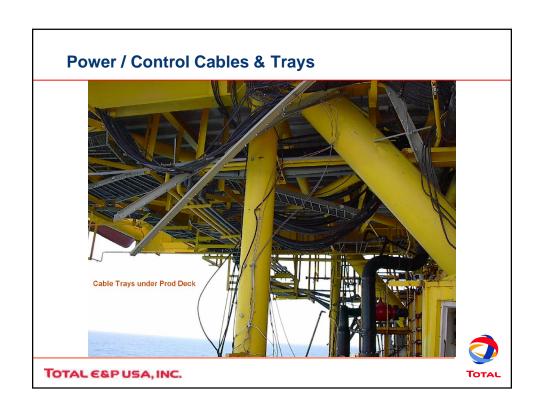
Power / Control Cables & Trays

- Assess structurally soundness with a helicopter fly around.
- Board and perform initial 3rd Party visual checks with the operations team (Sept. 16, '04)
- Topside Inspection Utilized a rope access team to visually inspect all structural components (General visual, close visual and ACFM)
- Analyzed a damaged topside beam to assess its residual strength
- Performed overall structural analysis of the facility, using sea conditions that existed during Ivan, in order to assess the overall loading on the facility and to identify connections subject to the highest loads.
- Performed underwater ROV inspection covering structural integrity, selected weld integrity, anode condition, debris, scour risers.
- Performed flooded member inspection on most members.

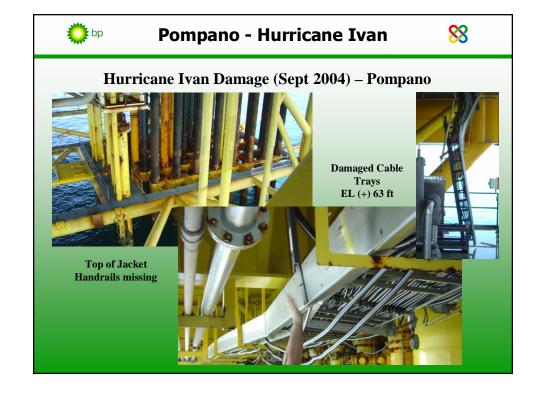
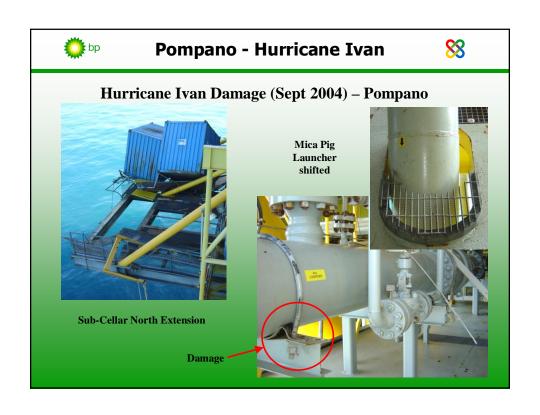
Hurricane Damage: -

- Hurricane Ivan Damage to Pompano: -
 - Top of jacket handrails majority missing
 - Cable trays & panels damaged on sub-cellar deck
 - Piping and equipment damaged on sub-cellar deck
 - Damaged & missing grating
 - Damage to lights
