BSEE 2015 Domestic & International standards Workshop

Emergency Disconnect Session UKCS Recent Experience of DP

HSE Hazardous Installations Directorate

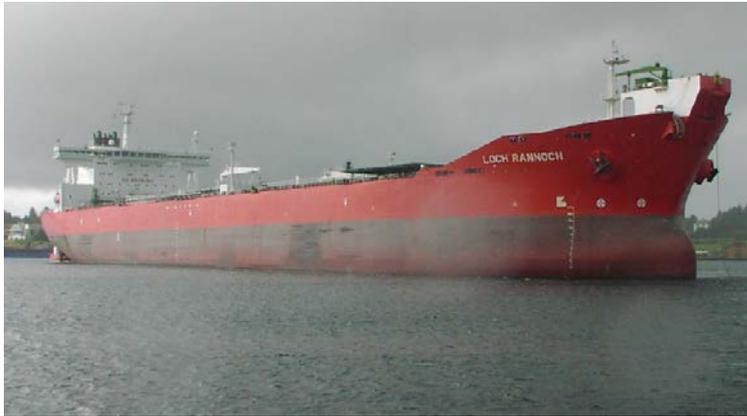
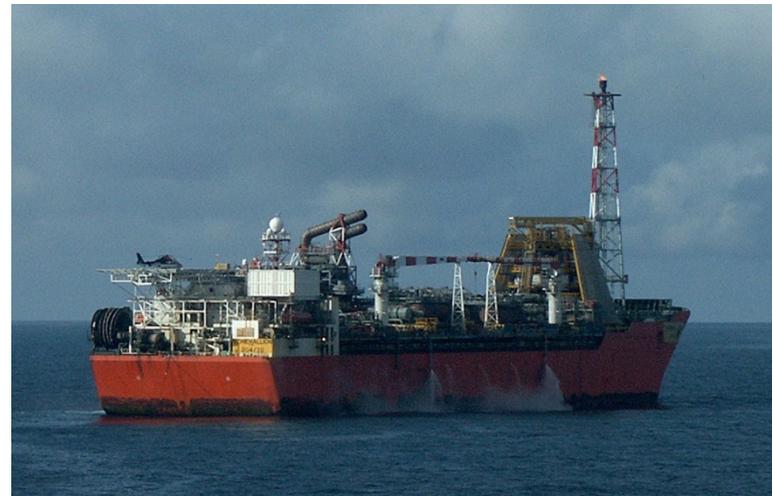
Shuttle tanker / FPSO collision, Oct 2009

- Tanker – DP class 2
- Recent DP upgrade – Fanbeam replaced with Radascan
- Radascan not tested in DP trials
- Radascan selected when approaching FPSO
- Collision – damage to FPSO offloading reel
- £100 million loss to FPSO operator

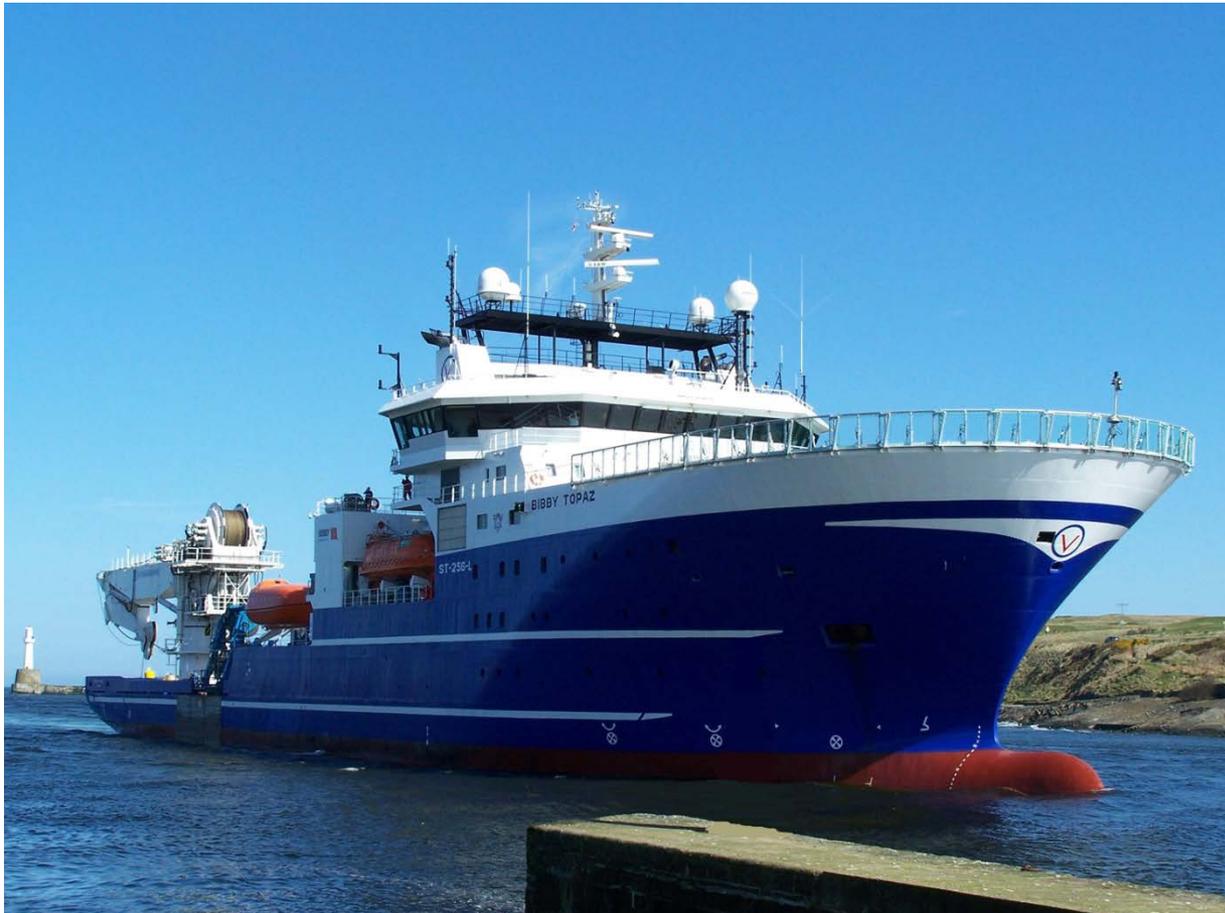
DSV drift-off, October 2010

- IMO class 2 DP
- 2 divers working 90m subsea on drilling template
- DP control lost due to DP control system failure
- Vessel drift-off position – 1 diver umbilical severed
- Position re-established under manual control – both divers recovered
- Jamming of internal comms. caused overall system failure

- *FMEA – “Today there is no established good method available for analysing software failures and field bus communication failures. Hence, this study’s dealing with such failures is very limited. This is according to common practise in the industry and accepted by all the Classification Societies”*
- Vendor firmware upgrade
- IMCA Safety flash 02/13
- HSE Safety Notice OSD 1-2013

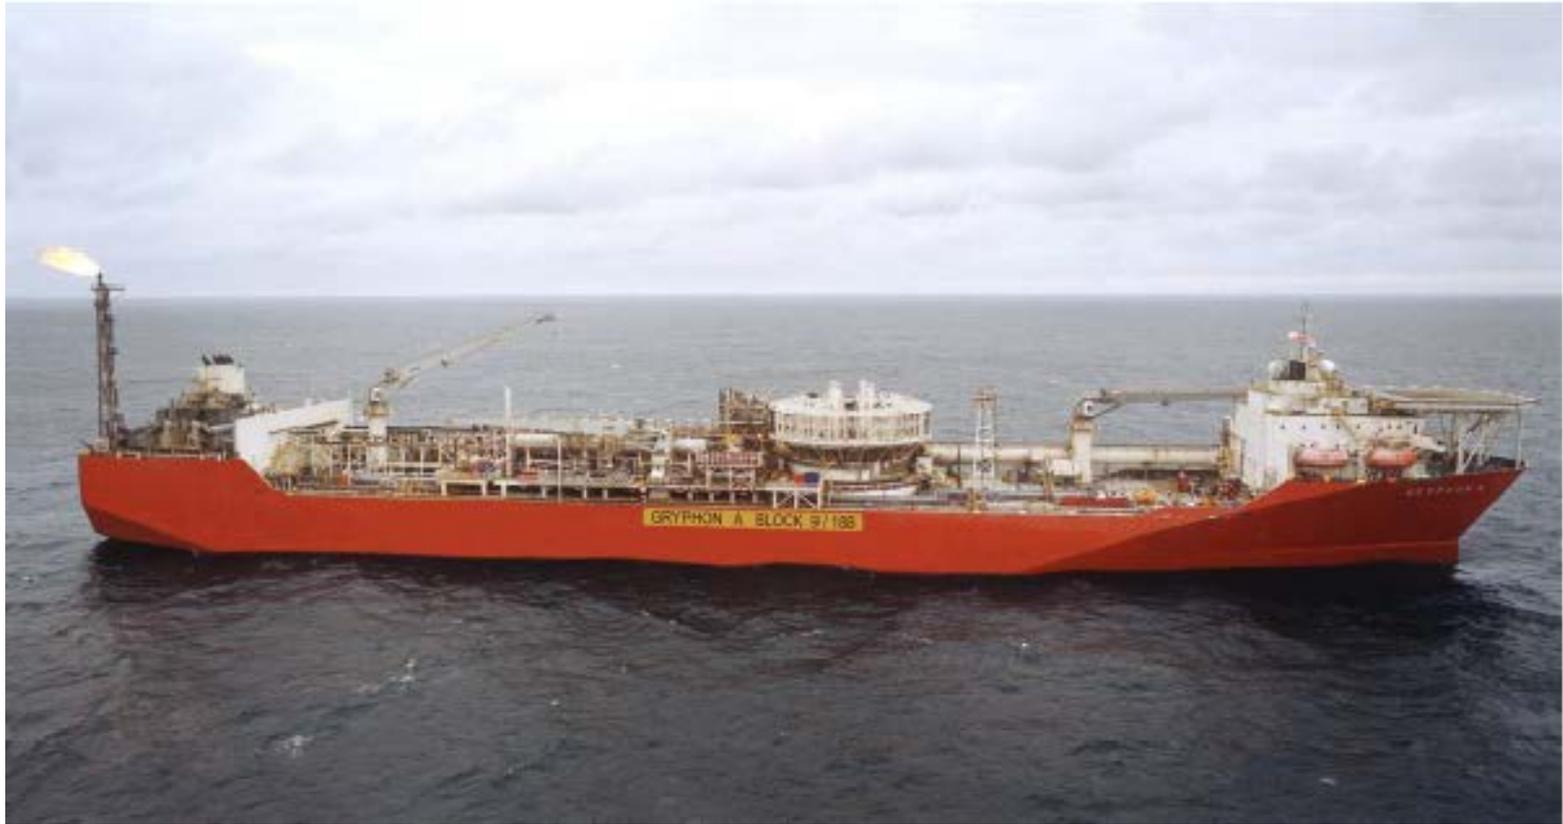
FPSO Loss of heading, Feb 2011

- SDPMDP in POSMOOR mode
- 60 knots wind, 10-15m wave height
- Mooring line break due to chain link weld failure (below design load) – not detected
- Drive-off heading
- Loss of electrical power due to turbine and DG trips
- 3 further mooring line failures due to overload
- Extensive riser damage (wells shut-in)
- Major overhaul required (dry dock)

- Anemometers reading 20%-30% low
- Ineffective transfer from auto to manual
- Insufficient redundancy in position referencing systems and electrical supply
- Inadequate operator training
- Inadequate FMEA
- Data recording problems
