Fire Boom Testing at Ohmsett in 2000

Ian Buist, James McCourt,
 Jake Morrison
 SL Ross Environmental Research
 Ottawa, ON
Ian@slross.com

Abstract

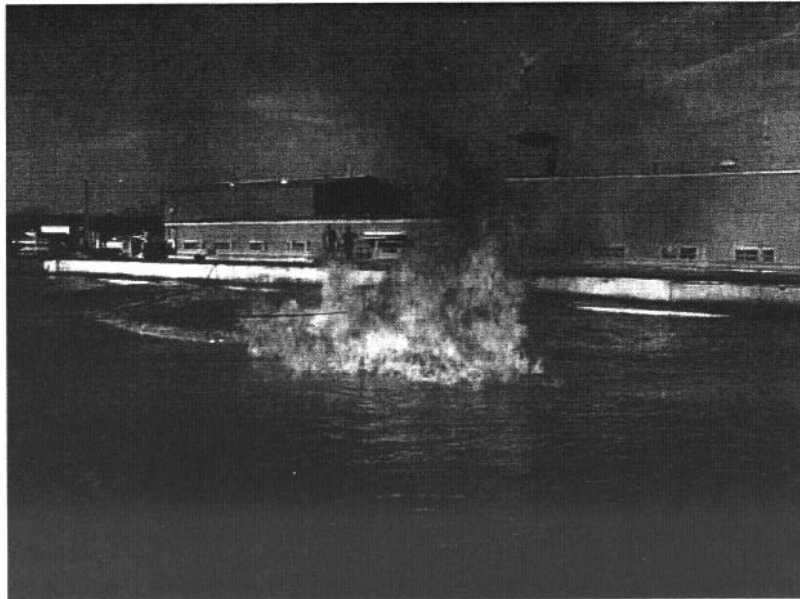
Figure 6 shows the first hour of burn tests with the Oil Stop boom. Note that the boom is not centered in the flame. This was done in an attempt to avoid propane bubbles entering an air chamber valve access slit in the skirt at the center of the test section. For these tests the wave beaches were raised, to produce regular waves. The boom rode the waves well. After initial adjustments a steady 26 kg/min (58 lb./min) propane flow was recorded. It was observed that the water entrained by the propane bubbles pushed on the skirt of the boom, forcing it over to rest against the air standpipe floats on the east side of the frame. After several attempted adjustments of the frame the propane was shut down, the frame was adjusted and the tension on the boom increased to 2200 N (500 lb_f). The flames were then re-started with a steady

Figure 6 - Boom undergoing burn test in waves.

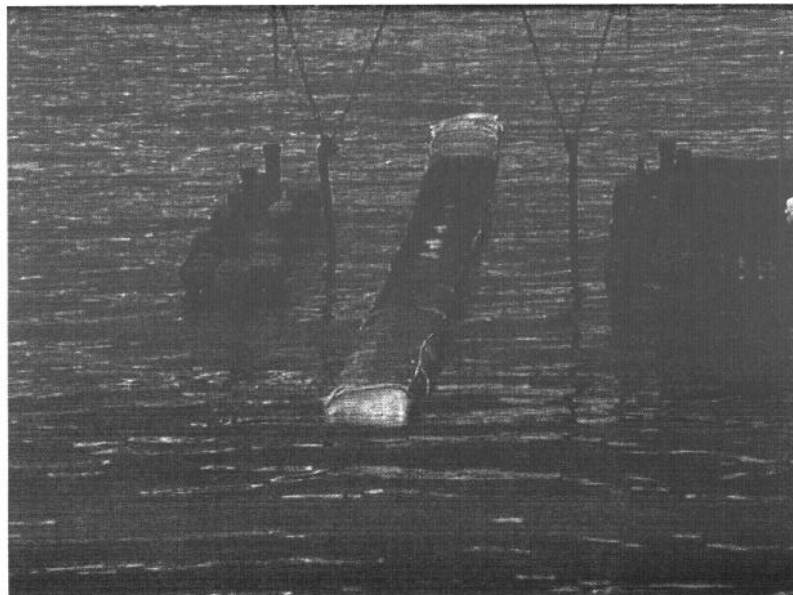
After the first hour of flame exposure, the propane flow was shut off and the SWEPI boom was allowed to cool down in waves for one hour. After the one-hour cool-down, the boom was inspected. There was some staining of the refractory material with soot and some evidence of the beginning of abrasion cracking caused by flexure between flotation units (see Figure 7), but the boom was judged to be in good, serviceable condition.

Figure 7 - SWEPI boom after first burn test.

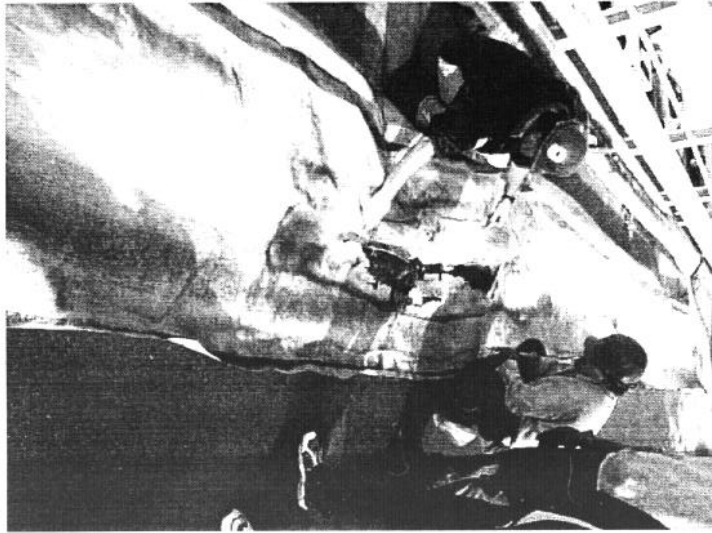
Inspection of the boom revealed that there was a large hole in the top of the boom at the south end of the flame zone. Too much air was escaping from this hole to maintain flotation in the portion of the boom north of the hole. The boom was subsequently removed from the tank and laid out on the deck for inspection. Figure 16 shows the damage to the underlying felt layer, with the stainless steel mesh outer cover peeled back. It was apparent that the combination of heat from the flames and loss of insulation to abrasion from flexing in waves had caused the coated glass fabric forming the wall of the flotation chamber to melt.

The version of the Oil Stop, Inc, Auto Boom Fire Model tested was an older model (see Section 3 for a list of changes in newer models). After two hours of exposure to waves prior to the fire tests, it was exhibiting some cracking of the outer stainless steel mesh cover. It failed, by melting of a hole in the pressurized air-inflated flotation chamber membrane, after 1 hour and 24 minutes exposure to flames.

Figure 16 – Oil Stop, Inc. Auto Boom on deck showing damage to felt layer with stainless steel mesh peeled back.

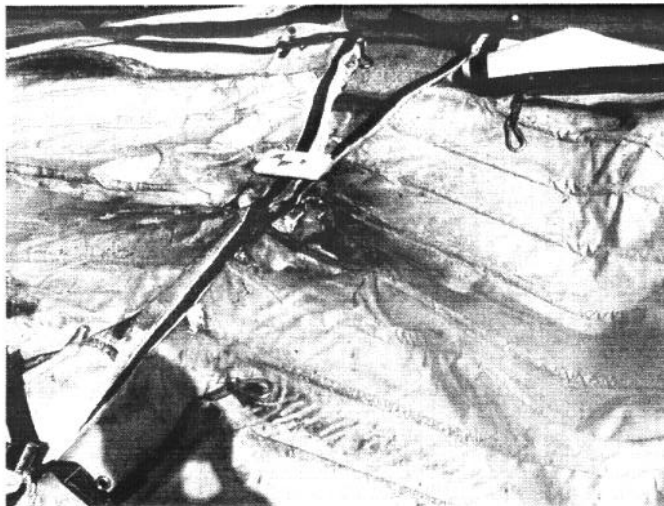
Figure 17 shows the underside of the blanket after its removal from the boom and placement on the deck: the hole at the zipper is apparent (the field book in the background for scale is approximately 7" x 4"). Melting and charring of the plastic occurred, and a water distribution hose had been exposed.

The Elastec/American Marine water-cooled fire protection blanket failed, after 2 hours and 46 minutes exposure to flames, at the blanket connector, by allowing the underlying boom flotation chamber material to melt.

Figure 17 – Close-up of underside of Elastec/American Marine blanket showing damage at zipper.

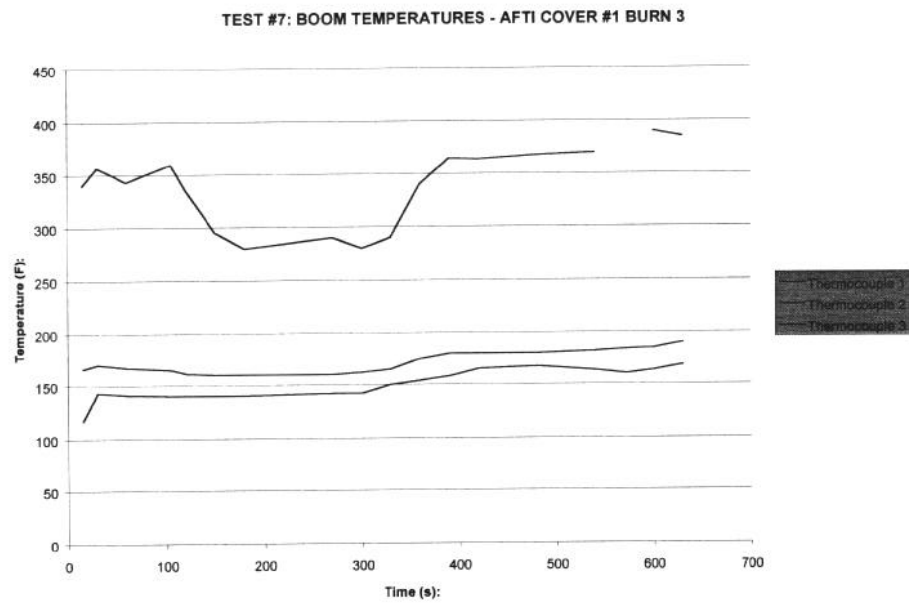
moved closer to the flames for the second test, about 17 feet from the center of the fire. The boom was moved even closer to the flames for the third test with cover #1, approximately 12 feet from the center of the fire. Figure 19 shows the boom temperatures recorded for this third test (Thermocouple 3 is outside the cover, 1 and 2 are under the cover). There was no visible damage to cover #1 or the underlying USS-42B boom on inspection after the tests.

Figure 19 – Example of boom temperature measurements with AFTI covers.
