OPERATIONAL EXAMPLES OF IN-SITU BURNING: LESSONS FROM THE BURNING OF TWO RECENT DIESEL SPILLS ON THE B.C.COAST

Ian Robertson
Gartner Lee Limited
6400 Roberts Street, Burnaby, B.C.

Environment Canada. Arctic and Marine Oilspill Program
Technical Seminar, 14th. June 12-14, 1991, Vancouver,
B.C., Environment Canada, Ottawa, Ontario, 411-419 pp, 1991

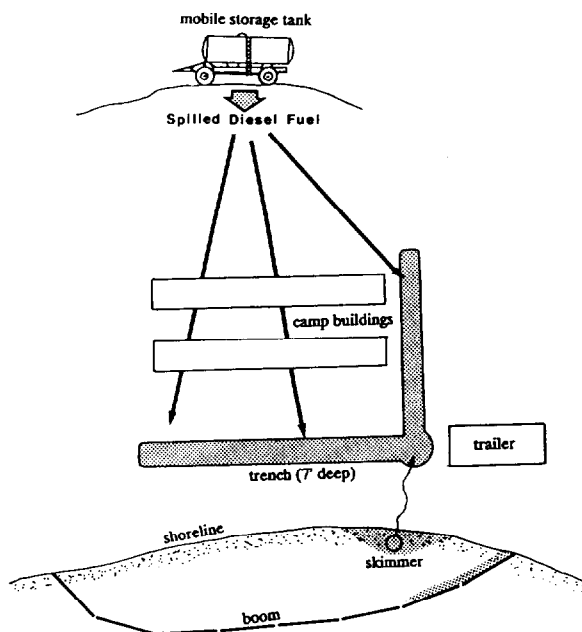
Figure 1

Incident Details: Over the Christmas period, 1987-1988, an estimated 9,000 L of diesel fuel leaked out of a mobile storage tank at a logging camp. The camp was situated along the shore of a West Coast inlet. The distribution of the storage tank, camp buildings, countermeasures activities, and shoreline are shown in Figure 1.

Approximate location of storage tank, camp buildings and trailer, countermeasures activities, and shoreline, St. Vincent's Bay spill, January, 1988

Containment/collection: While this response was being mobilized, the logging company moved one of its large backhoes to the spill site where it quickly excavated a trench 50' long, 7' deep and 3.5' wide with a deeper pit at one end to intercept the spilled fuel. This was successful, and several hours later an estimated 3"-5" of diesel had collected in the trench. With the arrival of the equipment in the late morning, the boom and skimmer were deployed in the bay. A hose from the skimmer was directed into the trench. Very little fuel was collected in this way, probably owing to the fact the slicks in the bay were so thin.

- i) feasibility of burning seemed favourable, particularly in view of successful collection of diesel in the trench;
- ii) safety and property damage considerations appeared to be met by excavating a deeper pit at one end of the trench (Figure 1), and by placing a mound of fill between the pit and the rest of the trench to limit the extent of individual burns.
- iii) government agencies had been immediately notified, but no formal approval for burning appears to have been attempted.

Burn Phase: In all but one case the diesel burnt for several minutes before dying out. In that one case, within less than one minute, the fire jumped the earth mound and spread down the trench, was generating more heat than anticipated, and was threatening the nearby trailer. The contractor on scene recognizing this risk quickly restarted the backhoe, and with sideways sweeps of the bucket was able to backfill part of the trench and extinguish the fire. The elapsed time from ignition to extinguishing the fire was no more than five minutes. There was considerable external damage to the trailer.

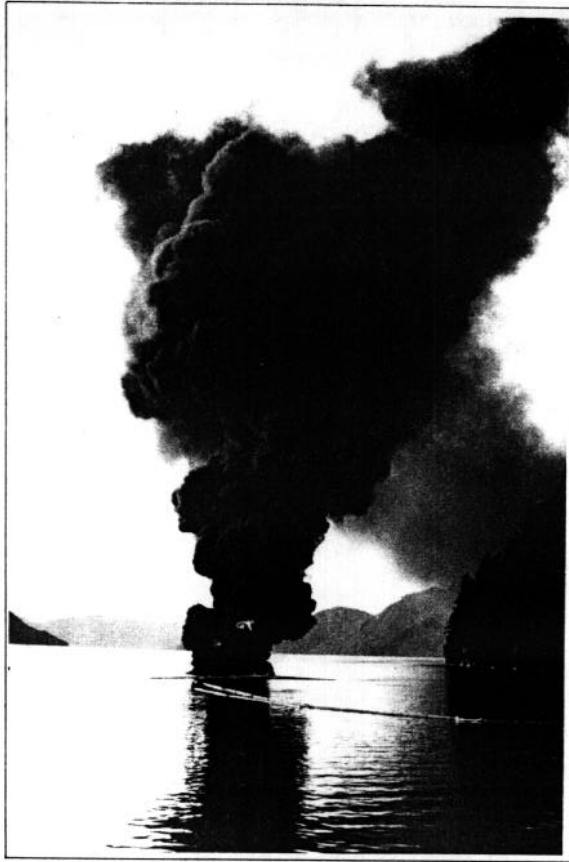
Ignition took place over a period of several minutes, starting at approximately 1415 hours. A fuel-soaked absorbent pad was reported to have been thrown from one of the two attending dozer boats onto the collected fuel. Ignition was slow, and the process was repeated. Whether gasoline was used to speed up this process has not been confirmed. After fifteen minutes, a substantial burn was taking place (Figure 3).

Burn Phase: Neither the precise timing of the burn, nor its dimensions were recorded at the time. Recollections indicate that the period from the initial attempts at ignition to the fire going out approximated 30 minutes. Burn dimensions have been estimated using the 16' dozer boats as a point of reference. This indicates a spill diameter of less than 40'. Fuel thickness was not determined. On the basis of this limited information, it would appear that the burn consumed no more than 10,000 L. While modest in relation to the total released from the various tank ruptures, the burn was a success and provides a model for future spills in remote locations.

Figure 3 *In-situ burning of spilled diesel fuel, Rivers Inlet November, 1990.*
