***ASSESSMENT OF FIXED OFFSHORE
PLATFORM PERFORMANCE IN HURRICANES
KATRINA AND RITA***

**FINAL REPORT
May 2007**

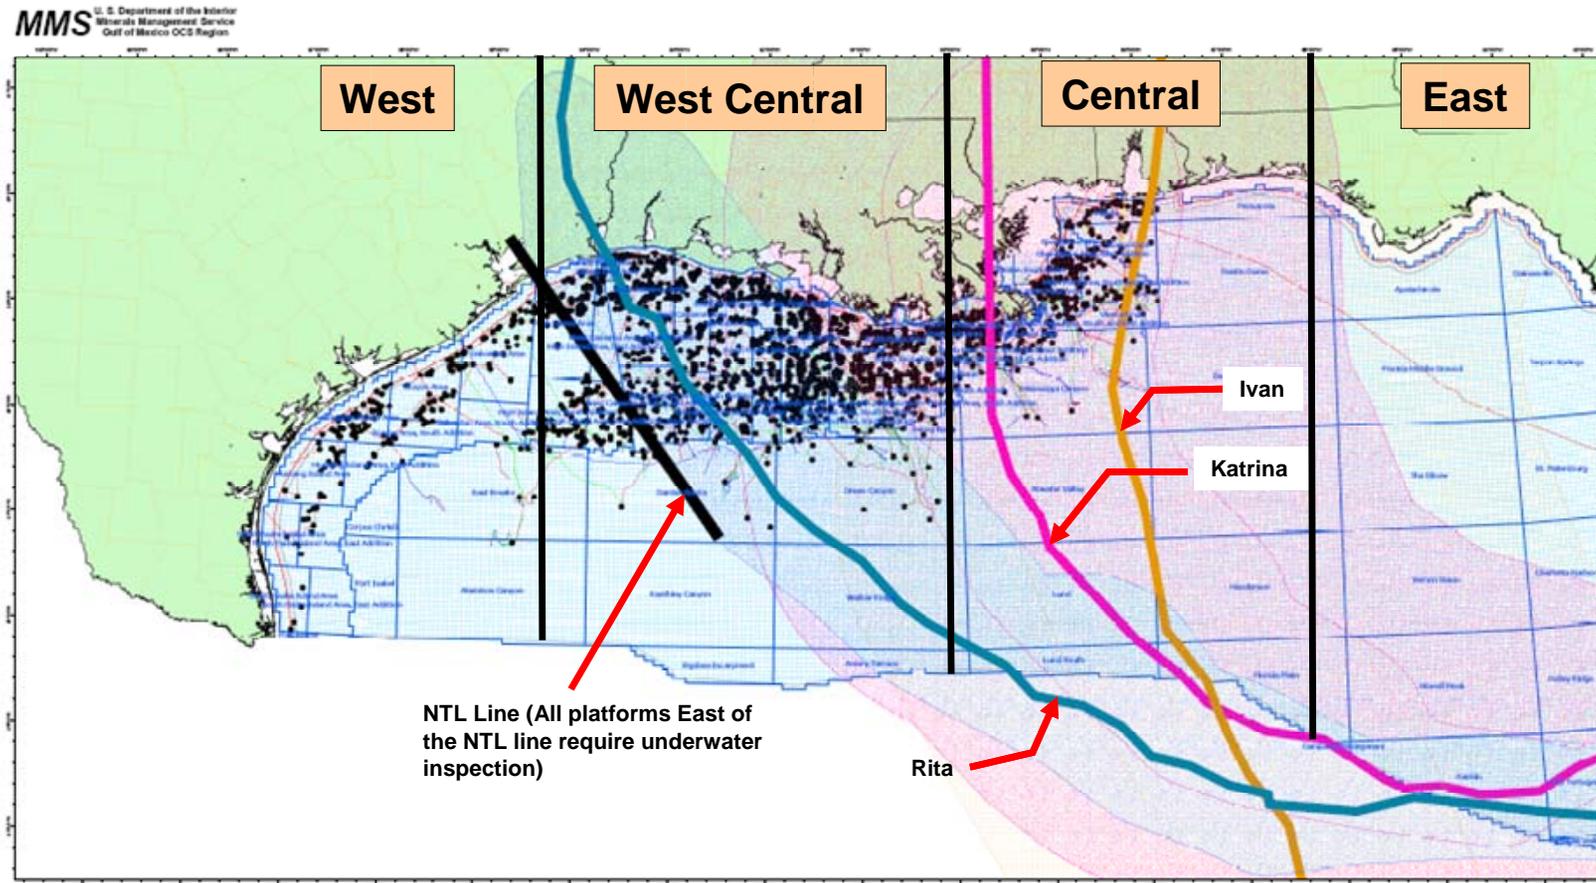
Figure 2.1 Path of Hurricanes Katrina and Rita and the Gulf of Mexico Offshore Infrastructure.
The dots indicate specific platforms. The West, West Central, Central and East Regions are per API Bulletin 2INT-MET. All platforms located east of the NTL had to be inspected following the hurricanes per MMS NTL 2005-G20 and NTL 2005-G20 Addendum 1. Also shown for reference is the path of hurricane Ivan.

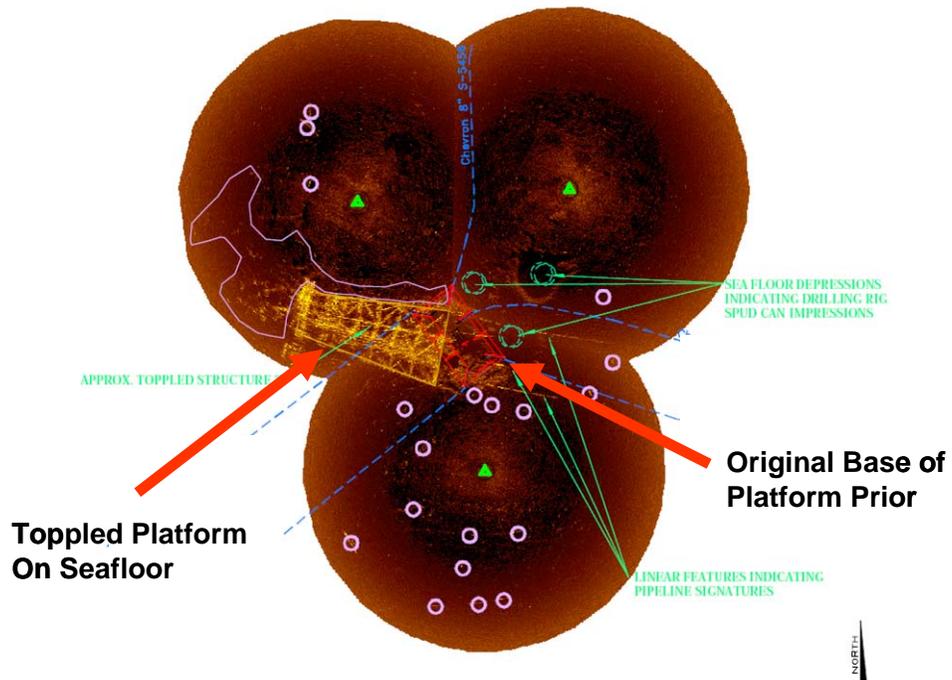
Figure 4.1 Sonar Image of a Toppled Platform in the West Delta Area

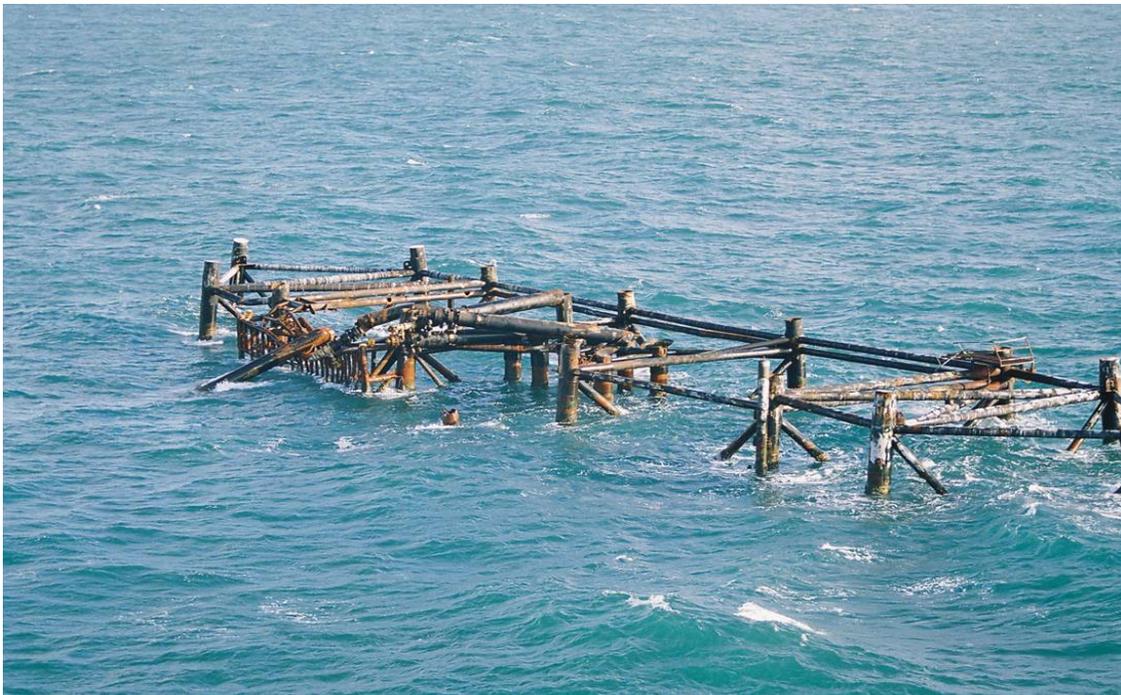
Figure 4.4 Destroyed Platform in the South Timbalier Region

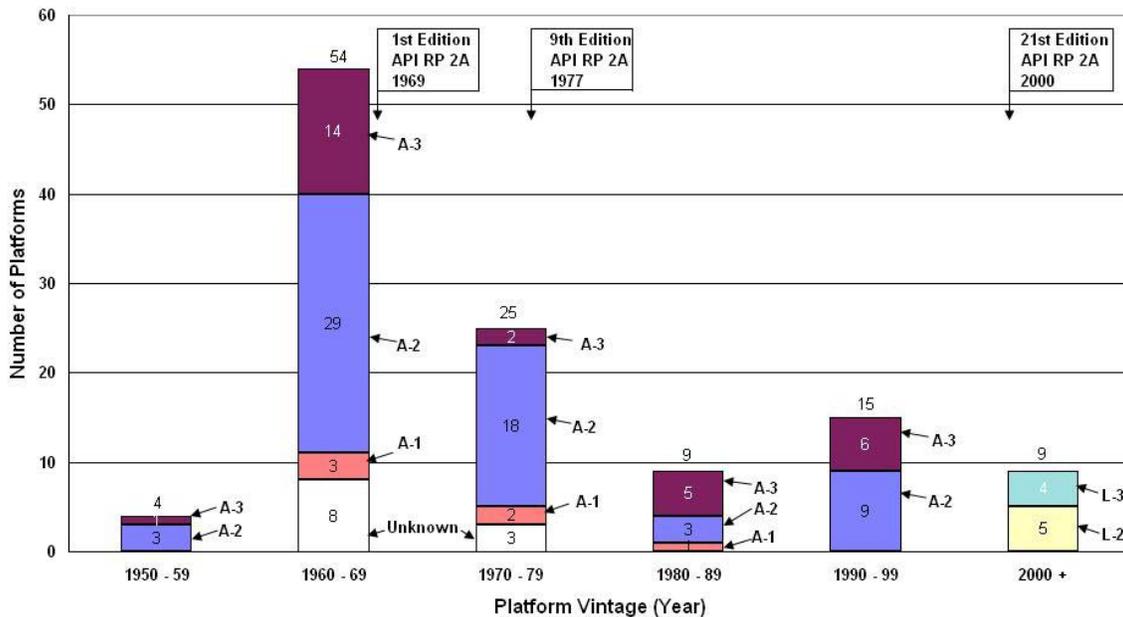
Figure 4.6 Destroyed Platforms by Vintage and API Category

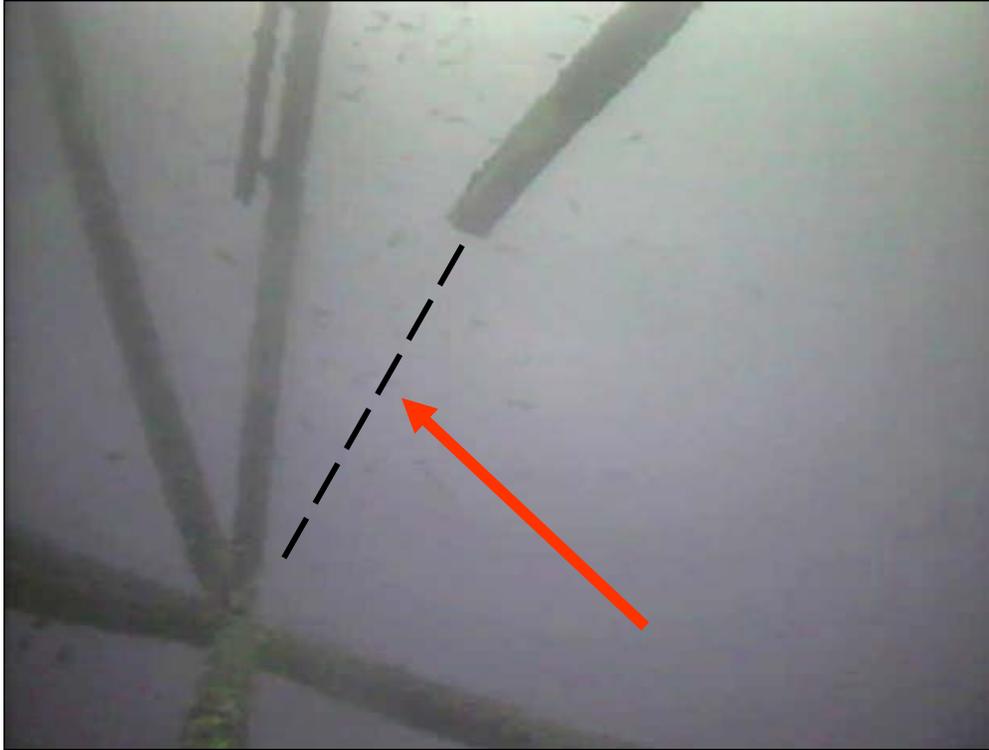
Figure 5.1 Major Damage – Missing Underwater Brace

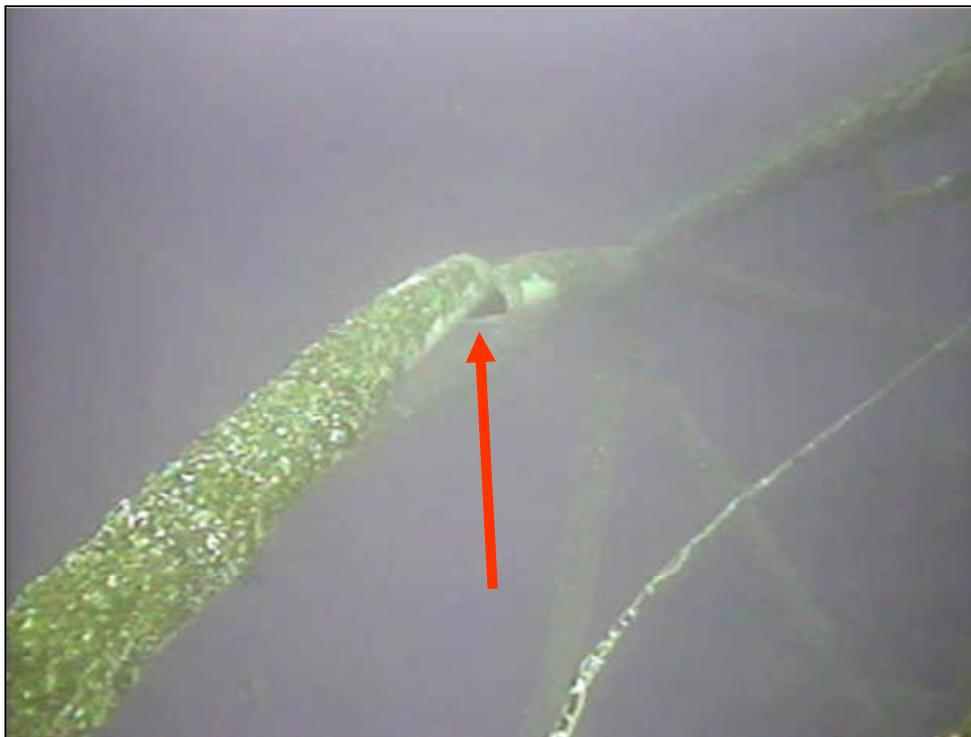
Figure 5.2 Major Damage – Severed Underwater Brace

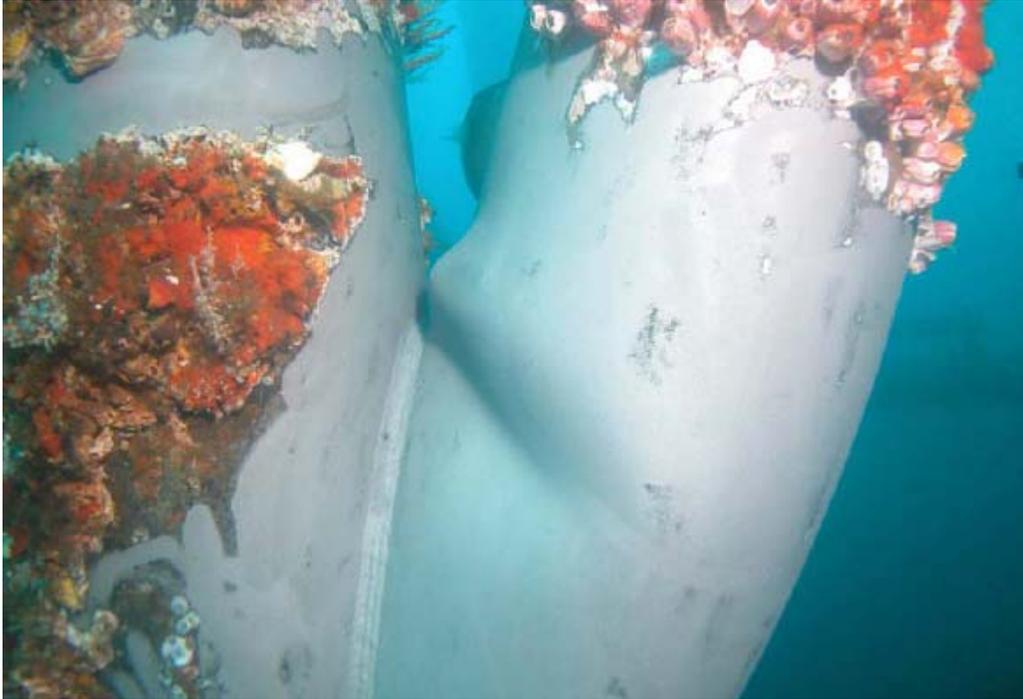
Figure 5.3 Major Damage – Buckled Underwater Brace

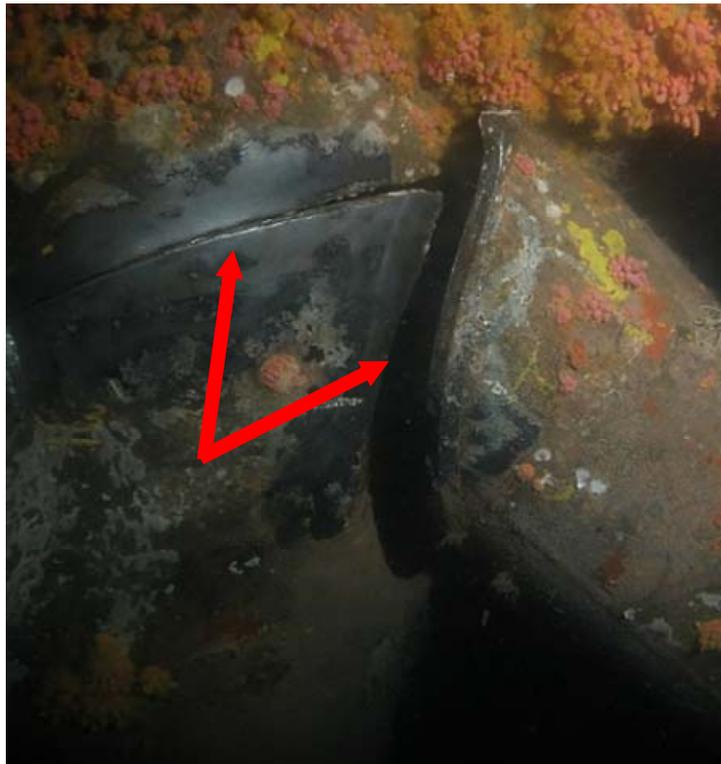
Figure 5.4 Major Damage – Underwater Cracked Joint at Leg

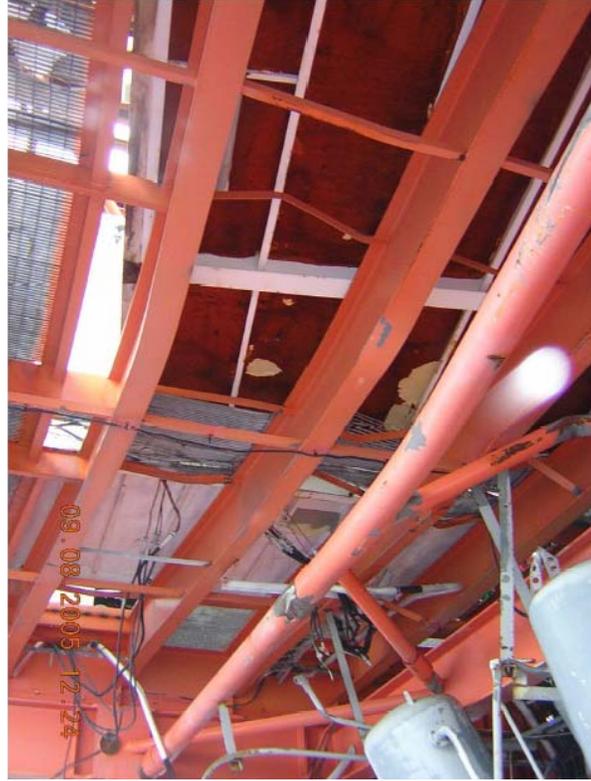
Figure 5.5 Major Damage – Above Water Bent Deck Beams Caused by Waves

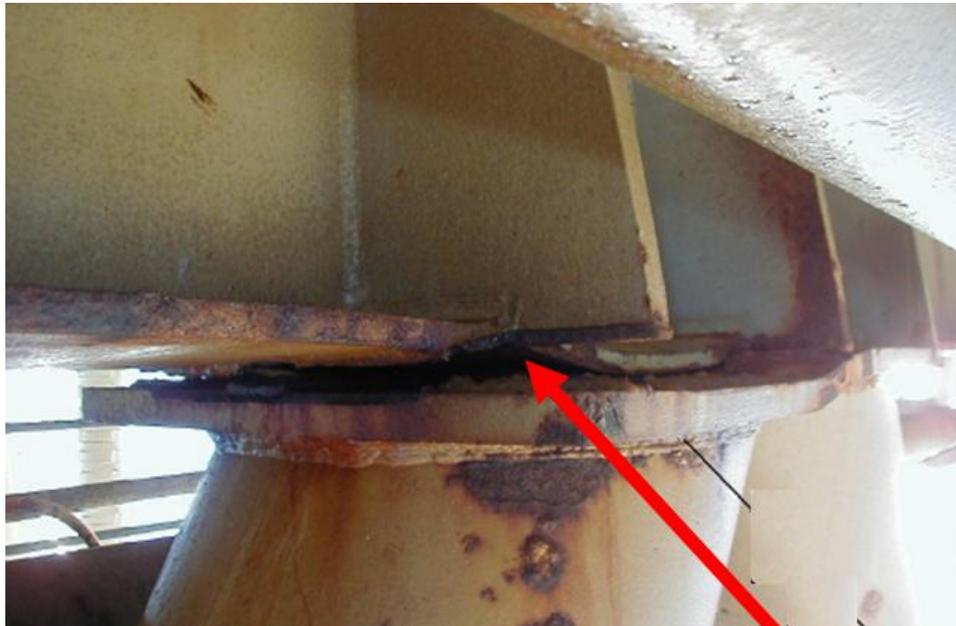
Figure 5.6 Major Damage – Above Water Vertical Diagonals Separated from Truss Row Beam

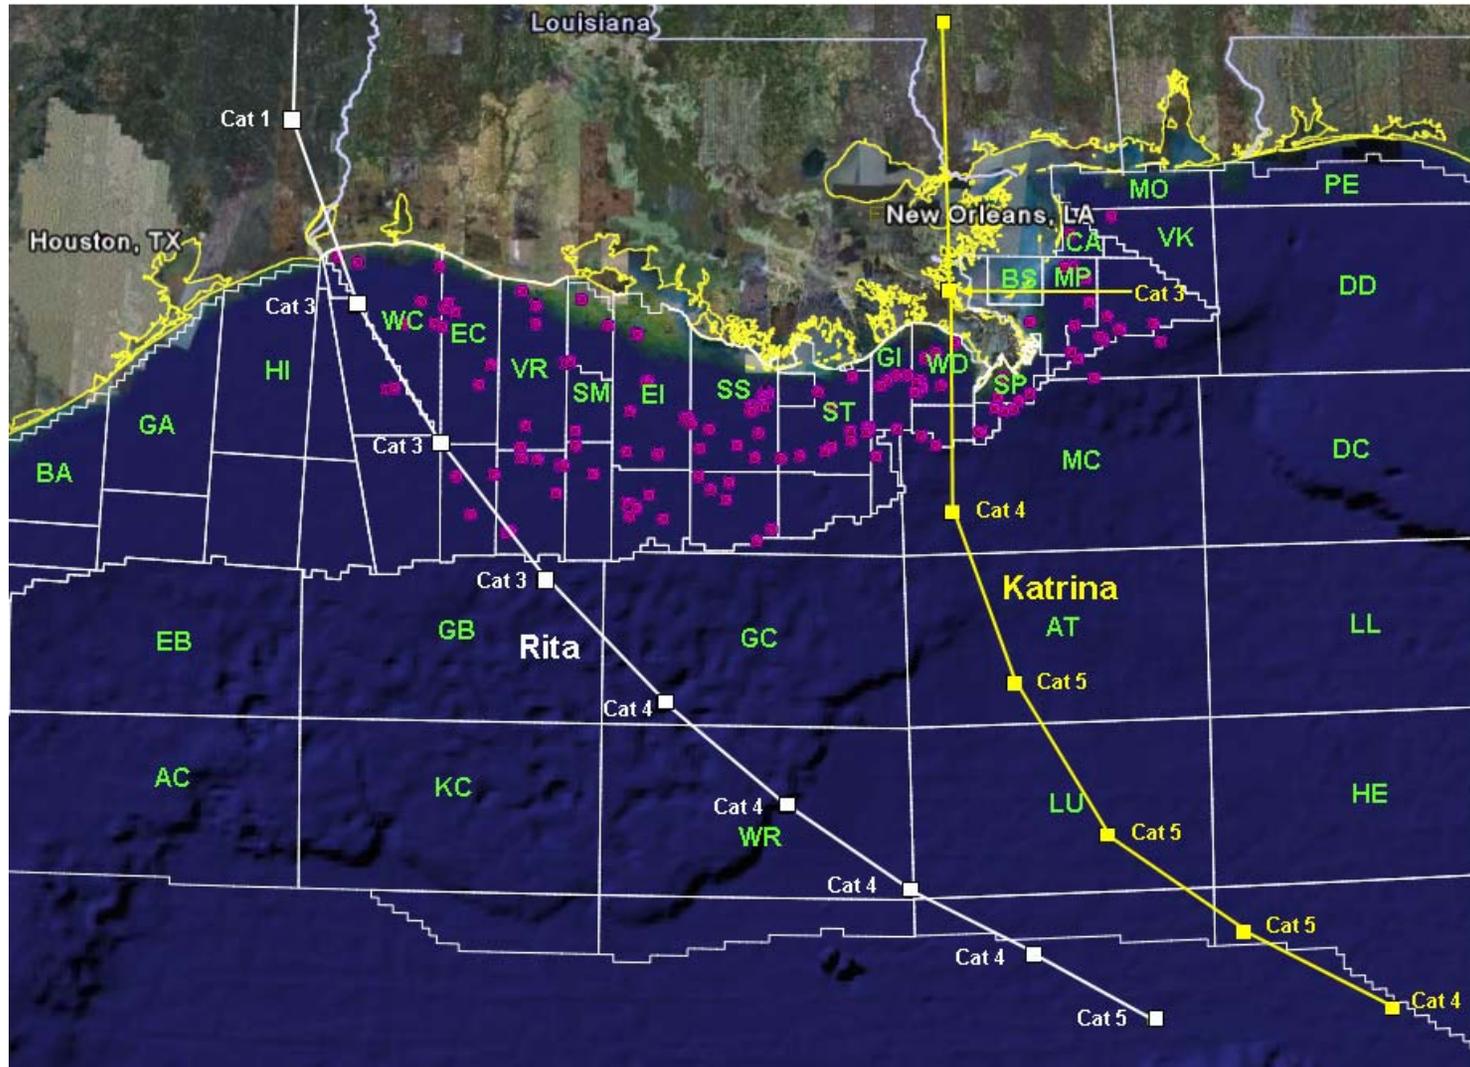
Figure 5.7 Location of Platforms with Major Damage Compared to Path of Hurricanes.
The dots indicate platforms with major damage. The SSI Category of the hurricanes at selected locations is also shown.

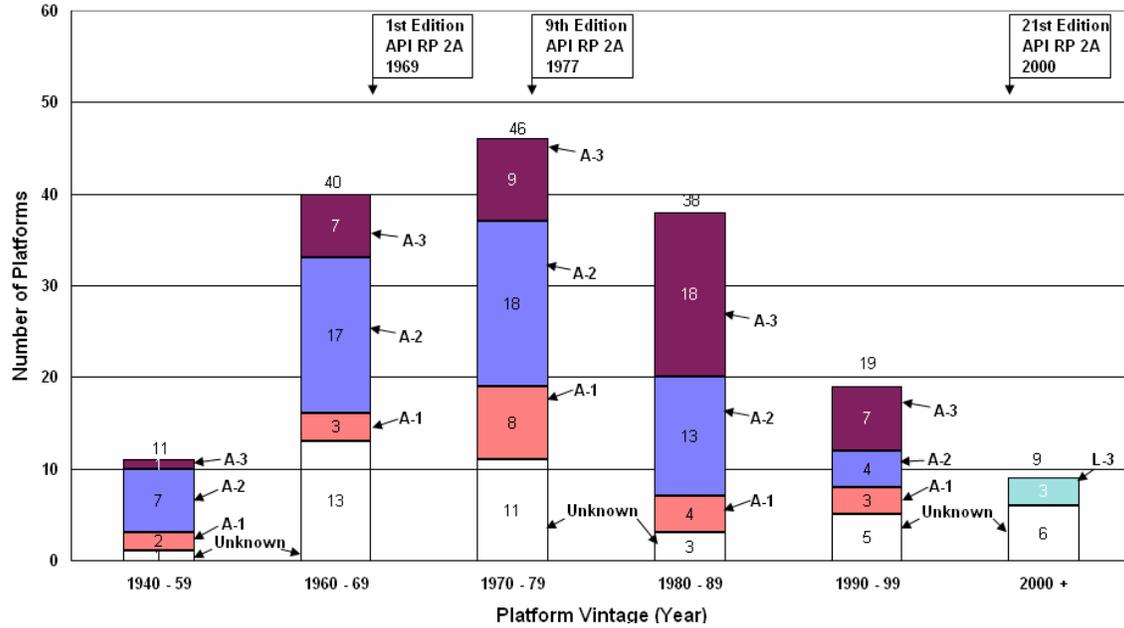
Figure 5.8 Platforms with Major Damage by Vintage and API Category

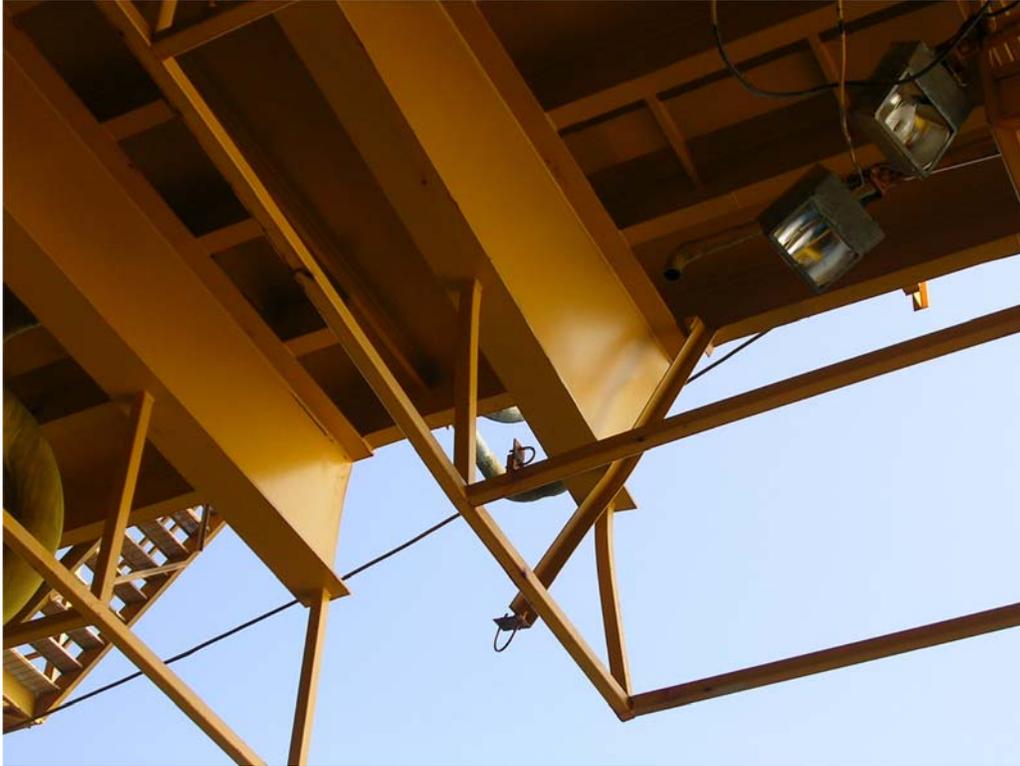
Figure 6.1 Structural Damage from Local WID

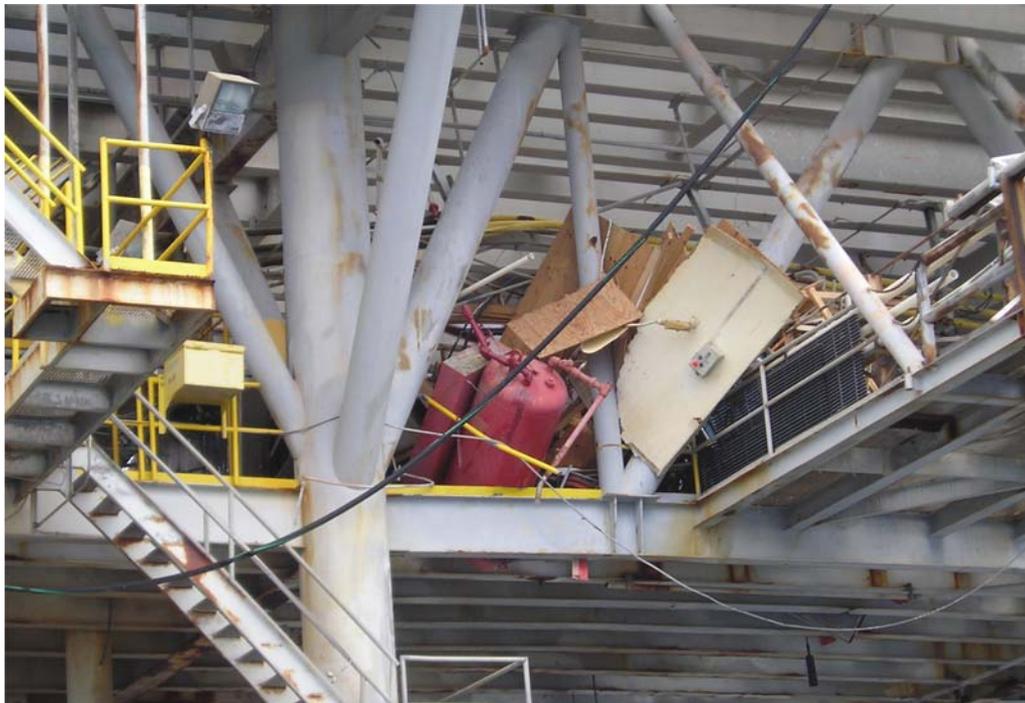
Figure 6.2 Non-Structural Damage from Local WID

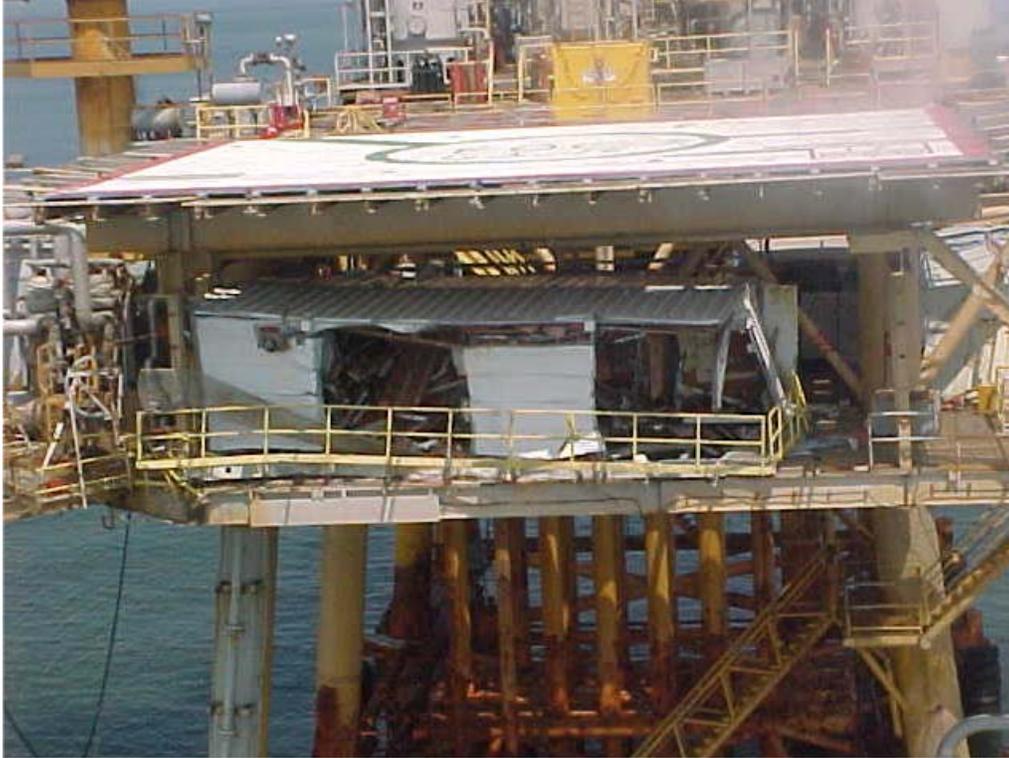
Figure 6.3 Destroyed Building Typical Non-Structural Local WID Damage

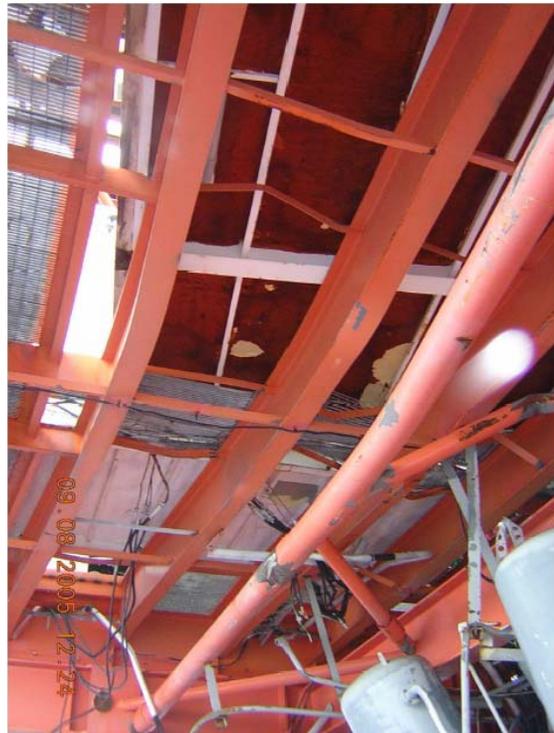
Figure 6.4 Bent Main Deck Beams at a Higher Elevation in a Platform

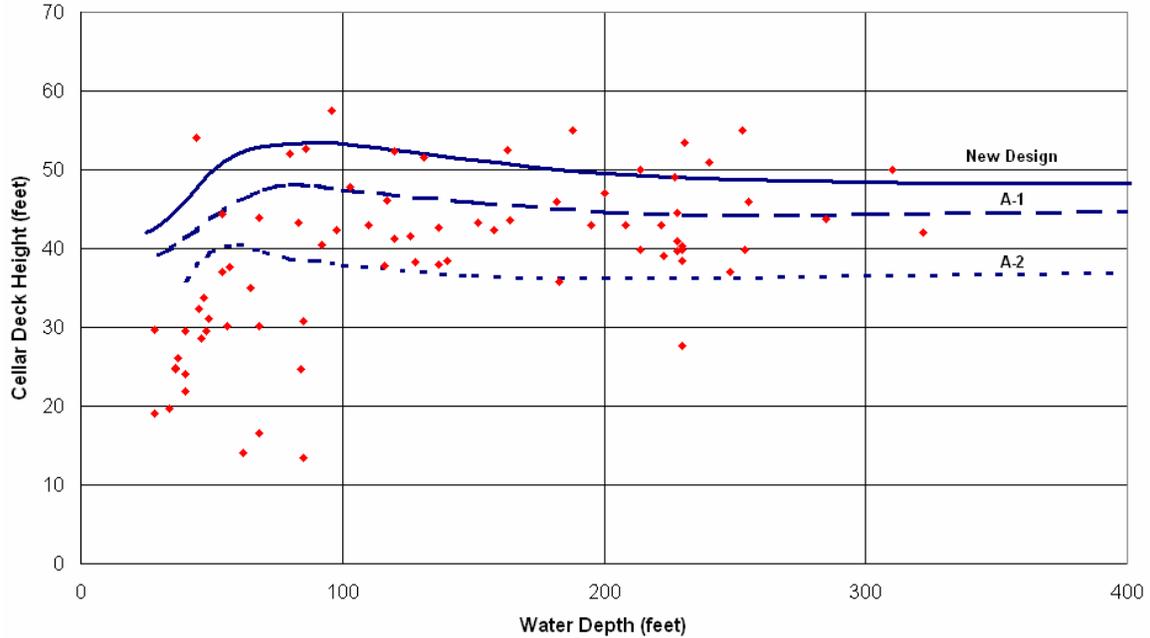
Figure 6.7 Destroyed Platforms by Platform Deck Elevation

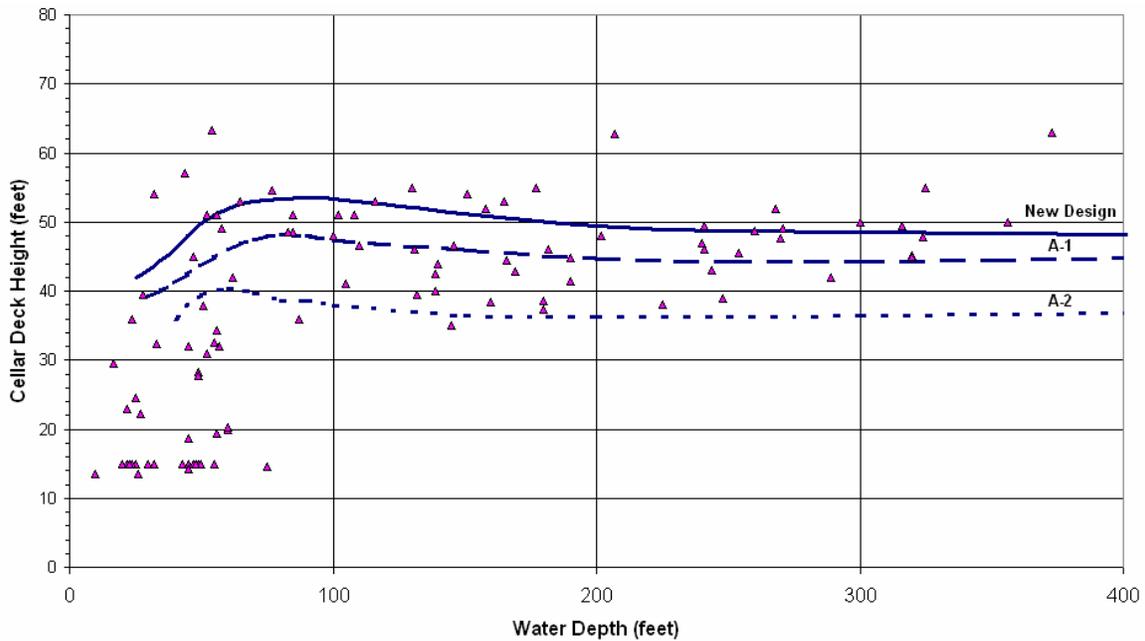
Figure 6.8 Major Damage Platforms by Platform Deck Elevation

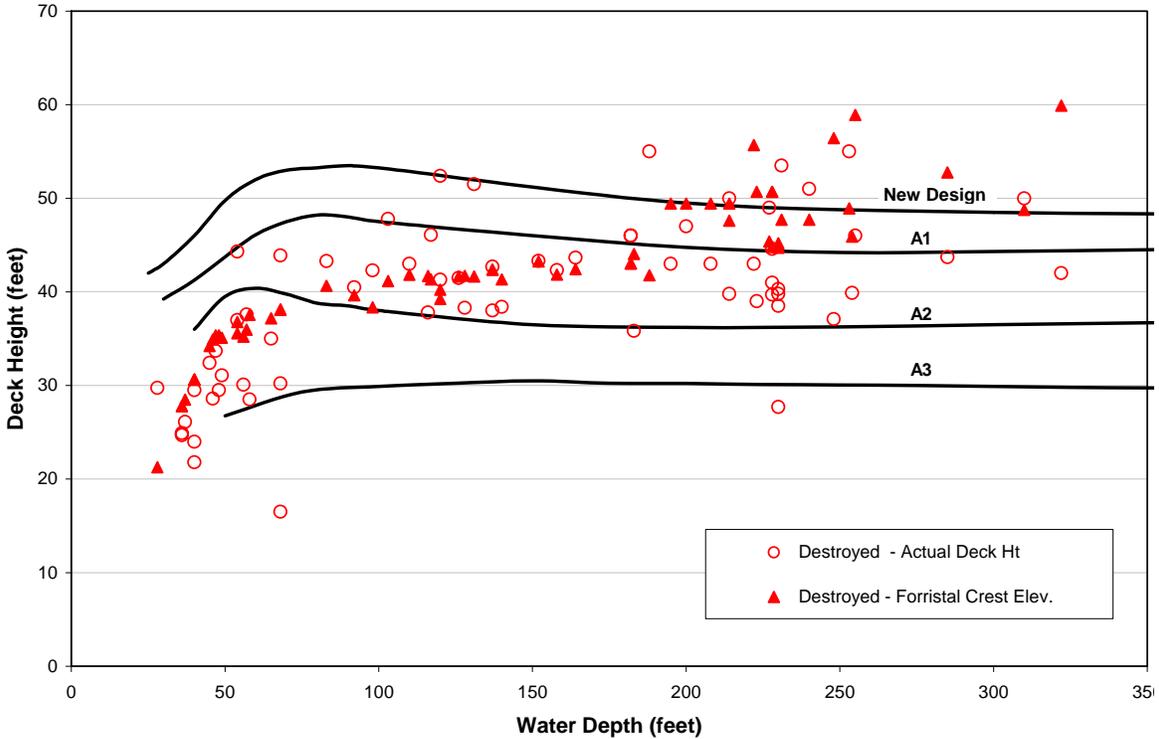
Figure 6.9 Destroyed Platforms – Platform Deck Height Compared to Predicted Wave Crest Height

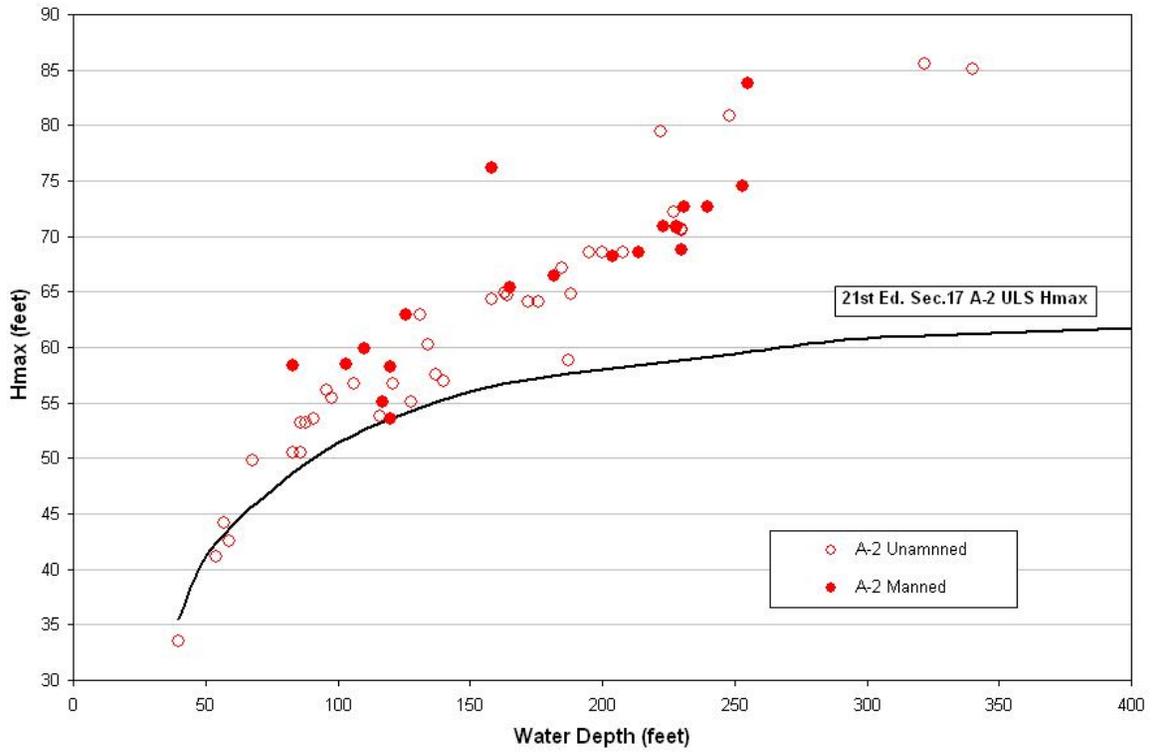
Figure 6.13 Performance of Destroyed A-2 Category Platforms

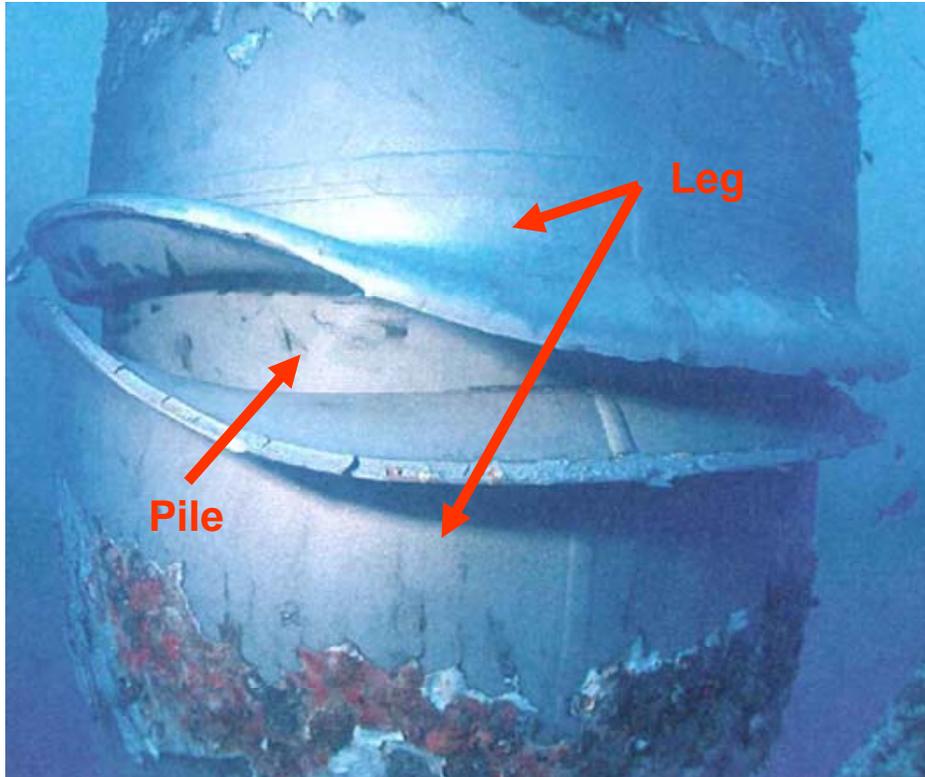
Figure 7.1 Pancake Leg Damage – Final Damage Configuration

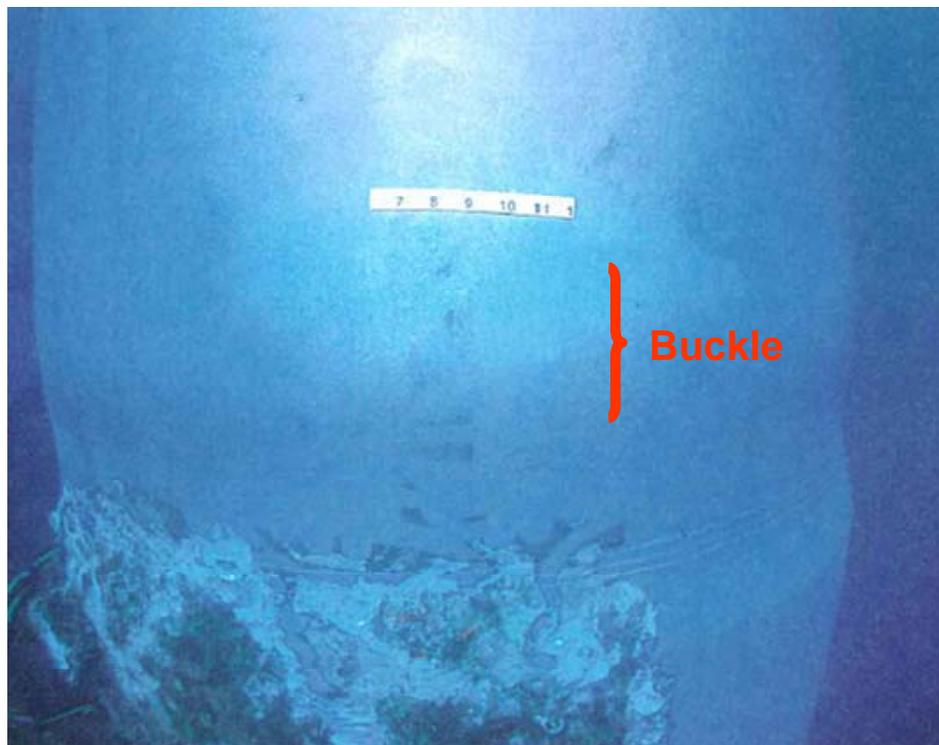
Figure 7.2 Initiating Damage – Local Buckle of Leg

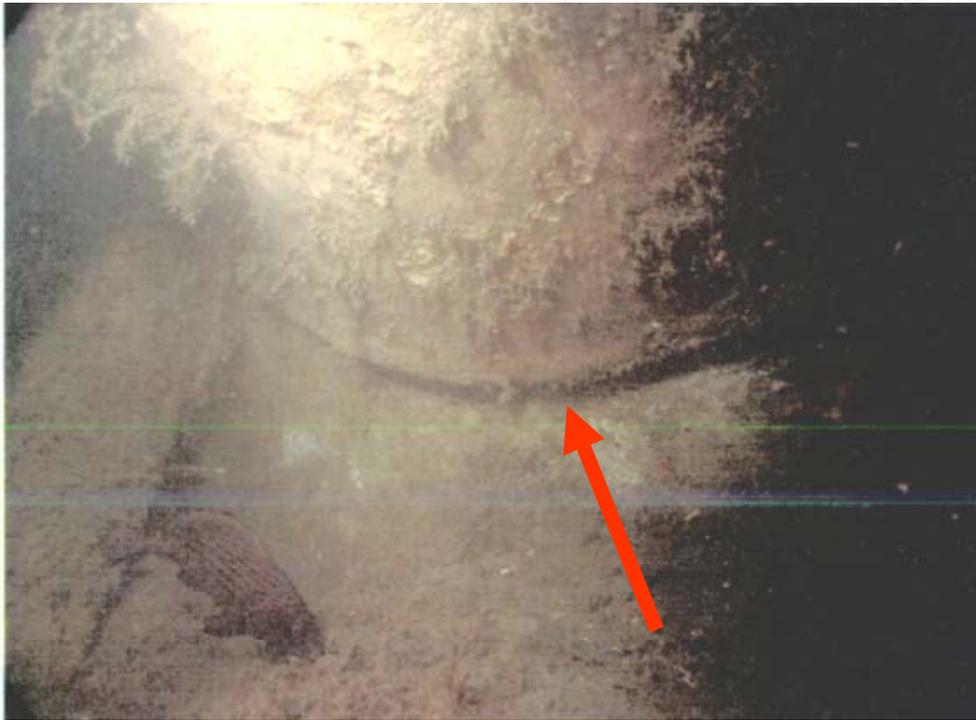
Figure 7.3 Separation of Leg at Buckle

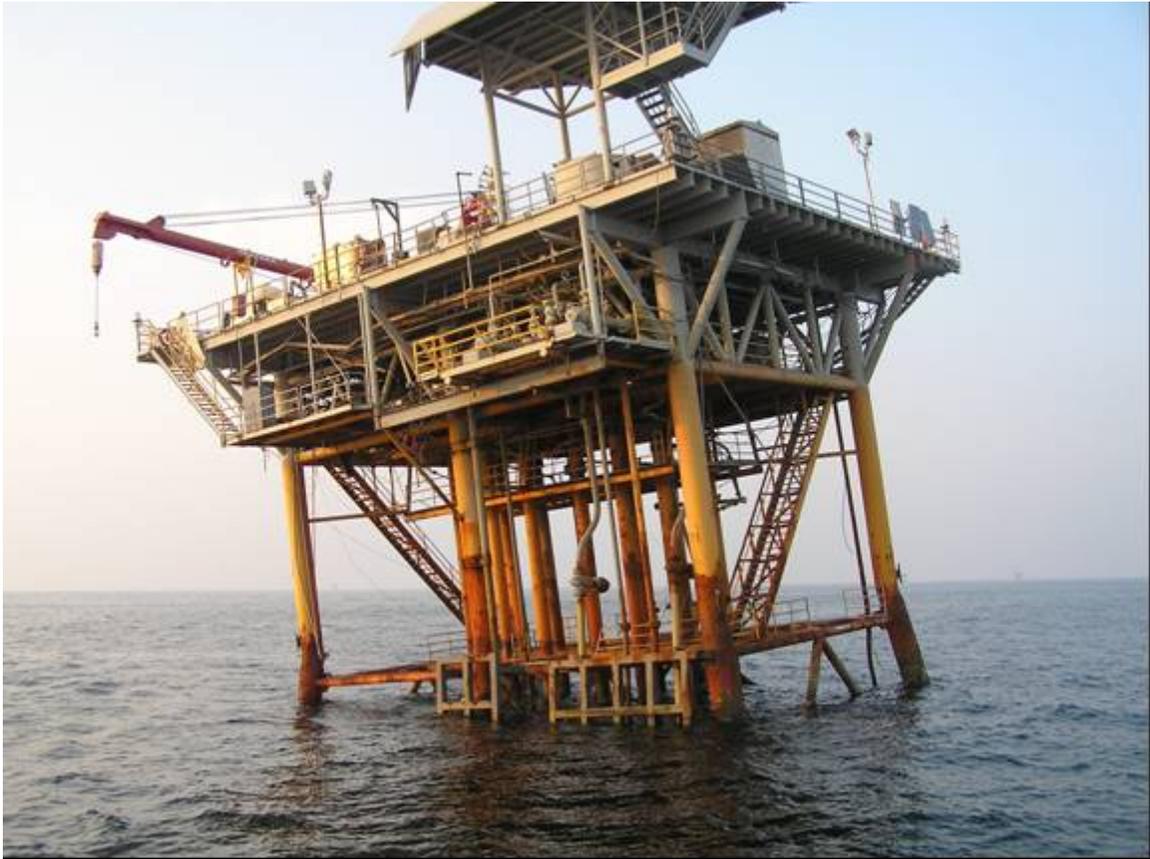
Figure 8.1 Destroyed Platform Suspected to be a Foundation Failure

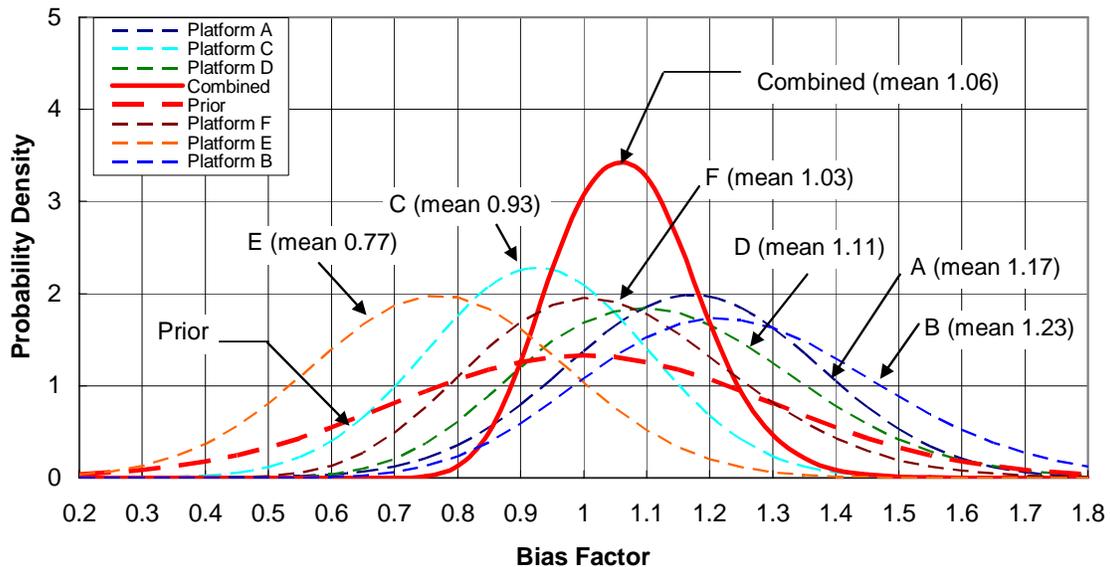
Figure 9.1 – Jacket Bias Factors for Six Platforms Analyzed for Hurricanes Katrina/Rita

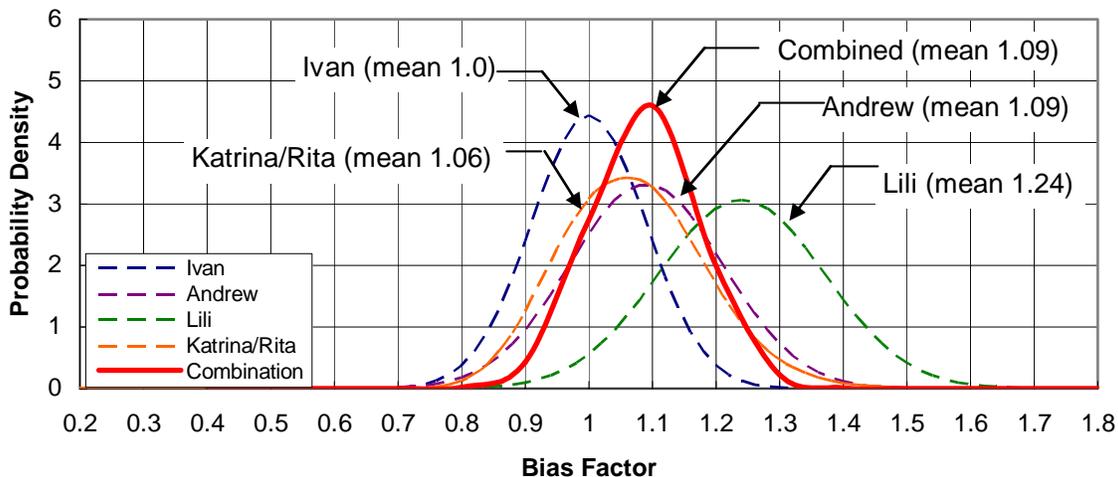
Figure 9.2 – Jacket Bias Factor of Combined Results for Hurricanes Andrew, Lili, Ivan, Katrina and Rita

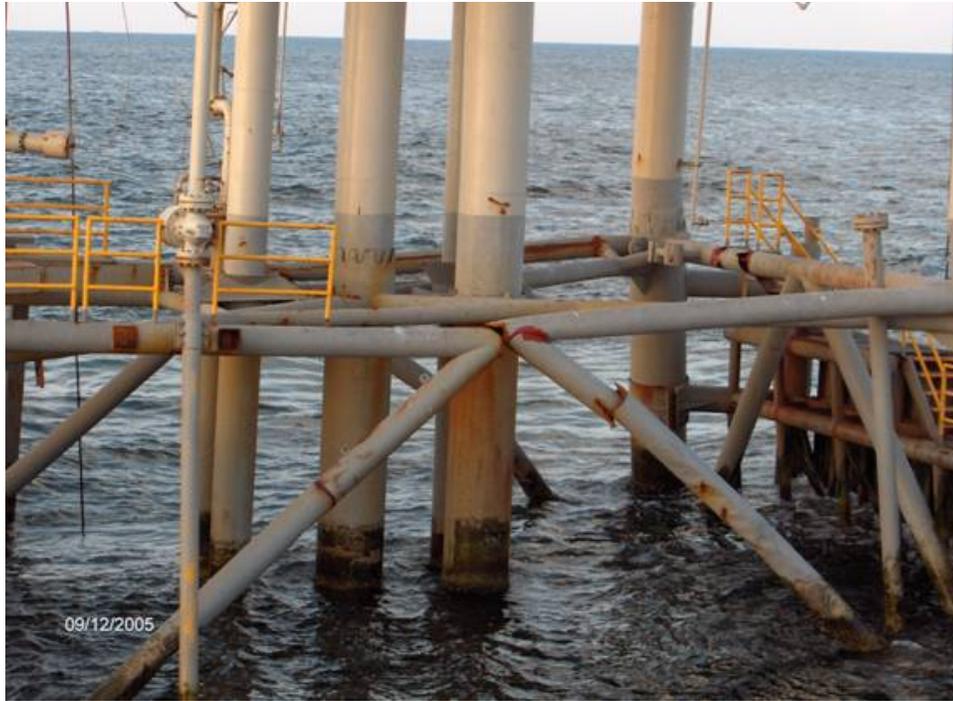
Damaged Grand Isle Area Platform – Damaged vertical diagonals and horizontal noted to be around (+) 10’.

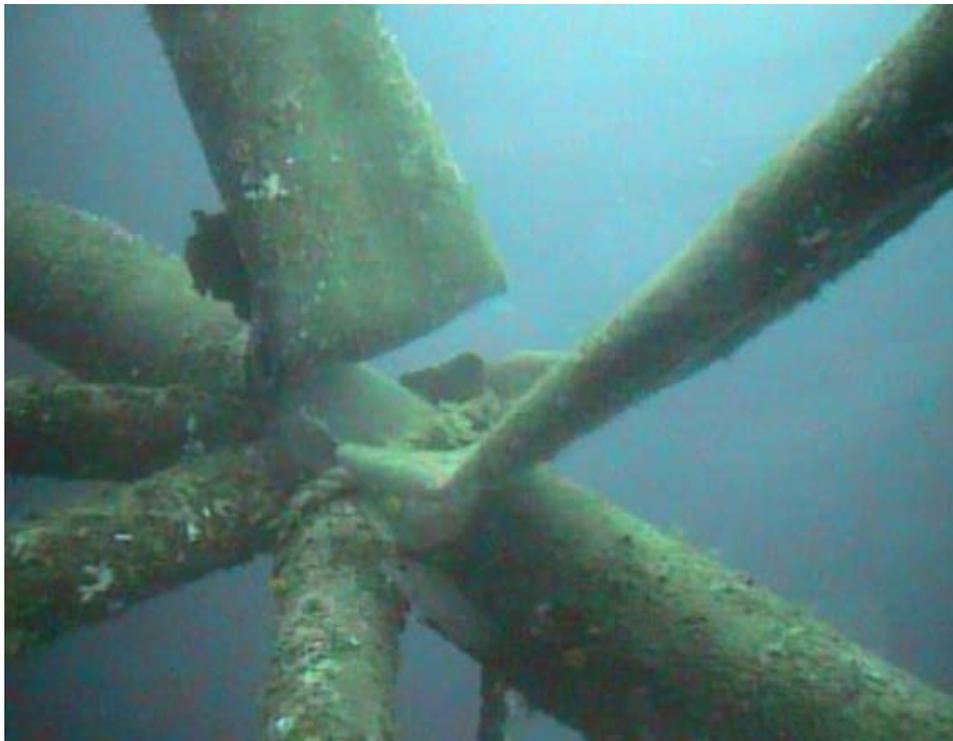
Damaged Eugene Island Area Platform – Damaged vertical diagonals around (-) 147’.

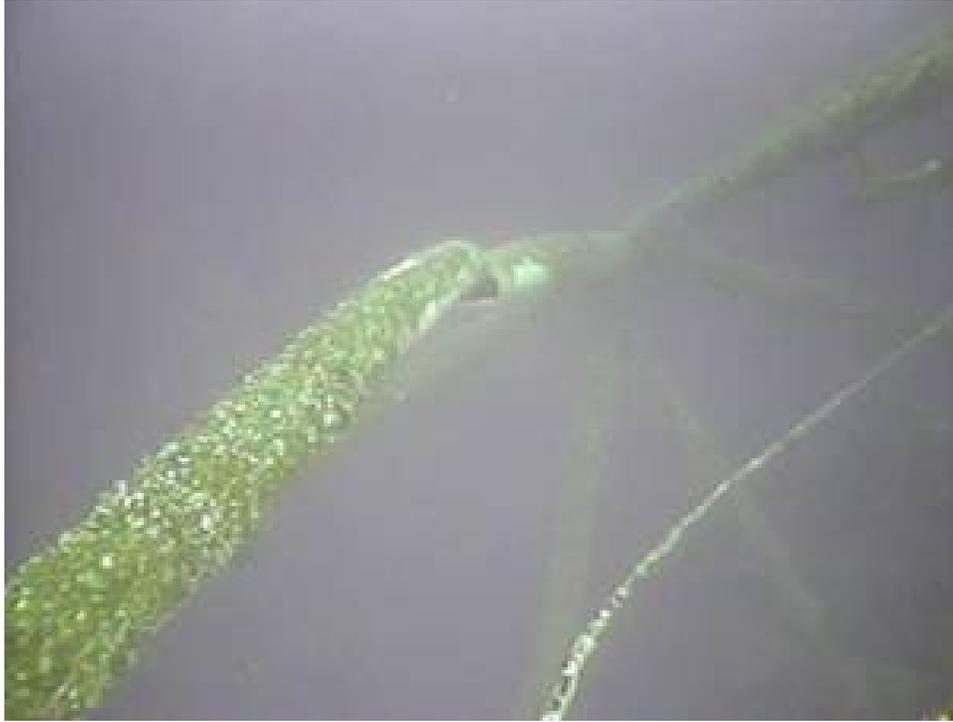
Damaged East Cameron Area Platform – Severed vertical diagonal around (-) 40’.

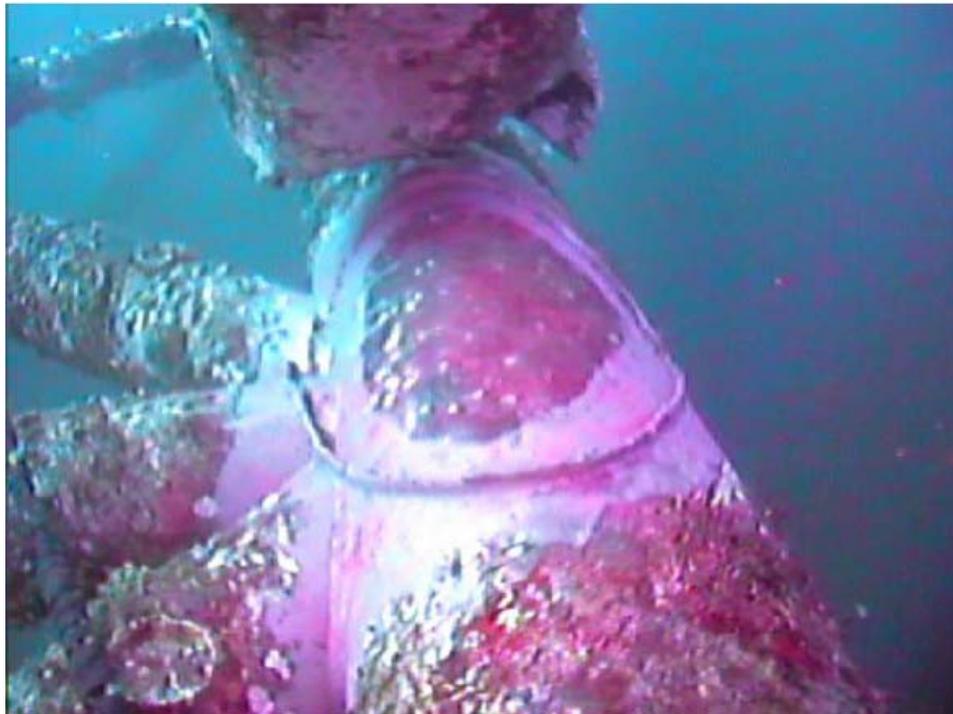
Damaged Eugene Island Area Platform – Missing vertical diagonal around (-) 147’.
