***ASSESSMENT OF FIXED OFFSHORE
PLATFORM PERFORMANCE IN HURRICANES
KATRINA AND RITA***

**FINAL REPORT
May 2007**

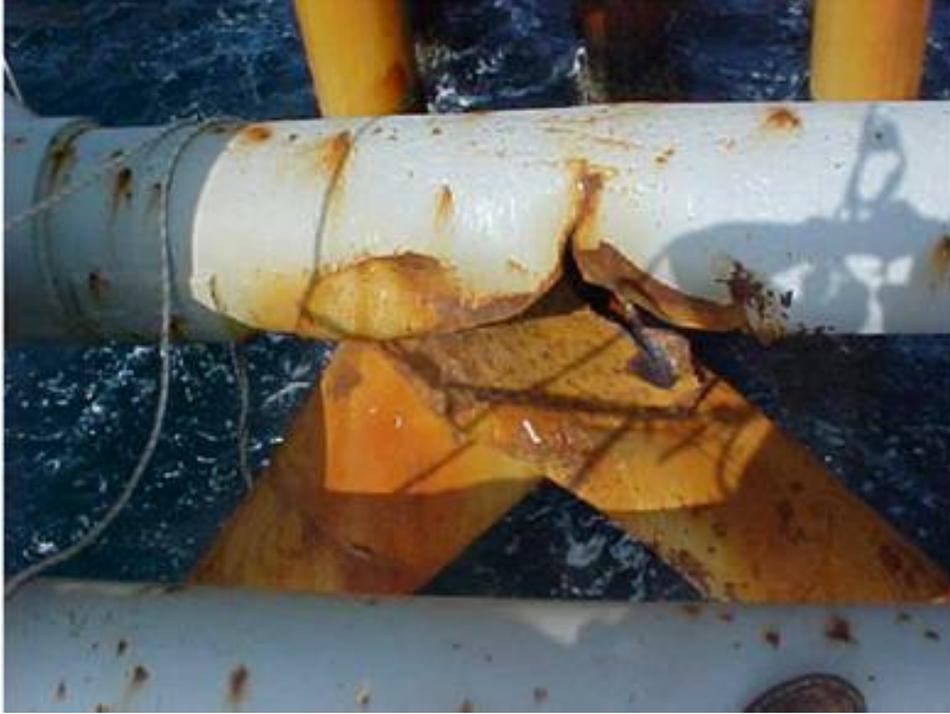
Damaged South Marsh Island Area Platform – Damaged vertical diagonals and horizontal noted to be around (+) 10’.

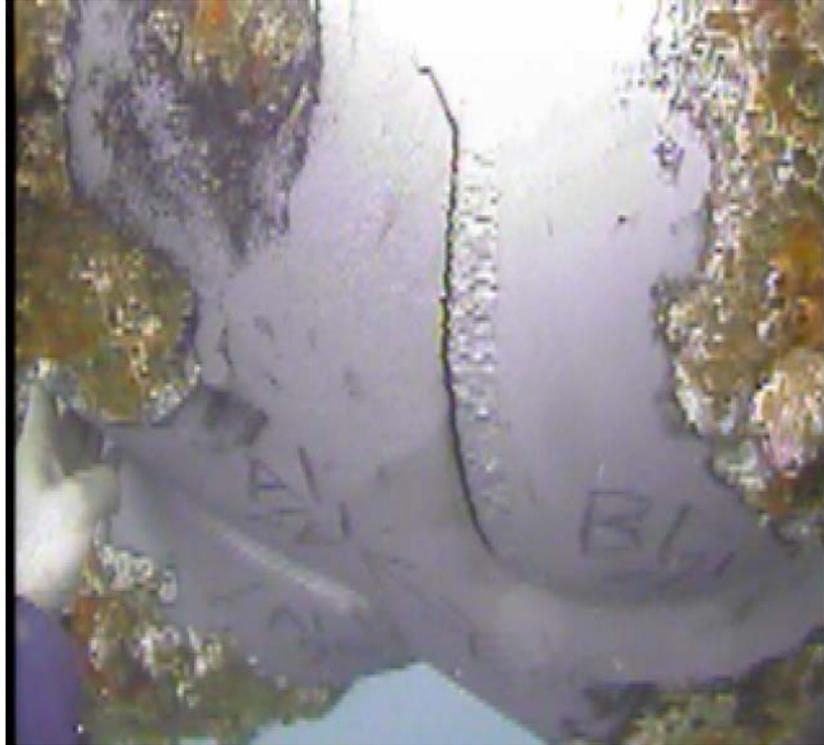
Damaged Grand Isle Area Platform – Damaged X-brace.

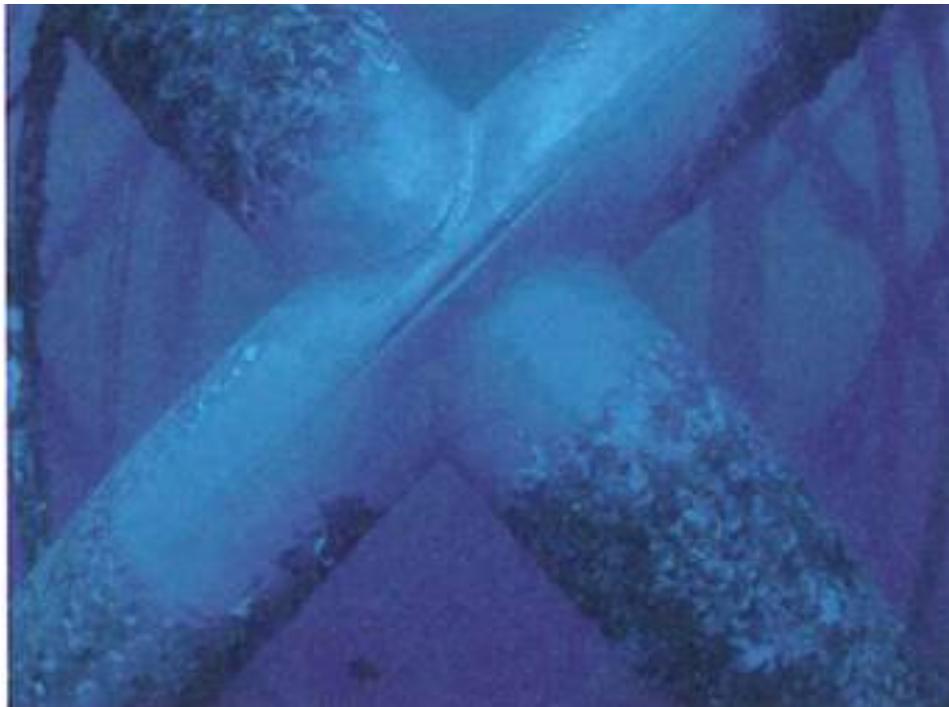
Damaged Vermillion Area Platform – Crushed X-Brace. Through member wall thickness not thick enough. Damage located at approximately (-) 60'

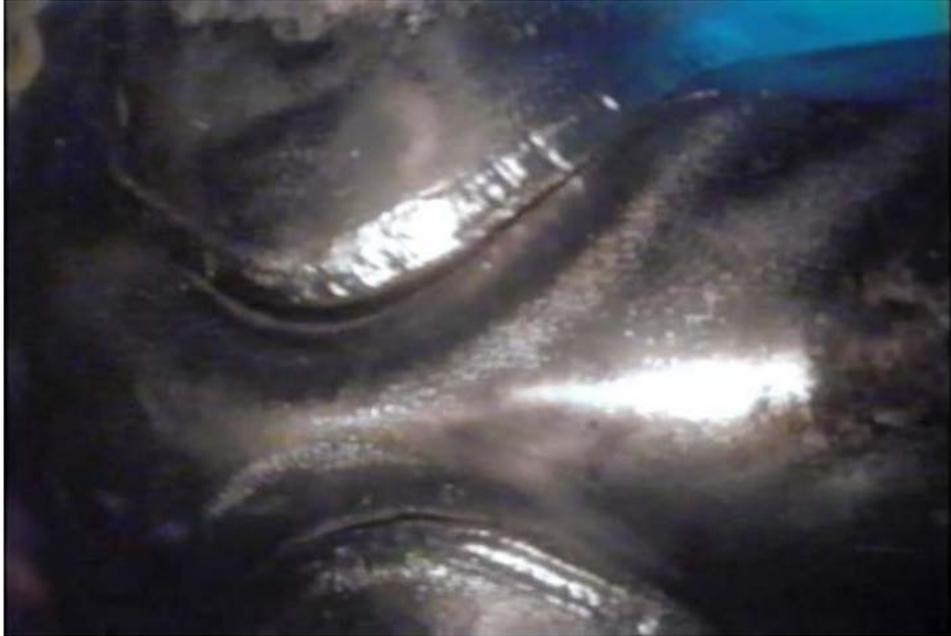
Damaged Grand Isle Area Platform – Crushed X-Brace.

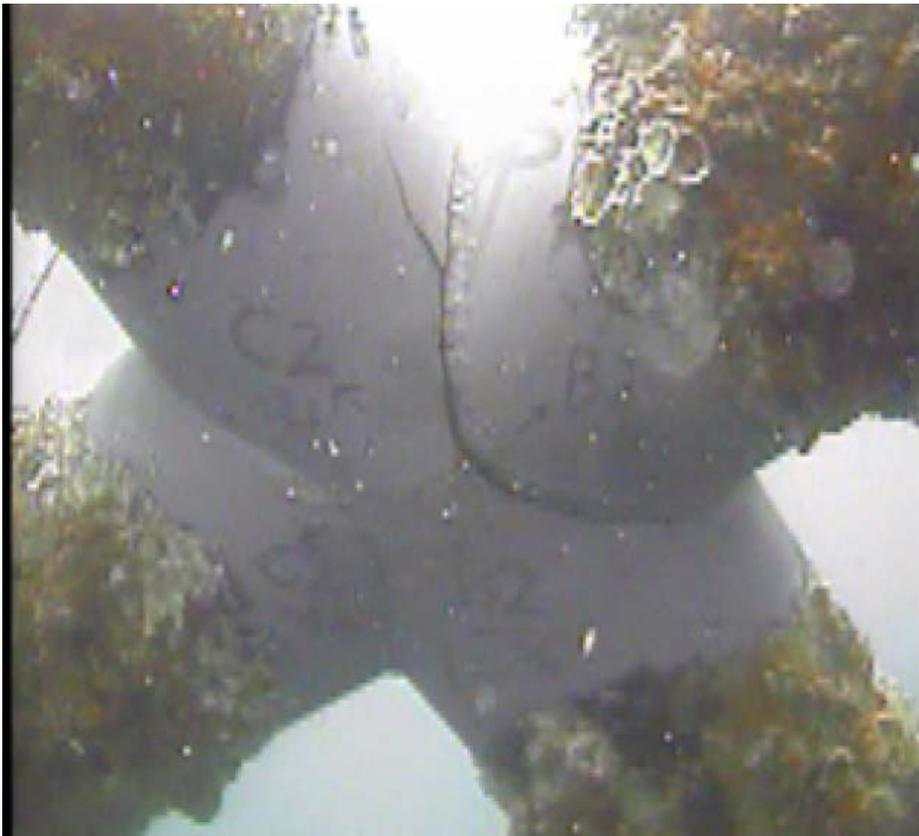
Figure 6: GI-40 | photograph of damage to X-brace on Row 2

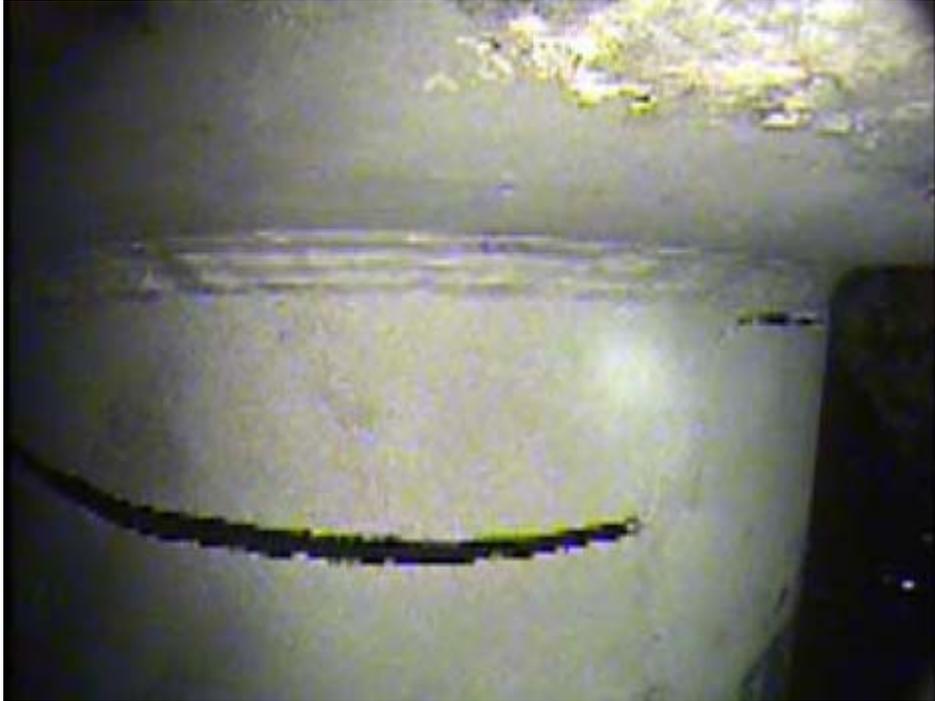
Damaged Eugene Island Area Platform – Cracked horizontal member located at the (-)40'. Typical conductor guide framing fatigue damage.

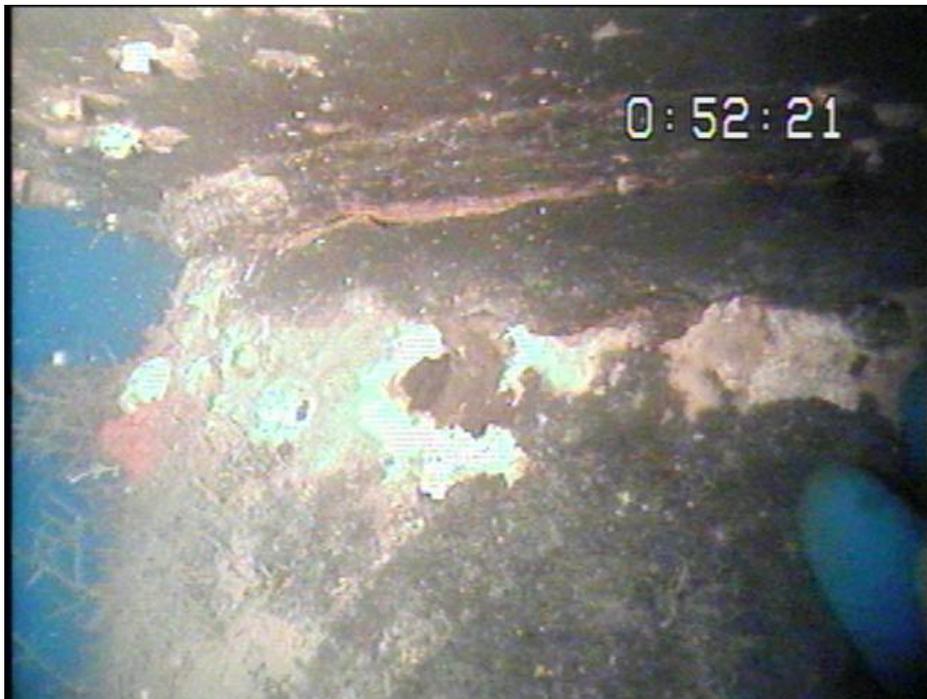
Damaged East Cameron Area Platform – Cracked horizontal member.
Typical fatigue damage.

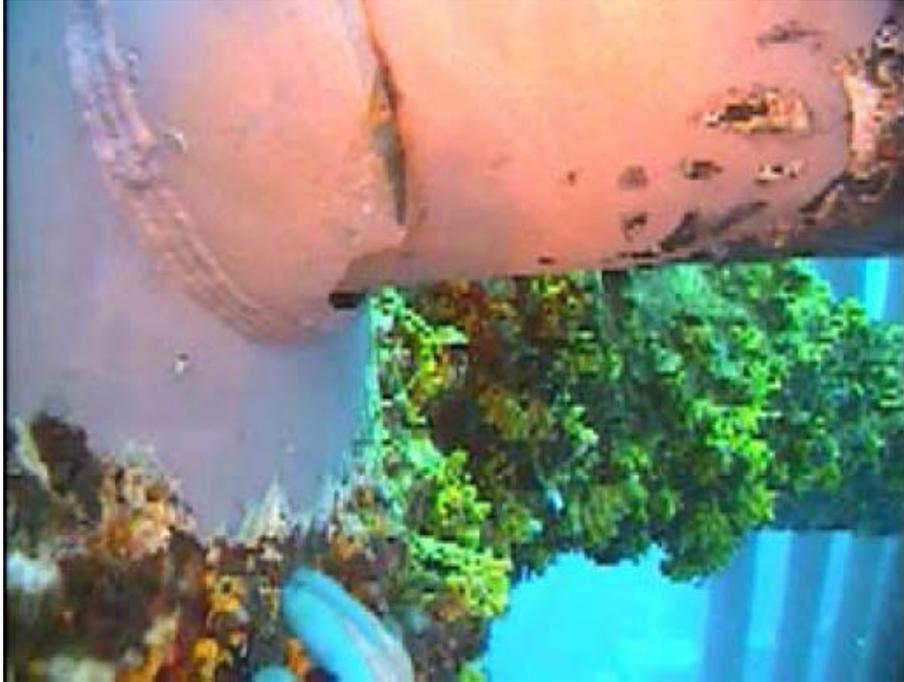
Damaged Eugene Island Area Platform – Cracked horizontal member located at the (-)40'. Typical conductor guide framing fatigue damage.

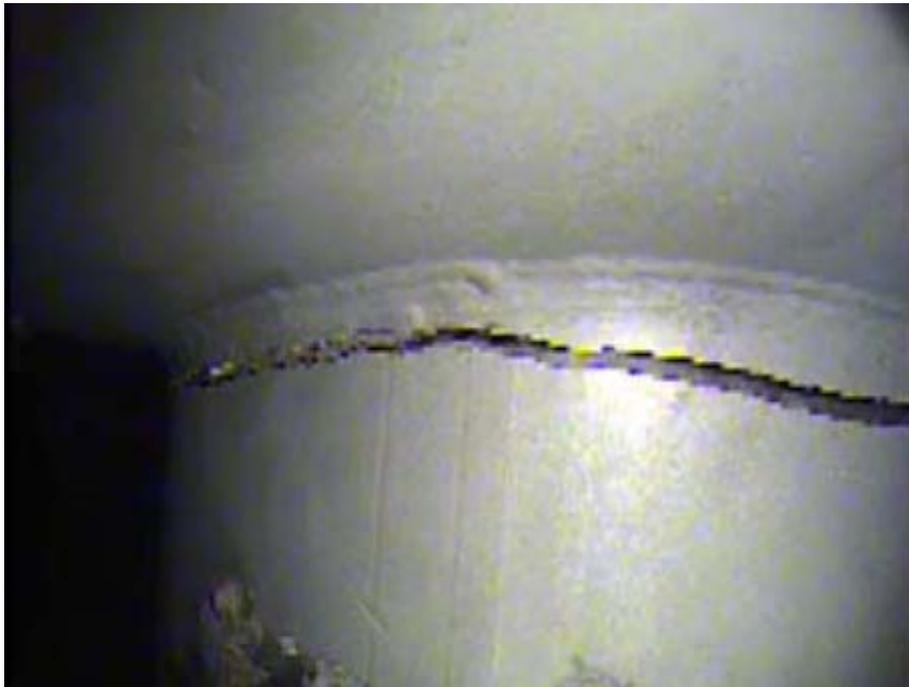
Damaged Eugene Island Area Platform – Cracked horizontal member located at the (-)40'. Typical conductor guide framing fatigue damage.

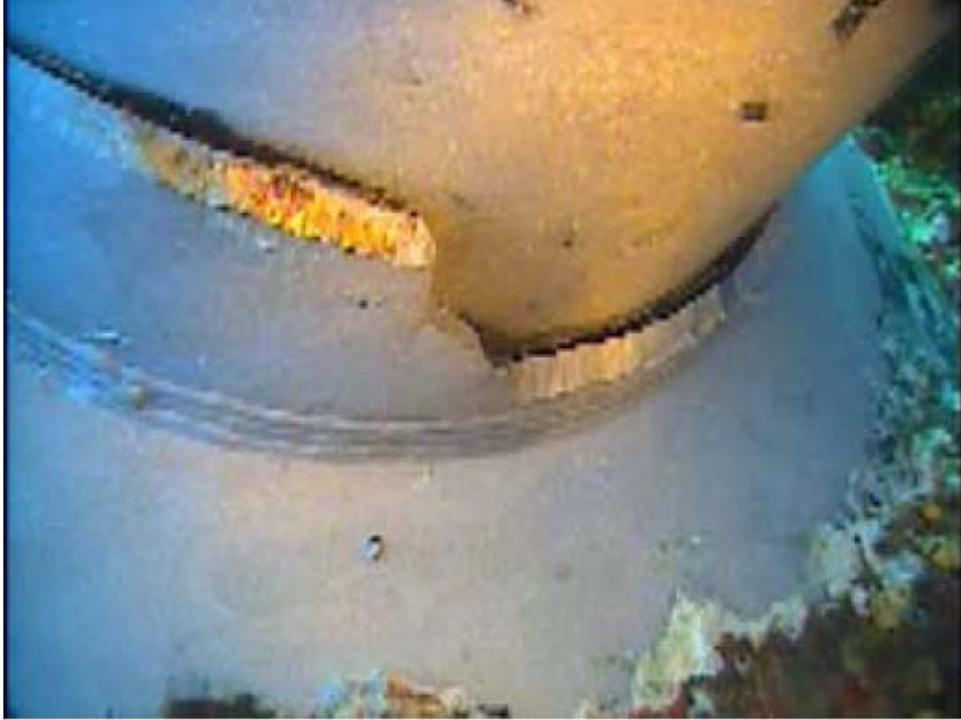
Damaged Eugene Island Area Platform – Cracked horizontal member located at the (-)40'. Typical conductor guide framing fatigue damage.

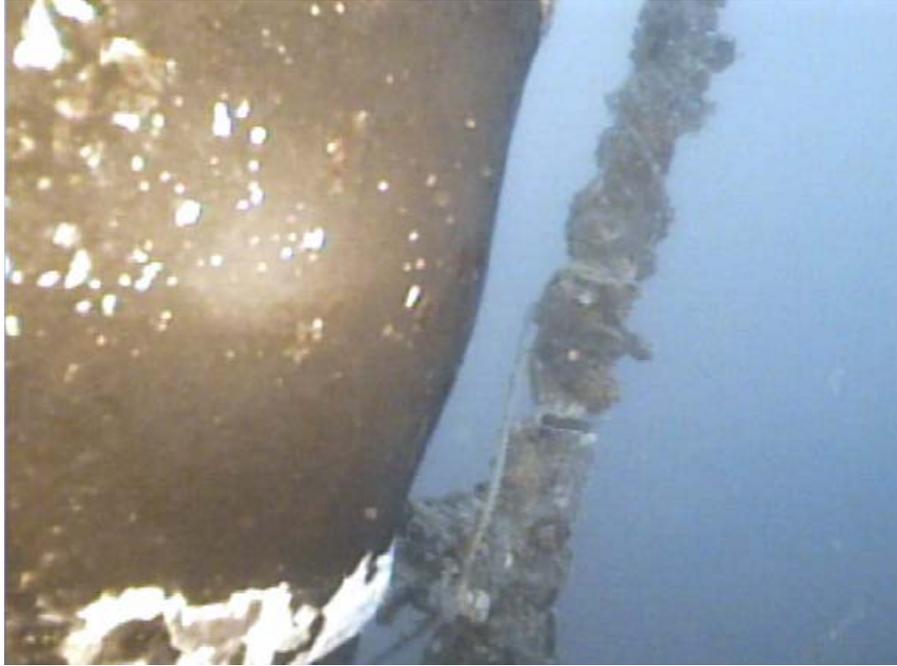
Damaged Eugene Island Area Platform – Local bulge found at the (-) 90'.

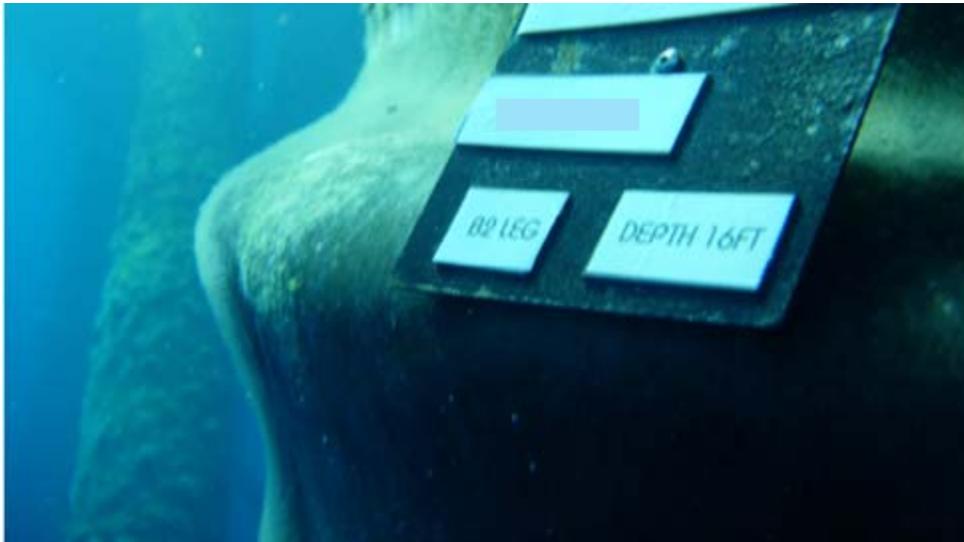
Damaged Mississippi Canyon Area Platform – Buckled leg found at the (-) 16'.

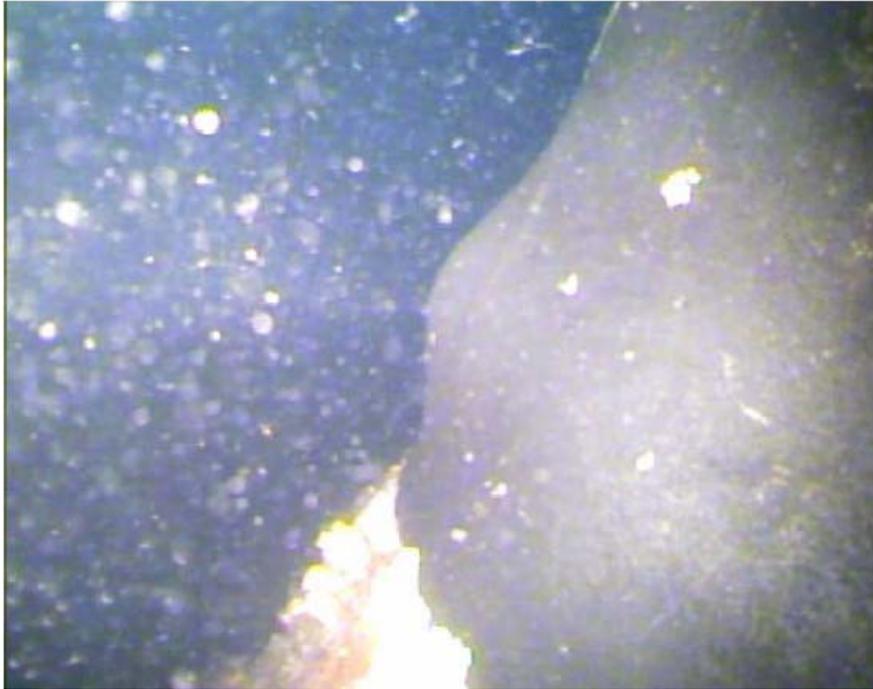
Damaged Eugene Island Area Platform – Local bulge found at the (-) 96’.

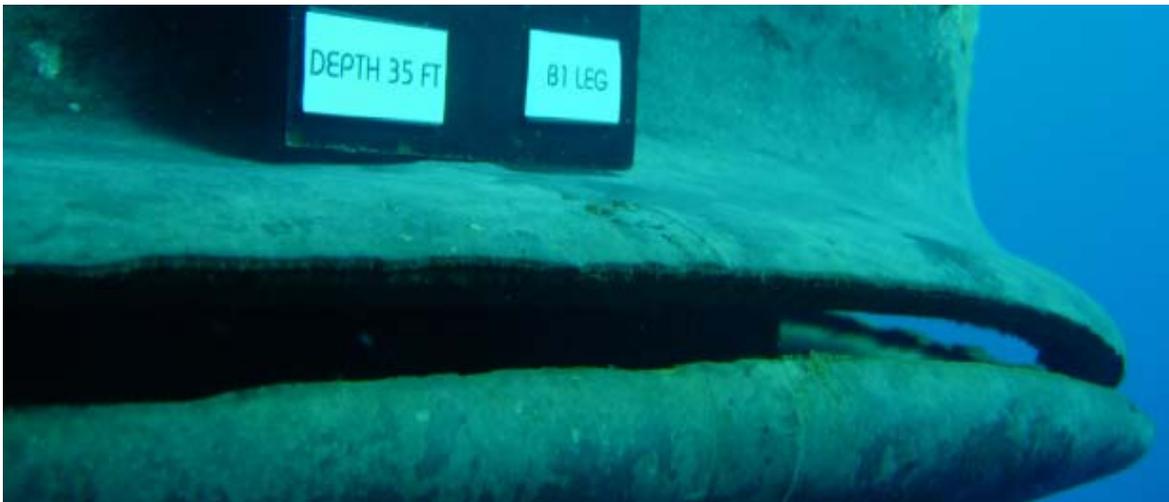
Damaged Mississippi Canyon Area Platform – Buckled and fully separated “Pancake”
Leg found at the (-) 35’.

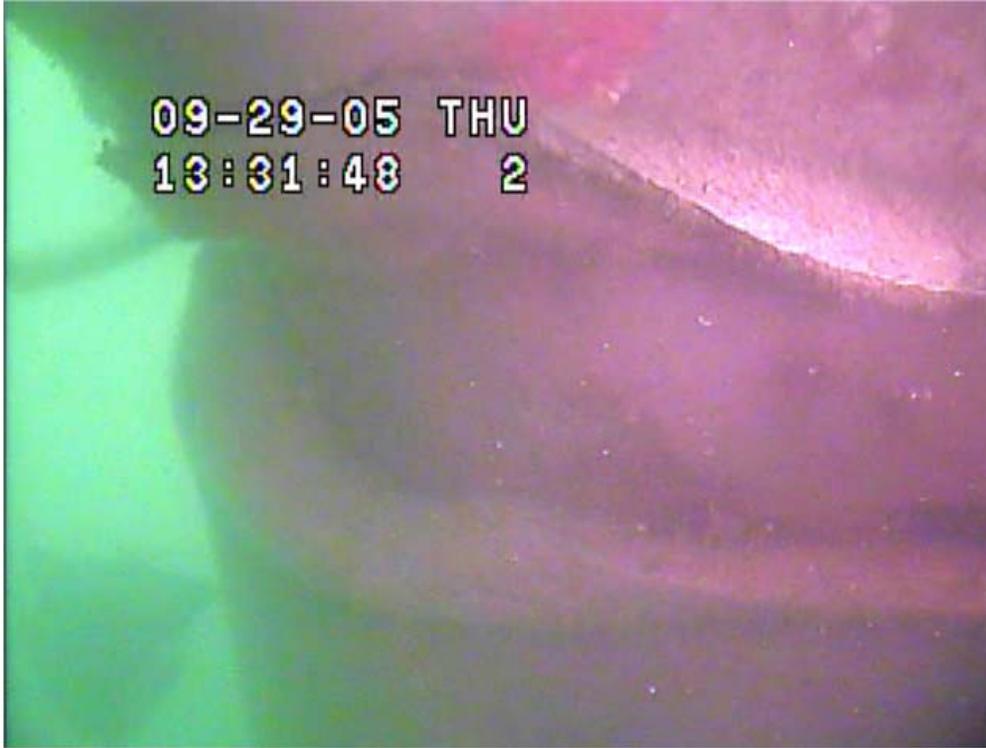
Damaged South Timbalier Area Platform – Local buckle and fully separated leg found at the (-) 38’.

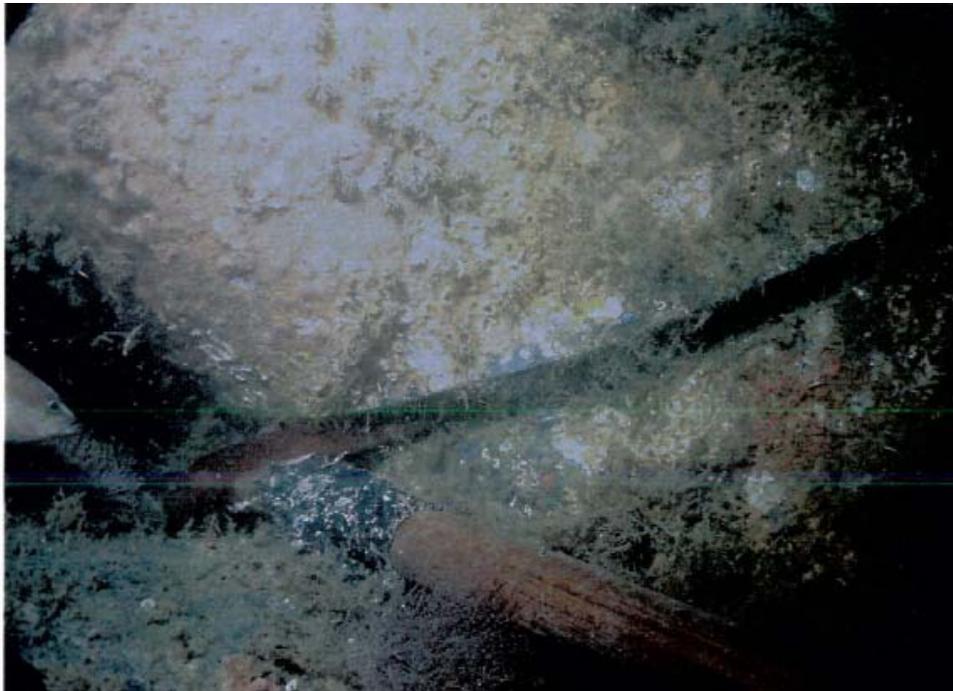
Damaged Eugene Island Area Platform – Local buckle and fully separated leg found at the (-) 139’.

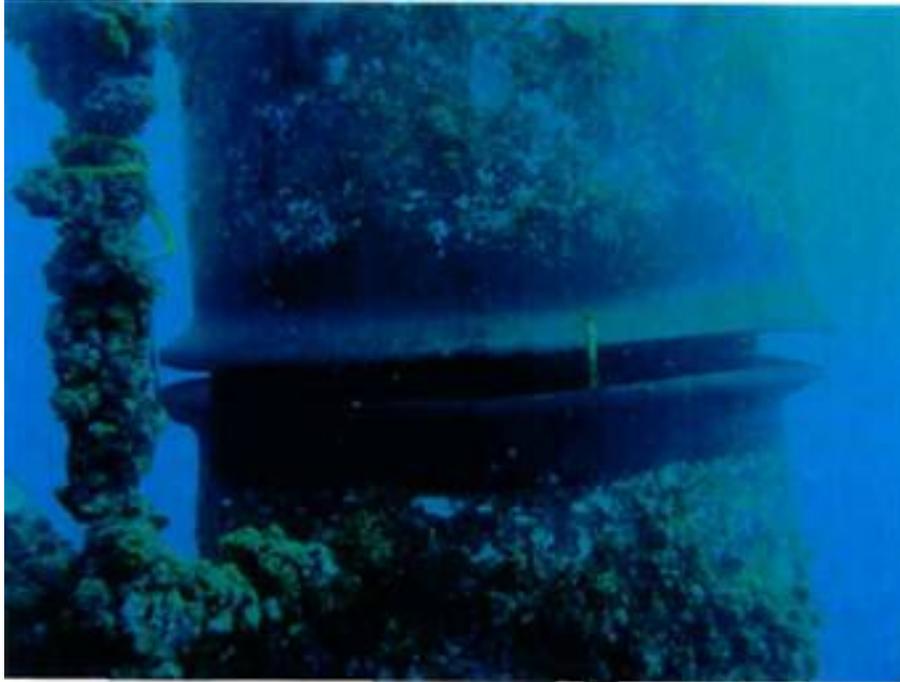
Damaged Eugene Island Area Platform – Buckle and fully separated “Pancake” leg found at the (-) 94’.

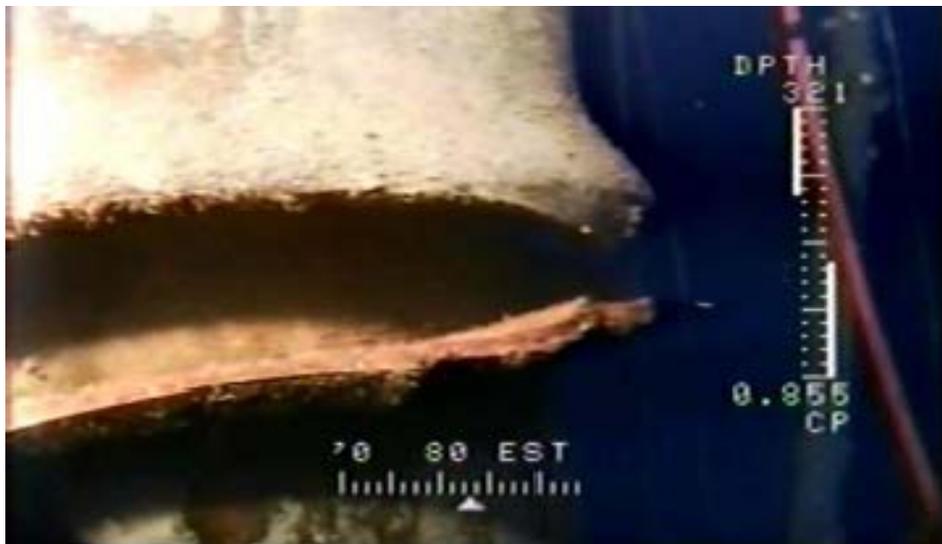
Damaged West Delta Area Platform – Buckled and fully separated “Pancake” leg at the (-)320’. Damage occurs in the nominal section of leg just under the joint can section of leg. Transition includes change in leg diameter from 54” to 53”, material yield strength from 42 ksi to 36 ksi and a differential of 1” in material thickness.

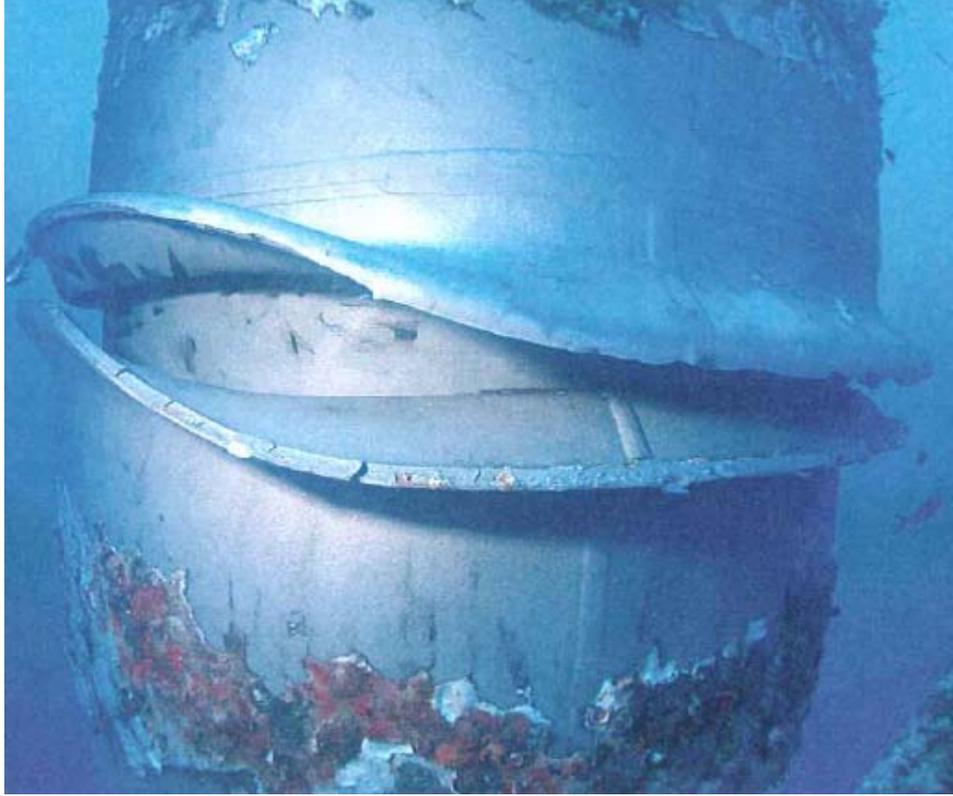
Damaged Vermillion Area Platform – Buckled and fully separated “Pancake” Leg found at the (-) 84’.

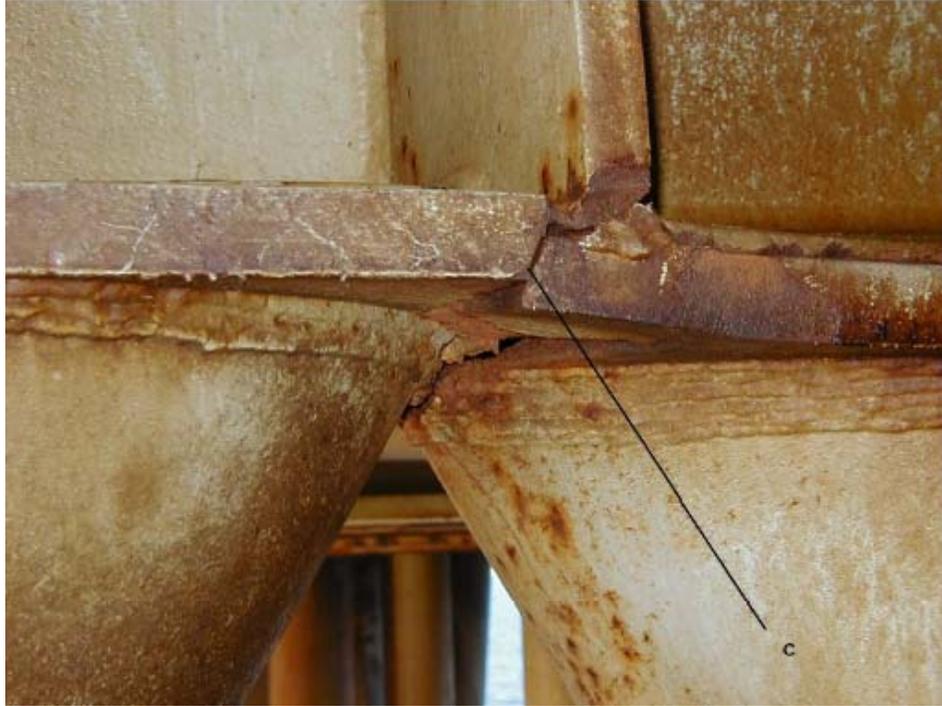
Major Structural Damaged Platform – Damaged Truss Row Node.
Cracked flange plate and separated vertical diagonal.

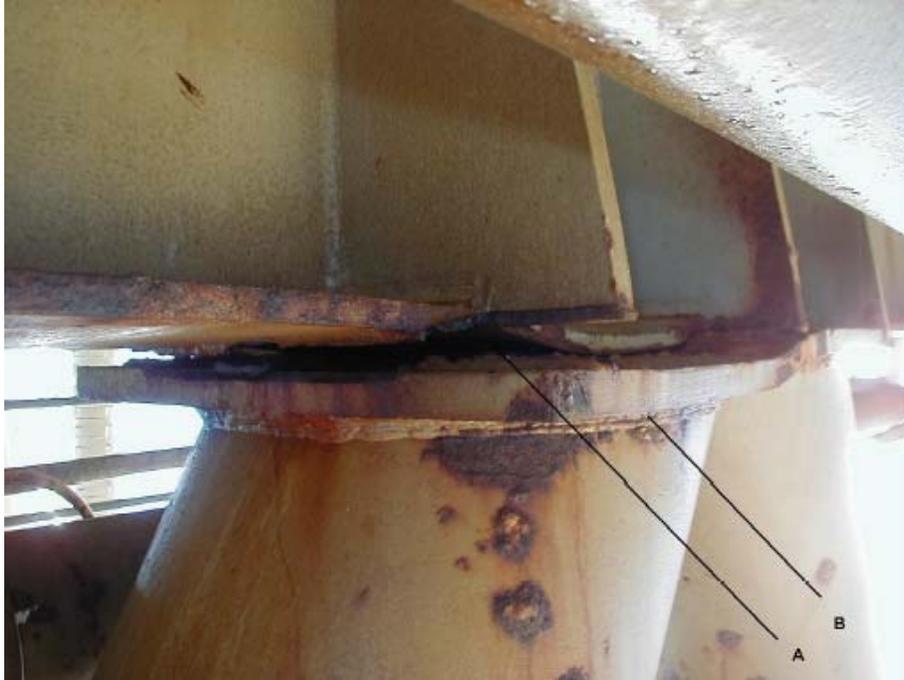
Major Structural Damaged Platform – Damaged Truss Row Node.
Wide flange beam separated from vertical diagonal extension plate.

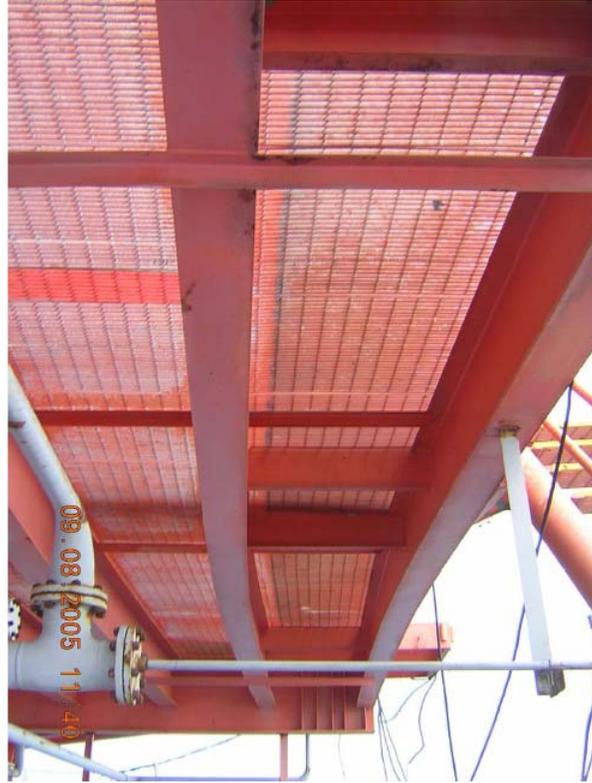
Damaged South Pass Area Platform – Bent cellar deck beams typical wave in deck damage. Bent beams located at the southern edge of cellar deck and bottom of steel noted to be at (+) 50'.

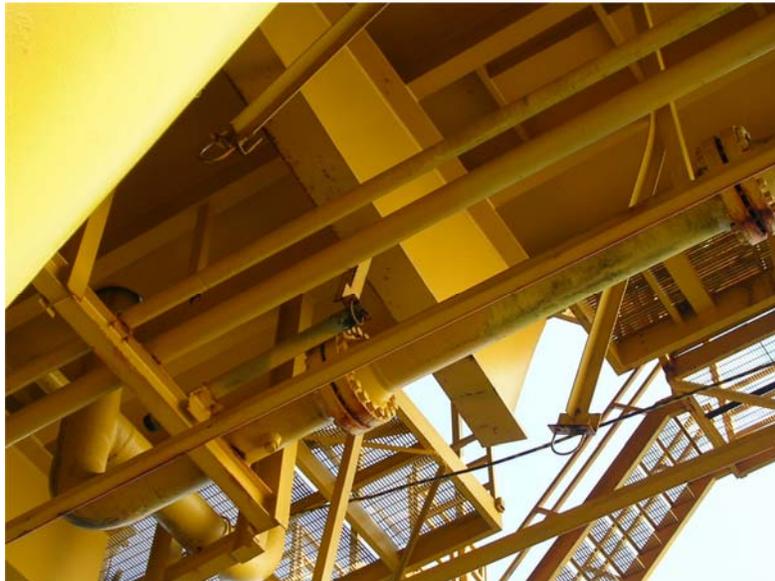
Damaged Green Canyon Area Platform – Bent cellar deck beams typical wave in deck damage. Bottom of steel of cellar deck noted to be at (+) 50'.

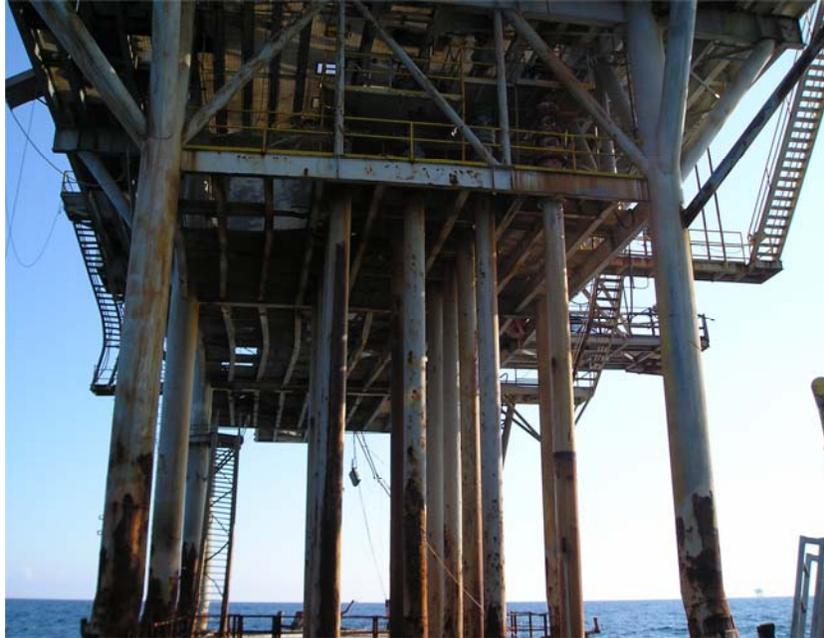
Damaged East Cameron Area Platform – Bent cellar deck beams typical wave in deck damage.

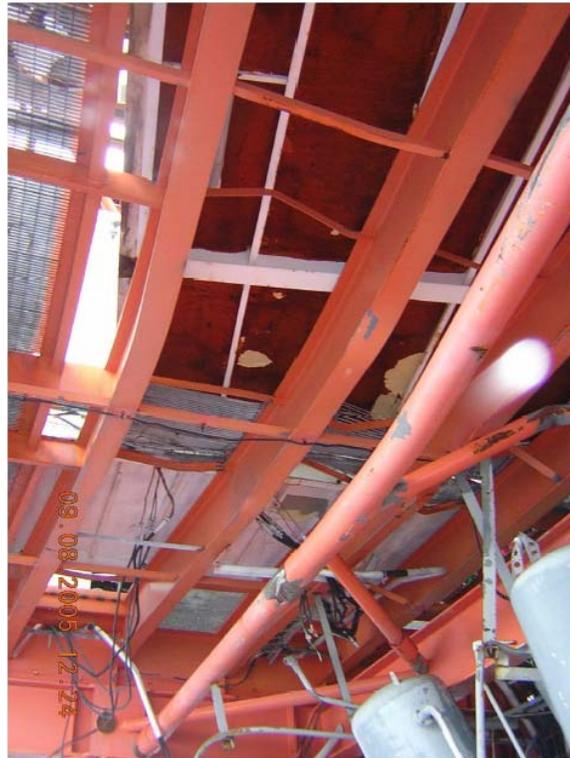
Damaged South Pass Area Platform – Bent main deck beams typical wave in deck damage. Top of steel of main deck noted to be at (+) 73’.

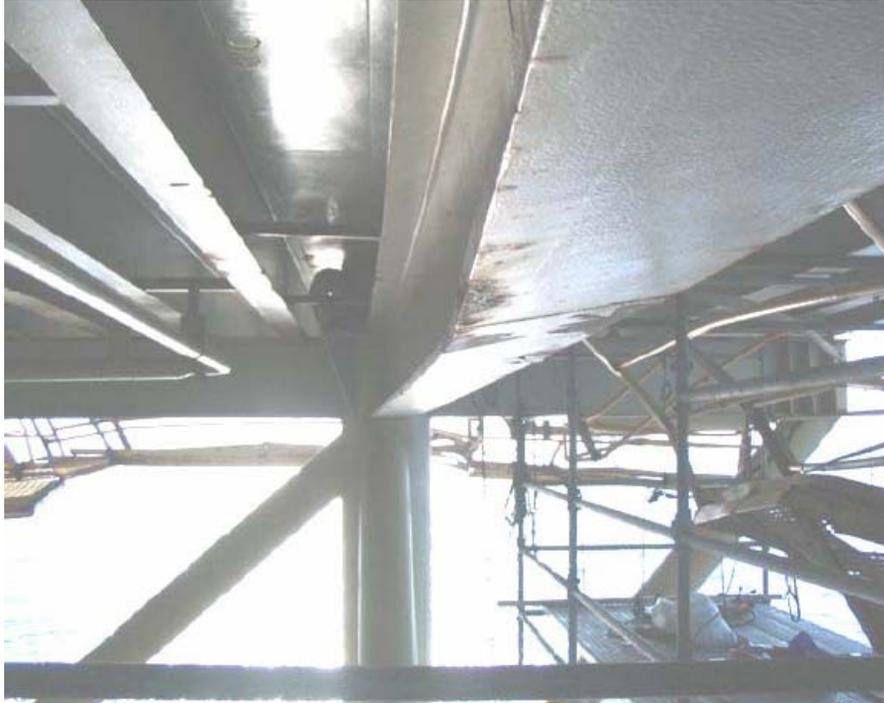
Damaged Eugene Island Area – Bent cellar deck girder typical wave in deck damage. Girder bent towards northwest indicating a wave from the southeast. Measured bottom of steel of cellar deck noted to be at (+) 40'-3".

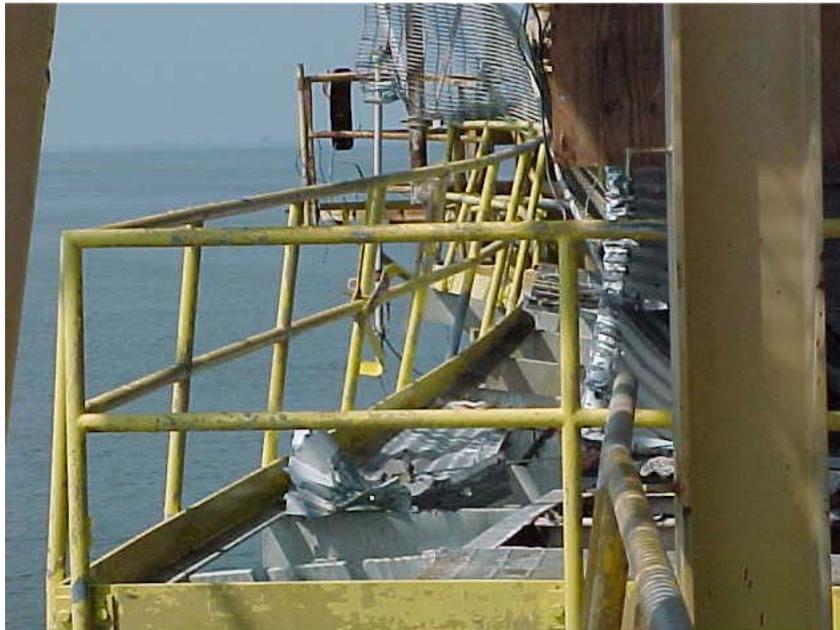
Damaged Grand Isle Area Platform – Bent cellar deck beams and handrails typical wave in deck damage. Top of steel of cellar deck noted to be at (+) 55'.

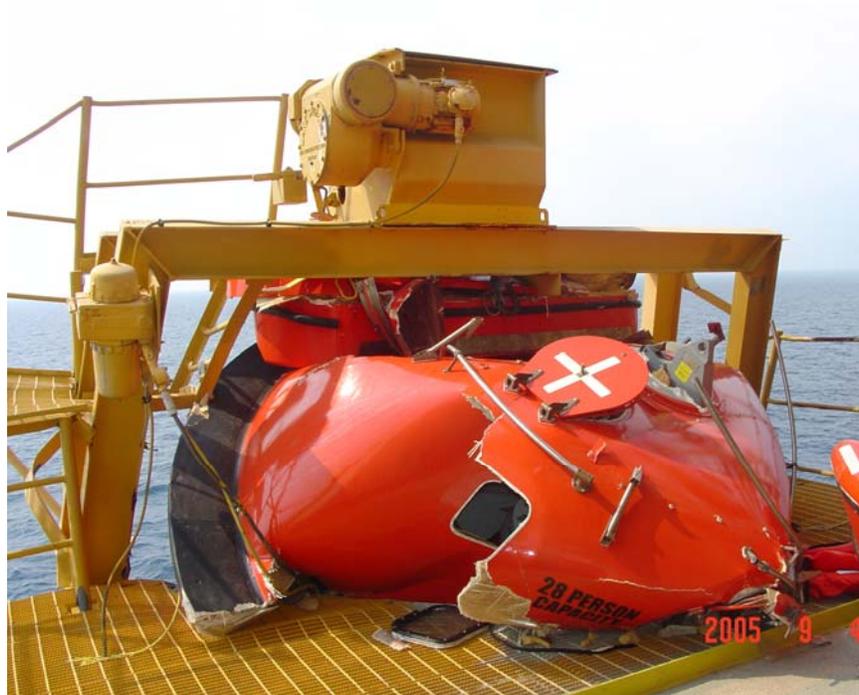
Damaged Main Pass Area Platform – Destroyed Escape Capsule on cellar deck typical wave in deck damage.

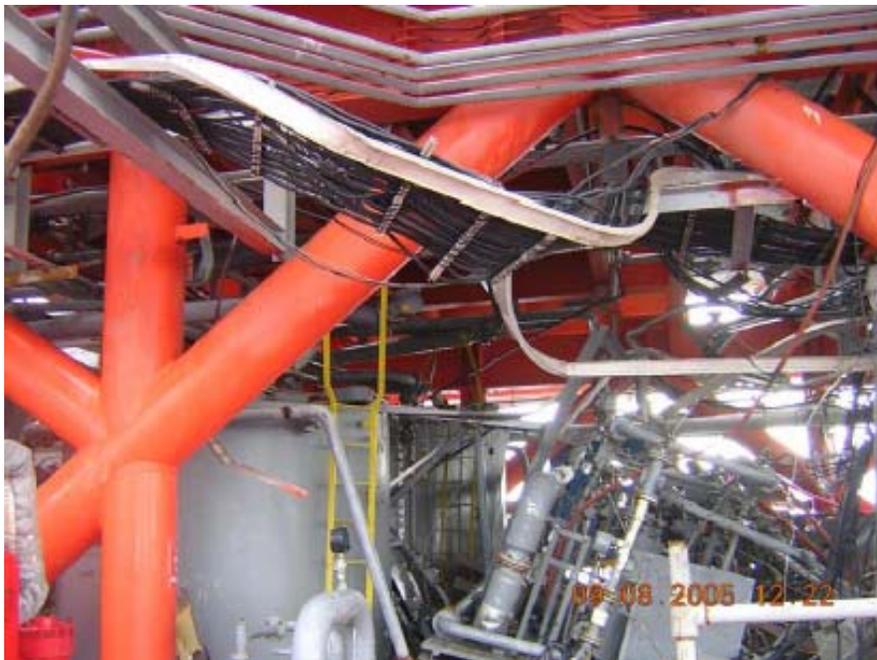
Damaged South Pass Area Platform – Damaged production equipment skids, piping, and cable trays typical wave in deck damage. Area of damage noted to be between (+) 50' and (+) 73' from MLLW.

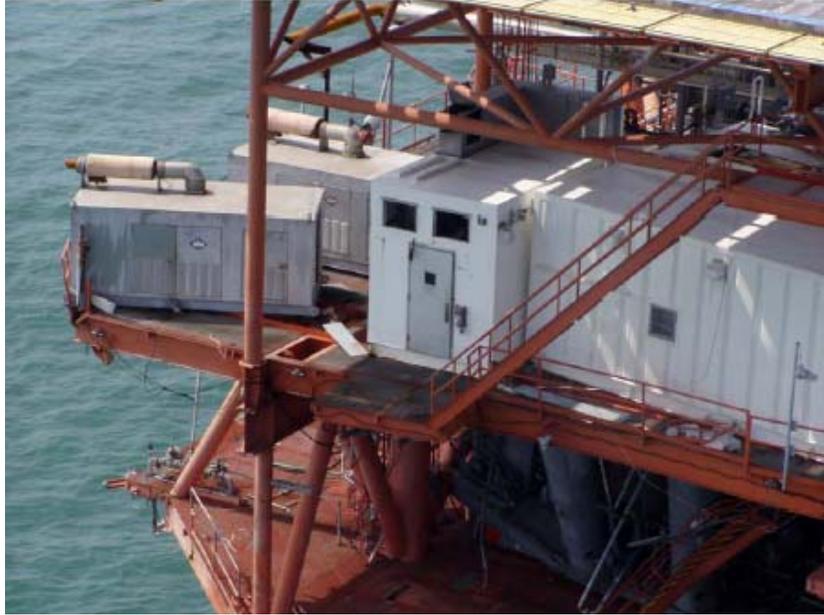
Damaged South Pass Area Platform – Shifted MCC and Quarters Building and Generator Skid typical wave in deck damage. Area of damage noted to be on the south side of platform and above (+) 73’.

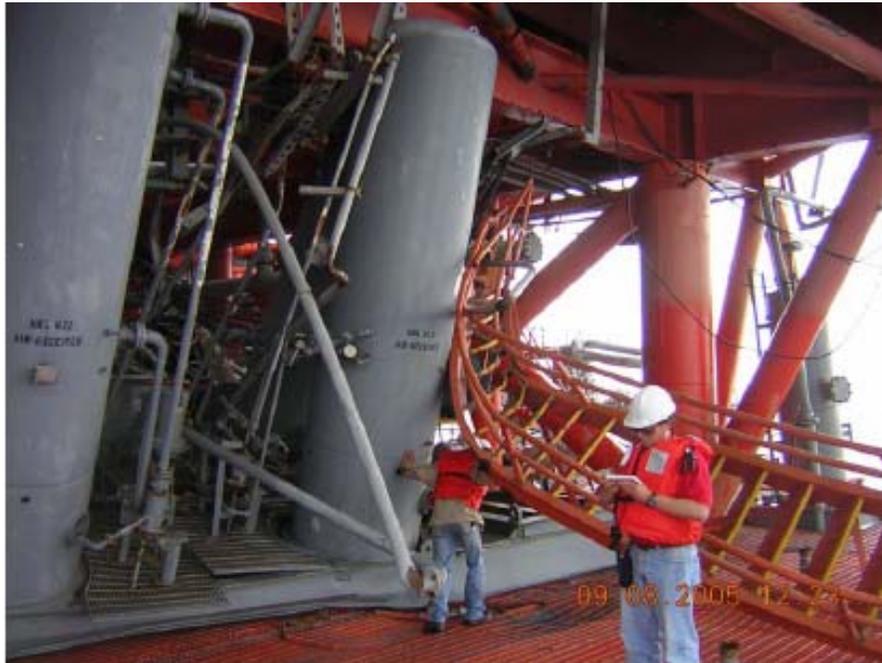
Damaged South Pass Area Platform – Damaged production equipment skids, piping, and cable trays typical wave in deck damage. Area of damage noted to be between (+) 50’ and (+) 73’ from MLLW. Wave impact from southeast direction.

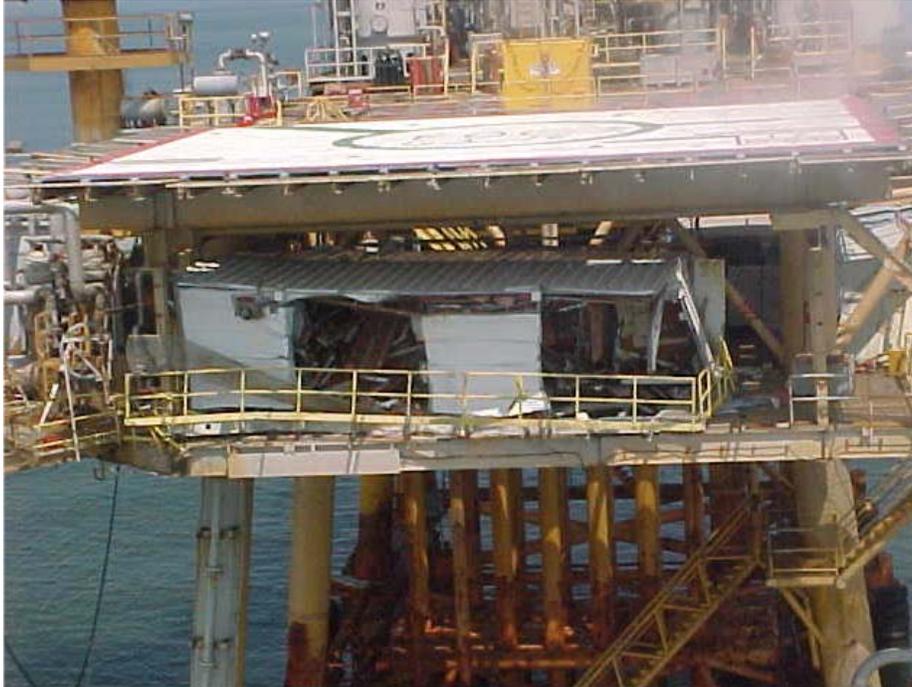
Damaged Grand Isle Area Platform – Destroyed Quarters Building typical wave in deck damage. Area of damage noted to be on the south side of platform and above (+) 55’.

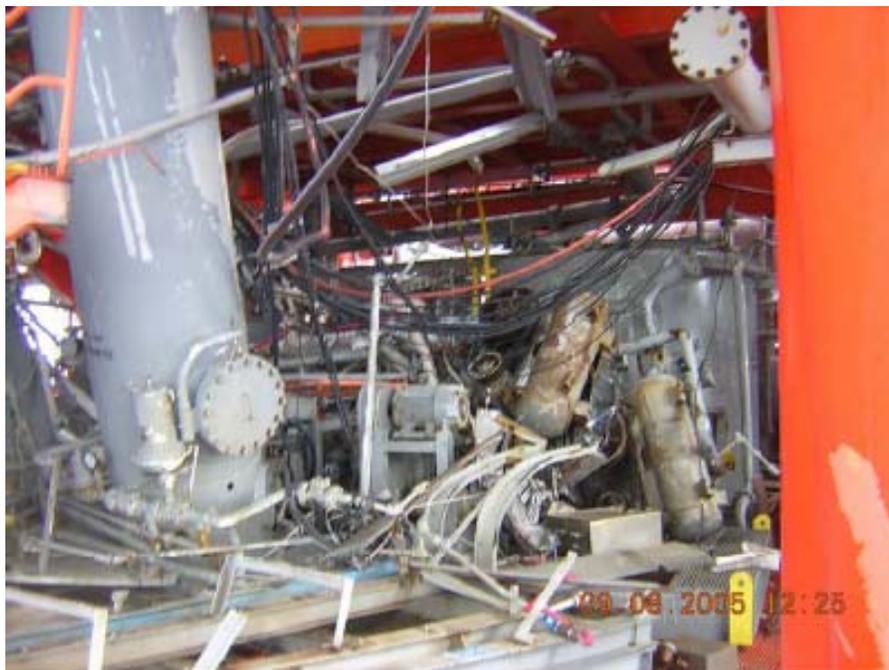
Damaged South Pass Area Platform – Damaged production equipment skids, piping, and cable trays typical wave in deck damage. Area of damage noted to be between (+) 50’ and (+) 73’ from MLLW.

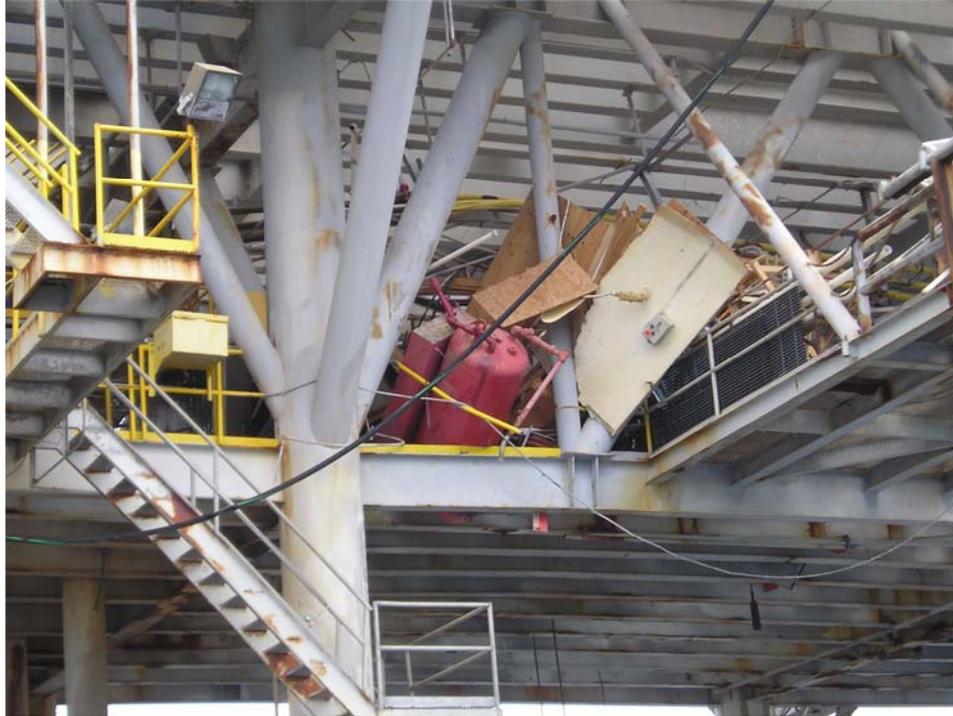
Damaged East Cameron Area Platform – Damaged production equipment skids, piping, and cable trays typical wave in deck damage.

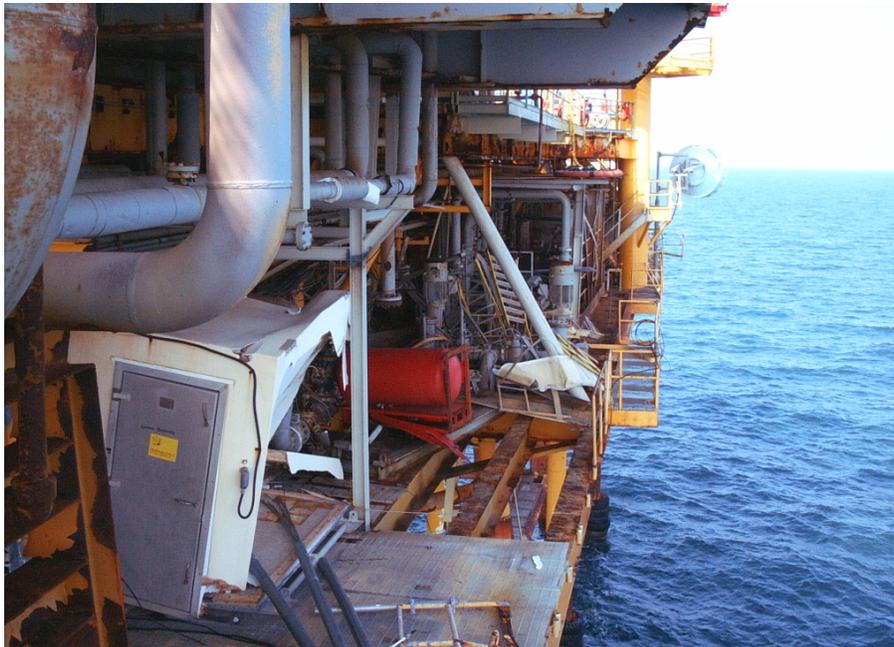
Damaged South Pass Area Platform – Destroyed Communications building and missing grating on cellar deck typical wave in deck damage. Area of damage noted to be above (+) 50' from MLLW.

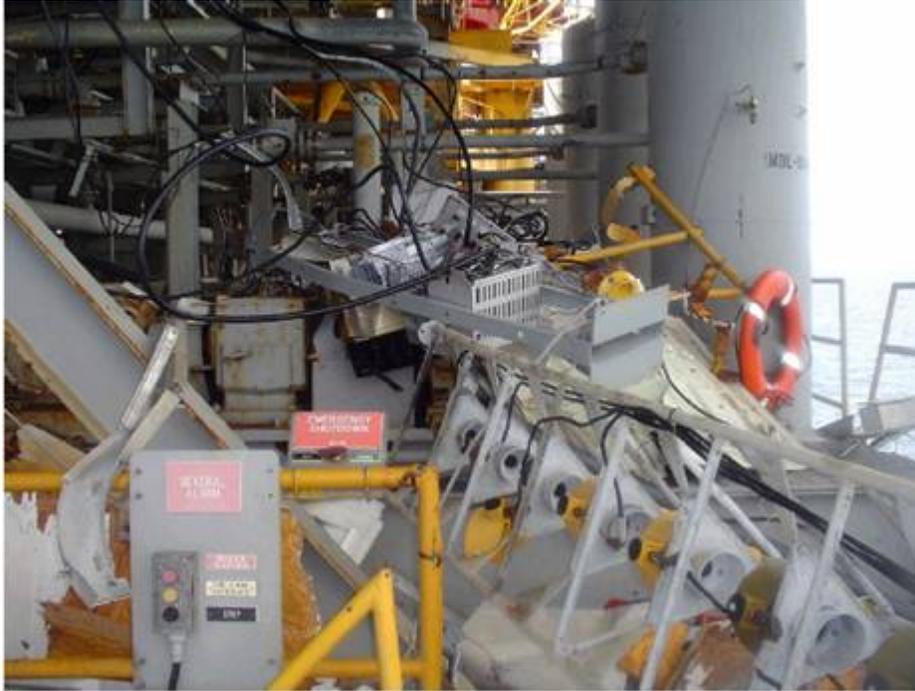
Damaged Mississippi Canyon Area Platform –
Debris pile on cellar deck typical wave in deck damage.
