***ASSESSMENT OF FIXED OFFSHORE
PLATFORM PERFORMANCE IN HURRICANES
KATRINA AND RITA***

**FINAL REPORT
May 2007**

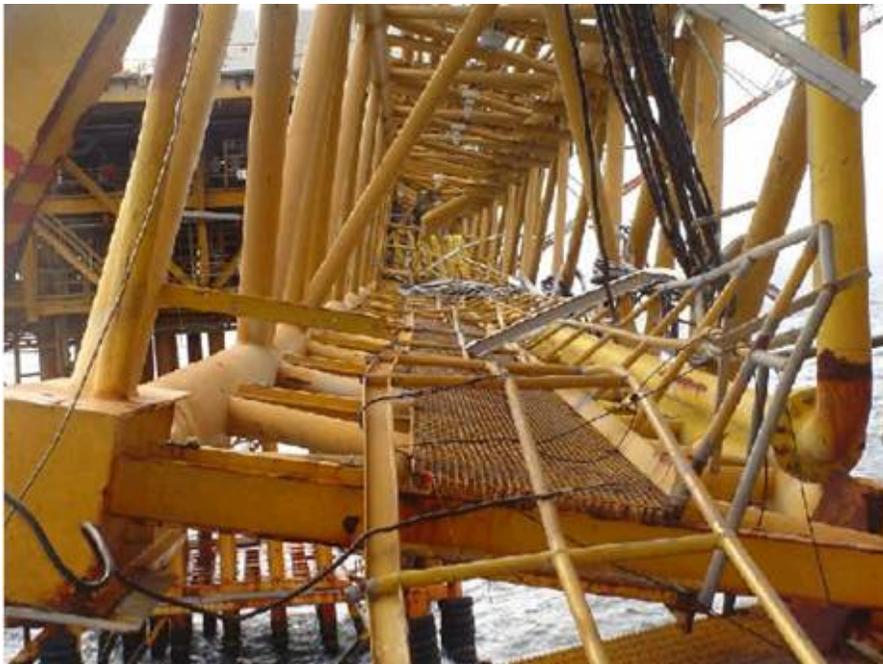
Damaged South Pass Area Platform – Damaged bridge
between two platforms typical wave in deck damage.

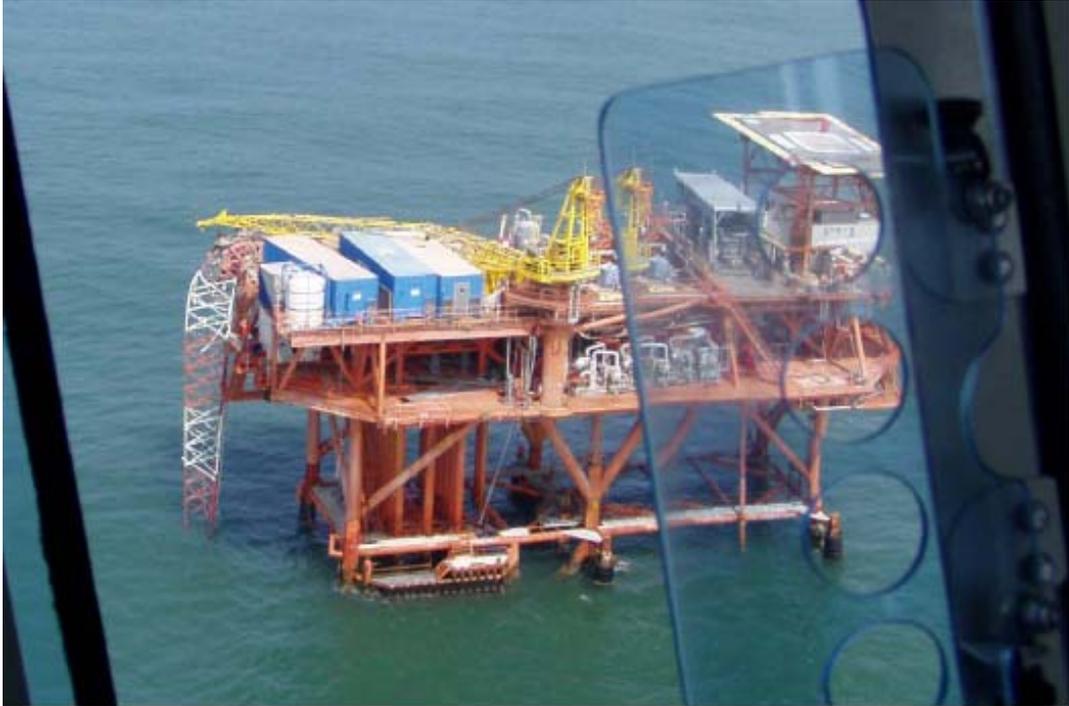
Damaged South Pass Area Platform – Collapsed vent tower on east side of platform.

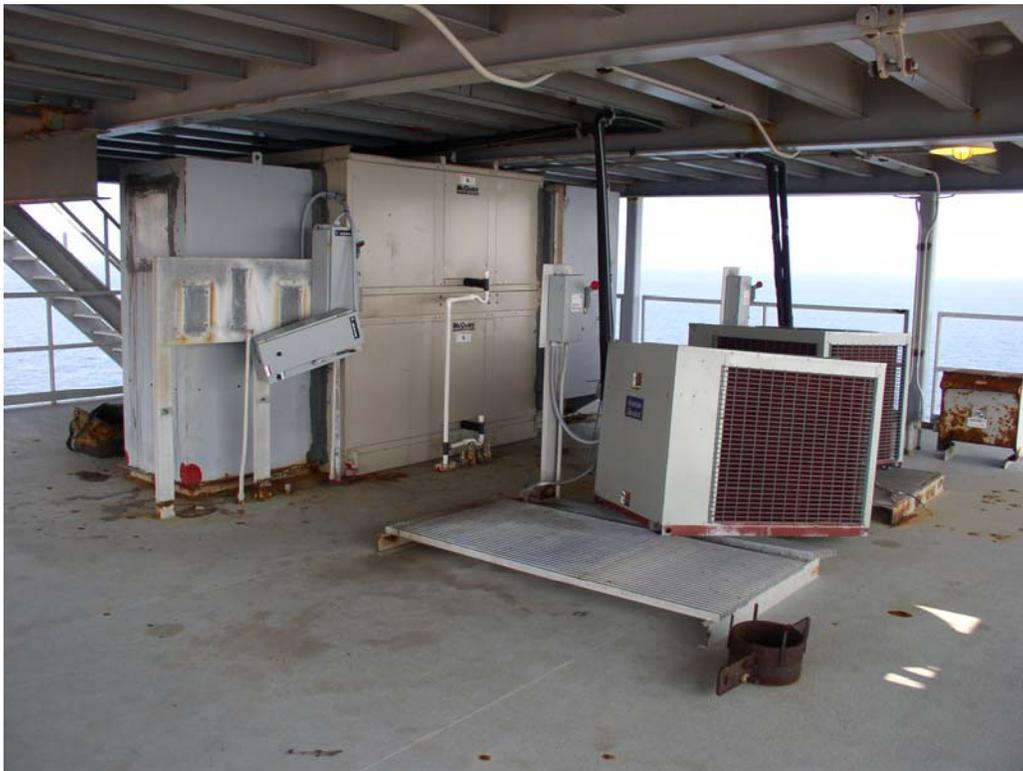
Damaged Ewing Banks Area Platform – Displaced AC units due to wind.

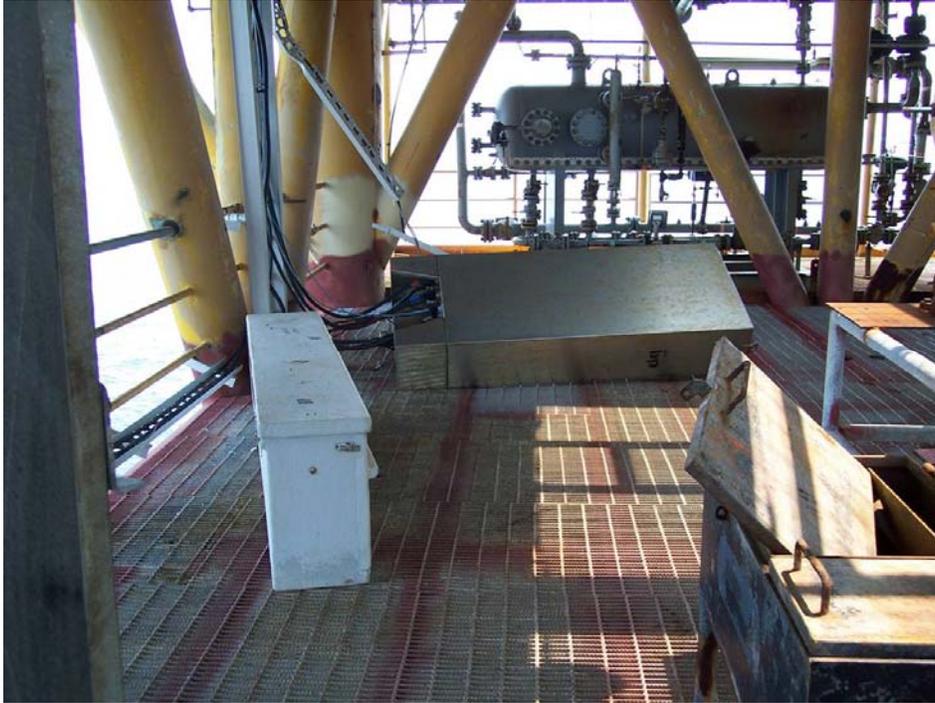
Damaged Grand Isle Area Platform – Control Panel knocked over due to wind.

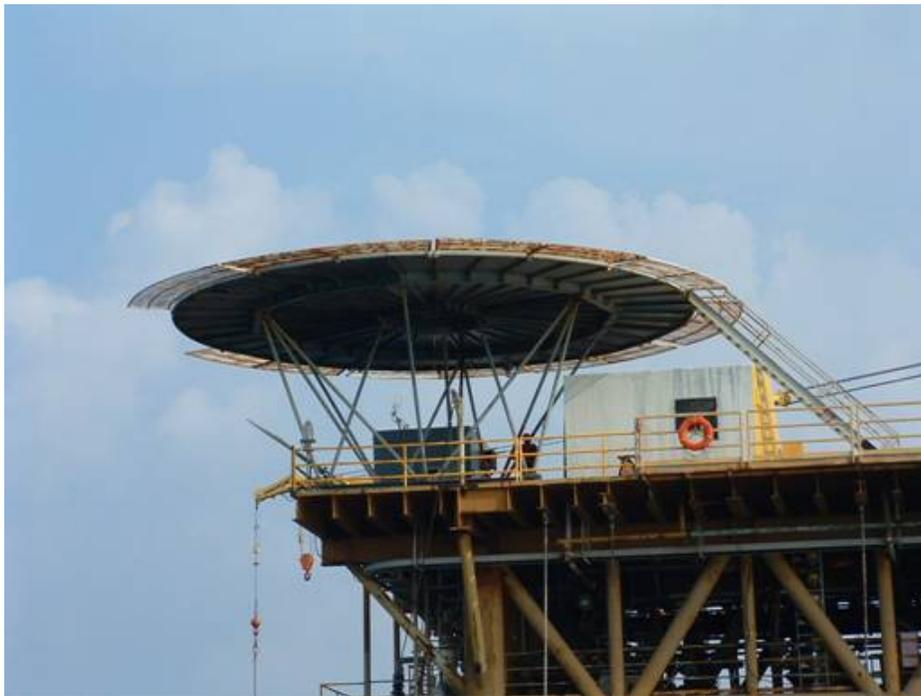
Damaged Grand Isle Area Platform – Helideck Panels missing due to wind.

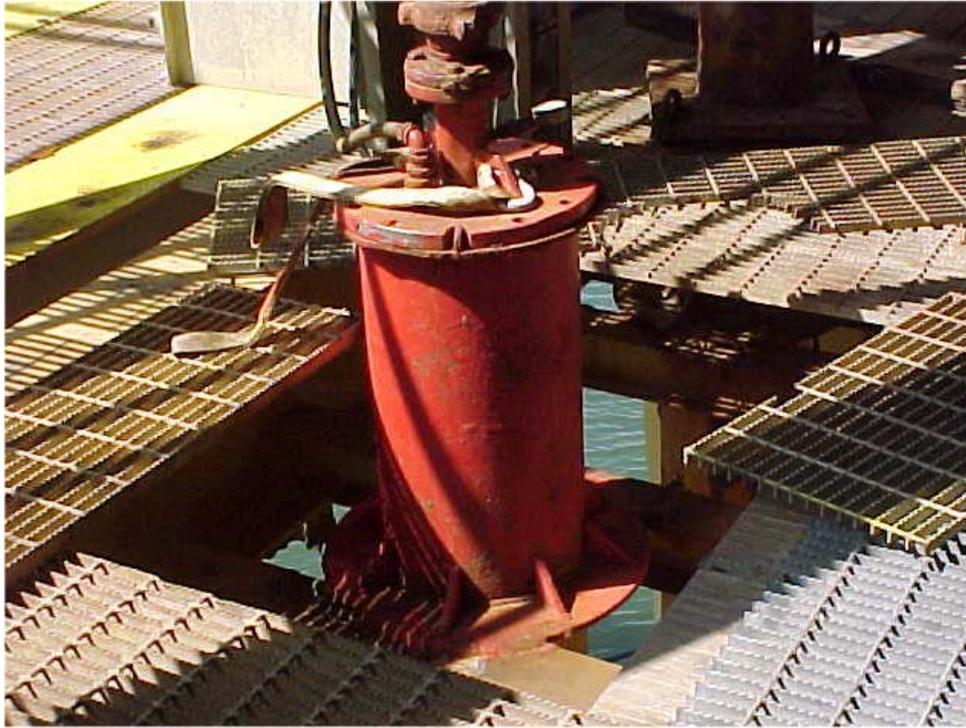
Minor Damaged Platform – Damaged grating from well movement.

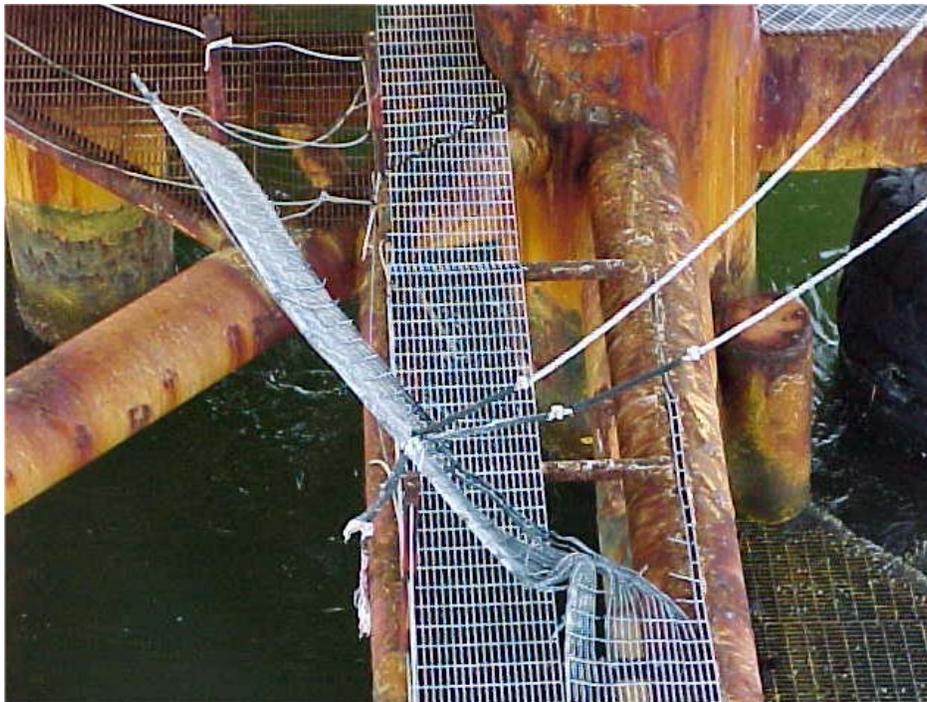
Minor Damaged Platform – Missing grating and handrails at (+) 15' from MLLW.

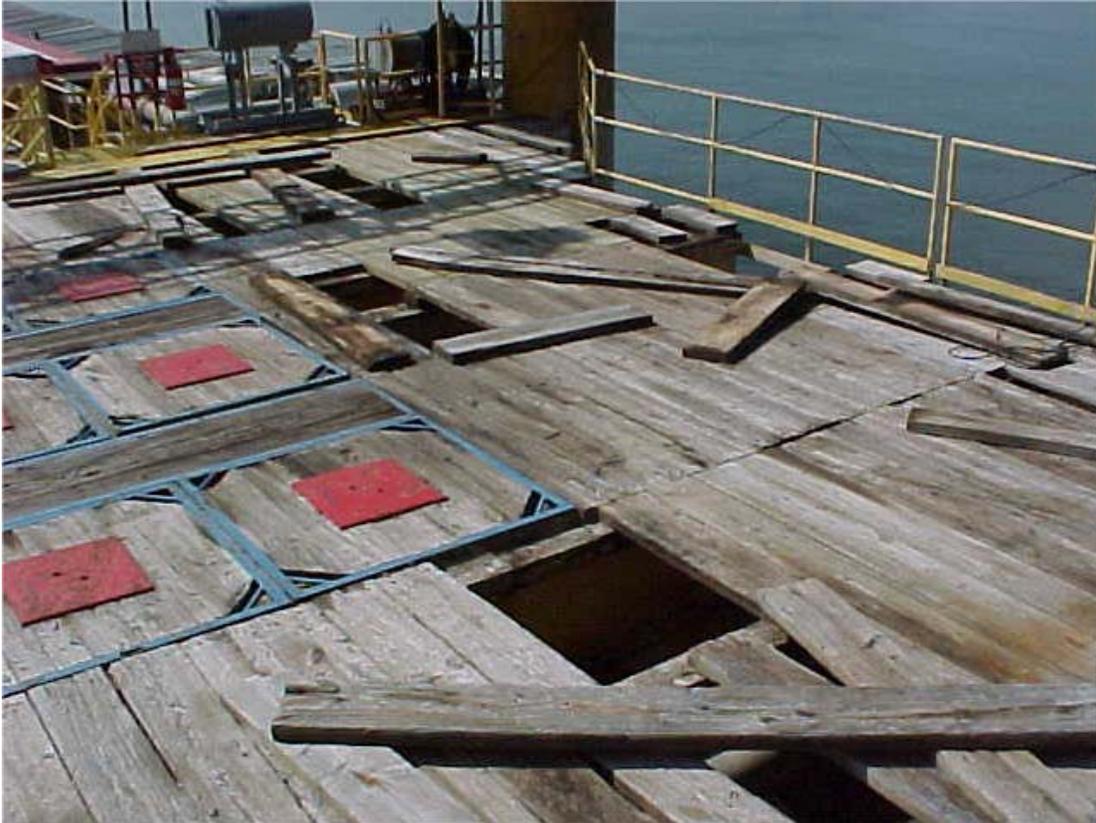
Minor Damaged Platform – Loose timbers on drilling deck.

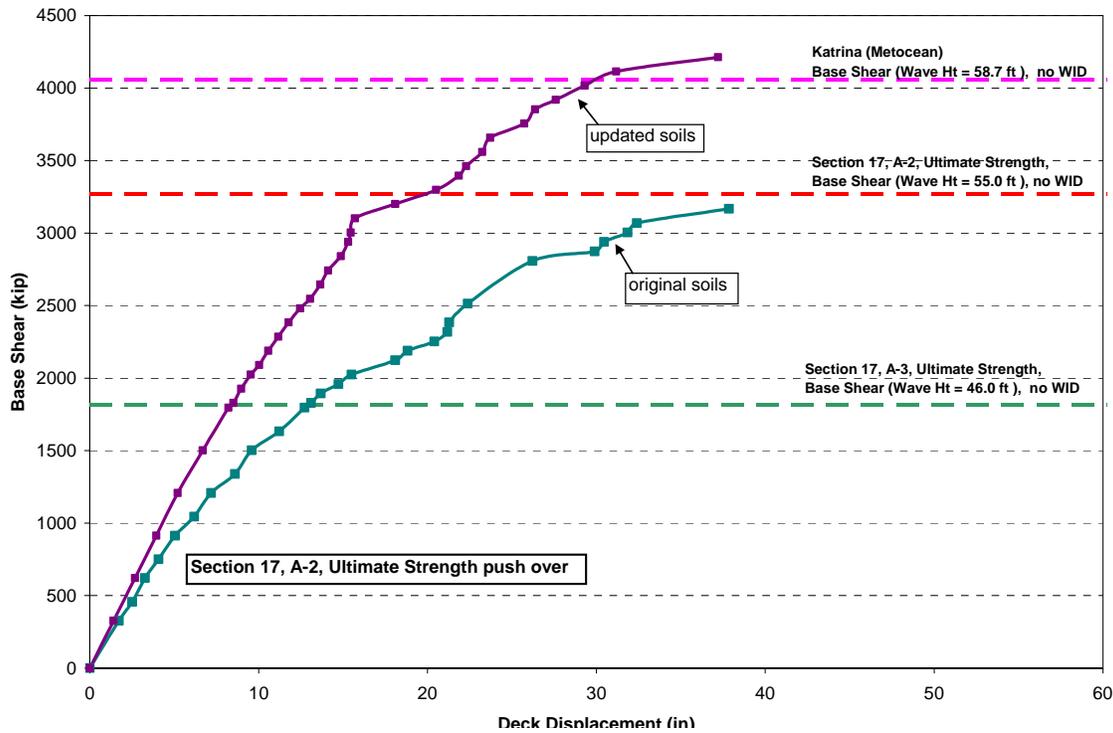
Figure 3 Ultimate Strength Analysis for the End-On Direction for Case B Platform

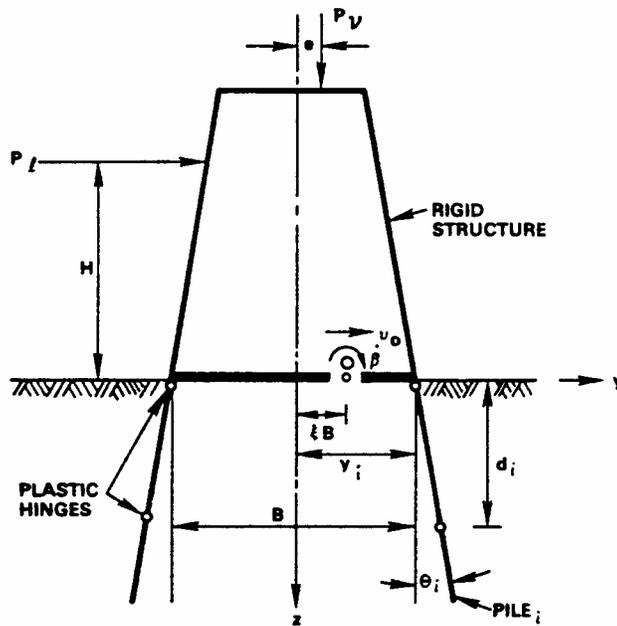
Figure 4 Schematic of Foundation System Model for Plastic Collapse

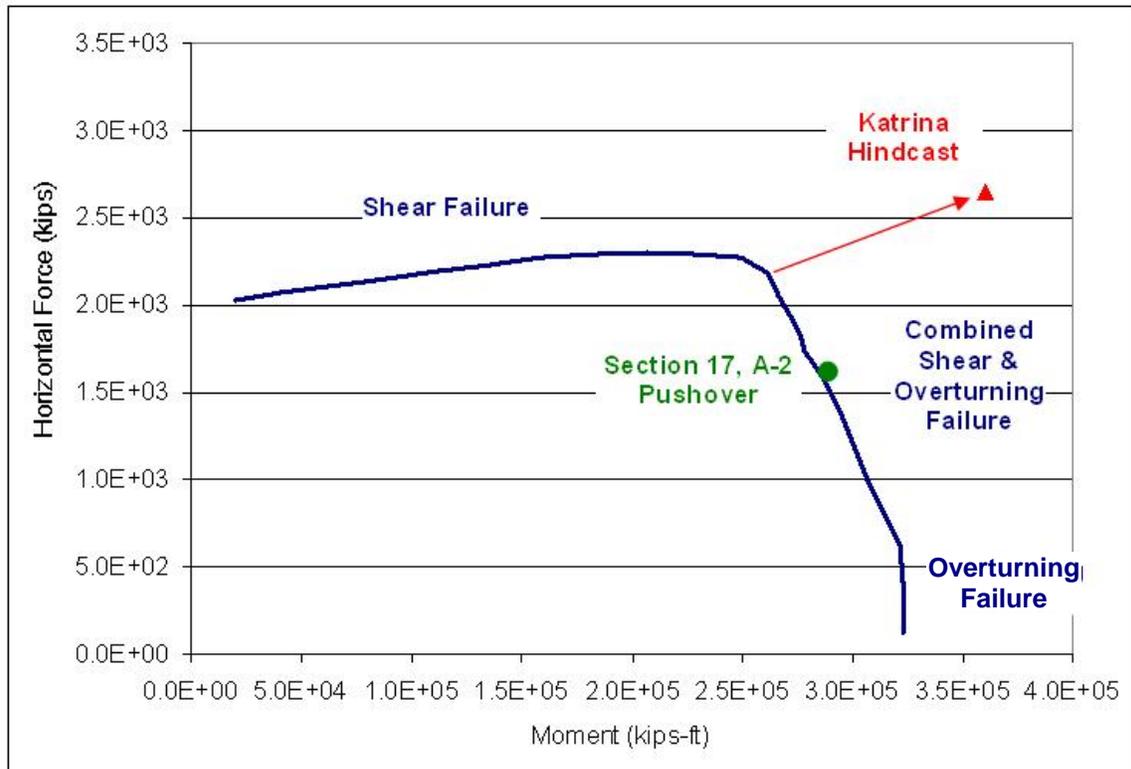
Figure 5 Interaction Diagram Showing Predicted Capacity of Case B Platform Foundation System in End-On Direction

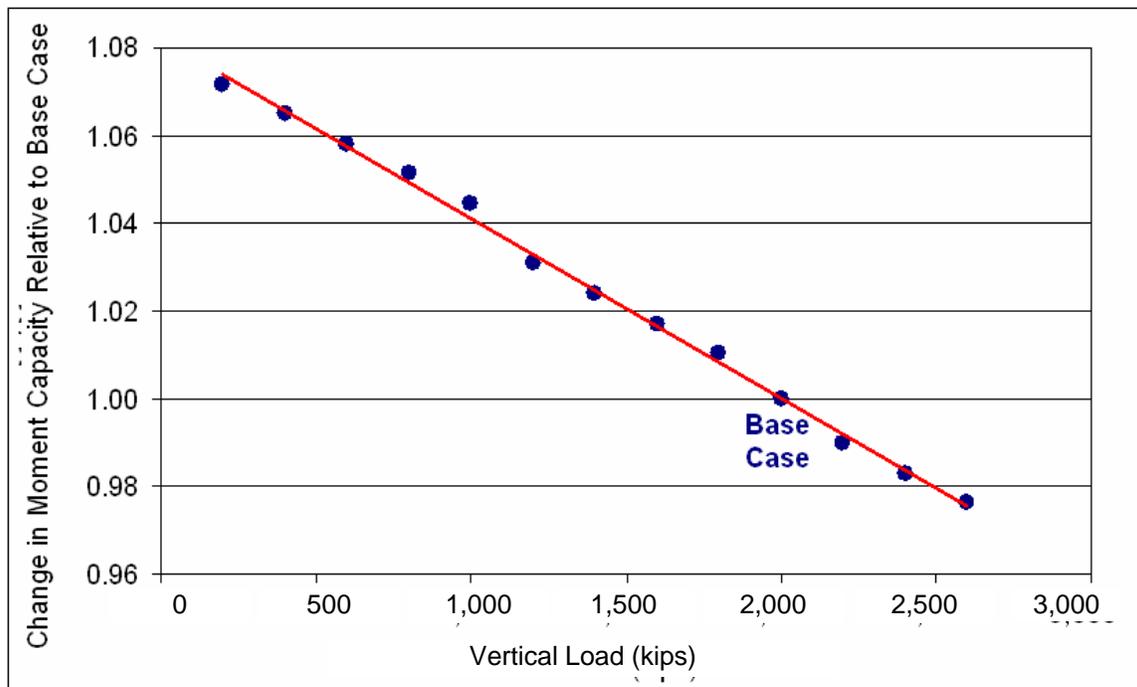
Figure 6 Sensitivity of Moment Capacity to Vertical Load Applied to Foundation System for Case B Platform

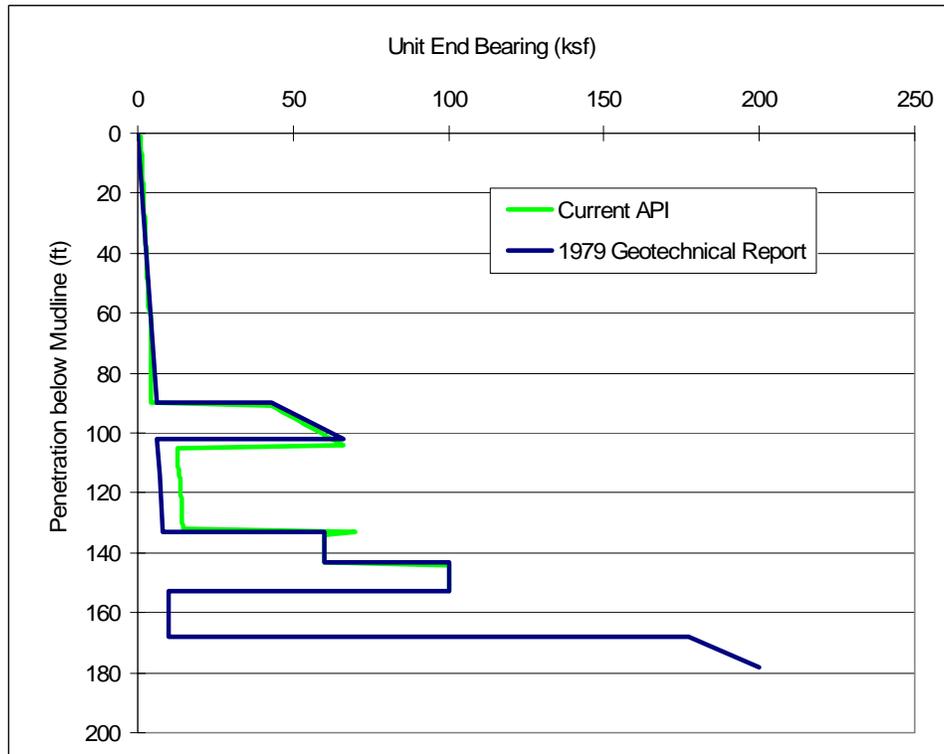
Figure 9 Design Unit End Bearing for Piles in Compression, Case B Platform

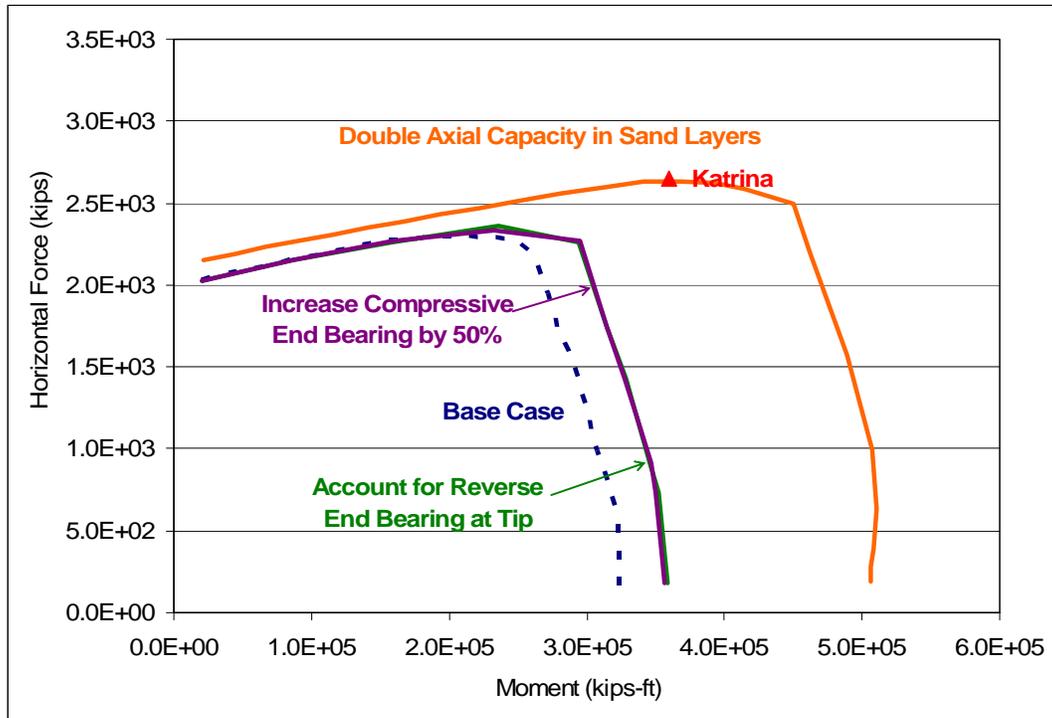
Figure 10 Sensitivity of Foundation System Capacity to Axial Capacity in Sand Layers for Case B Platform

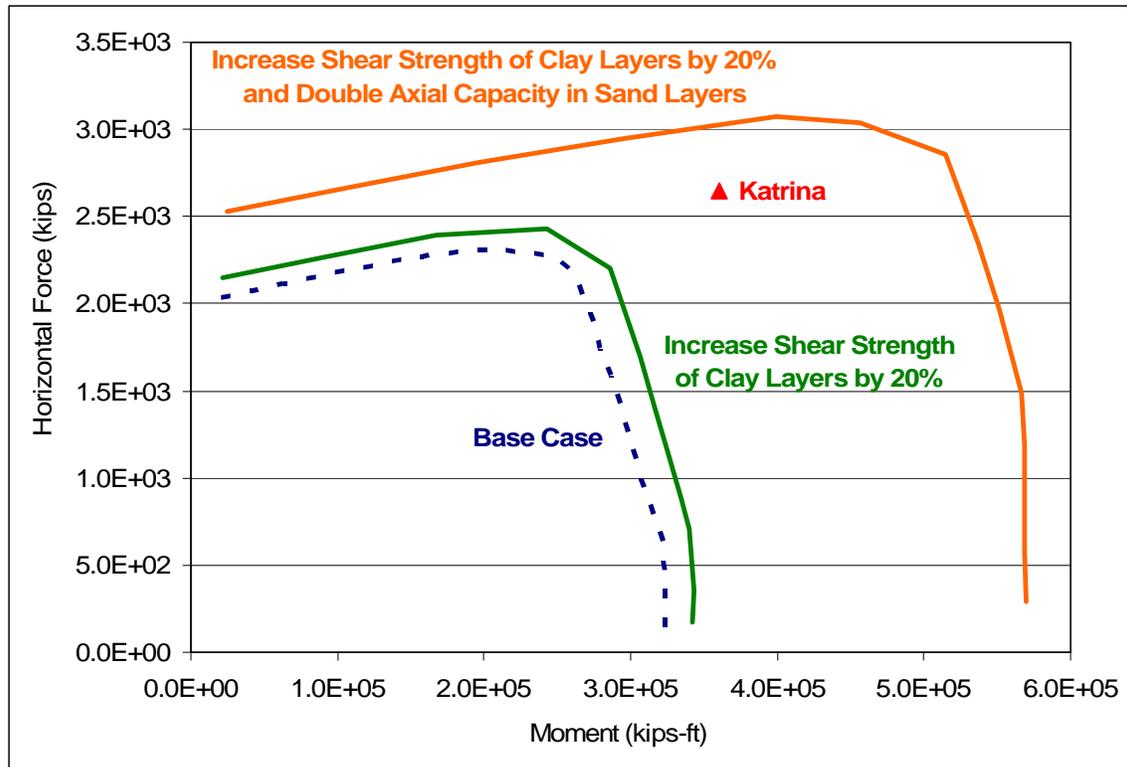
Figure 11 Sensitivity of Foundation System Capacity to Axial and Lateral Capacity for Case B Platform
