HPHT 17TR8 Test Articles: Post-Test Characterization Following Pressure Burst Testing (Final)

*Examination of F22 Materials Following Plastic Deformation from Controlled
Pressure Testing*

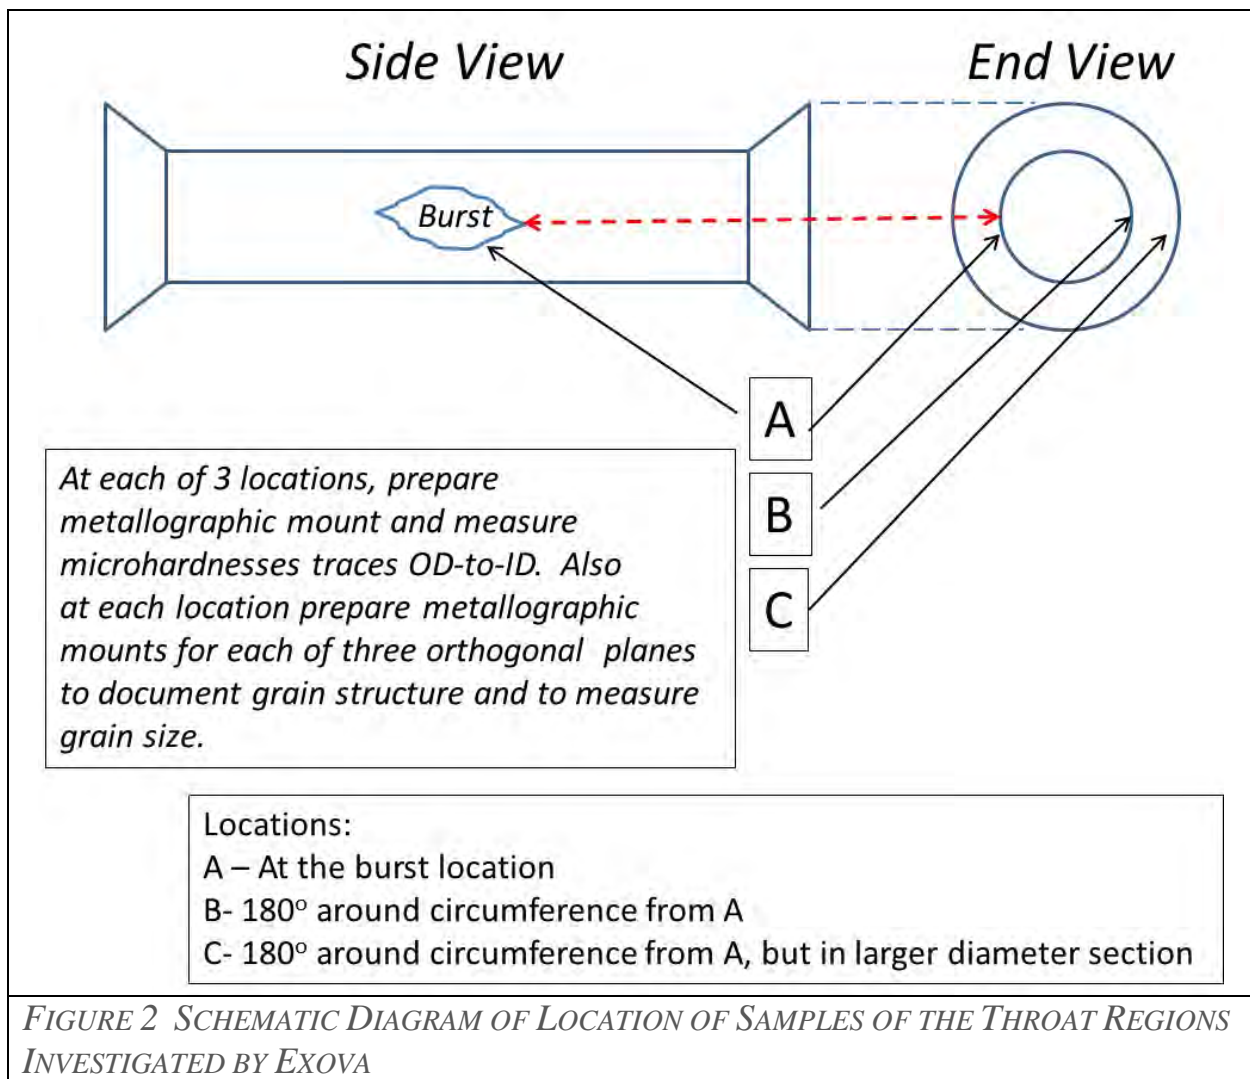
2.1 Hardness Examinations and Results

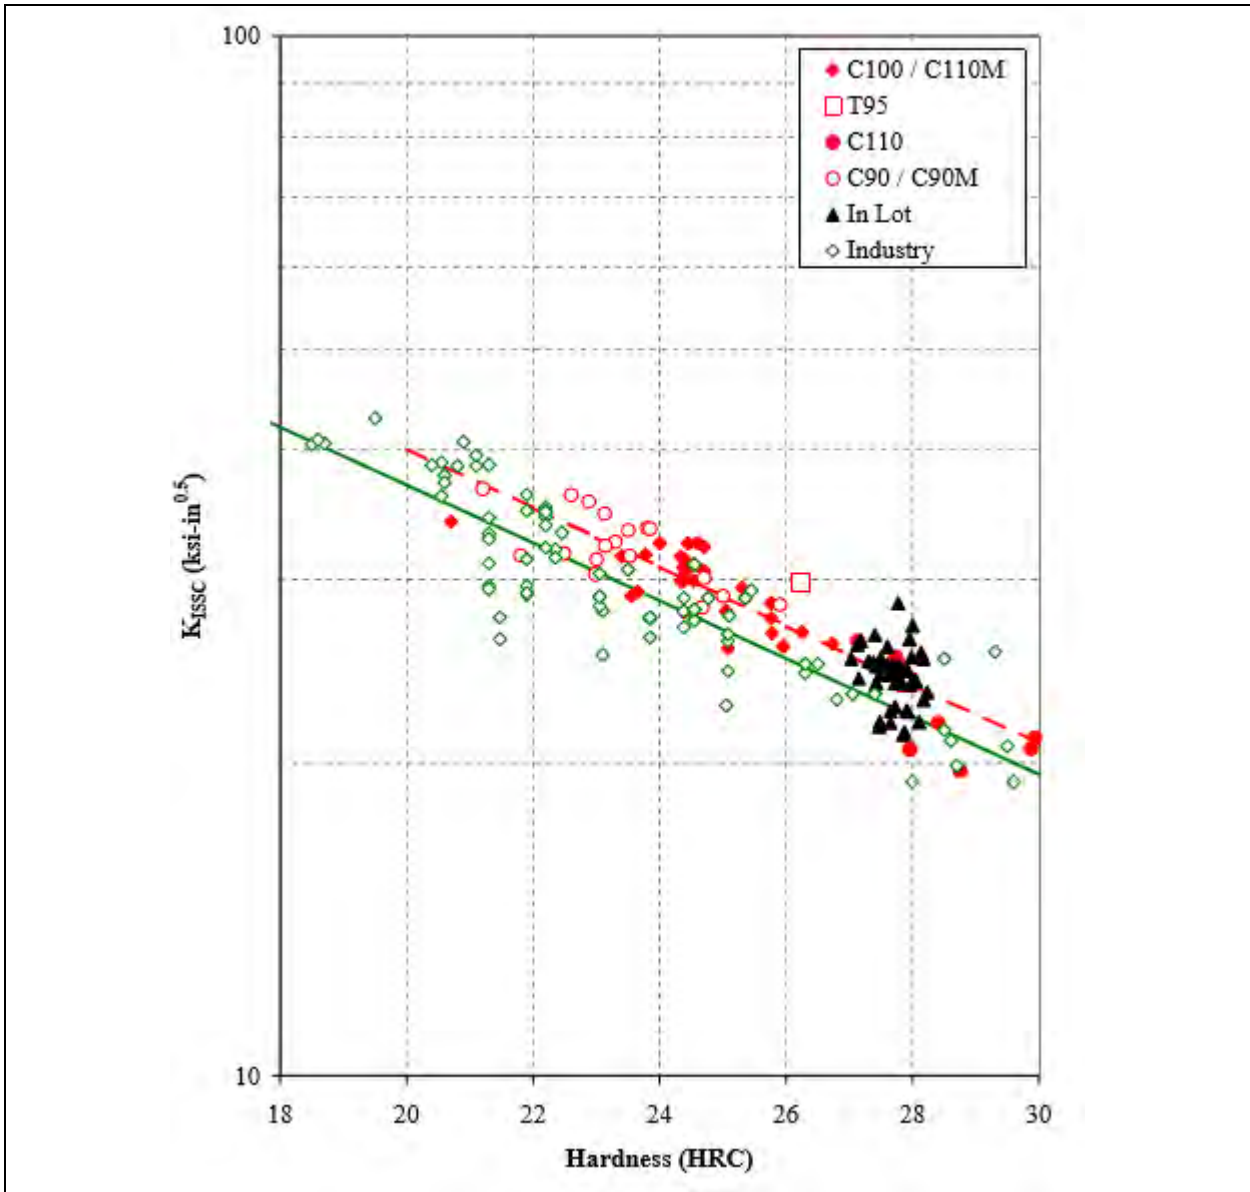
FIGURE 6 PLOT OF KISSC VERSUS MATERIAL HARDNESS FOR WROUGHT OCTG STEELS (2)

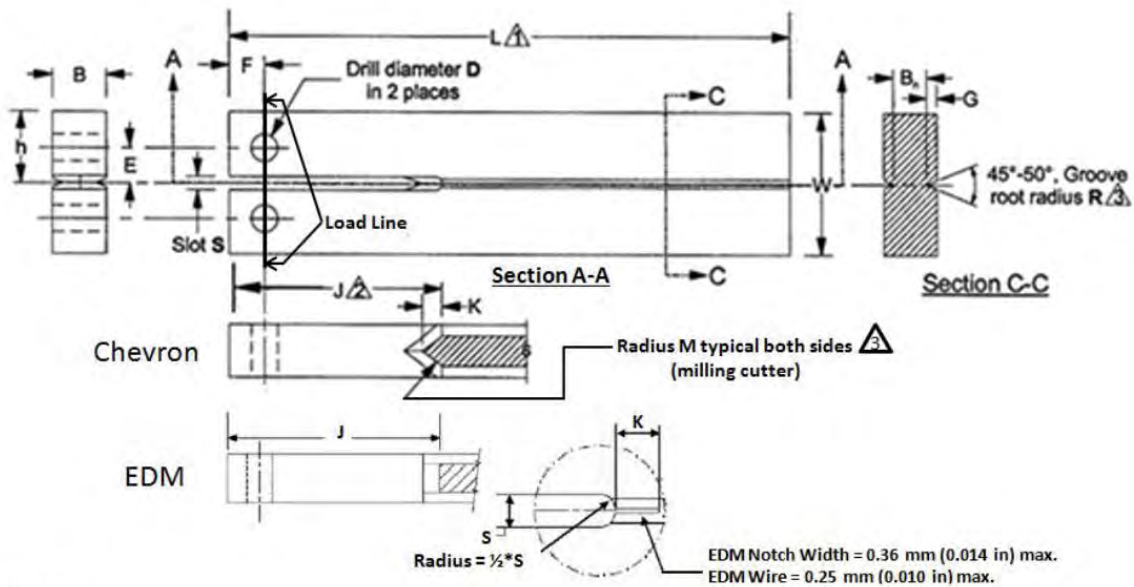
Omni Metals Laboratory (Ann Arbor, MI) was contracted to determine the sulfide cracking behavior (SSC) of the forged F22 material. Specifically, Omni was provided the remnants of the two throat regions Exova had used in their metallurgical assessment studies. Omni obtained at least 30 double cantilevered beam (DCBs; see Figure 7) specimens from the throat region remnants and tested them per NACE TM0177-2016 Method D. Omni got the largest range in hardness values possible from the pieces provided to them. Lastly, Omni conducted two sulfide stress cracking evaluations, one in the standard test environment (100% H₂S, initial pH of 2.7, 75°F) and the other in a mild environment (7% H₂S, initial pH of 4.0, 75°F).

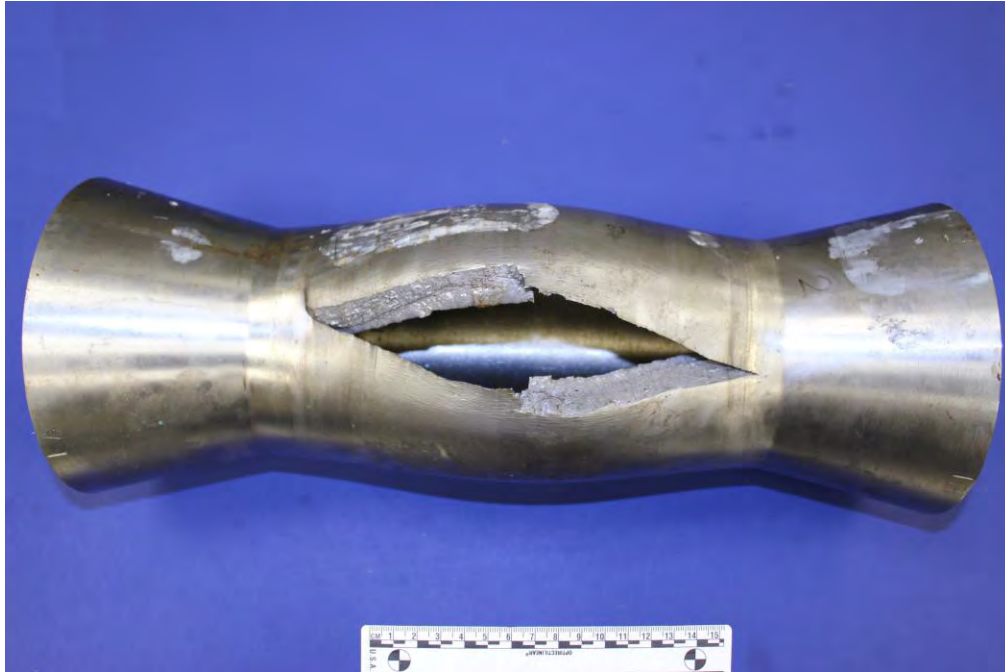
Figure 1: As Received Photograph – Sample 1 - Top View of Reduced Case at Burst (scale in mm)

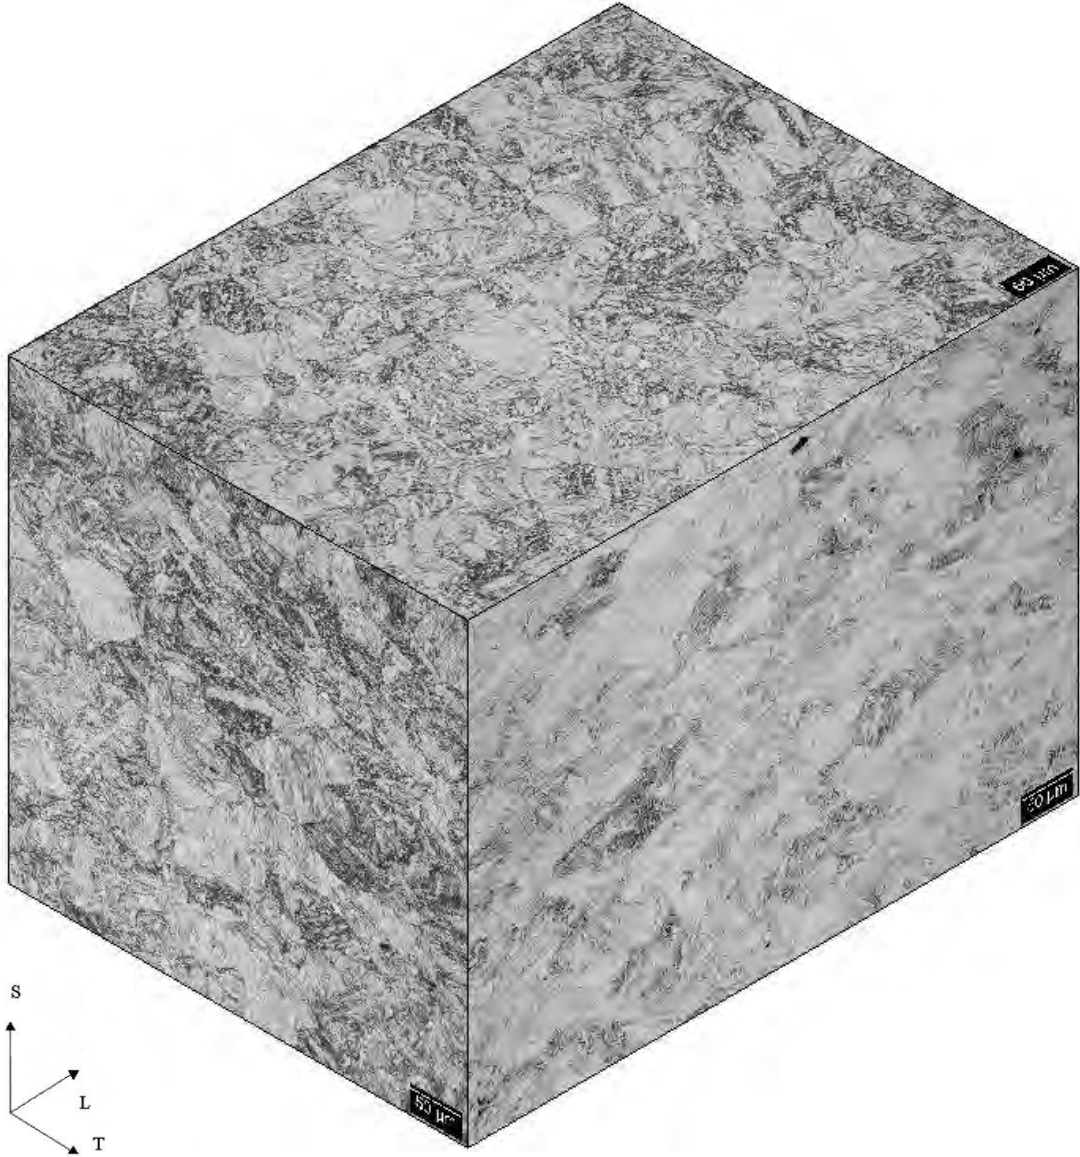
Figure 15: Sample 1 – Summary Composite Photo – At Burst

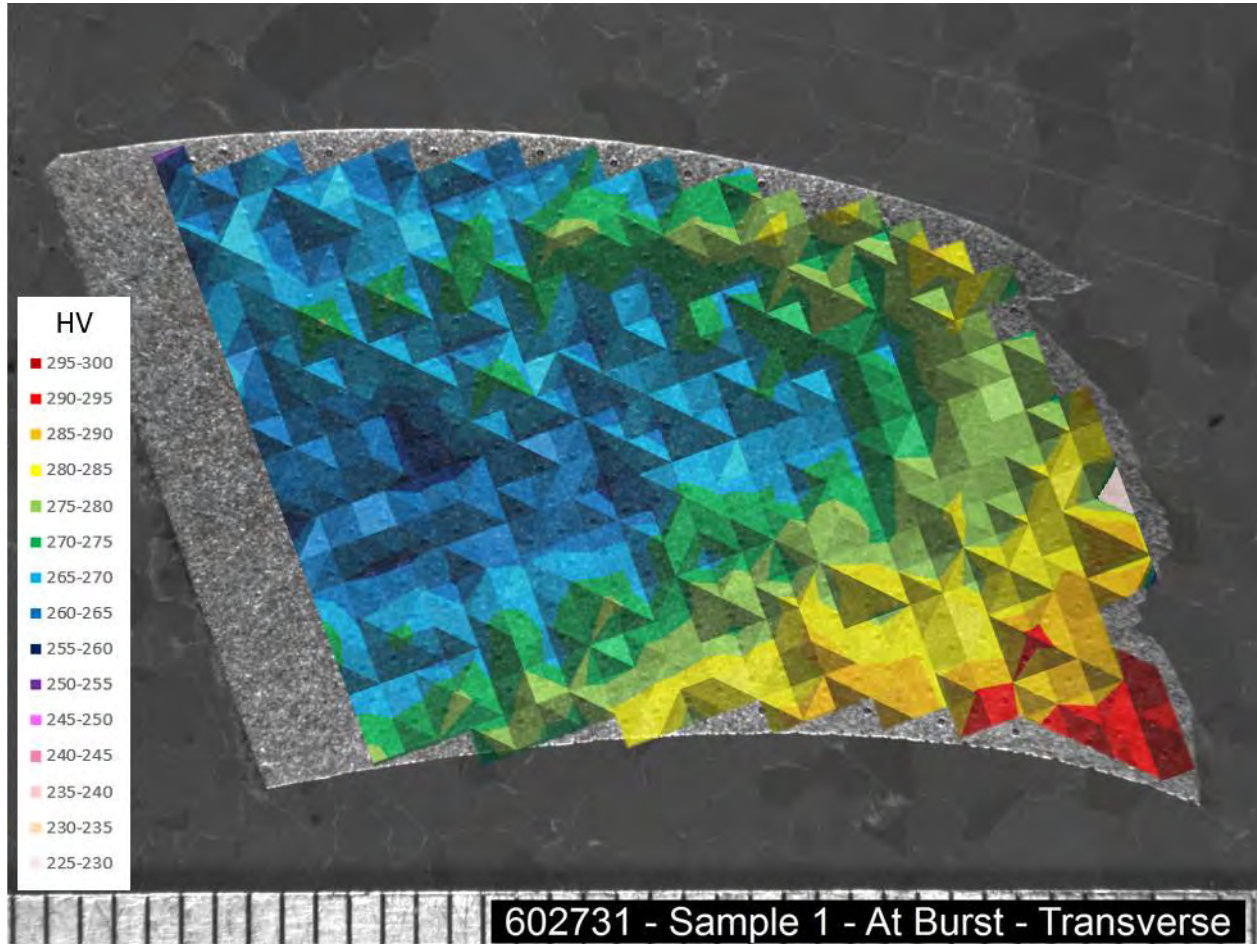
Figure 57: Sample 1 – Hardness Map of At Burst - Transverse Area (scale in mm)

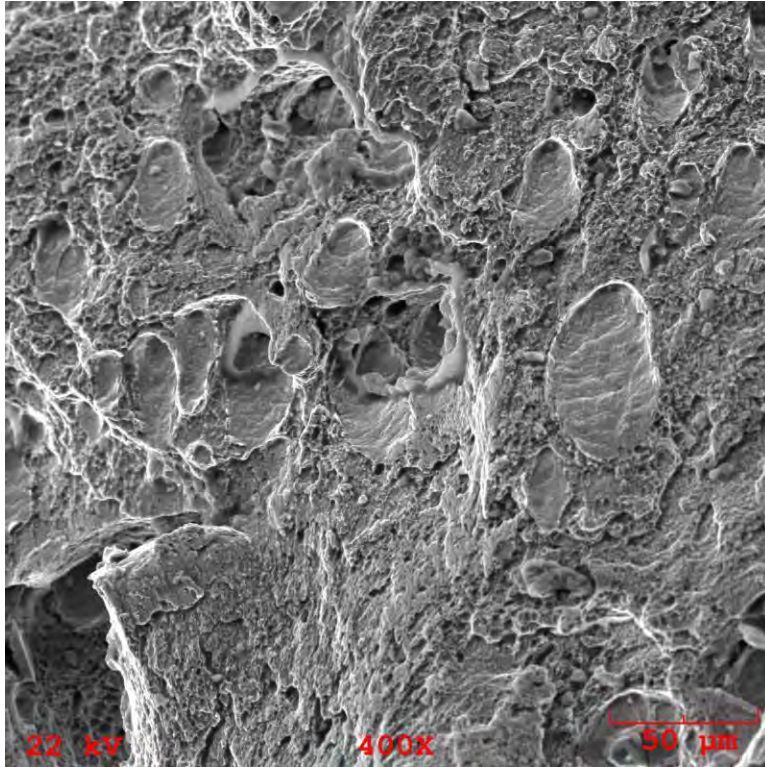
Figure 64: Sample 1 – SEM Image of Fracture Face near OD

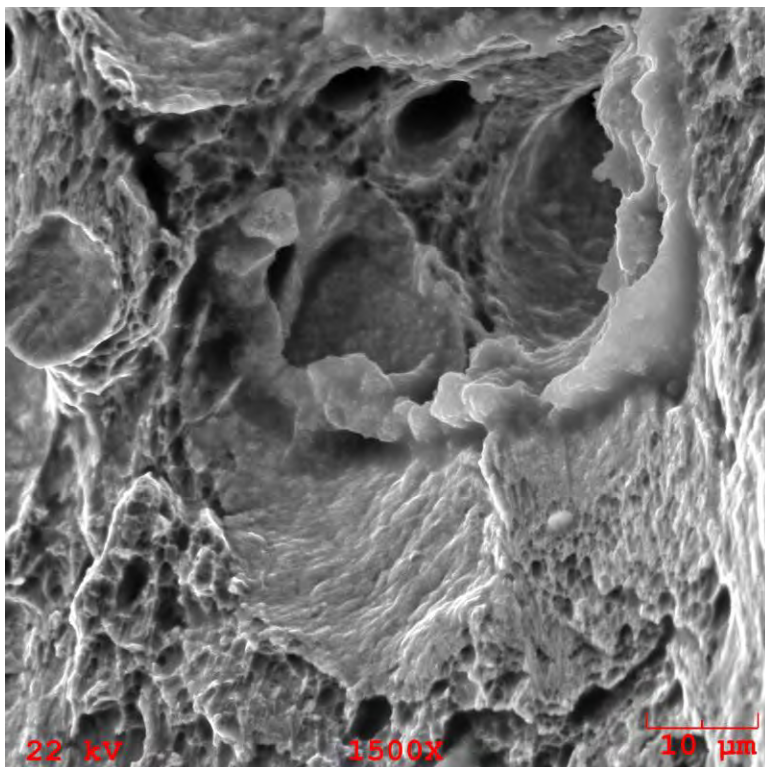
Figure 65: Sample 1 – SEM Image of Fracture Face near OD

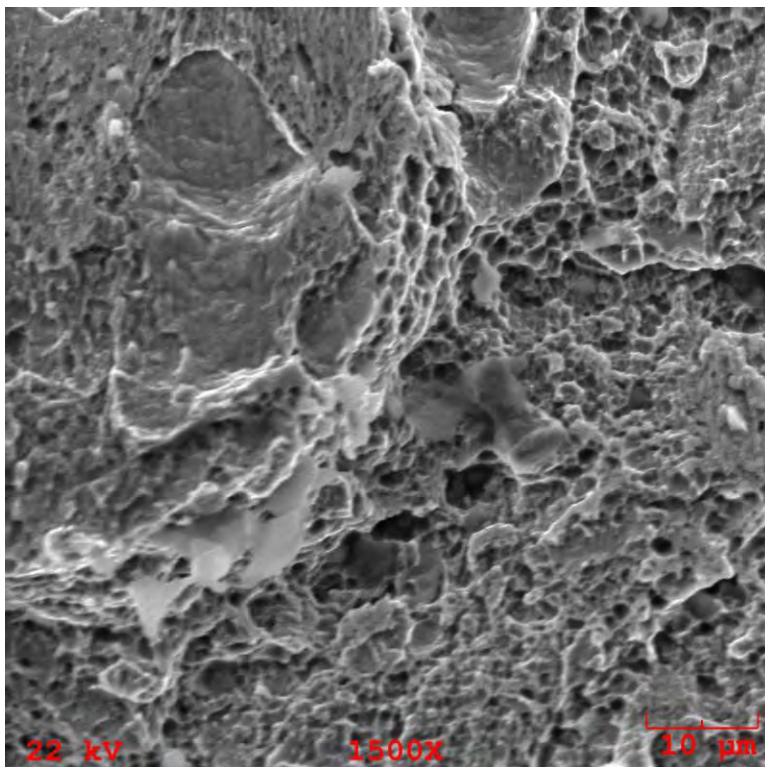
Figure 67: Sample 2 – SEM Image of Fracture Face near MW

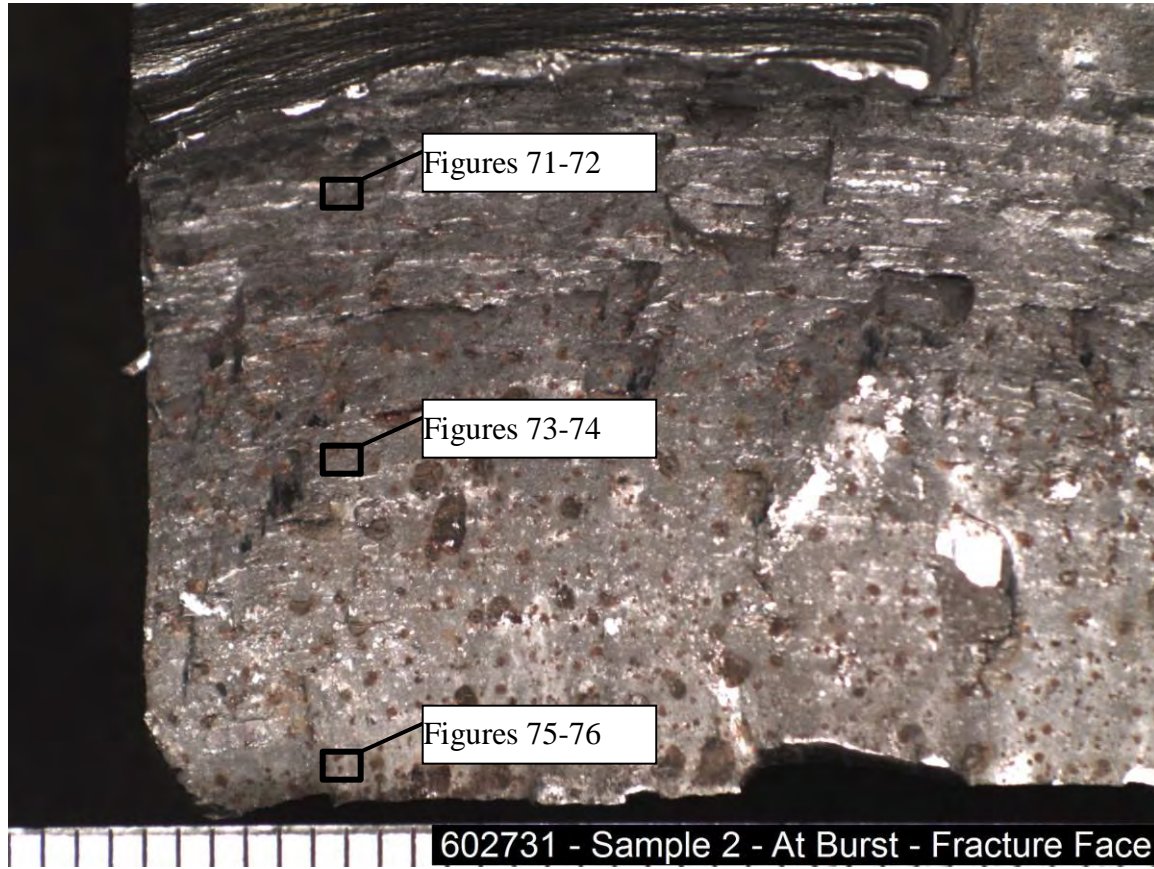
Figure 70: Sample 2 – Fracture Face and SEM Locations (scale in mm)

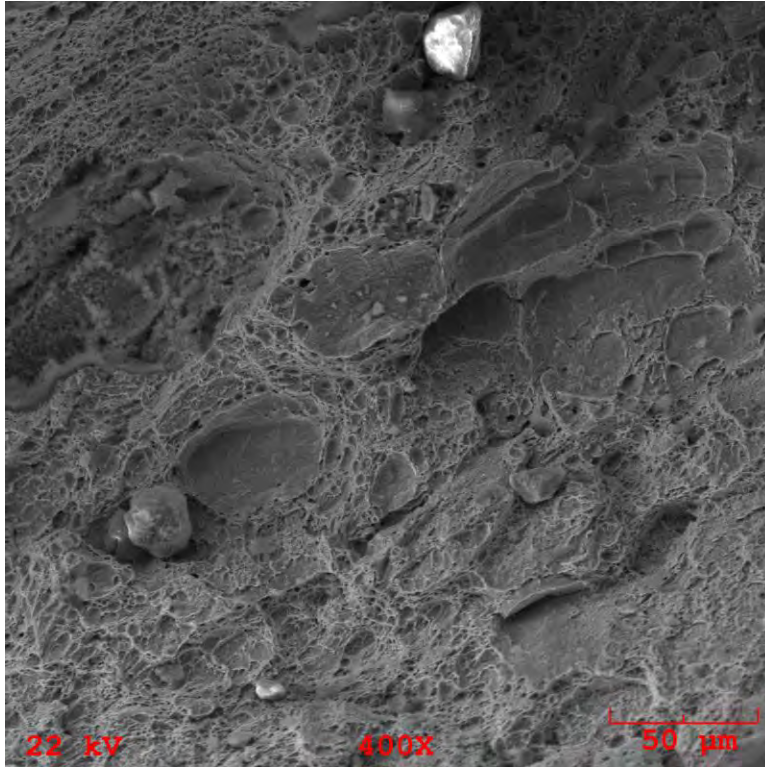
Figure 71: Sample 2 – SEM Image of Fracture Face near OD

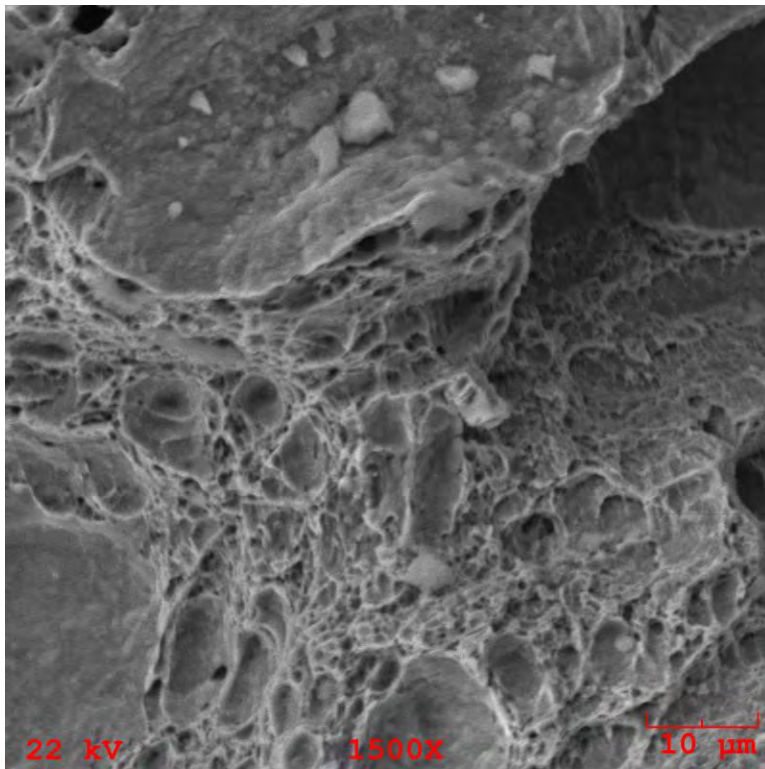
Figure 72: Sample 2 – SEM Image of Fracture Face near OD

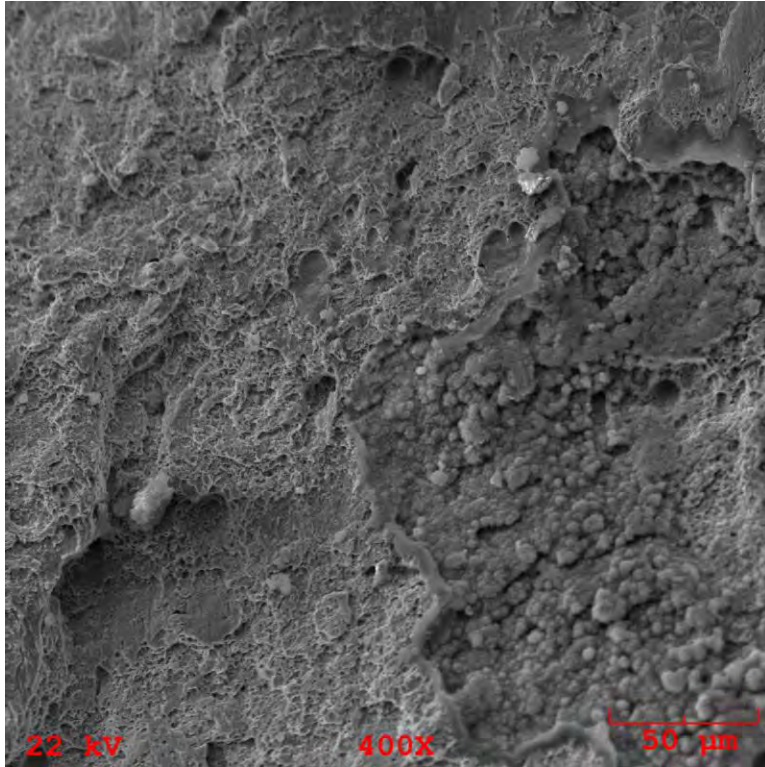
Figure 73: Sample 2 – SEM Image of Fracture Face near MW

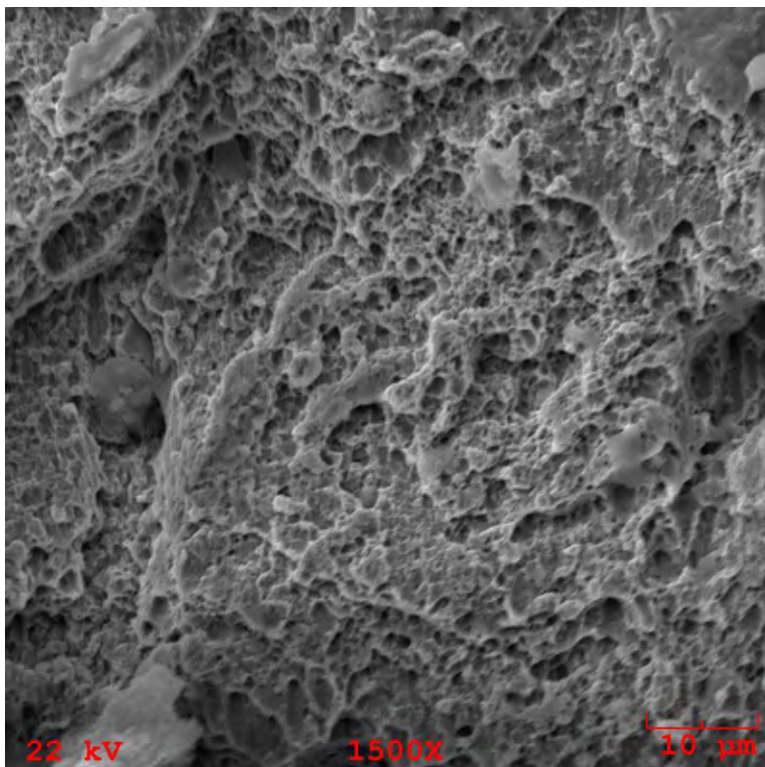
Figure 74: Sample 2 – SEM Image of Fracture Face near MW
