***ASSESSMENT OF FIXED OFFSHORE
PLATFORM PERFORMANCE IN HURRICANES
ANDREW, LILI AND IVAN***

December 2005

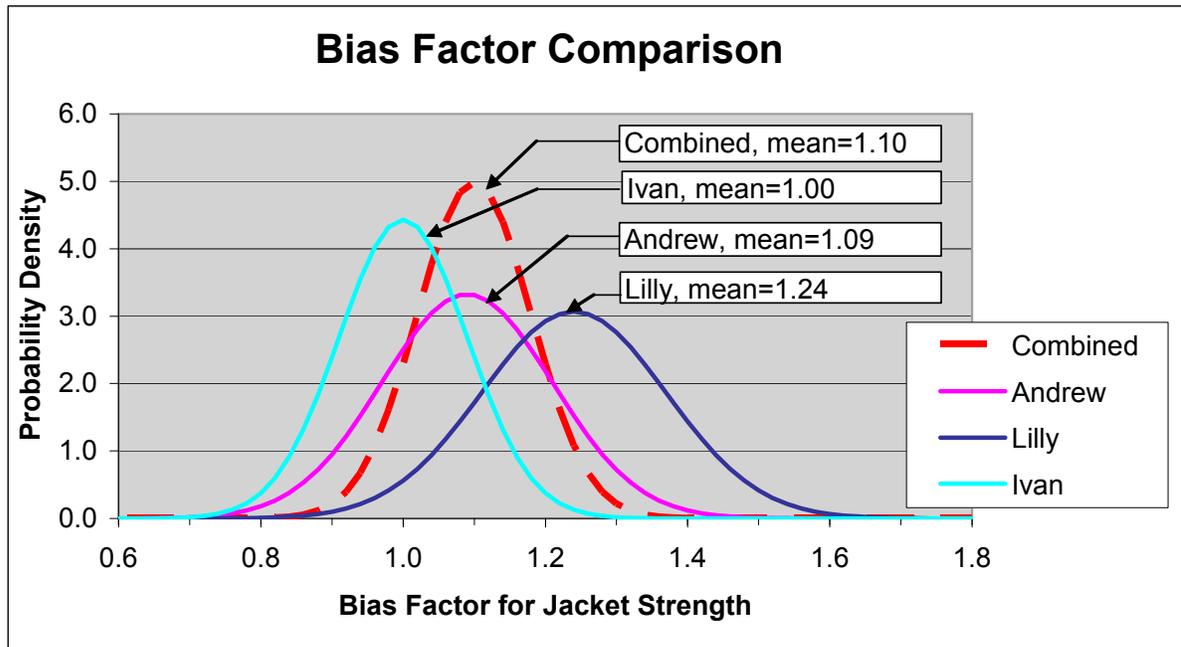
Figure E.1 - Bias Factor of Combined Results for Hurricanes Andrew, Lili and Ivan

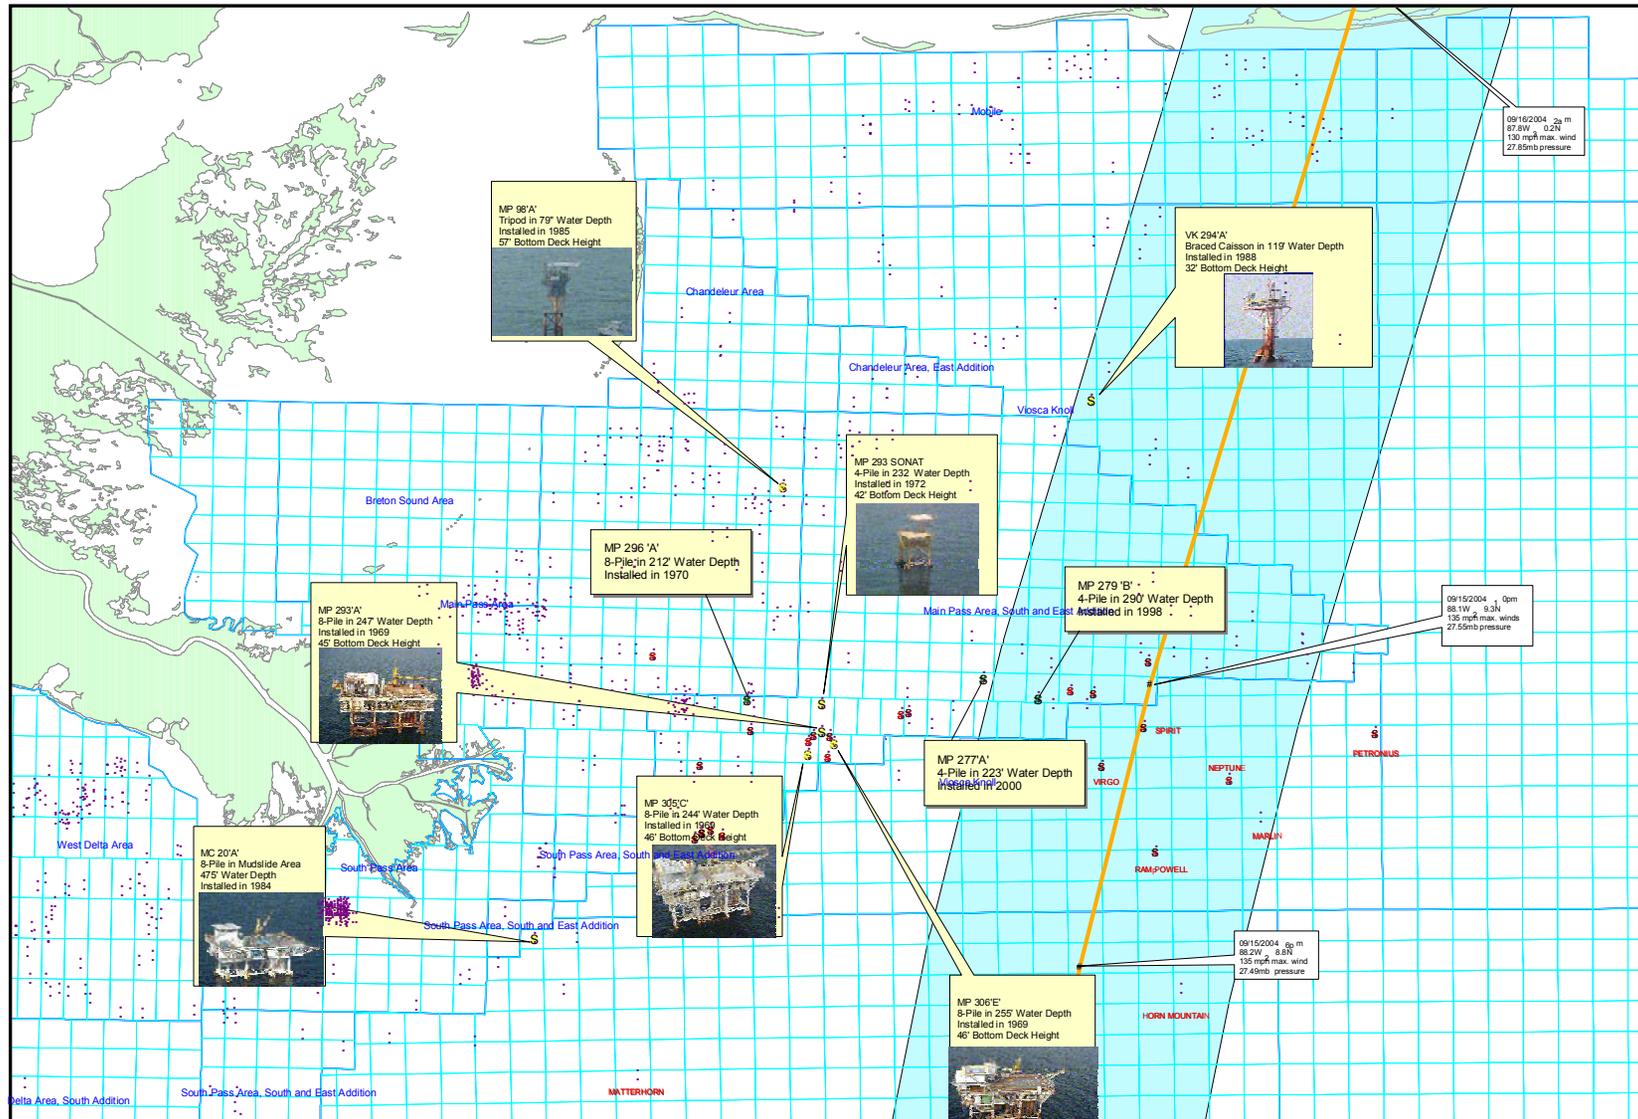
2.3 Fixed Platform Performance

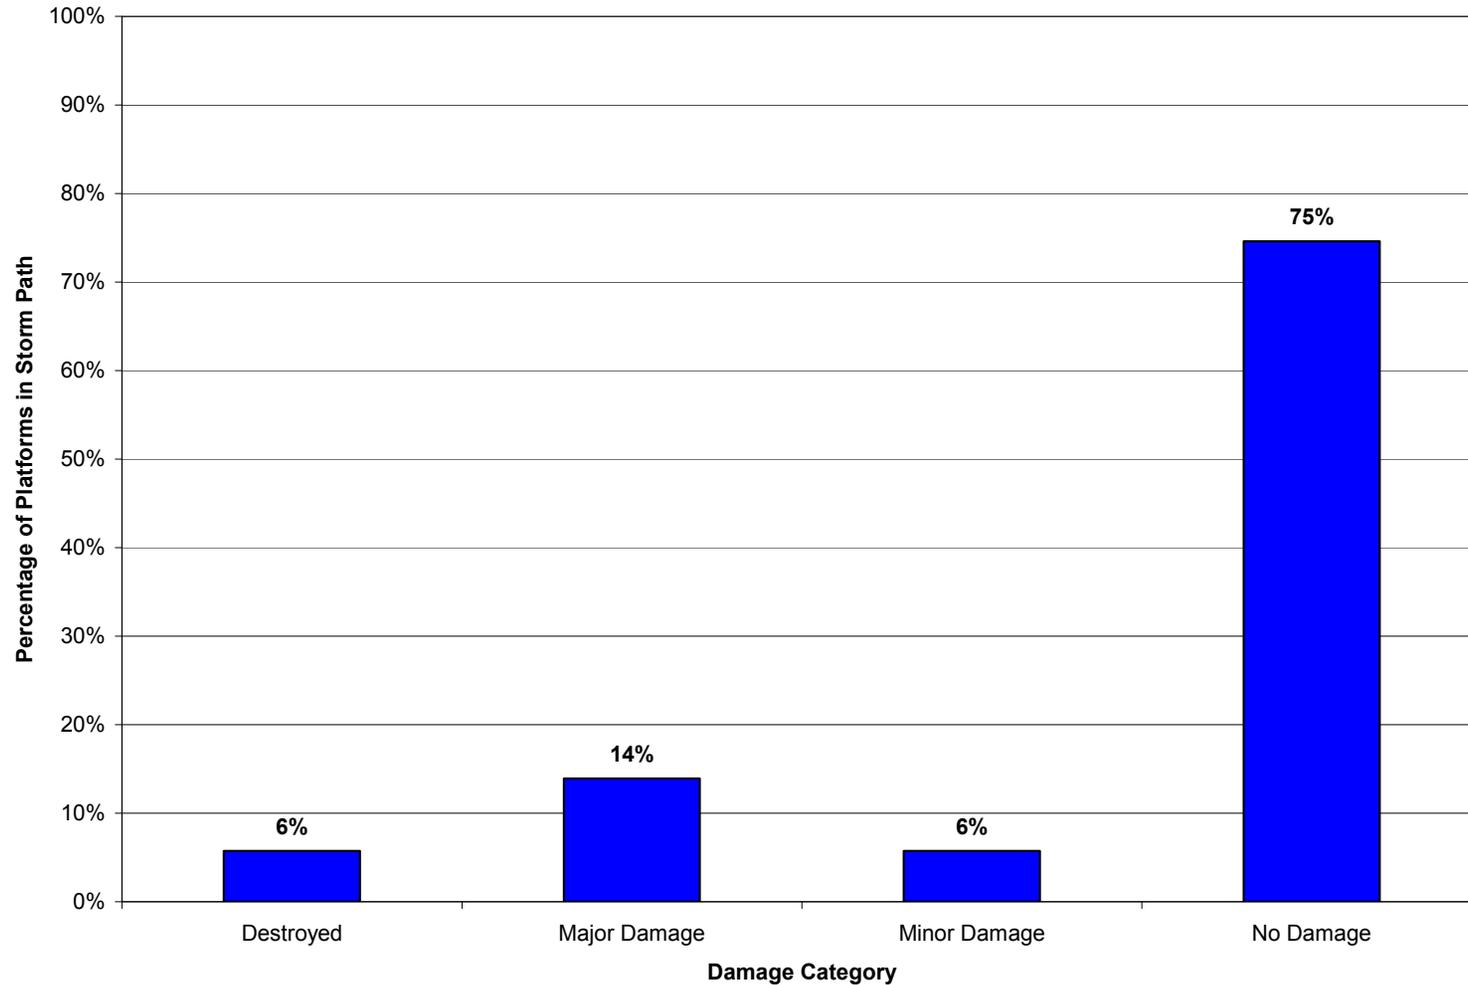
Figure 2.3 – Vintage of Fixed Platforms in Path of Hurricane Ivan

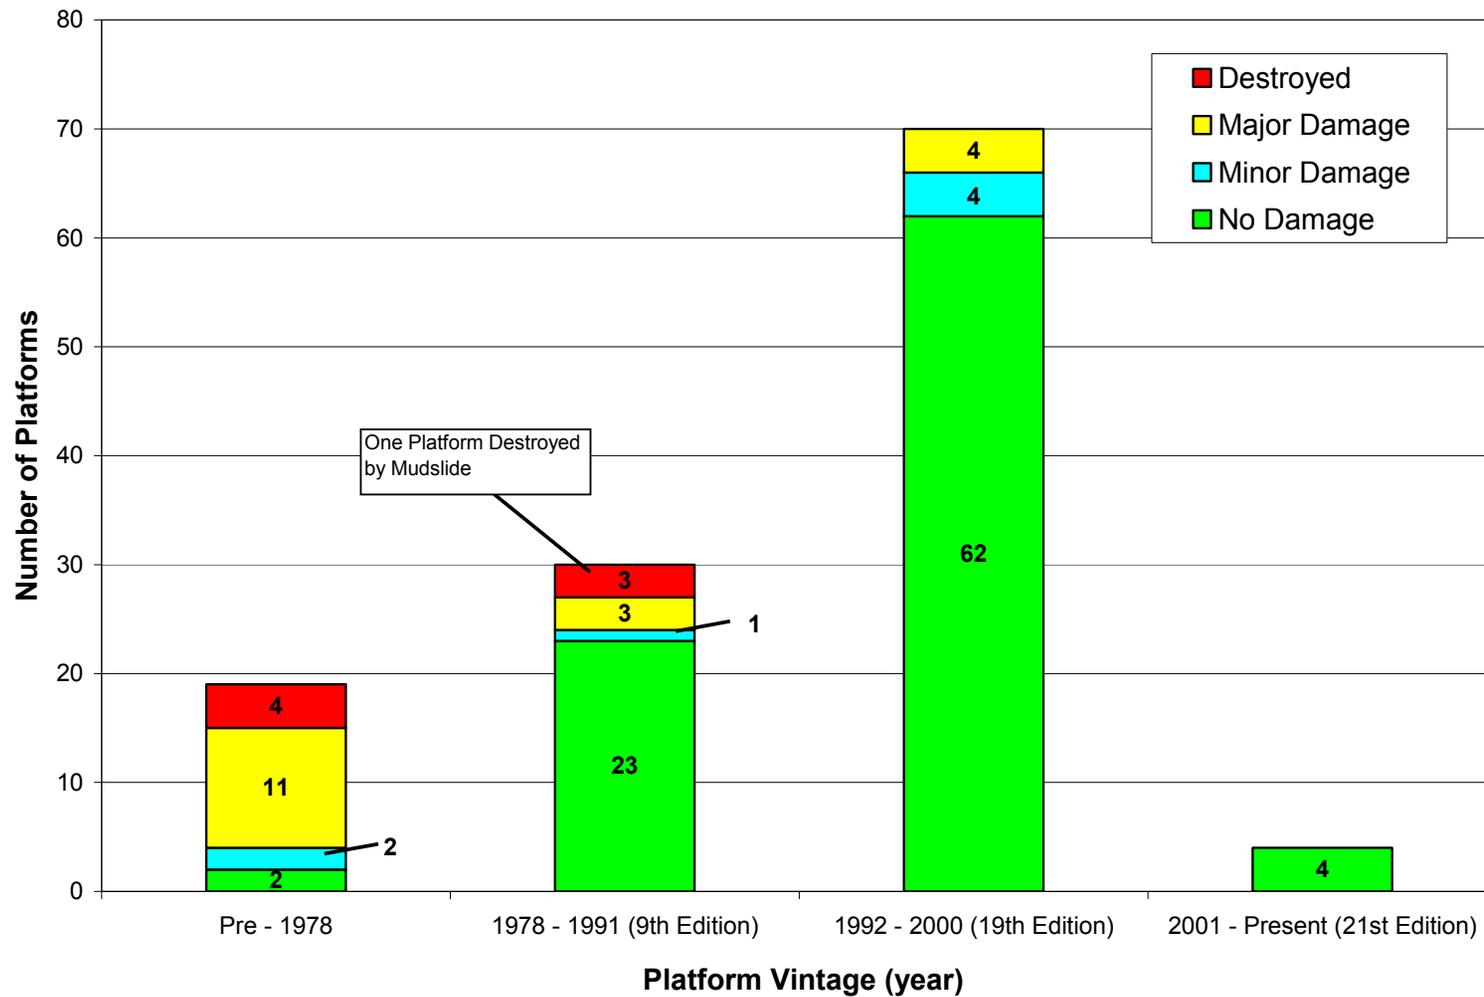
Figure 2.3 shows the majority of the platforms that failed or sustained major damage during Ivan were older vintage platforms. As mentioned above, these platforms were generally designed to lower environmental criteria and have lower global strength characteristics (e.g., weaker joints, less robust bracing patterns, less leg batter, etc.) than platforms designed to current industry practices. Additionally, these older platforms typically have lower topside deck heights which make them significantly more susceptible to wave-in-deck, which can increase the loading on the platform well over the platform's ultimate capacity.

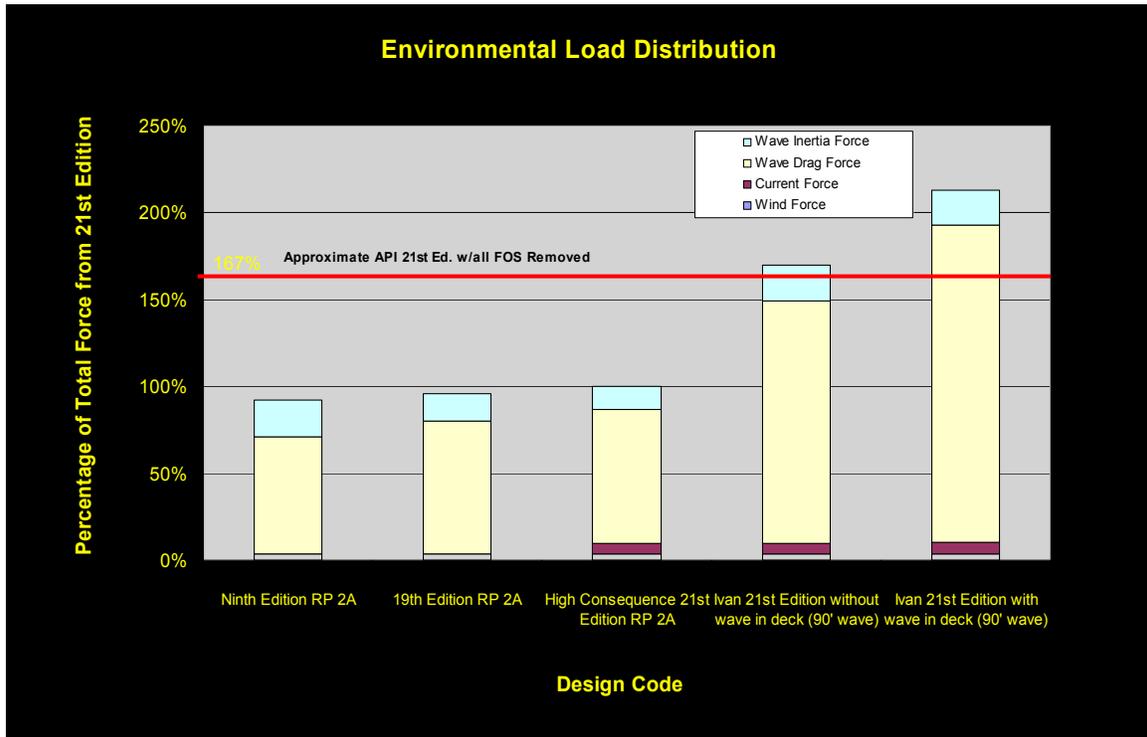
Figure 2.4 – “Generic” 8-Pile Platform Characteristics

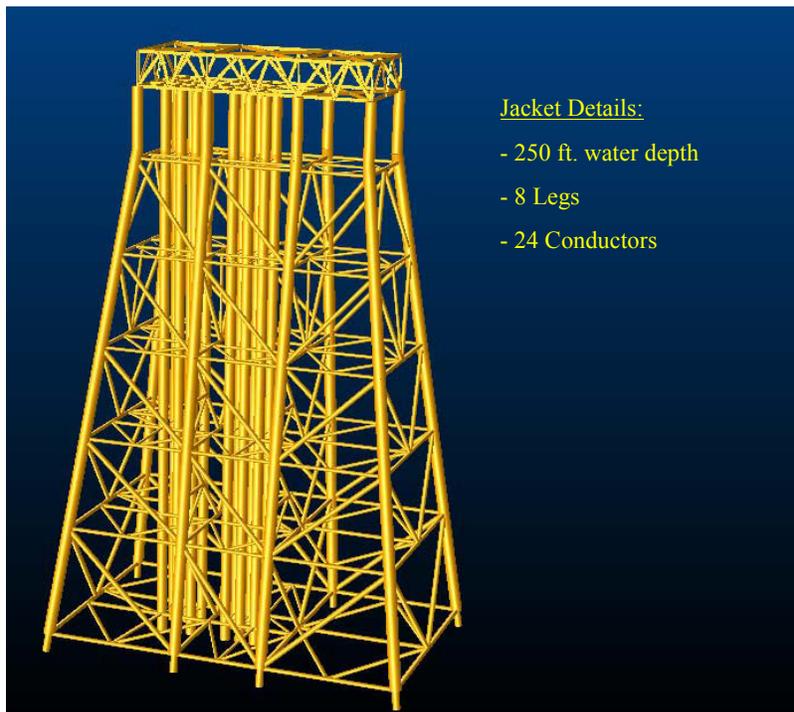
2.4 Platform Damage Summary

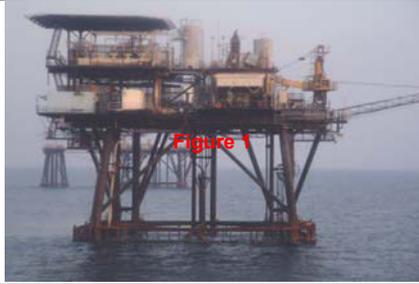
Deck Height	65 ft		
No. of Slots	14		
No. of Conductors	12+2		
Installation Date	1968		
API 2A Assessment Category	L2		
Jacket Type	Platform		
No. of Piles	2 + 2 sets of 6 conductors		
Distance from Shore	24 mi		
Bracing Configuration	K bracing for top and bottom bay; XH bracing for middle bay		
Storm Exposure			
Min. Distance/Direction from Eye	36 mi		Maximum Storm Surge 1.3 ft
Maximum Wave Height	66 ft		Maximum Wind Speed 64 kts
Significant Wave Height	37 ft		Current Speed 2.5 kts
Wave Crest Elevation	41 ft		
Storm Damage			
Structural Damage	Yes	Evidence of Wave in Deck	No
Structural Damage Description	Many deck members in a 13' x 60' cantilever deck section sustained significant damage during the storm. All other damage to the platform were either known from previous inspections or from a marine vessel collision which occurred after the storm in November 2004.

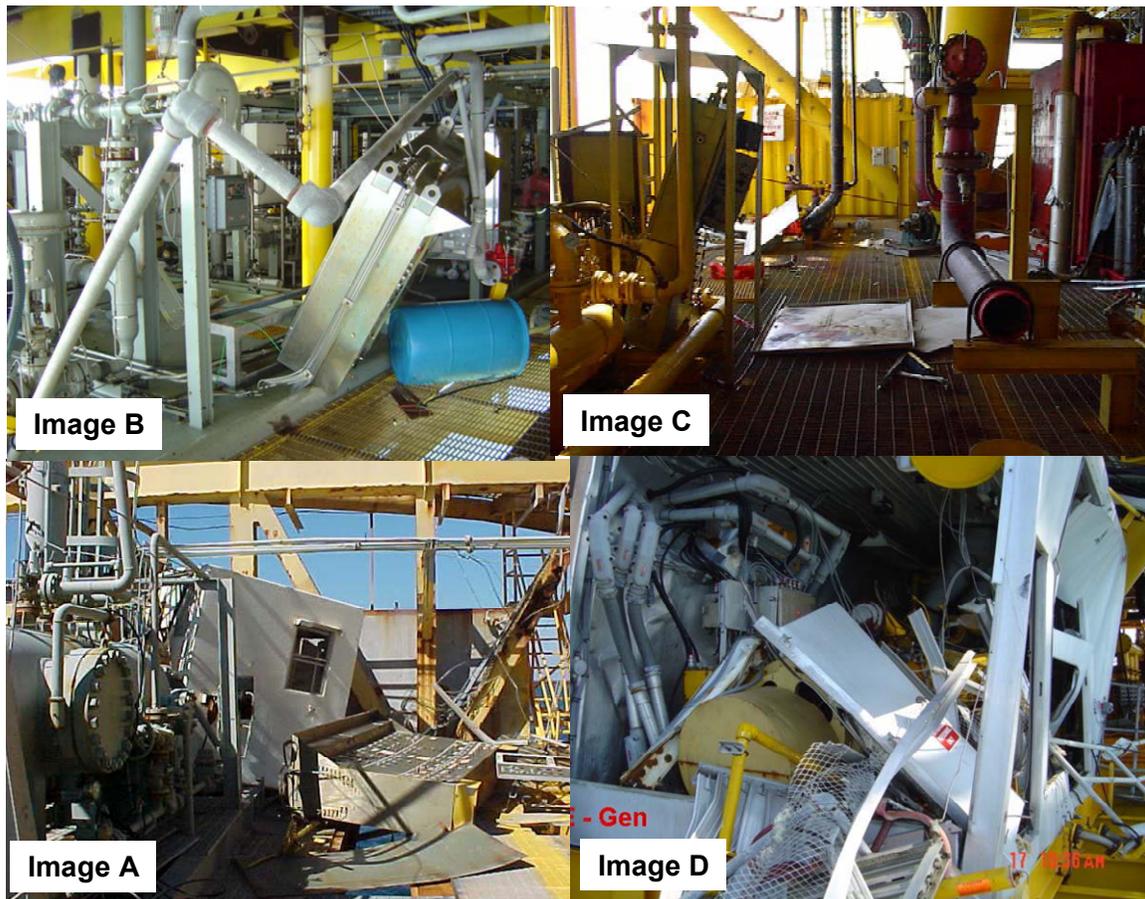
One other observation regarding the wave-in-deck damage was the apparent wave and wave crest heights during Ivan. Many of the platforms that had evidence of wave in deck observed damage in the upper regions of the cellar deck. For example in the case of the Pompano platform, the deck damage was observed at an elevation of +63 feet above the water level. This equates to a postulated 105 ft maximum wave height when using present design calculation methods. This estimate is well above the hindcast estimates for maximum wave. For the Pompano location, the hindcast estimates put the maximum wave height at approximately 80 feet [O'Connor, 2005]. These sorts of discrepancies between the calculated wave heights based on damage and the hindcast estimates are highlighted in the Section 2.5.

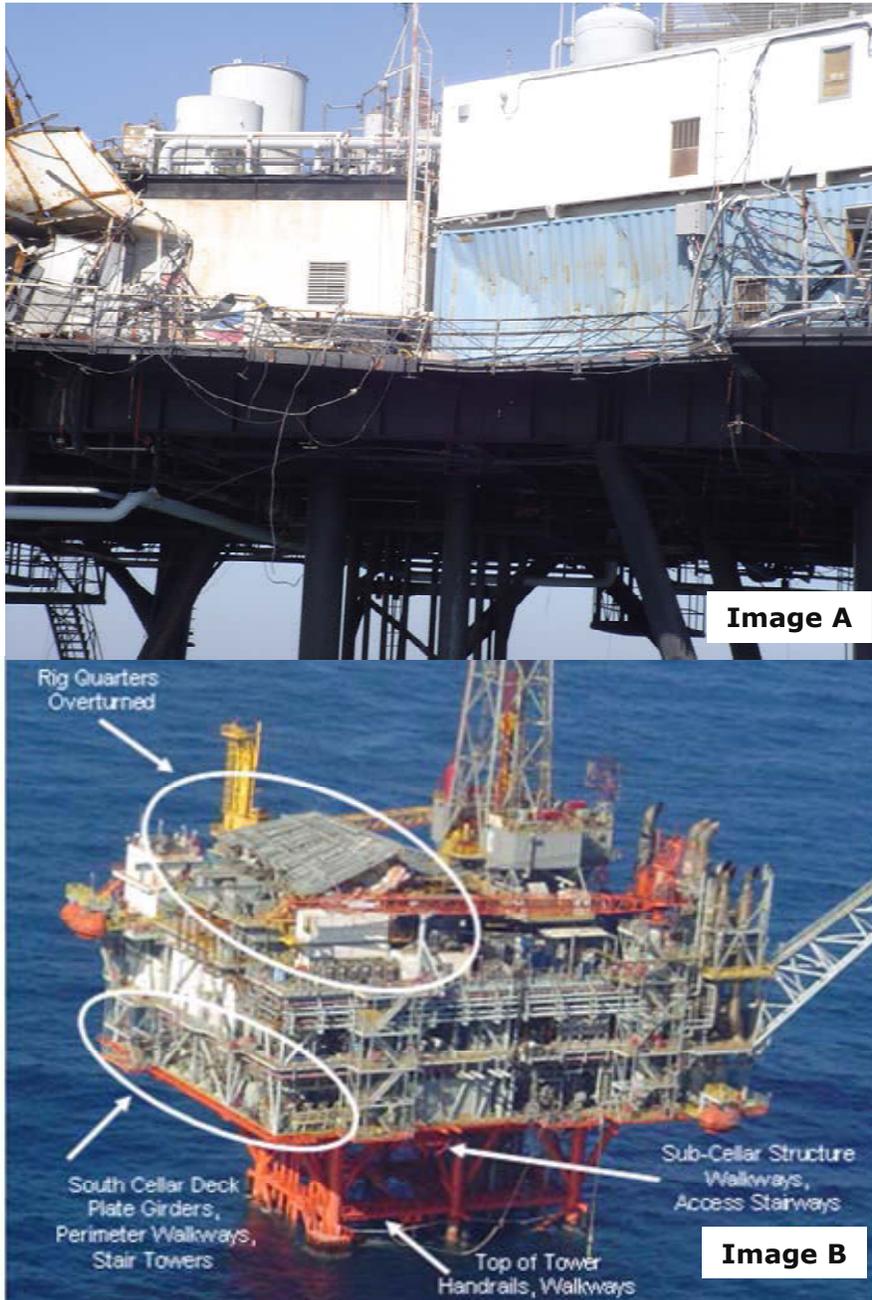
2.4.2 Jacket Damage (Underwater)

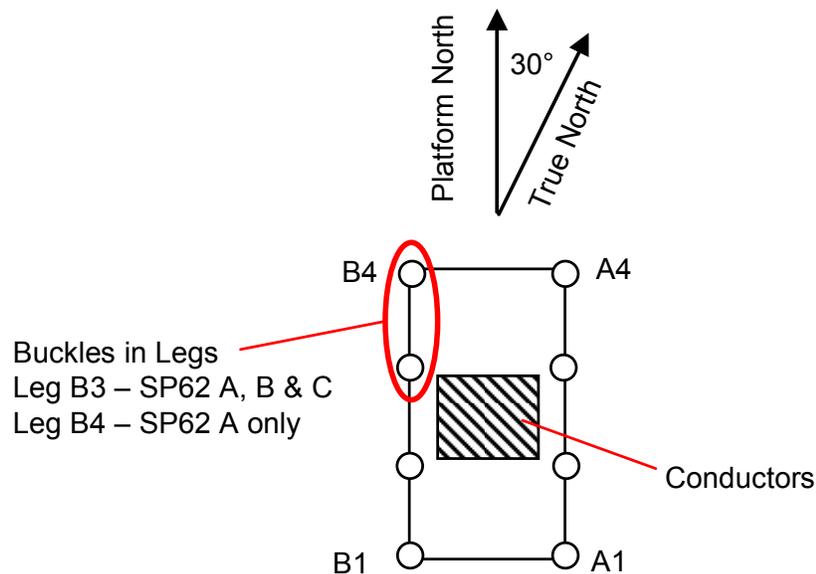
Another platform that sustained local leg buckling was MP 306F. This platform also sustained major damage to the main jacket bracing. The platform is a 4 pile with 4 skirt piles and there is no batter in the Row A and B direction. Rows A and B sustained major damage to the upper three bays of X-bracing. The platform orientation is shown in Figure 2.9. Similar to the SP 62 platforms, the buckled leg was on the Northern leg or leeward side of the platform with respect to the storm track.

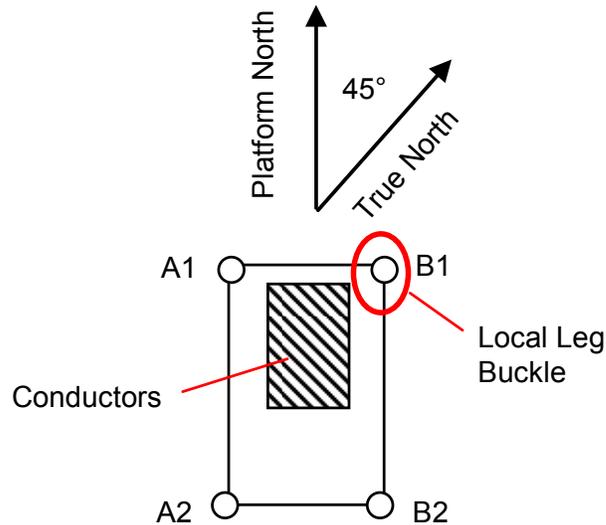
MP 281 A sustained leg buckling and separation on the two diagonally opposed legs. The platform is a four pile platform and the A1 and B2 legs were observed to be separated. The X-bracing was also separated at two locations near the leg damage. The specific orientation was not shown in the documents but the inspection report shows the conductors to be on the north face of the platform. The orientation of the platform and photos of the observed damage are shown in Figure 2.10. Note that the wave action and subsequent movement of the platform caused the leg to expand outward at the both ends. Similar damage was seen in Lili [Puskar, 2004]. This is shown in Figure 2.10, Image B.

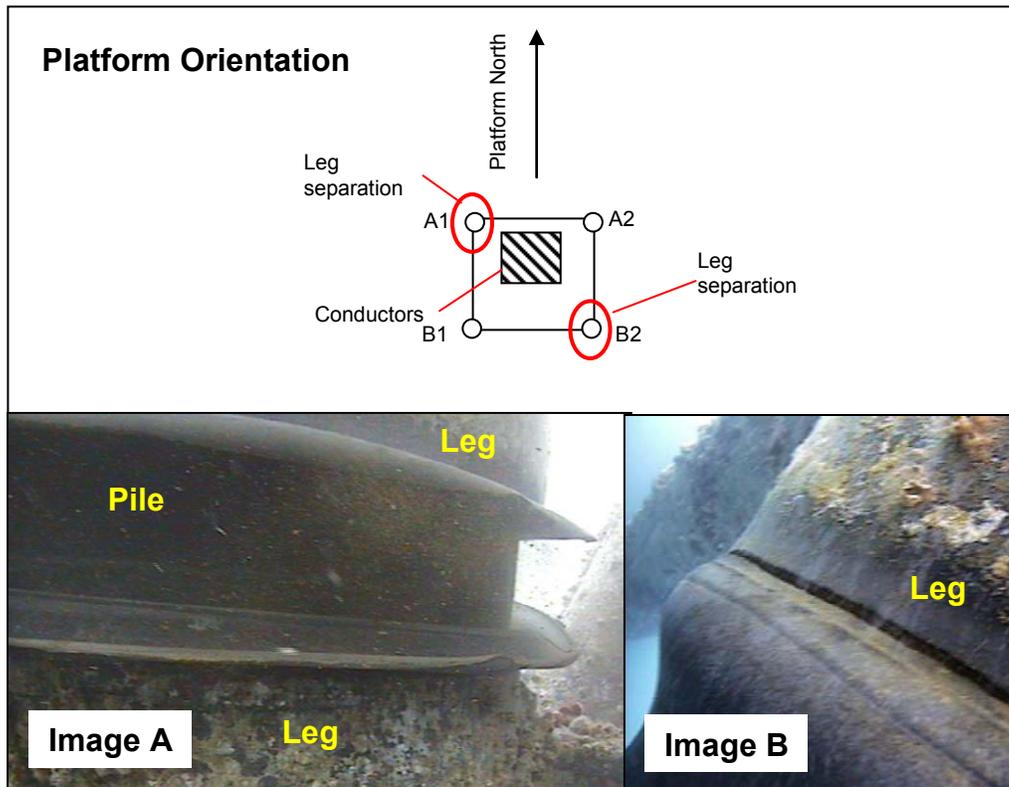
Figure 2.10 – Platform Orientation of MP 281 A Platform and Photos of Leg Damage

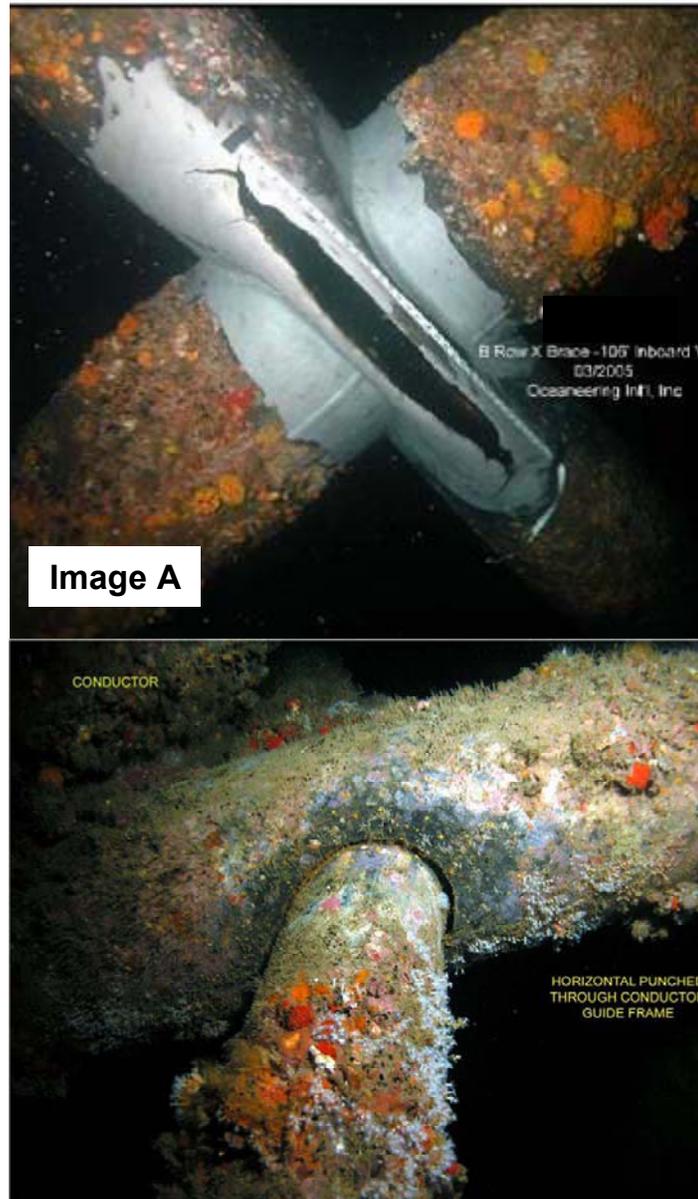
Figure 2.11 – Typical Joint Failures

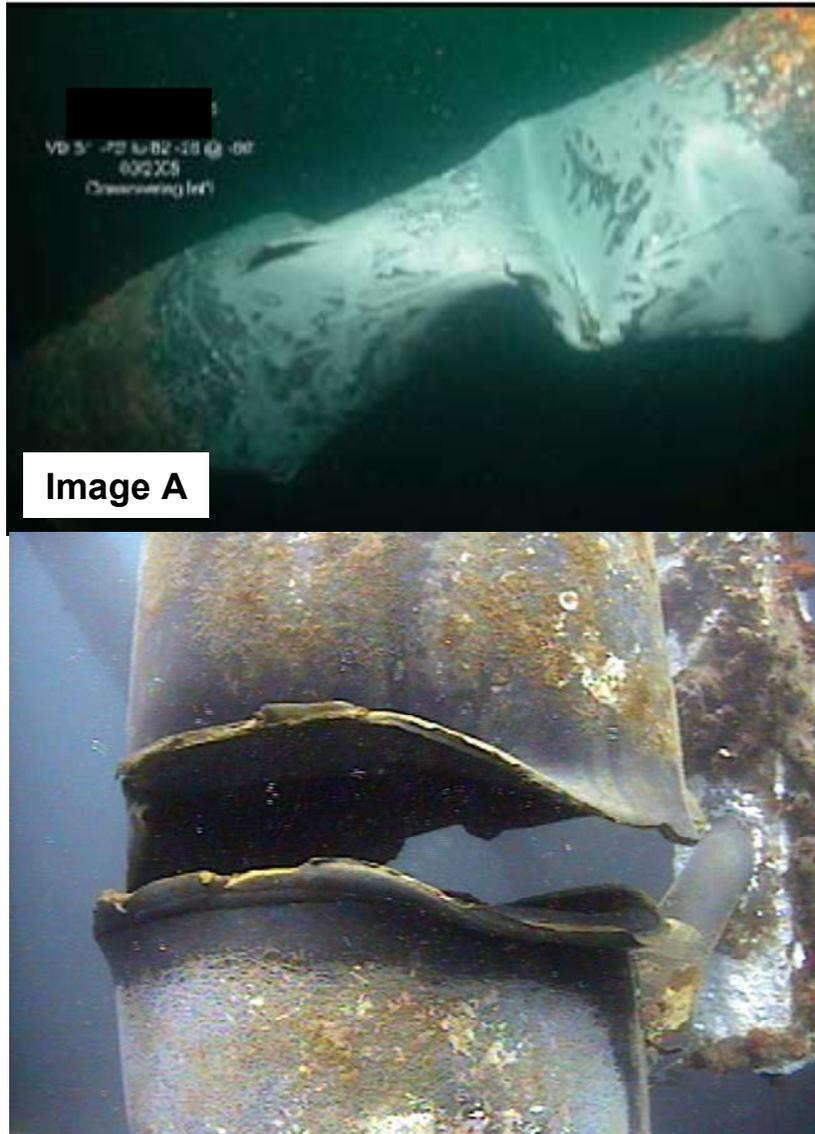
Fractured / Detached Conductor Guide Framing

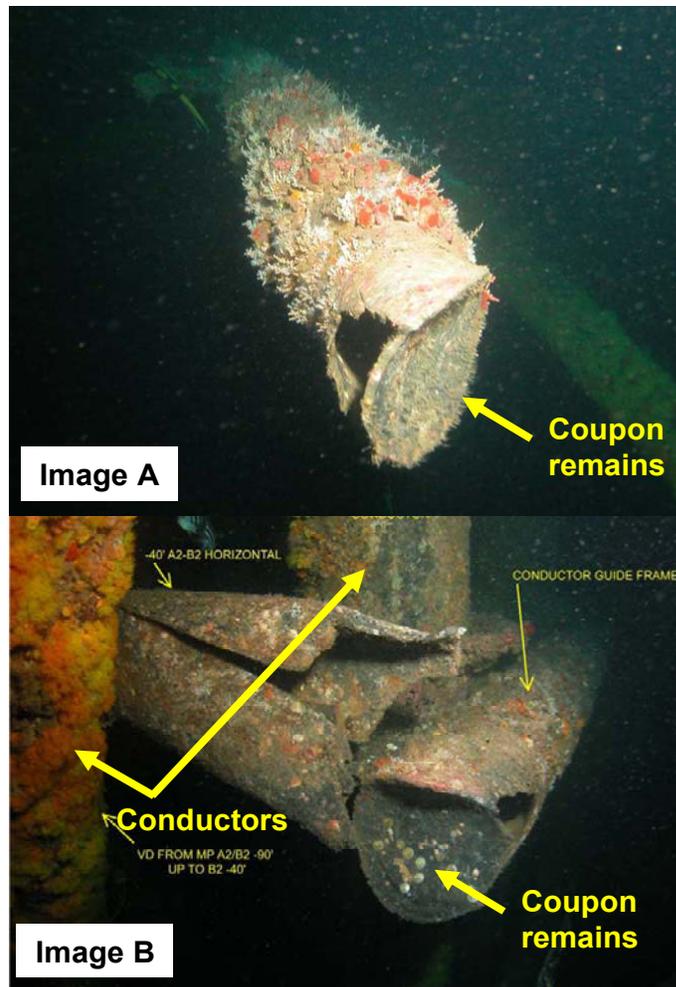
2.5 Data Comparisons

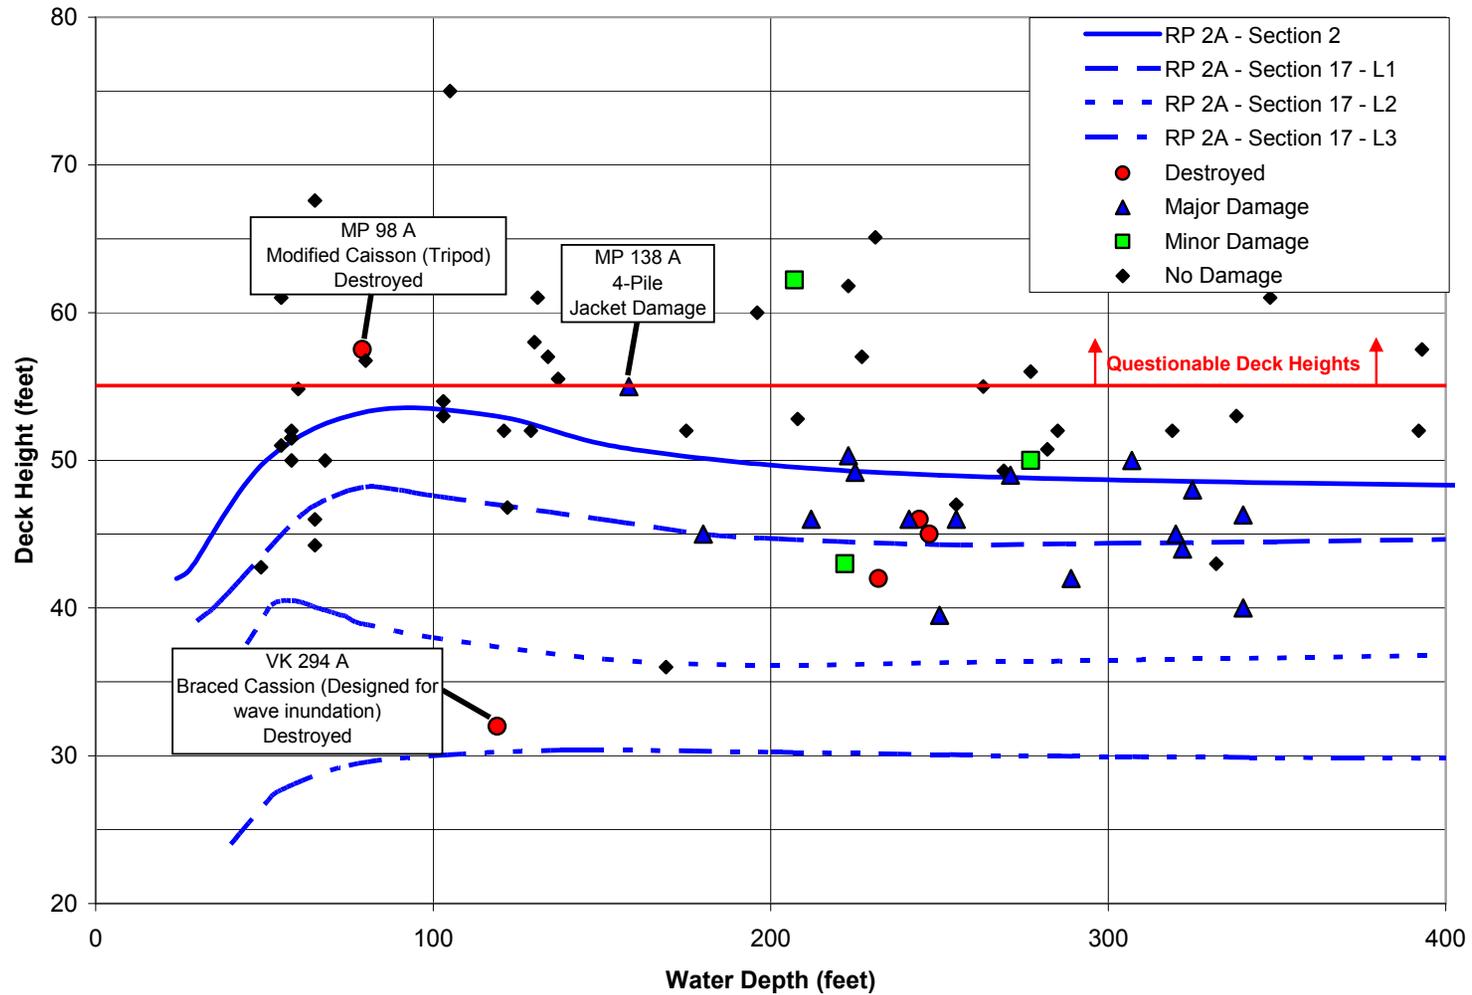
Figure 2.15 – Ivan Hindcast Maximum Wave Crests of Damaged Platforms

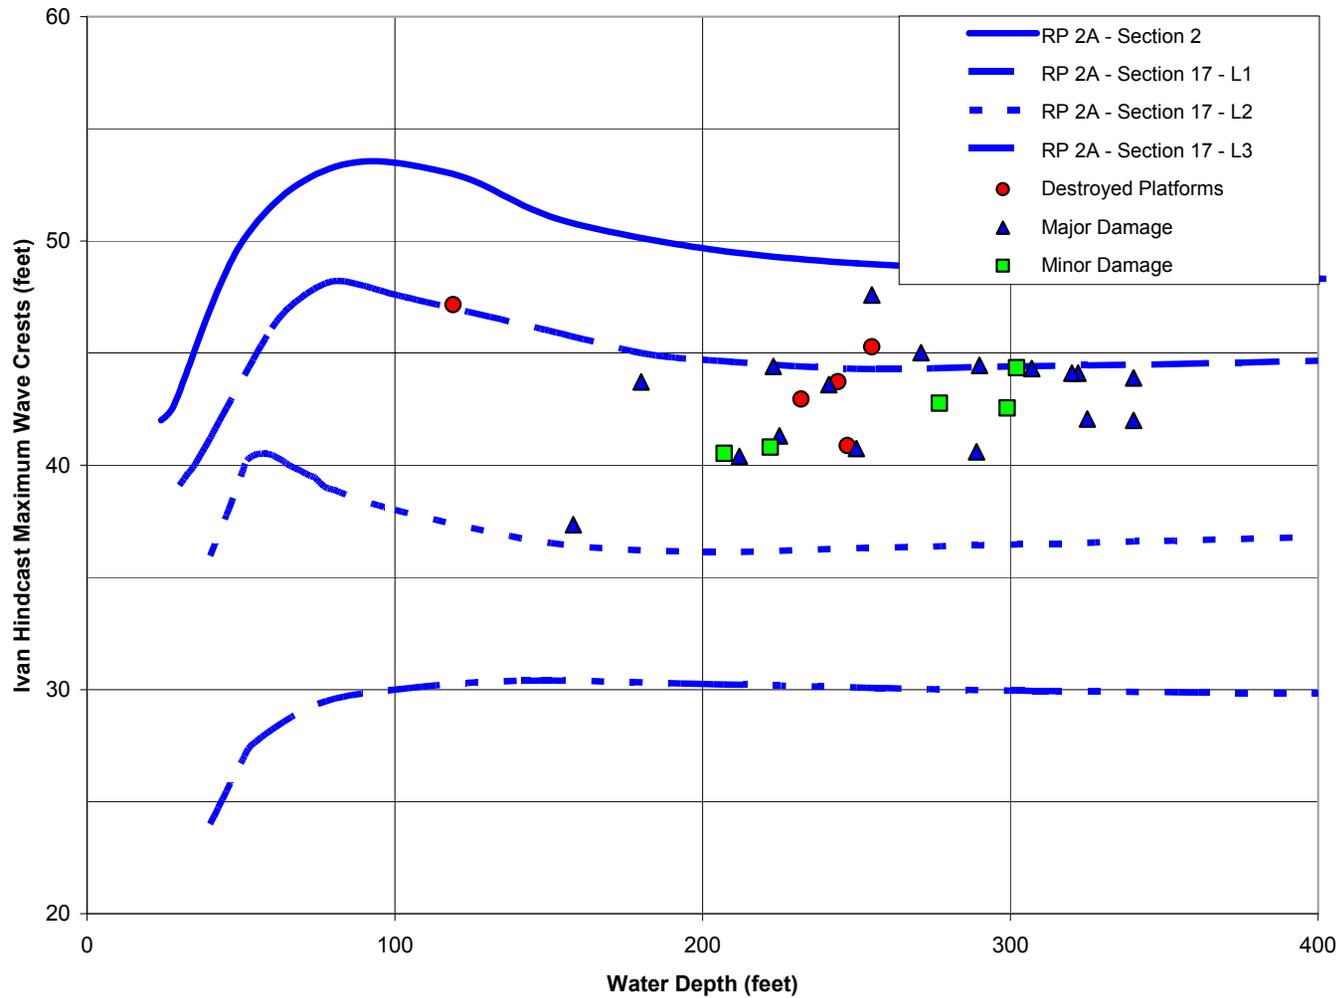
Figure 2.16 – Ratio of Ivan Hindcast Wave Crest versus Deck Heights

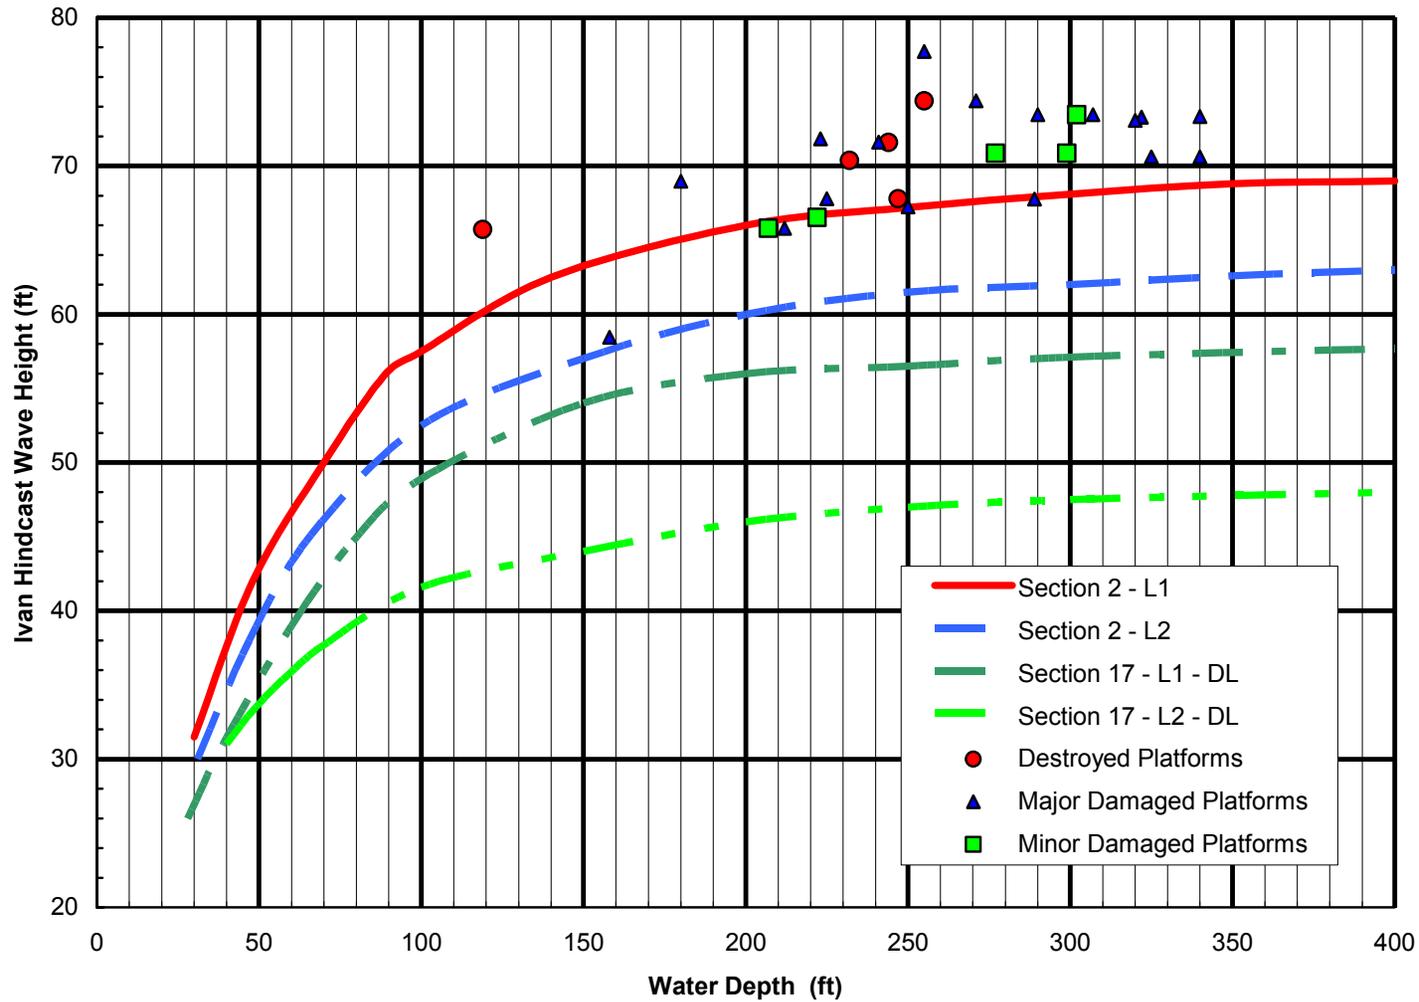
Figure 2.19 – Seafloor Bathymetry and Location of Damaged Platforms

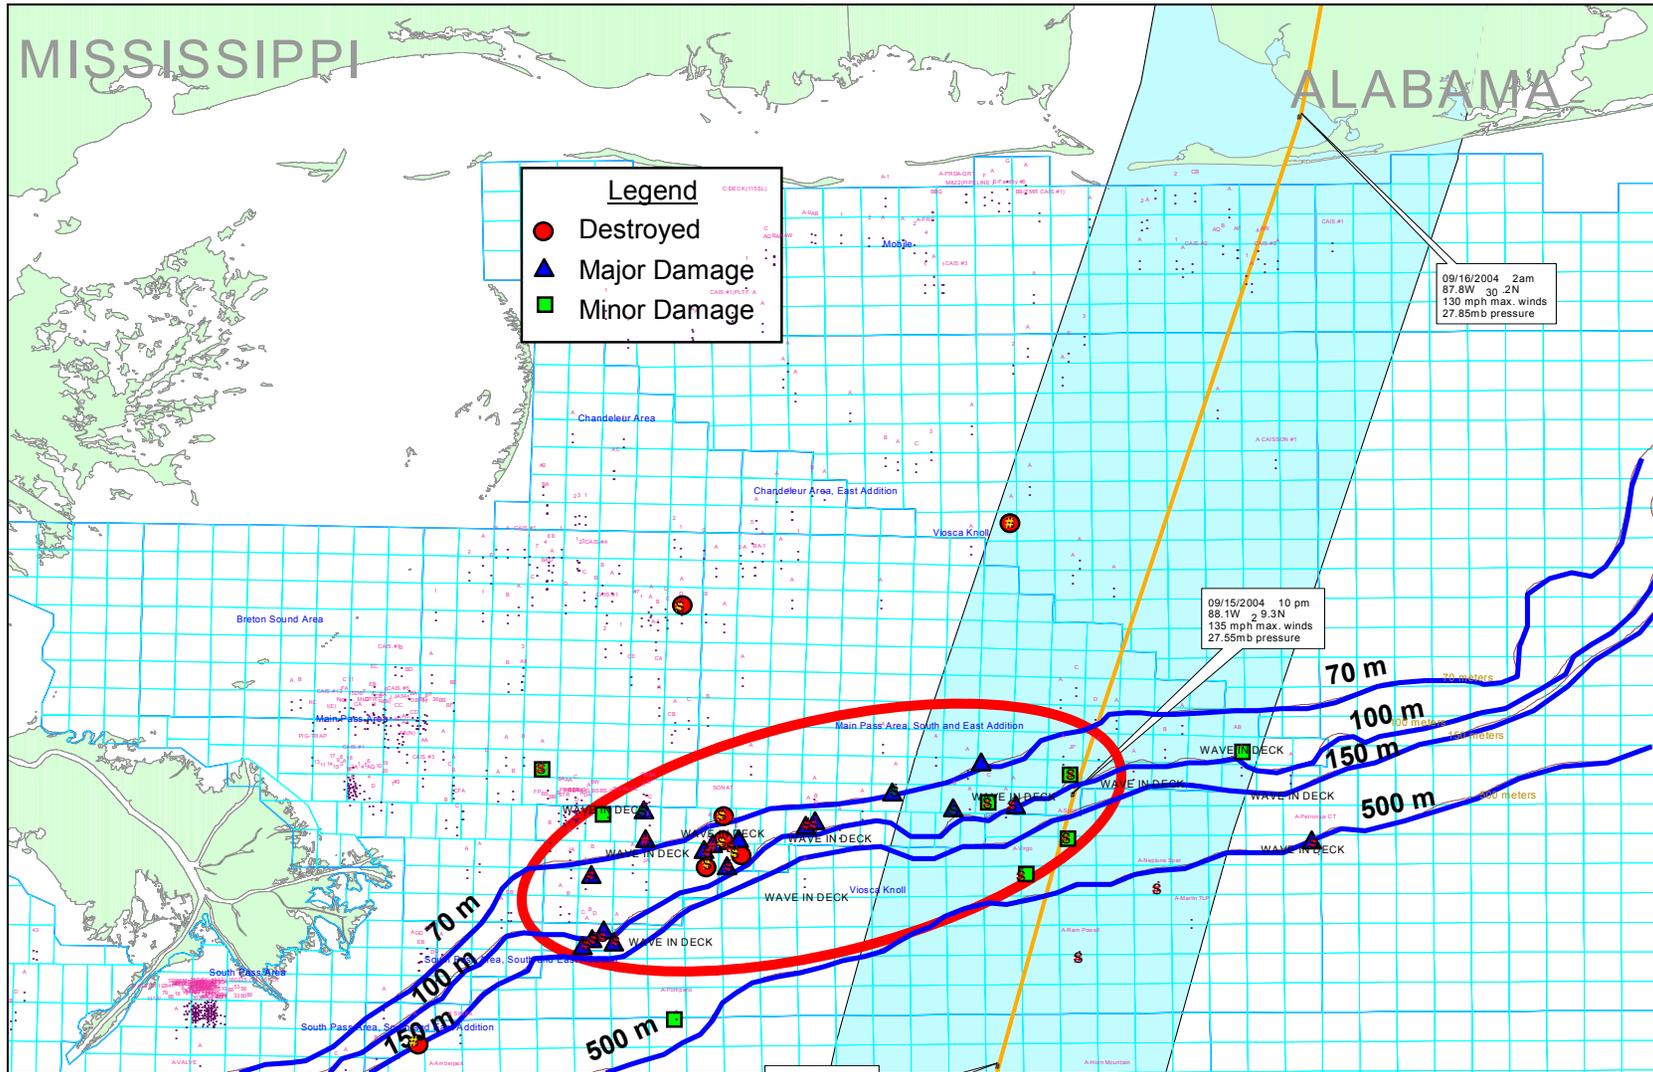
2.6 Ivan Recovery Effort

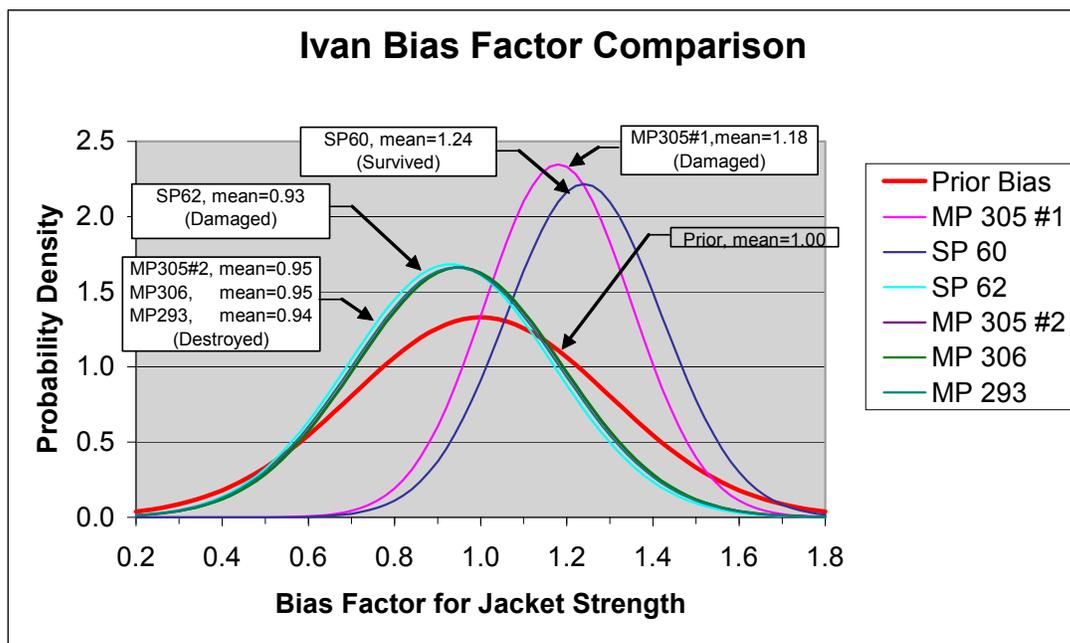
Figure 3.1 - Jacket Bias Factors for Six Platforms Analyzed for Hurricane Ivan

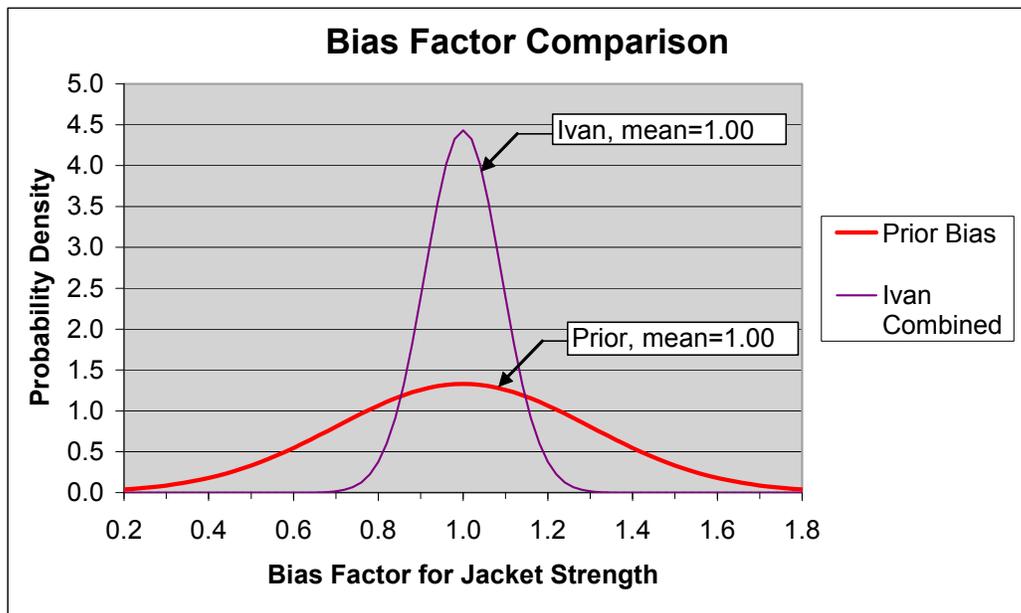
Figure 3.2 - Combined Jacket Bias Factor from Six Platforms Analyzed for Hurricane Ivan

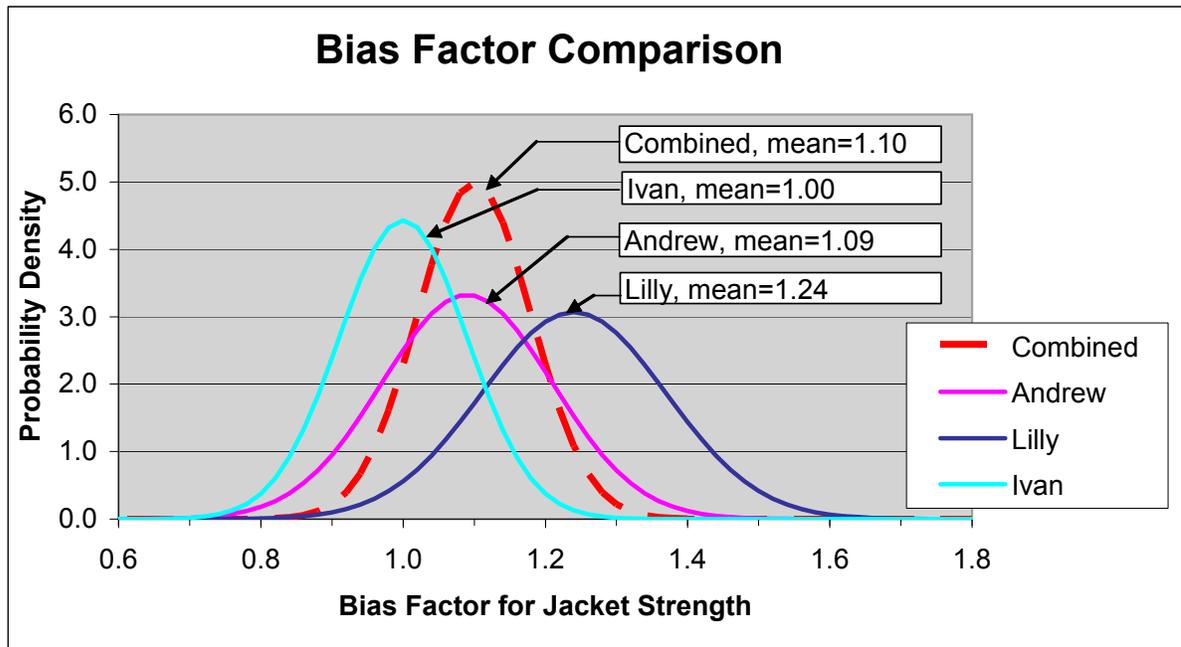
Figure 3.3 - Jacket Bias Factor of Combined Results for Hurricanes Andrew, Lily and Ivan

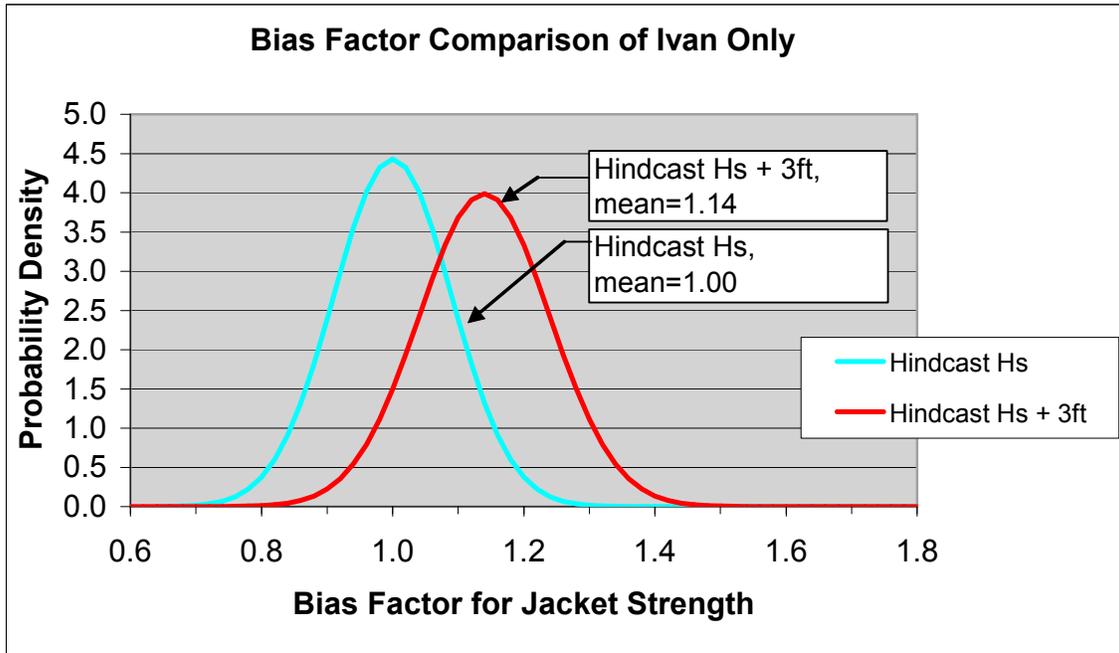
Figure 3.4 – Sensitivity of Ivan Bias Factor with Hindcast H_s Increased by 3 Feet
