***ASSESSMENT OF FIXED OFFSHORE
PLATFORM PERFORMANCE IN HURRICANES
ANDREW, LILI AND IVAN***

December 2005

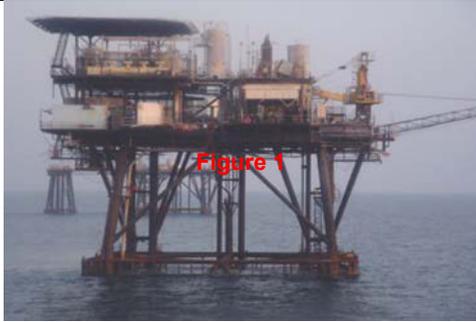
Platform Damage Summary			
Platform	Main Pass 144A		
Operator	Chevron		
Platform Description			
Water Depth	206 ft

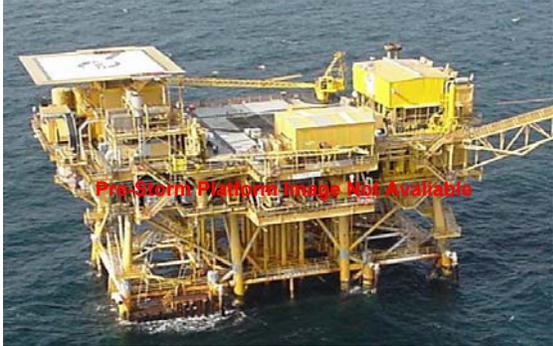
Platform Damage Summary			
Platform	Main Pass 311 B		
Operator	Apache Corporation		
Platform Description			
Water Depth	246 ft

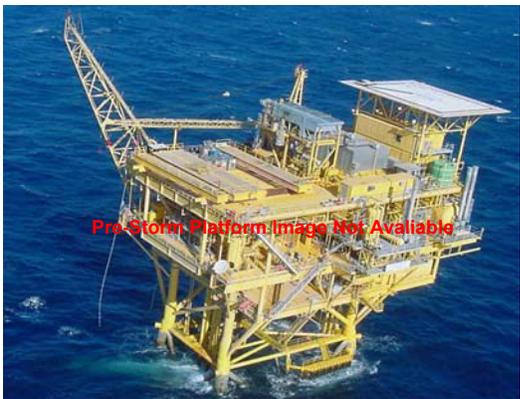
Platform Damage Summary			
Platform	Main Pass 281 A		
Operator	Dominion E & P		
Platform Description			
Water Depth	307 ft

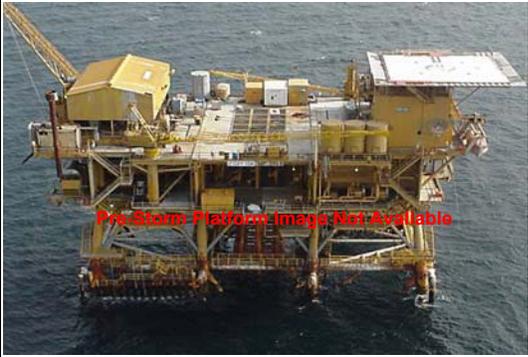
Deck Height	52 ft		
No. of Slots	18		
No. of Conductors	19		
Installation Date	1982		
API 2A Assessment Category	L2		
Jacket Type	Platform		
No. of Piles	8 Piles and 4 Skirt piles		
Distance from Shore	24 mi		
Bracing Configuration	Tran Frame: Rows 1 & 4: K bracing for bottom bay and XH bracing above it. Rows 2 & 3: XH bracing on one vertical half side and / bracing on the other. Long Frame: Bottom bay of both faces have XH bracing. Among the top bays, the center bay has XH bracing and the end bays have / bracing.		
Storm Exposure			
Min. Distance/Direction from Eye	35 mi	Maximum Storm Surge	1.2 ft
Maximum Wave Height	68 ft	Maximum Wind Speed	63 kts
Significant Wave Height	38 ft	Current Speed	2.4 kts
Wave Crest Elevation	41 ft		
Storm Damage			
Structural Damage	Yes	Evidence of Wave in Deck	No

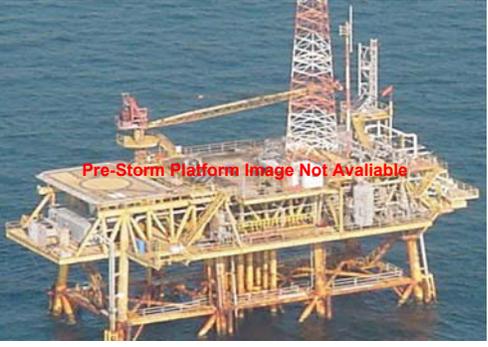
Deck Height	45 ft		
No. of Slots	18		
No. of Conductors	16		
Installation Date	1968		
API 2A Assessment Category	L1		
Jacket Type	Platform		
No. of Piles	8 main piles and 4 skirt piles		
Distance from Shore	39 mi		
Bracing Configuration	Long Frame: All the bays have / bracing except the bottom end bays, which have a K bracing. Tran Frame: Rows 1&4 have K bracing for the bottom bay and / bracing for the ones above. Rows 2&3 have K bracing for the bottom row, XH bracing for the 2 bays above it and / bracing for the top 2 bays.		
Storm Exposure			
Min. Distance/Direction from Eye	20 mi	Maximum Storm Surge	1.2 ft
Maximum Wave Height	73 ft	Maximum Wind Speed	71 kts
Significant Wave Height	41 ft	Current Speed	1.8 kts
Wave Crest Elevation	44 ft		
Storm Damage			
Structural Damage	Yes	Evidence of Wave in Deck	Yes

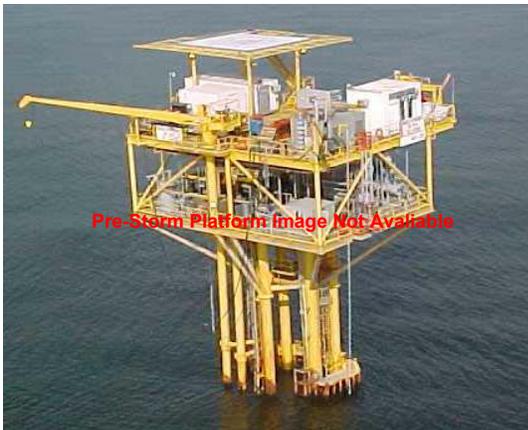
Platform Damage Summary			
Platform	Main Pass 138 A		
Operator	Newfield Exploration Company		
Platform Description			
Water Depth	158 ft

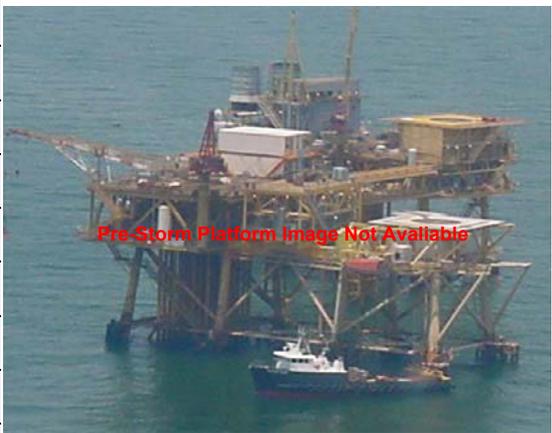
Deck Height	47.8 ft		
No. of Slots	18		
No. of Conductors	18		
Installation Date	1967		
API 2A Assessment Category	L2		
Jacket Type	Platform		
No. of Piles	8 main piles and 8 skirt piles		
Distance from Shore	19 mi		
Bracing Configuration	<p>Long Frame: All the bays have / bracing except the bottom end bays, which have a K bracing.</p> <p>Tran Frame: Rows 1&4 have K bracing for the bottom bay and / bracing for the ones above. Rows 2&3 have K bracing for the bottom row, XH bracing for the 3 bays above, and / bracing for the topmost bay.</p>		
Storm Exposure			
Min. Distance/Direction from Eye	37 mi	Maximum Storm Surge	0.9 ft
Maximum Wave Height	71 ft	Maximum Wind Speed	60 kts
Significant Wave Height	40 ft	Current Speed	1.3 ft
Wave Crest Elevation	42 ft		
Storm Damage			
Structural Damage	Yes	Evidence of Wave in Deck	Yes

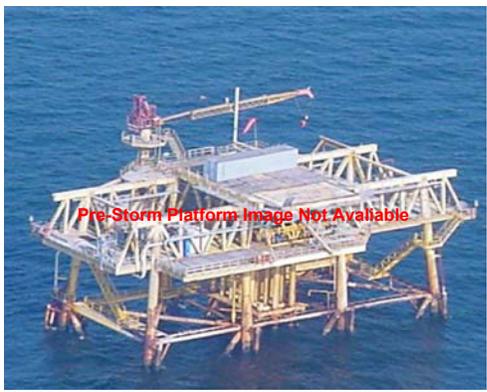
Platform Damage Summary			
Platform	Main Pass 290 A		
Operator	Apache Corporation		
Platform Description			
Water Depth	288 ft

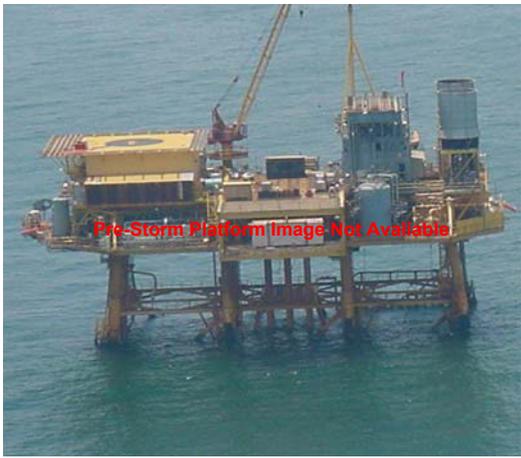
Deck Height	44 ft		
No. of Slots	18		
No. of Conductors	18		
Installation Date	1968		
API 2A Assessment Category	L2		
Jacket Type	Platform		
No. of Piles	8 main piles and 8 skirt piles		
Distance from Shore	19 mi		
Bracing Configuration	<p>Long Frame: All the bays have / bracing except the bottom end bays, which have a K bracing.</p> <p>Tran Frame: Rows 1&4 have XH bracing in the center of the bottommost bay and / bracing on both sides of the XH bracing. All bays above have / bracing. Rows 2&3 have K bracing for the bottom row, XH bracing for the 3 bays above, and / bracing for the top bays.</p>		
Storm Exposure			
Min. Distance/Direction from Eye	37 mi	Maximum Storm Surge	0.9 ft
Maximum Wave Height	73 ft	Maximum Wind Speed	63 kts
Significant Wave Height	41 ft	Current Speed	1.2 ft

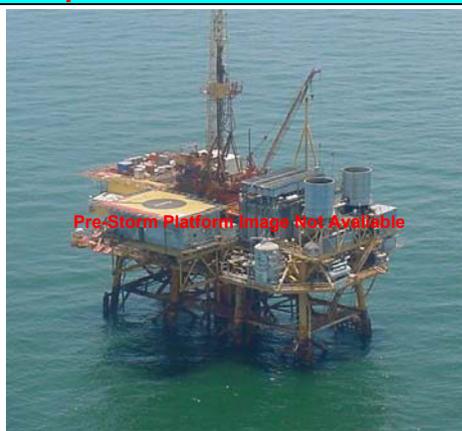
Deck Height	44.0 ft		
No. of Slots	18		
No. of Conductors	18		
Installation Date	1967		
API 2A Assessment Category	L1		
Jacket Type	Platform		
No. of Piles	8 main piles and 8 skirt piles		
Distance from Shore	19 mi		
Bracing Configuration	Long Frame: Both the faces have / bracing throughout. Tran Frame: Rows 1&4 have XH bracing in the center of the bottommost bay and / bracing on both sides of the XH bracing. All bays above have / bracing. Rows 2&3 have K bracing for the bottom row, XH bracing for the 3 bays above, and / bracing for the top bays.		
Storm Exposure			
Min. Distance/Direction from Eye	37 mi	Maximum Storm Surge	0.9 ft
Maximum Wave Height	71 ft	Maximum Wind Speed	60 kts
Significant Wave Height	40 ft	Current Speed	1.3 ft
Wave Crest Elevation	42 ft		
Storm Damage			
Structural Damage	Yes	Evidence of Wave in Deck	Yes

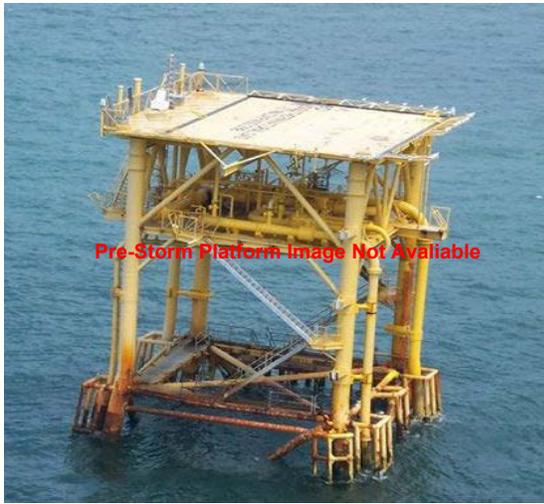
Deck Height	43 ft		
No. of Slots	None		
No. of Conductors	4 Risers		
Installation Date	1972		
API 2A Assessment Category	L2		
Jacket Type	Platform		
No. of Piles	4		
Distance from Shore	20.0 ft		
Bracing Configuration	Both long frame and tran frame have KH type of bracing.		
Storm Exposure			
Min. Distance/Direction from Eye	39 mi	Maximum Storm Surge	1.3 ft
Maximum Wave Height	67 ft	Maximum Wind Speed	63 kts
Significant Wave Height	37 ft	Current Speed	2.7 ft
Wave Crest Elevation	41 ft		
Storm Damage			
Structural Damage	Yes	Evidence of Wave in Deck	Unknown
Structural Damage Description	1. Crack on VD from leg B2 at (+)10' level to leg A2 at (-)29' level, 3' from leg B2. 2. Crack on HZ from leg B2 to A2 at (+)8' level, 8' from leg B2. 3. Dent on HZ from A2 to B2 at (+)8' level, 4' from leg A2. 4. Crack on VD from leg B1 at (+)10' level to leg B2 at (-)29' level, 2' from leg B1.

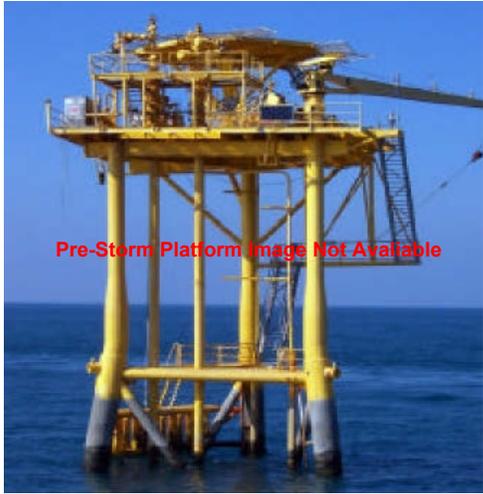
Deck Height	Unknown		
No. of Slots	Unknown		
No. of Conductors	Unknown		
Installation Date	1998		
API 2A Assessment Category	L3		
Jacket Type	Platform		
No. of Piles	3		
Distance from Shore	55 mi		
Bracing Configuration	Unknown		
Storm Exposure			
Min. Distance/Direction from Eye	7 mi	Maximum Storm Surge	1.3 ft
Maximum Wave Height	74 ft	Maximum Wind Speed	75 kts
Significant Wave Height	41 ft	Current Speed	1.8 ft
Wave Crest Elevation	44 ft		
Storm Damage			
Structural Damage	Yes	Evidence of Wave in Deck	Unknown
Structural Damage Description	1. One jacket member was damaged.		
Non-structural Damage (wiring, piping, safety systems, etc.)	None documented		
Major Infrastructure Damage (Pipelines)	-

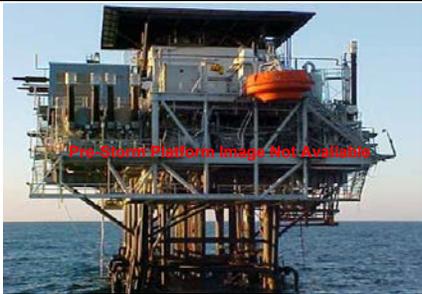
Platform Damage Summary			
Platform	Viosca Knoll 900 A		
Operator	Chevron		
Platform Description			
Water Depth	340 ft

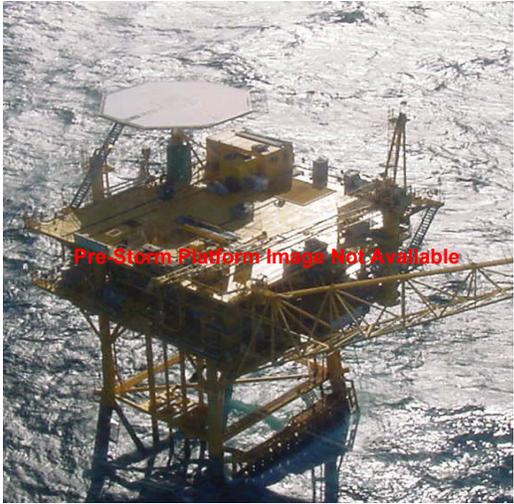
Platform Damage Summary			
Platform	Main Pass 279 B		
Operator	Dominion E & P		
Platform Description			
Water Depth	290 ft

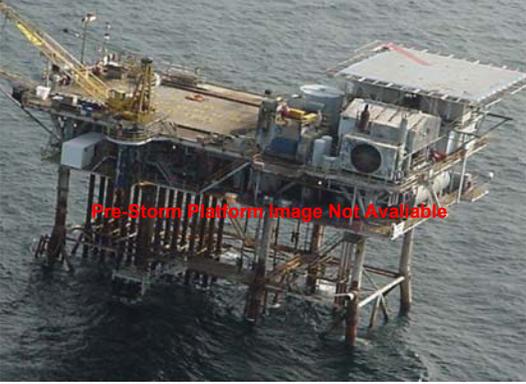
Platform Damage Summary			
Platform	Main Pass 305 A		
Operator	Noble Energy, Inc.		
Platform Description			
Water Depth	244 ft

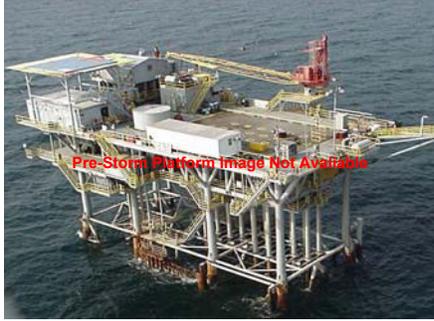
Platform Damage Summary			
Platform	Main Pass 305 B		
Operator	Noble Energy, Inc.		
Platform Description			
Water Depth	241 ft

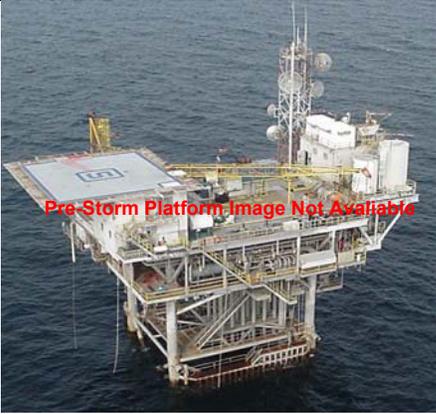
Platform Damage Summary			
Platform	Main Pass 306 F		
Operator	Noble Energy, Inc.		
Platform Description			
Water Depth	293 ft
