**Final Report
Volume I
Acoustic Corer™ Survey – MC-20**

Couvillion Group

Document Number: PAN-P22-0030-RPT-001

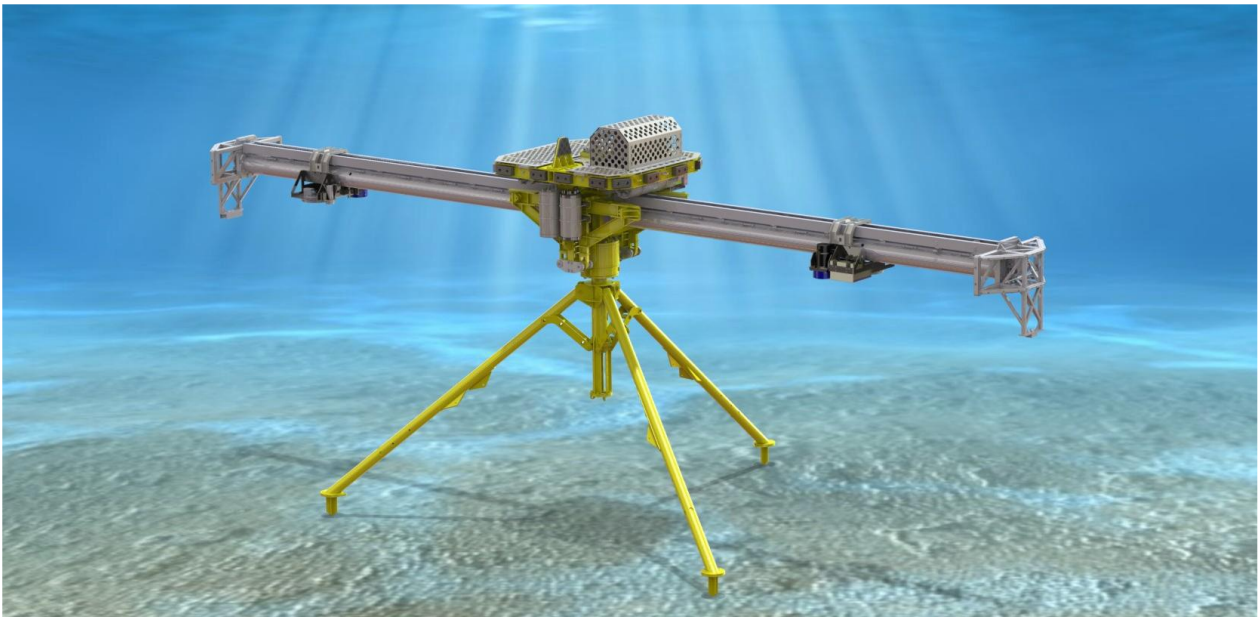
The Acoustic Corer™ unit consists of two sonar heads attached to each arm of a 40ft (12m) boom. A tight grid of acoustic data is acquired as the boom rotates 180°, thereby creating a 360° acoustic core.

Figure 7 – Acoustic Corer™ deployed with the standard configuration.

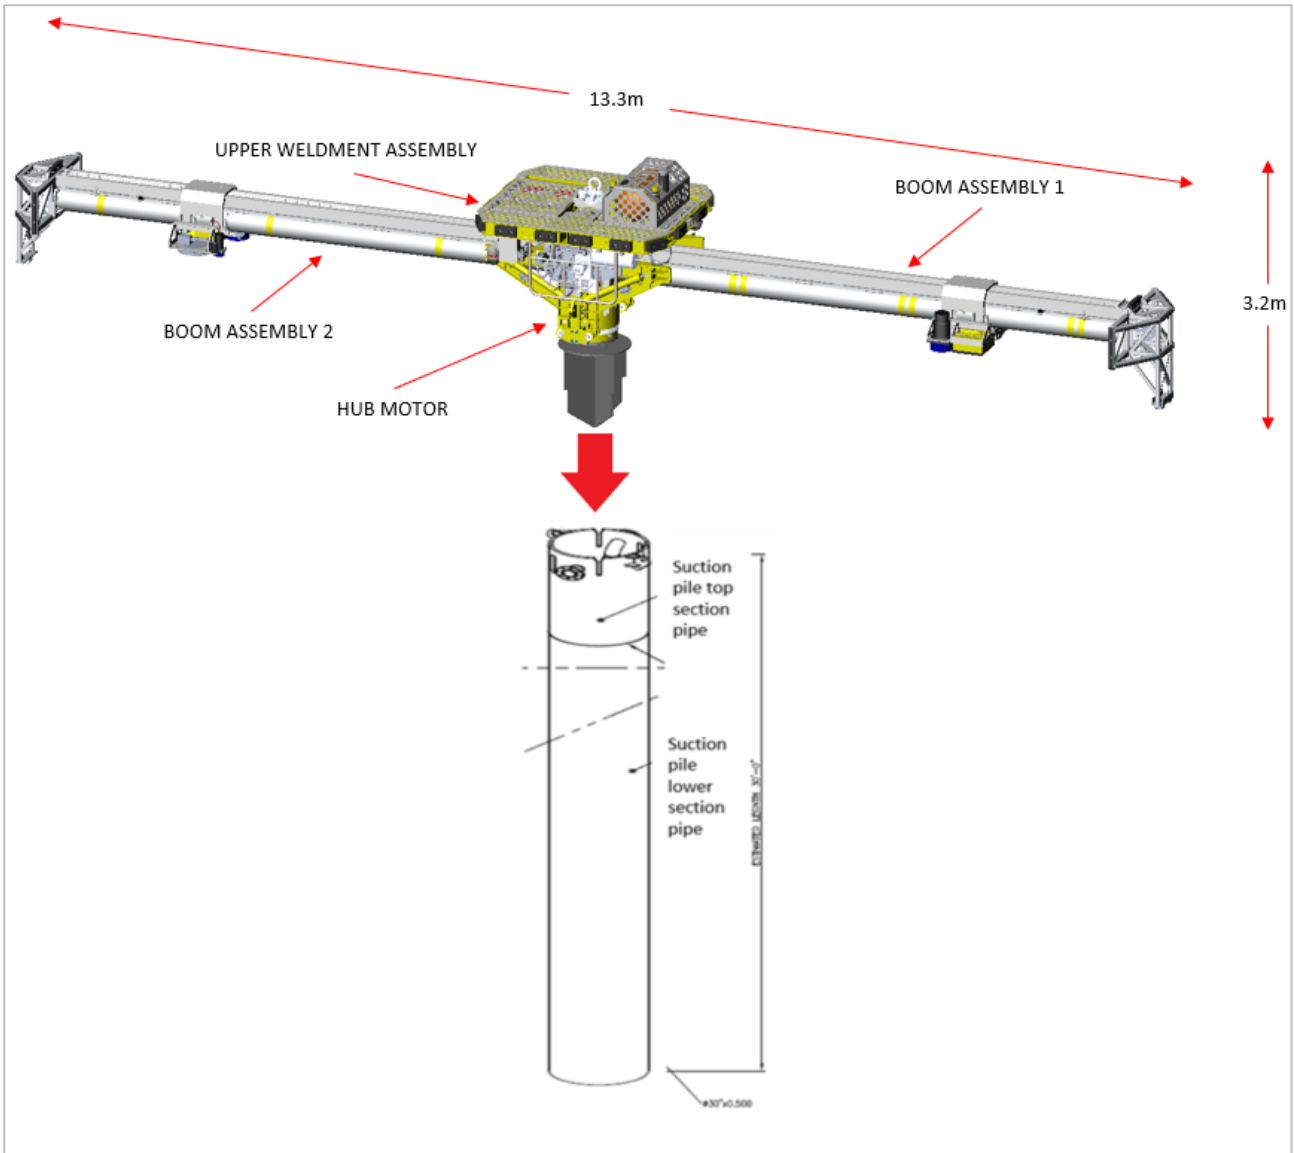
Figure 8 – AC in unfolded survey configuration with attached stab guide. Dimensions (L/H) are 43.6ft/10.5ft (13.3m/3.2m). Dimensions are of AC only, not including pile length.

Figure 8 and Figure 9 show the Acoustic Corer™ equipped with a stabbing guide used to connect the equipment to the suction piles installed at each site location.

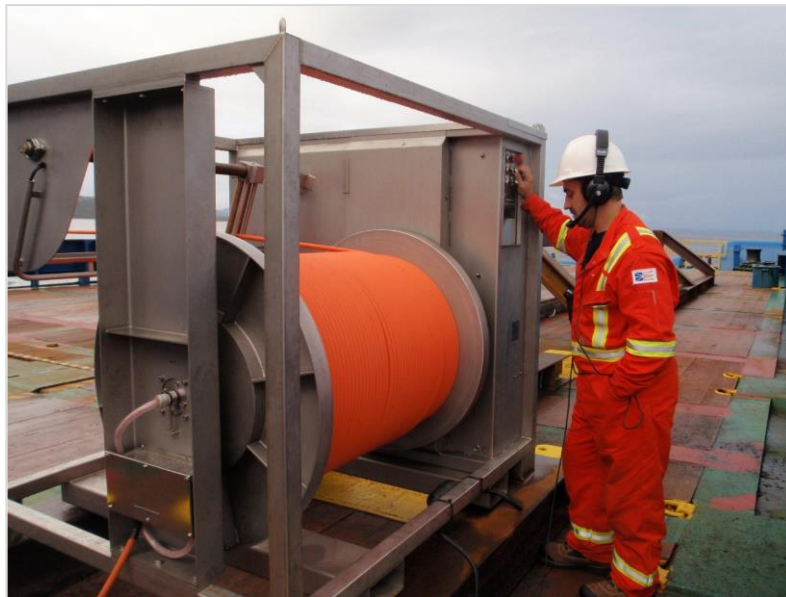
Figure 10 – AC umbilical winch.

The AC umbilical winch, shown in Figure 10, has 1970ft (600m) of non-load-bearing fibre and copper umbilical on its drum. The umbilical winch has a 5.2ft x 4.6ft (1.6m x 1.4m) footprint, weighs 5512lb (2500kg), and is normally operated from a wired remote control. The winch has speed control and an automatic level-wind system.

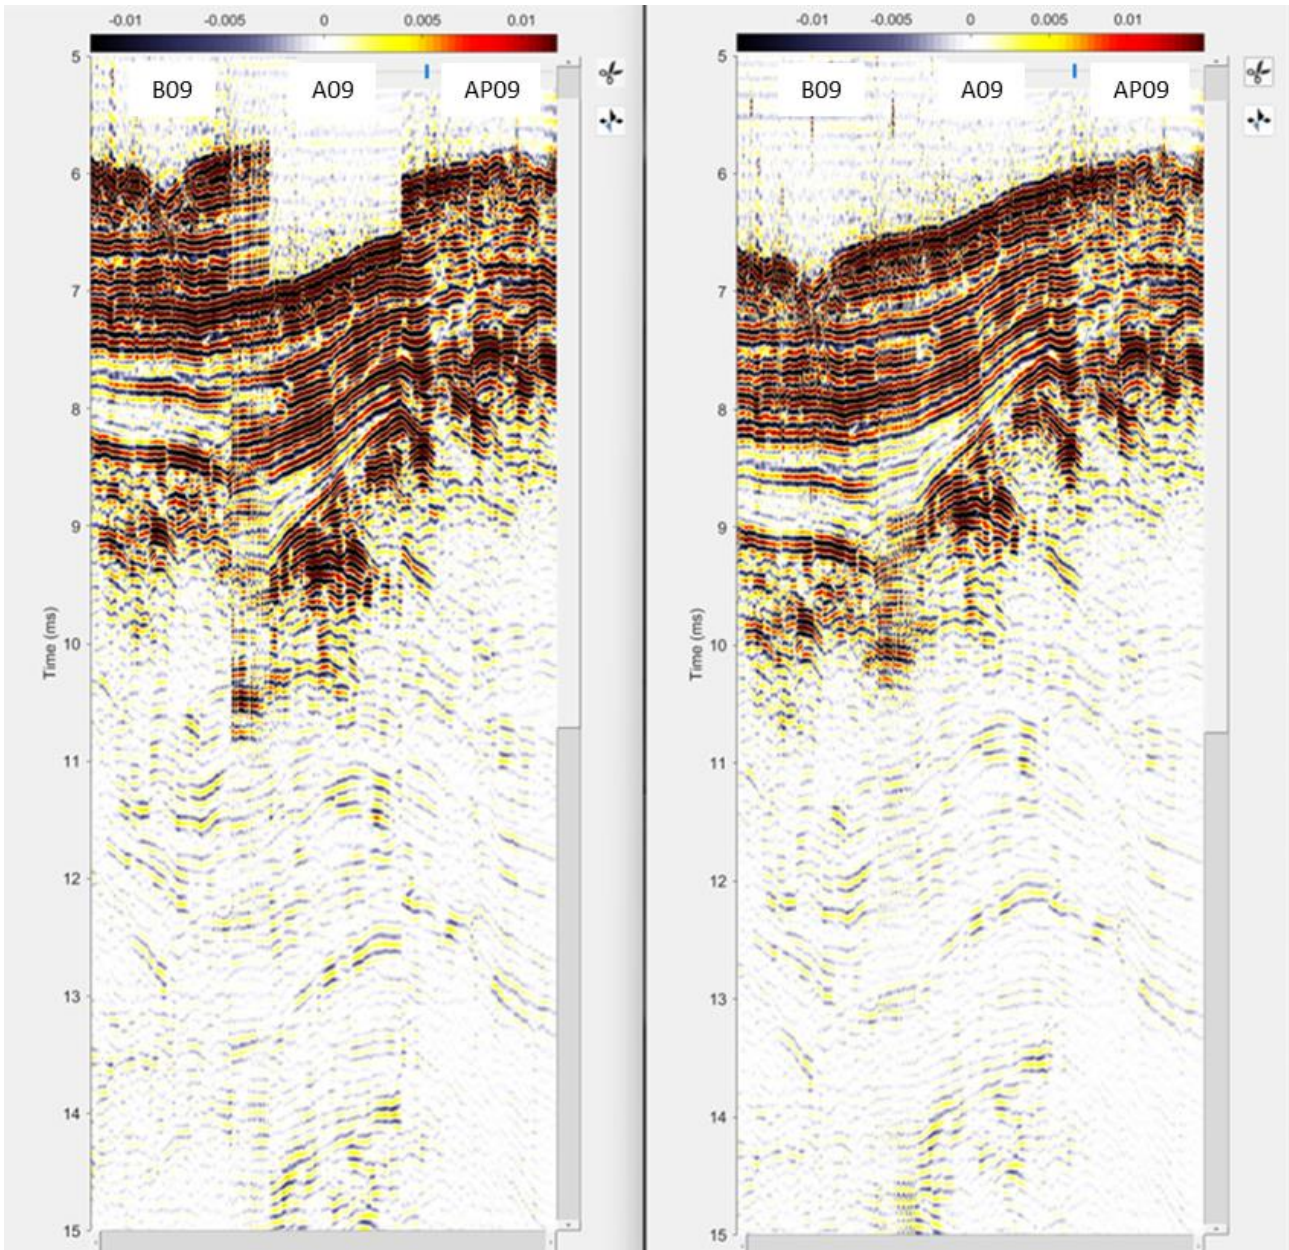
Figure 17 – Example of before (left) and after (right) topographic static corrections using the Innomar data from B09 – A09 – AP09.

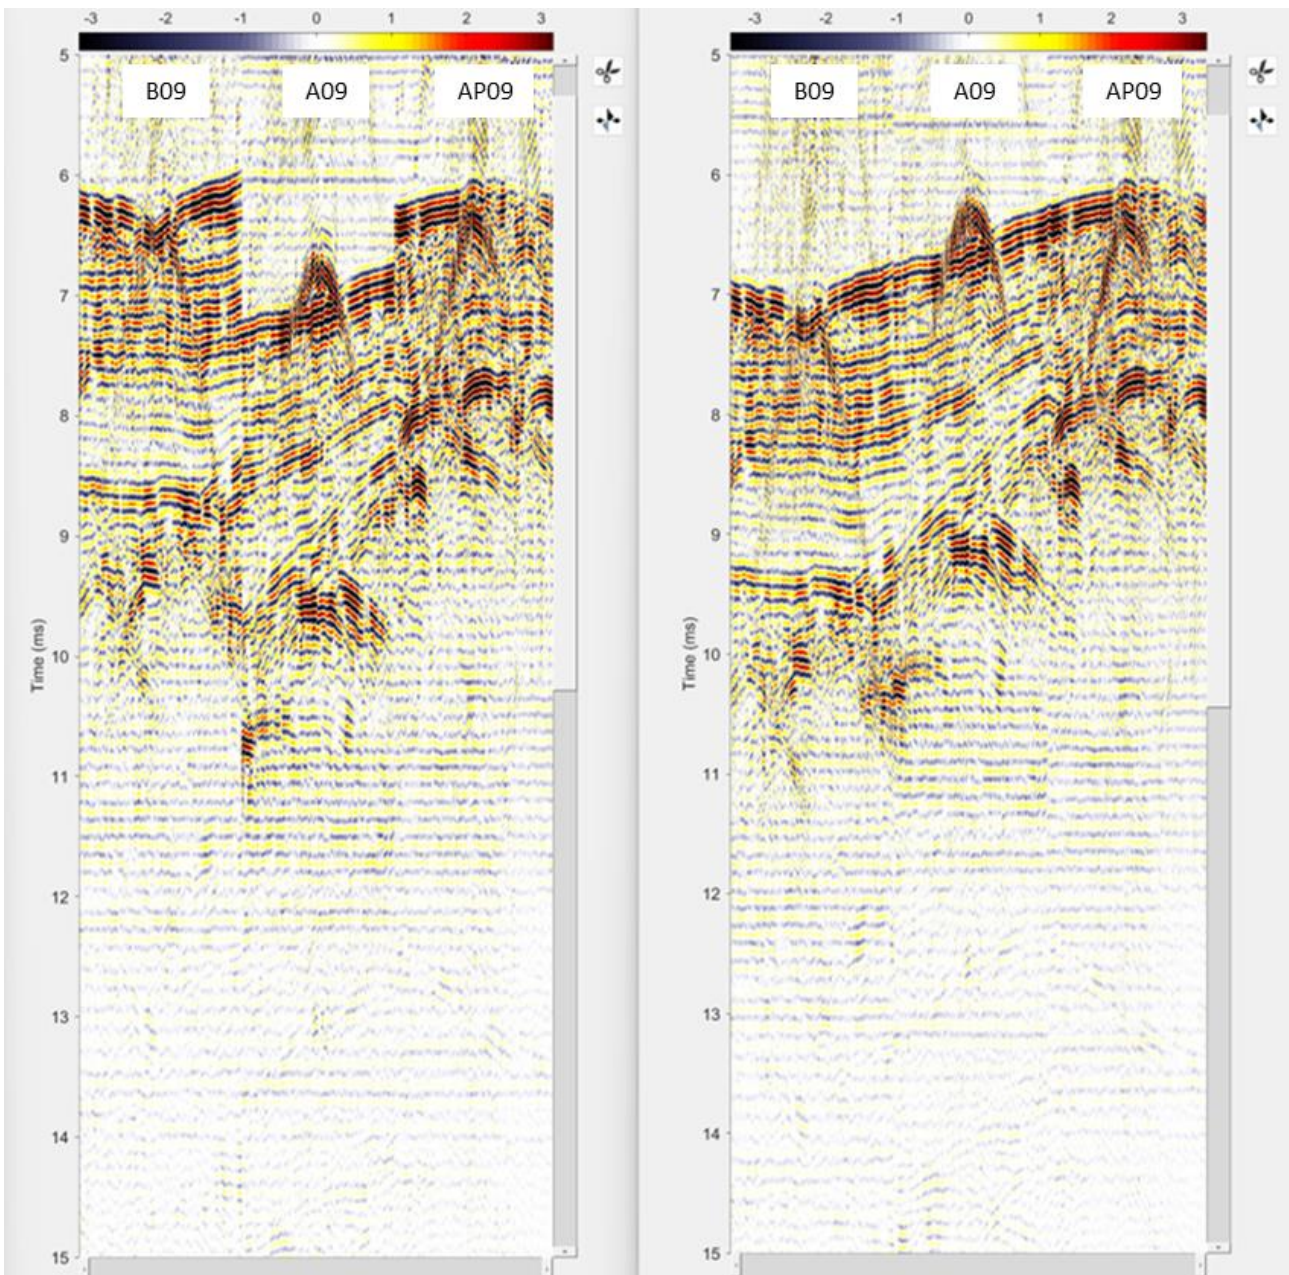
Figure 18 – Example of before (left) and after (right) topographic static corrections using the HF data from B09 – A09 – AP09.

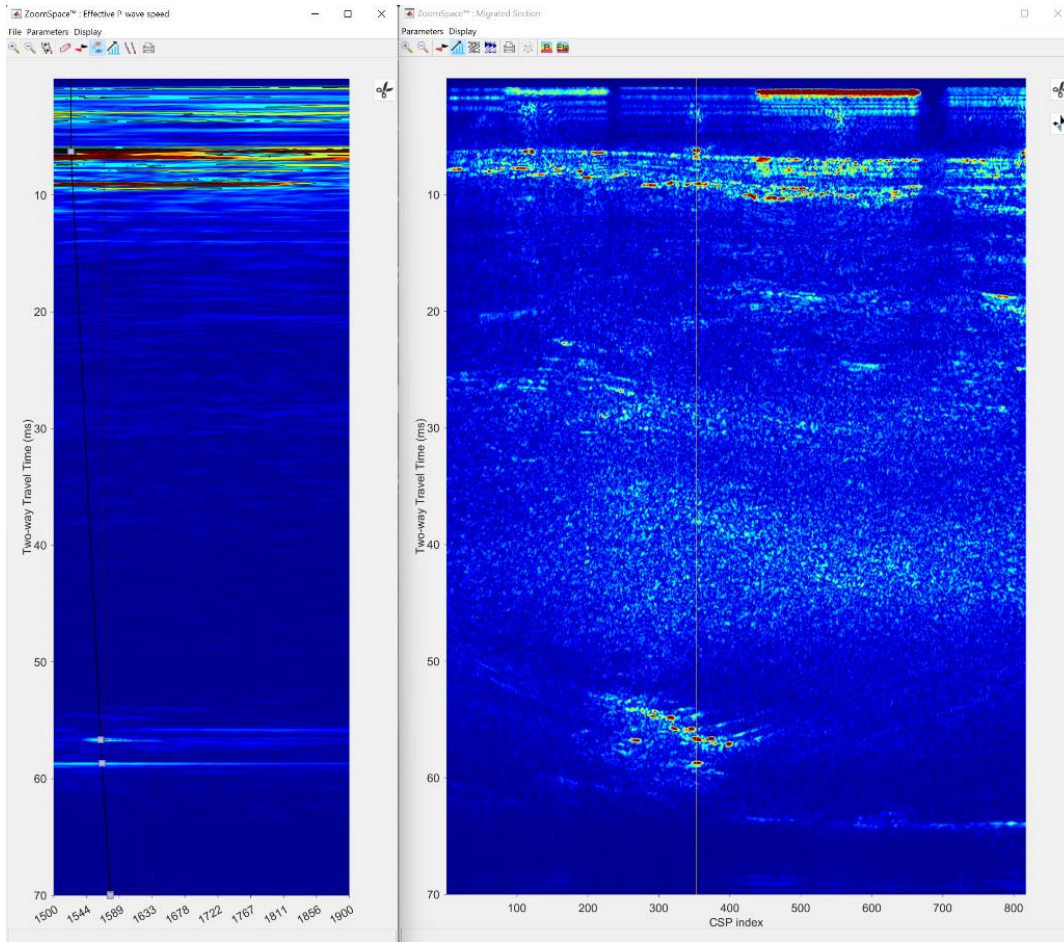
Figure 22 – Row 9 velocity modelling using semblance analysis. The semblance panel on the left has a velocity profile using five picks. The first two picks are equal to the speed of sound in water. The next two picks occur at roughly 56ms and 58ms, respectively. These picks correspond with diffractions associated with the conductors with migrated section across AC volumes on the right.

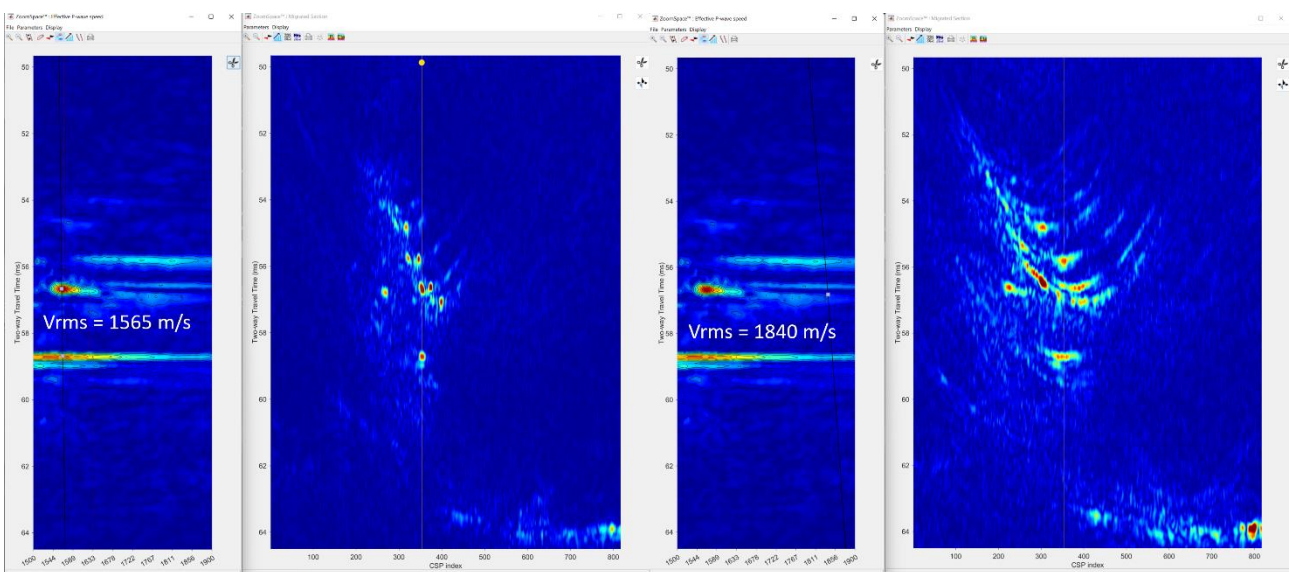
Figure 23 – An example of demonstrating the importance of using a proper velocity in the imaging process. On the left, the image shows that the targets are sharp and distinguishable when the correct velocity is used ($V_{rms} = 1565$ m/s). On the right, the targets appear smeared when the wrong velocity is used ($V_{rms} = 1840$ m/s).

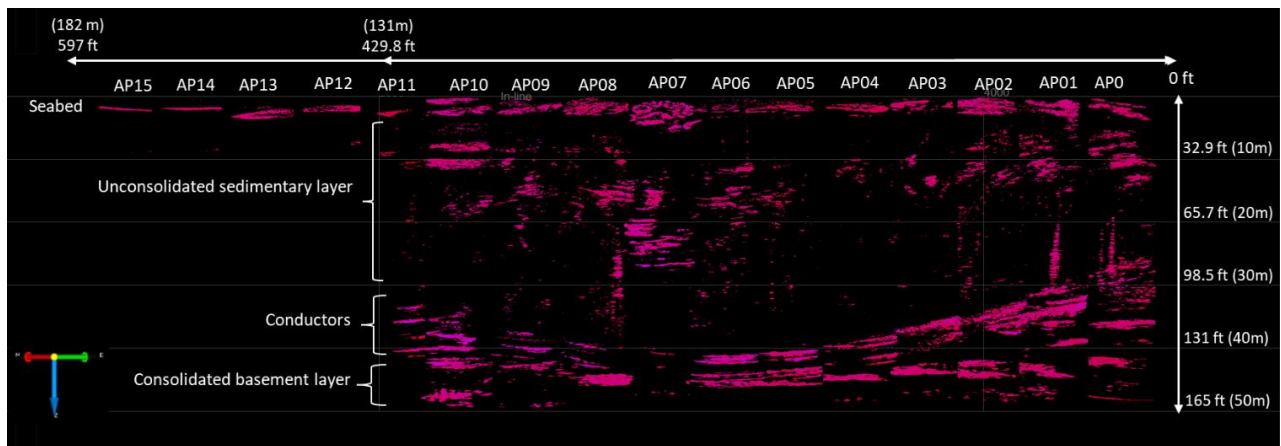
The AP and A gridline region showed the concentration of distinctly formed conductors (Figure 31, Figure 32, Figure 34, Figure 35). In three locations, vertical features associated with oil/gas emanating from the conductor features were observed at Sites AP0, AP01 and AP08 (Figure 32 and Figure 33). The acoustic response NW of Row 11 contrasts with what is seen in the SE. The geology in the upper 100ft (30m) and deeper to 165ft (50m) NW of Sites A11, B11, and C11 shows no linear features.

Figure 32 – Parametric volumetric profiles of all Sites in the AP-survey line combined coherently with annotated interpretations. It is important to mention that this image was captured prior to the final processing and unified volumetric interpretation. Therefore, the separation that appears between the features is due to the physical separation of the corers.

What we observe is that there is a continuous conductor or bundling of pipes as a pathway from the collector dome towards the original conductor bay. The presence of gas/oil escaping from the conductor bundles at depth along Sites AP08, AP01 and AP0 was especially interesting as these appeared to be minor gas escapes coming from conductor damage or leakage but not in an open unconstrained plume-like manner (Figure 33). AP0's presence is close to the collector dome, where several oil plumes are captured. The leaking hydrocarbons support that the conductor or pipe channel for the flow of oil and gas is continuous from the conductor bay to the dome.

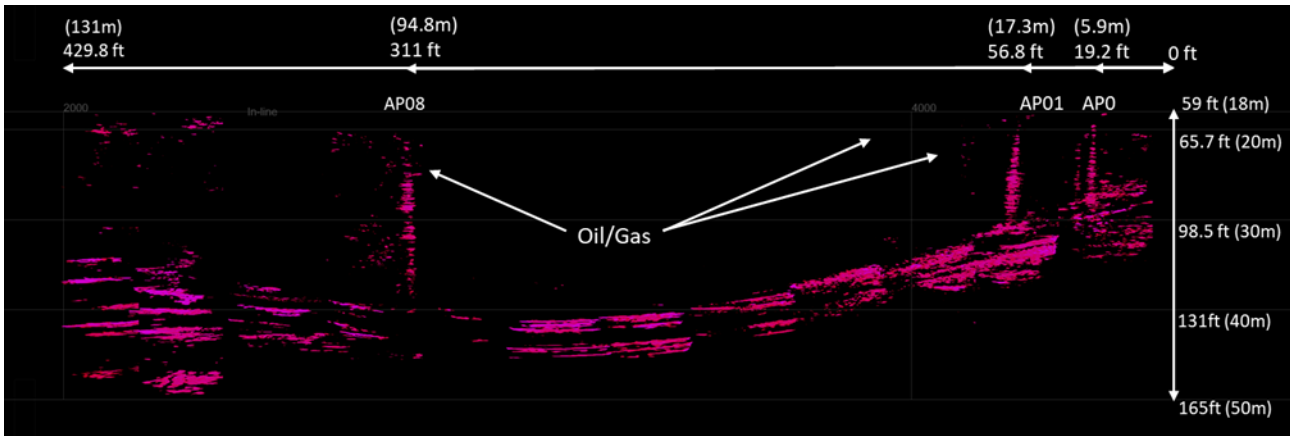
Figure 33 – Parametric volumetric profiles of Sites AP0 – AP08 showing the conductors and the associated oil/gas vertical features.

- The presence of gas/oil was identified at sites AP0, AP01, and AP08 moving vertically upwards from the conductor bundle. This is indicative of through wall damage in the conductors.

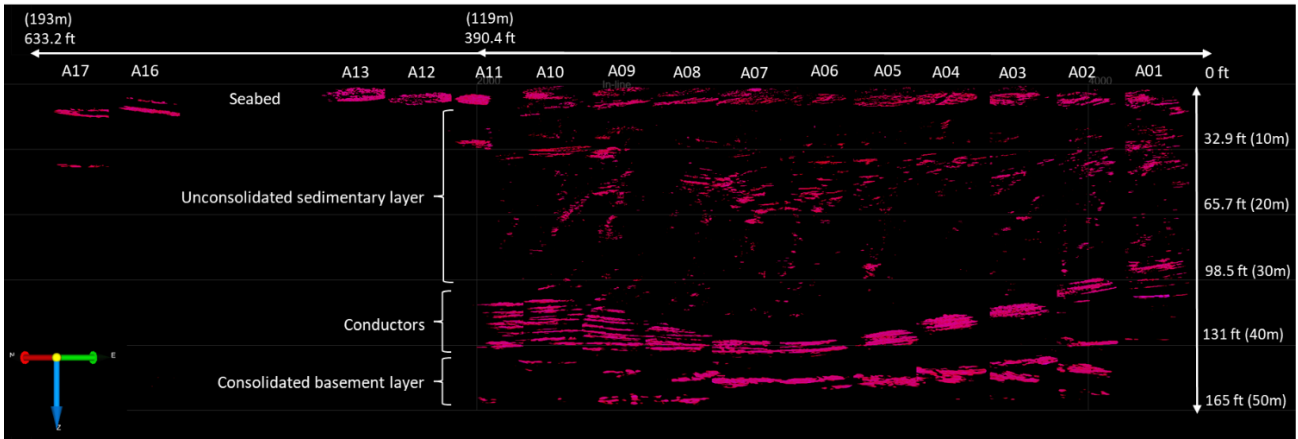
Figure 35 – Parametric volumetric profiles of all Sites in the A-survey line combined coherently with annotated interpretations. It is important to mention that this image was captured prior to the final processing and unified volumetric interpretation. Therefore, the separation that appears between the features is due to the physical separation of the corers.

Additional scans at the centre data gap of scans (X01, X02, X03, and X04) between Sites B11 – B12 and Sites A11 – A12 were acquired to provide more detailed examination. Pipe-like conductors near the original well source location at Sites A11 and AP11 appear loosely grouped, becoming more coherently bundled between sites AP09-A9 to AP04-A04. From AP03-A03, the bundles begin to separate as they slope upwards until they reach the active dome oil collector near Sites A01 and AP0. The conductors linearly repose on a gently sloping, reflectively pronounced consolidated basement floor. The basement slope and bundled conductor packages follow and curve upwards straight to the capture dome (see Figure 31 and Figure 32 for AP Sites; see Figure 34 and Figure 35 for A Sites).

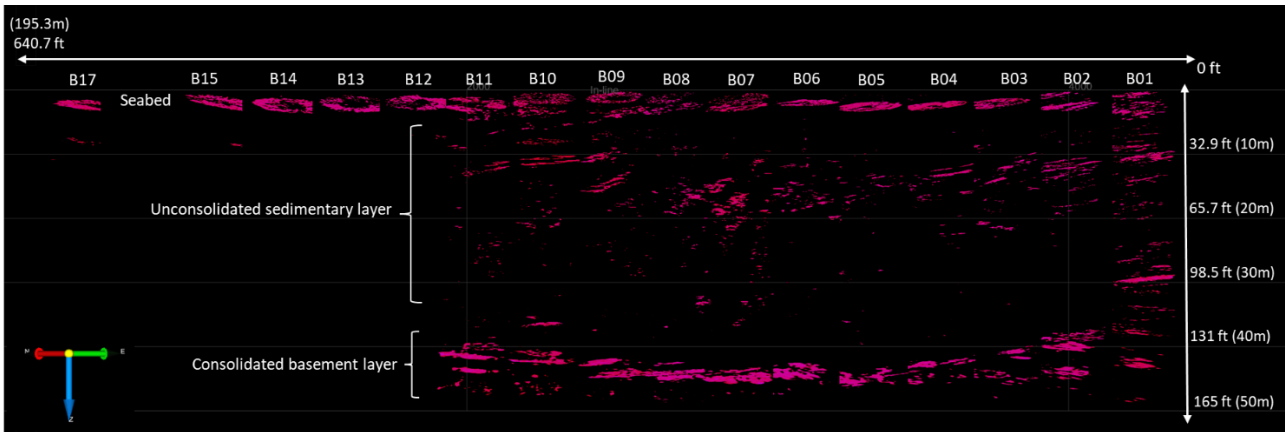
The corers acquired along the B-line are characterised by the unconsolidated upper sedimentary mud-slide-influenced shallow zone (Figure 36 and Figure 37). This upper region’s sediment character concords with what is noticed in the AP and A-lines and what is observed in the C-line. Apart from a distinct pipe feature deep in the sub-seabed at Sites B9 (Figure 39) and B12, the B-line only exhibit a few linear targets over a dominant consolidated basement layer.

Figure 37 – Parametric volumetric profiles of all Sites in the B-survey line combined coherently with annotated interpretations. It is important to mention that this image was captured prior to the final processing and unified volumetric interpretation. Therefore, the separation that appears between the features is due to the physical separation of the corers.

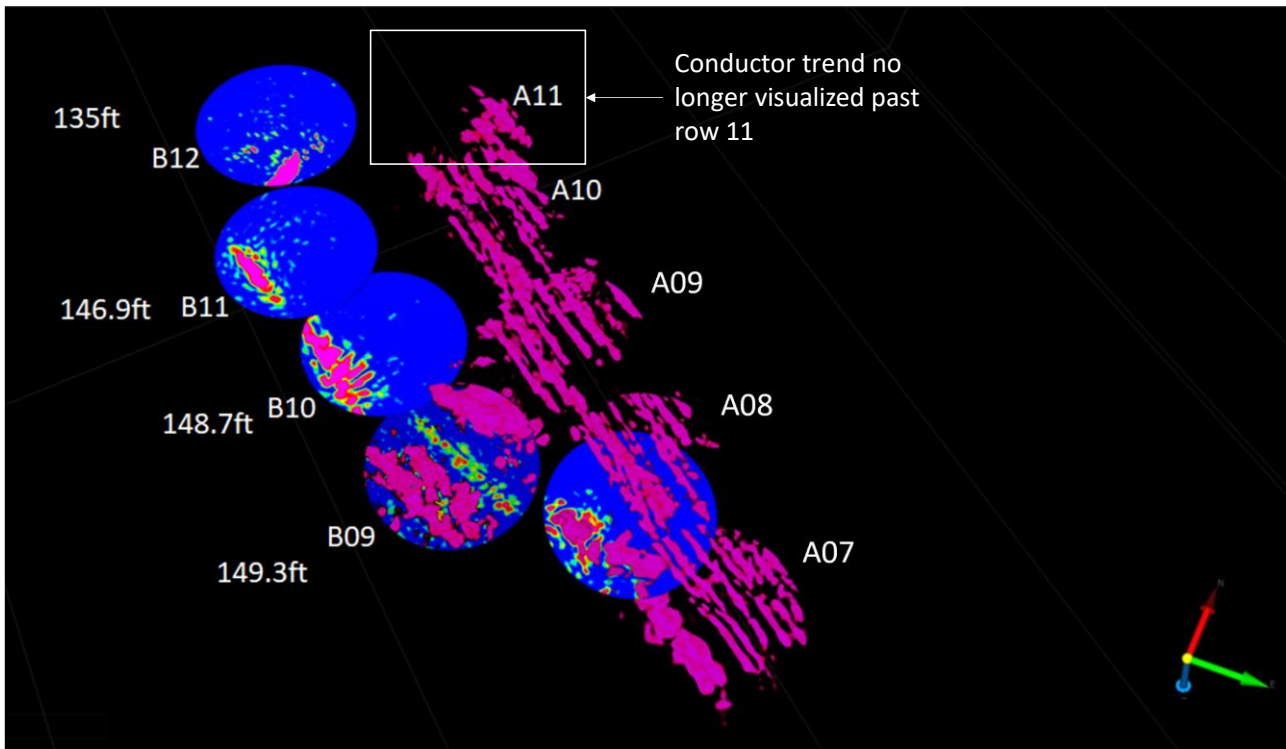
The conductors, as revealed to the NW, trend from lines A/AP, starting at Site A07 entering Sites B08 – B09 and continues as an isolated conductor before the acoustic response terminates around Site B11 (Figure 38). It should be noted that the depth of this isolated conductor is at 150ft (45m). At Site B12, there is a linear feature travelling E-W at the same depth 135ft (40m) as the features seen at Site A11. It is not clear if it is an isolated target or linked to the Site A11 related conductors.

Figure 38 – HF volumetric profiles of Sites A07 – A11 and B09 to B12 between the depth of 135 – 150ft (41 – 46m).

The data also supported the distinct and abrupt termination noted around Site A11. For the conductors in the 11th Row of A and AP, there are three potential reasons why they “appear to stop”. The first reason is they go vertically downward or at least close to vertically downward. The second reason is that the conductors have fractured. If the conductors completely were fractured and separated, we would have seen evidence of linear tubular features, discontinuous debris forms and chaotic structural members in the B, A and AP Lines at the 13, 14, 15 and 16 scan locations. This was not observed in any of these scans. Had it been, we would have been able to pick pipe fragments down to a depth of approximately 200ft (61m). These scan sites were examined in detail. No distinct, compelling targets were recorded. If the conductors were discontinuous, we would have captured hydrocarbon plumes. This we did not see in the data. The third reason is around Row 11, gas-laden soil inhibited the acoustic ability to get a return and collect data. However, whilst the termination is abrupt at Site A11, we see a N/S linear feature in Site B12 that heads to Site A11 (See Figure 38). This feature appears to be very minor and discontinuous. It is only noted for completeness, however, it does not mean it is related to the features seen in the rest of the A-Line or B-Line.

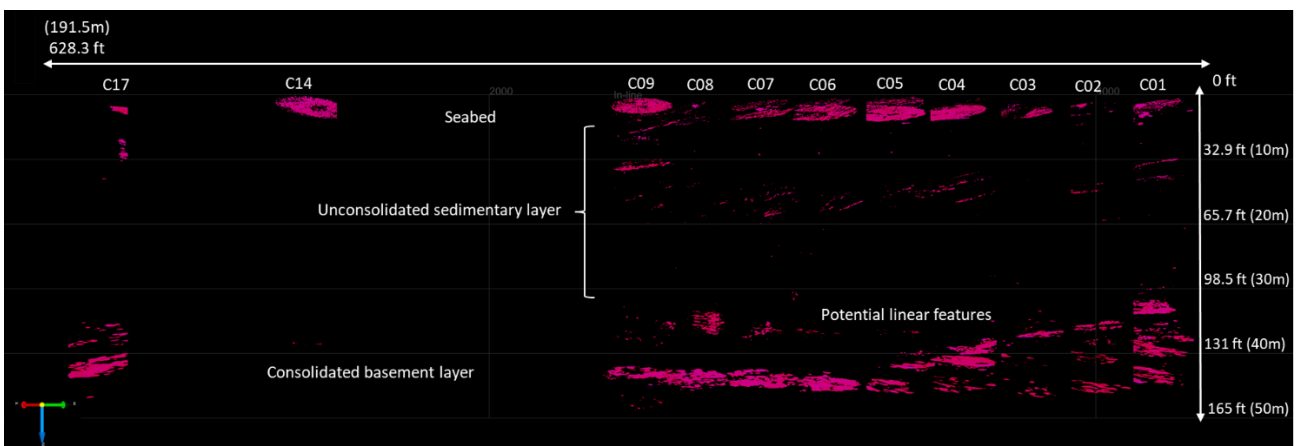
The C-line also holds similar sedimentary features, with a basement layer being the dominant feature (Figure 39 and Figure 40). Again, potential linear targets are noticed at the C1 to C5 sites, sloping upwards as the basement geology rises towards C1. The features trend more to the west from C5 and are not visualized in any adjacent cores, namely C06-C09. Sites C06-C09 are noted to contain sedimentary strata alongside a gently sloping basement layer at depth, with no other linear features of note. Sites C10-C14, C15 and C16 were not surveyed, while C14 and C17 show mostly transparent acoustic cores with few sedimentary strata.

Figure 39 – HF volumetric profiles of all Sites in the C-survey line combined coherently with annotated interpretations. It is important to mention that this image was captured prior to the final processing and unified volumetric interpretation. Therefore, the separation that appears between the features is due to the physical separation of the corers.

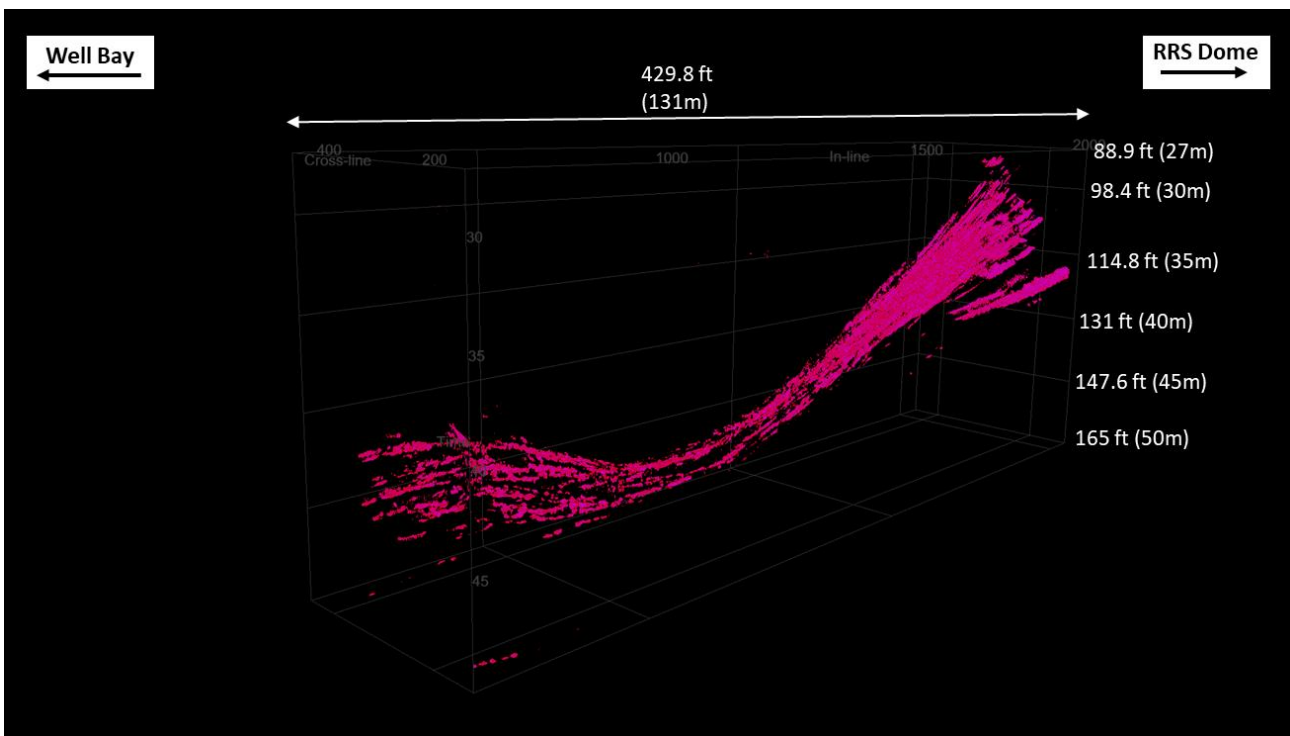
Figure 42 – Identified conductors as seen in the unified migrated volume.

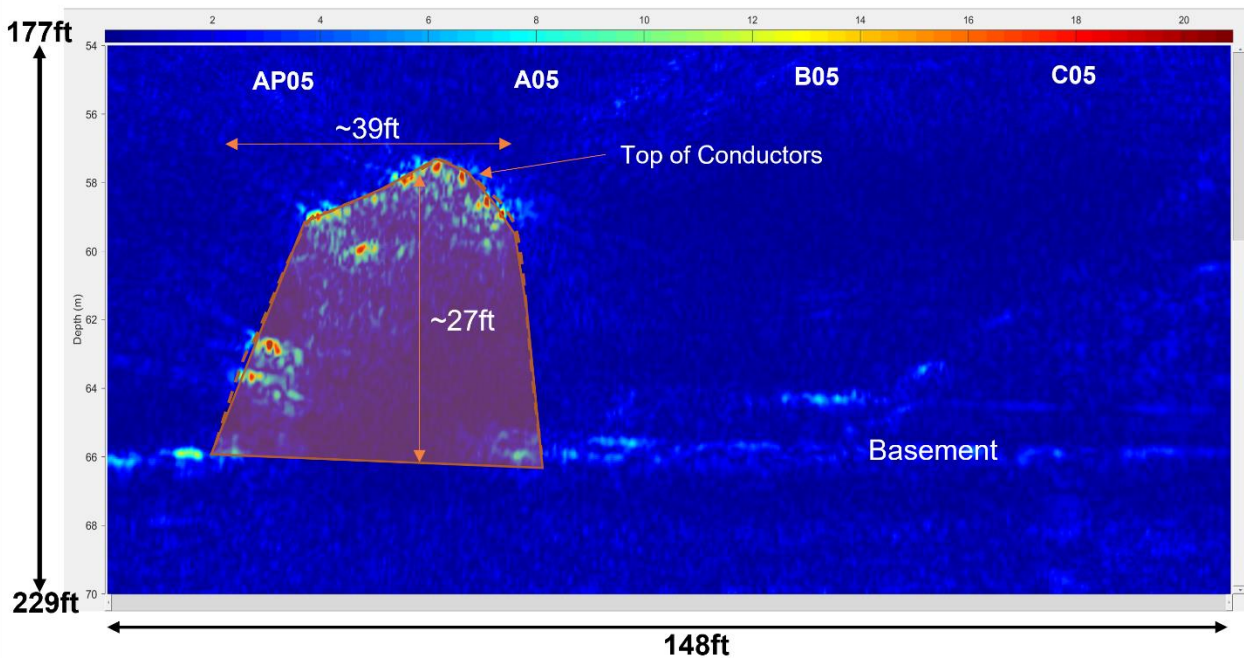
Figure 43 – Cross-section along Row 05 with the conductor responses shown along the perimeter of the shaded region. The shaded region, which has the approximate dimensions of 39ft x 27ft (L x H), most-likely contains the remaining ten (10) conductors which are being masked by the tightly packed conductors on top.

The cross-section at Row 05 (Figure 50) exhibits a near-perfect circumference of the conductors with approximately eighteen (18) distinct conductor responses that are plainly seen enveloping faint traces of remaining inner conductors. The outer pipes would mask pipes sandwiched beneath by their numbers, composition, and sizes. Because of the tightness in this central bundle of conductors and circular delineation of the form observed, it suggests that the number and presence of all original conductors are contained. Figure 43 shows a cross-section

At these locations, narrow gas/oil upward moving vertical propagation of bubbles is released from possible minor fracturing or through wall conductor damage. The gas/oil vertical flow found at Site AP0 is particularly interesting as it is touching or inside the curtain region of the collector dome.

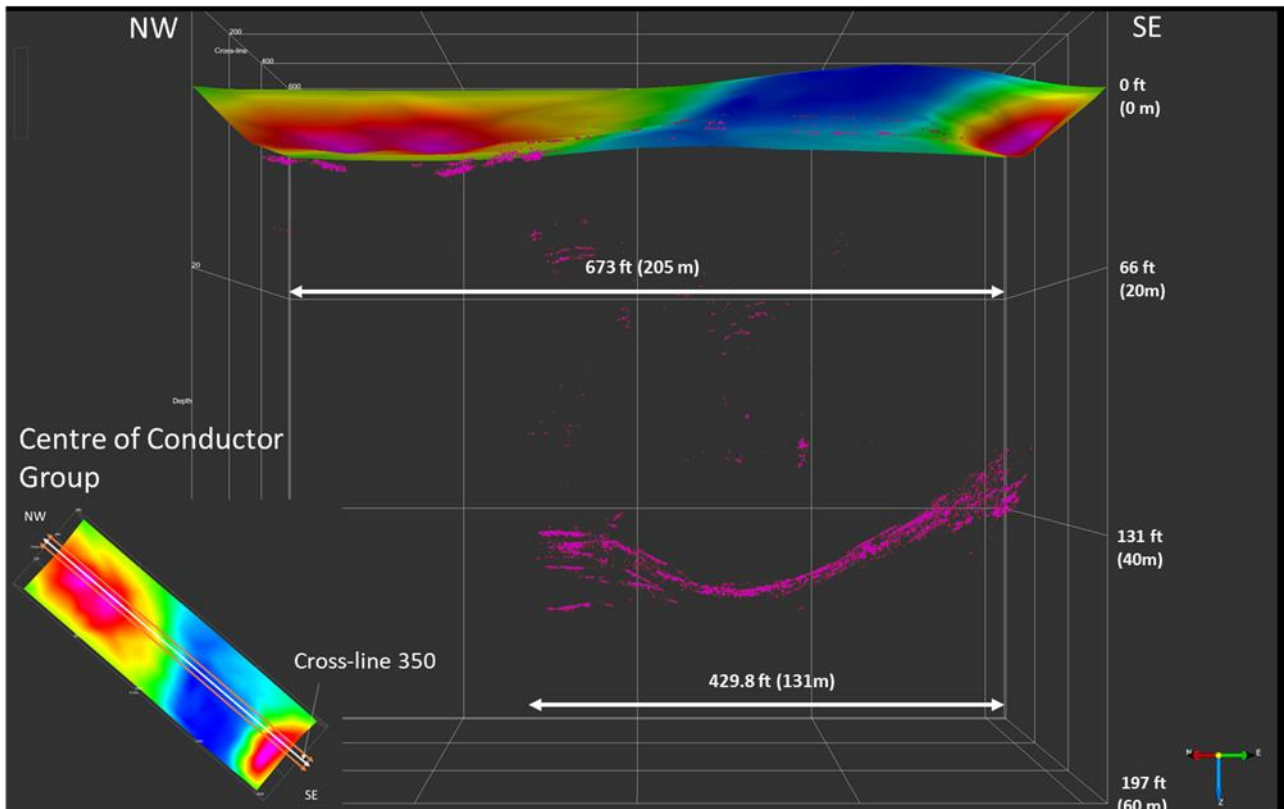
Figure 46 – Vertical section (NW to SE) of the parametric data showing the centre of the conductor group.

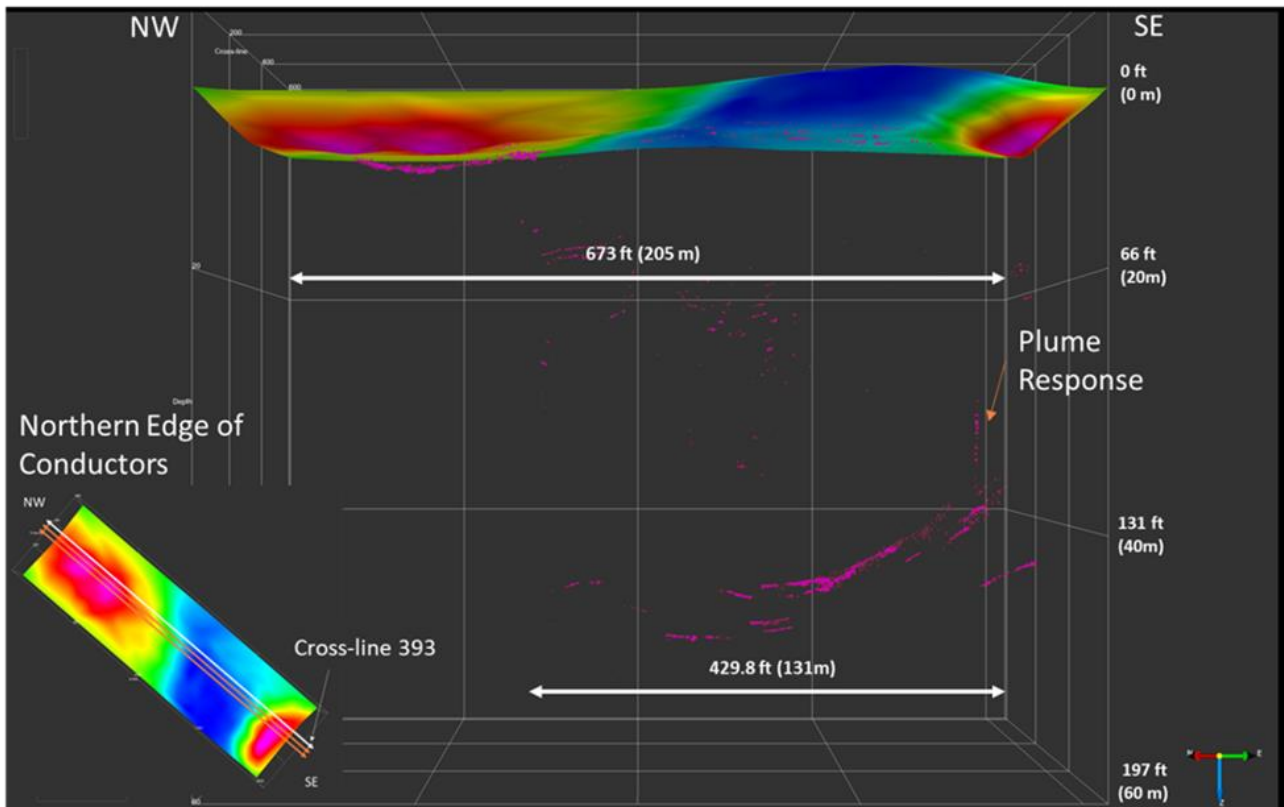
Figure 47 – Vertical section (NW to SE) of the parametric data showing the Northern edge of the conductors. Near the dome, the image shows the presence of oil/gas in the form of a plume.

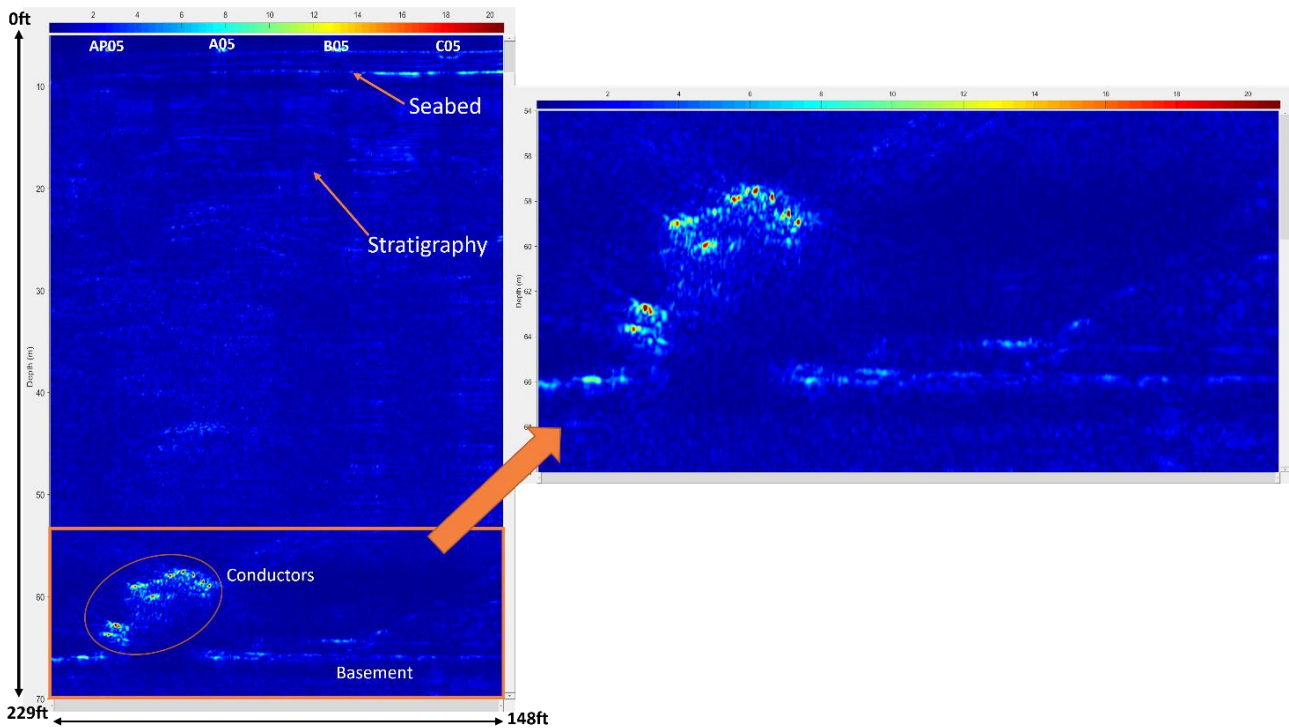
Figure 50 – Vertical section across Row 05. Faint coherent sedimentary layering in the upper 100ft is seen in the profile across Row 05 with a strong basement reflector.

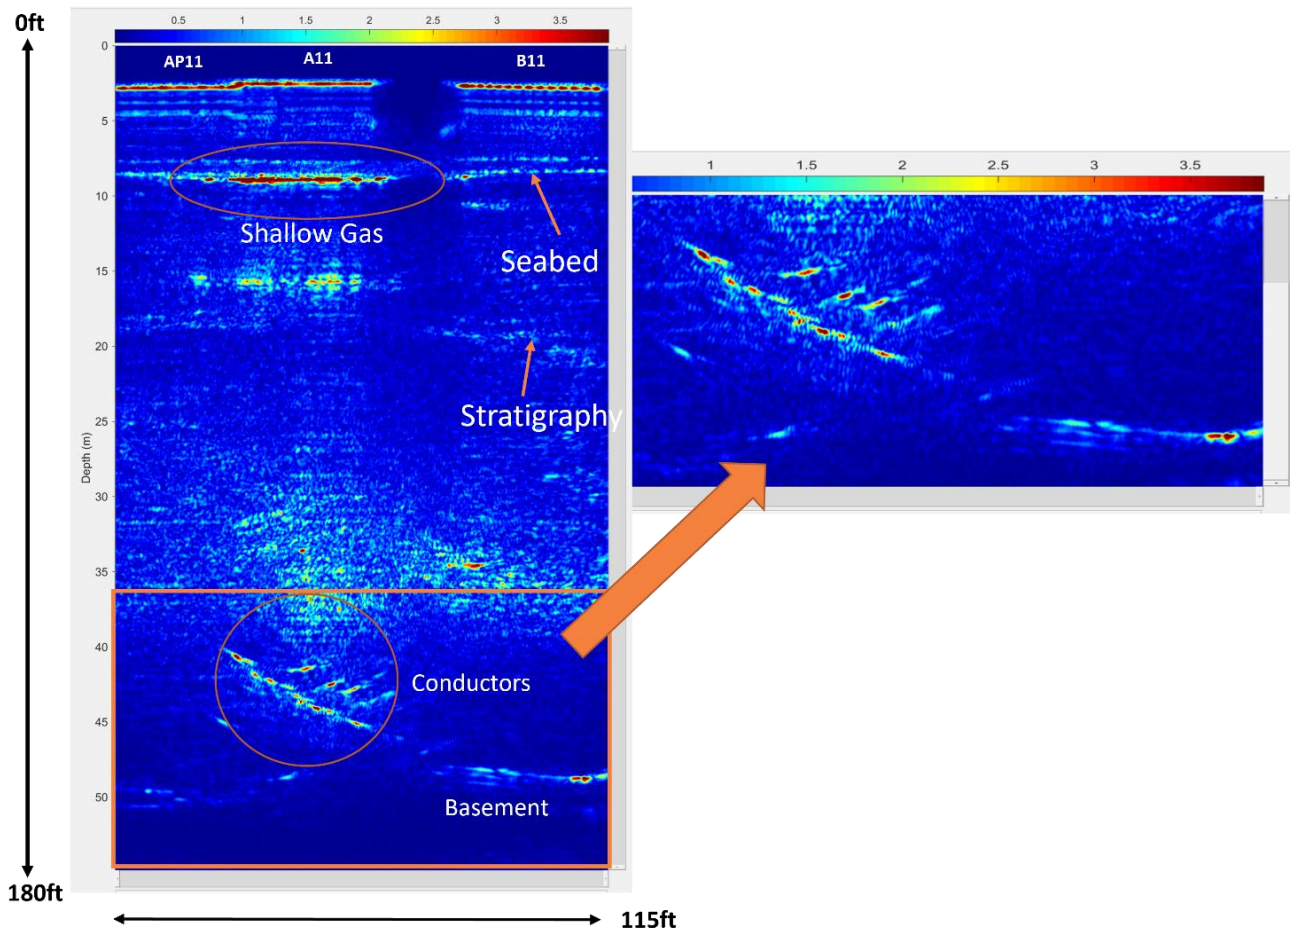
Figure 53 – Vertical section across Row 11. Weak acoustic response from sedimentary layering in the upper 100ft is seen in the profile across Row 11 with a strong basement reflector. The weak acoustic response is due to the presence of gas across Site A11 and, to a lesser extent, Site AP11.

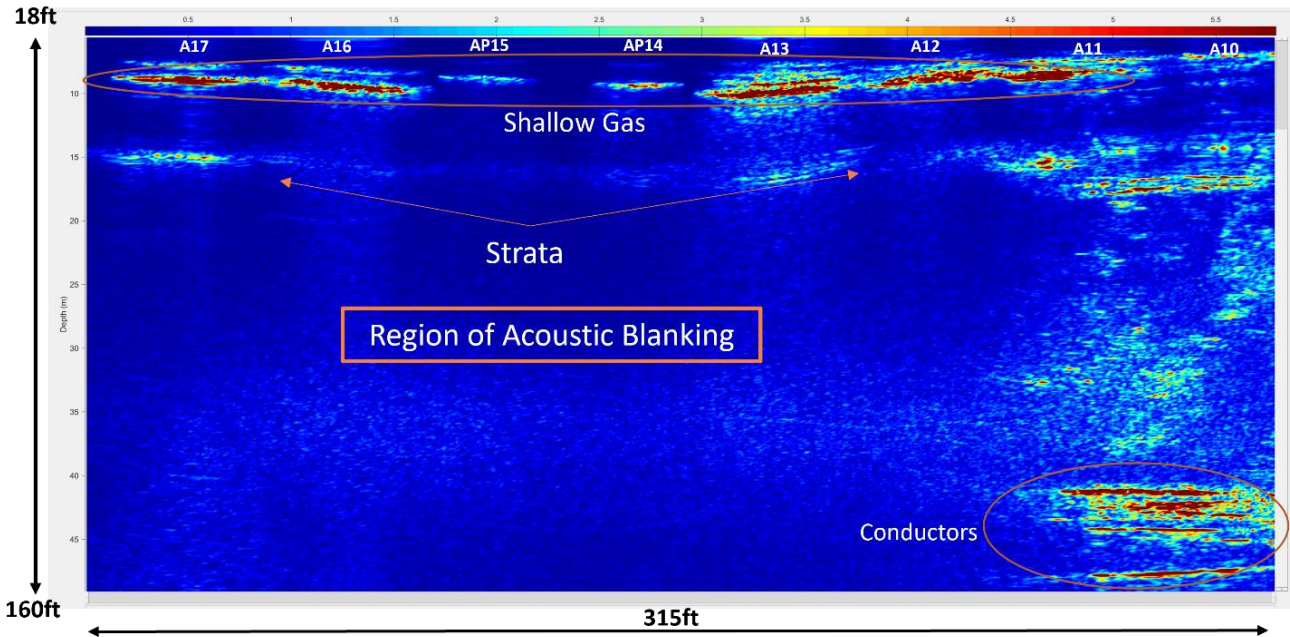
Conversely, we see the return of this strata at Sites A17 and A16 (Figure 54), with a faint hint of its presence remaining as we approach Sites A12 and AP12, forming an indefinite curved presence back to Site A10. Since the solid upper intensity at the mudline starts midway between Sites A11 and AP11, this also coincides with the sudden termination indicating we have an acoustic blanking present. Hence from our observations, we do not believe the conductors are fractured at Sites A11 and AP11. Still, as suggested by the separating rise of the conductors before the truncation and appearing to have a slight downward end direction, the conductors could be expected to have a rapid bending downward sloped path toward the vertical around Sites A14 and A13. The fact that we have rising linear gas percolating up along Sites AP08, AP01 and AP0 (Figure 47) from the conductors and that the conductors are intact through their observed length (ending precisely at the collector dome where at least four flowing plumes are being held) would indicate that the conductors have oil and gas still flowing through them. We have seen no evidence of discontinuous debris forming fractured, chaotic structural members down to our imaging depth of 200ft.

Figure 54 – Vertical profile across Sites A17 (NW region of survey area) to A10 (SE region of survey area) showing the presence of gas in the upper several ft of the sedimentary column which causes acoustic blanking across Sites A17 to A11.

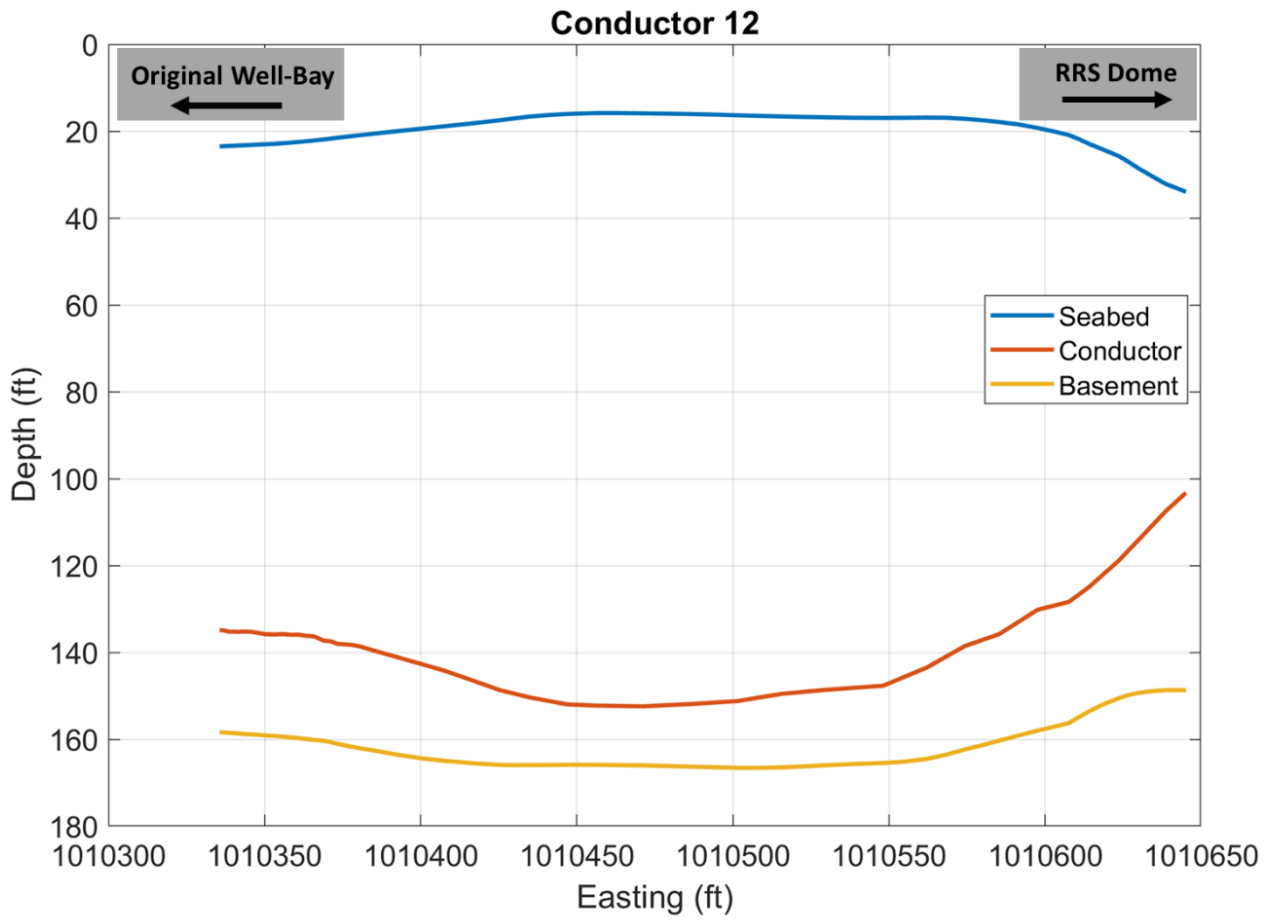
Figure 59 – 2D along-track visualization of the digitized conductor 12

Figure 58 and Figure 59 are examples of a 2D along-track visualization for conductors 5 and 12 respectively, and their locations with respect to the seabed and basement horizons. Figure 60 presents a summary of these tables by displaying the depths below the seabed of the smoothly interpolated conductors in terms of Easting (ft) and Northing (ft).
