**Final Report
Volume I
Acoustic Corer™ Survey – MC-20**

Couvillion Group

Document Number: PAN-P22-0030-RPT-001

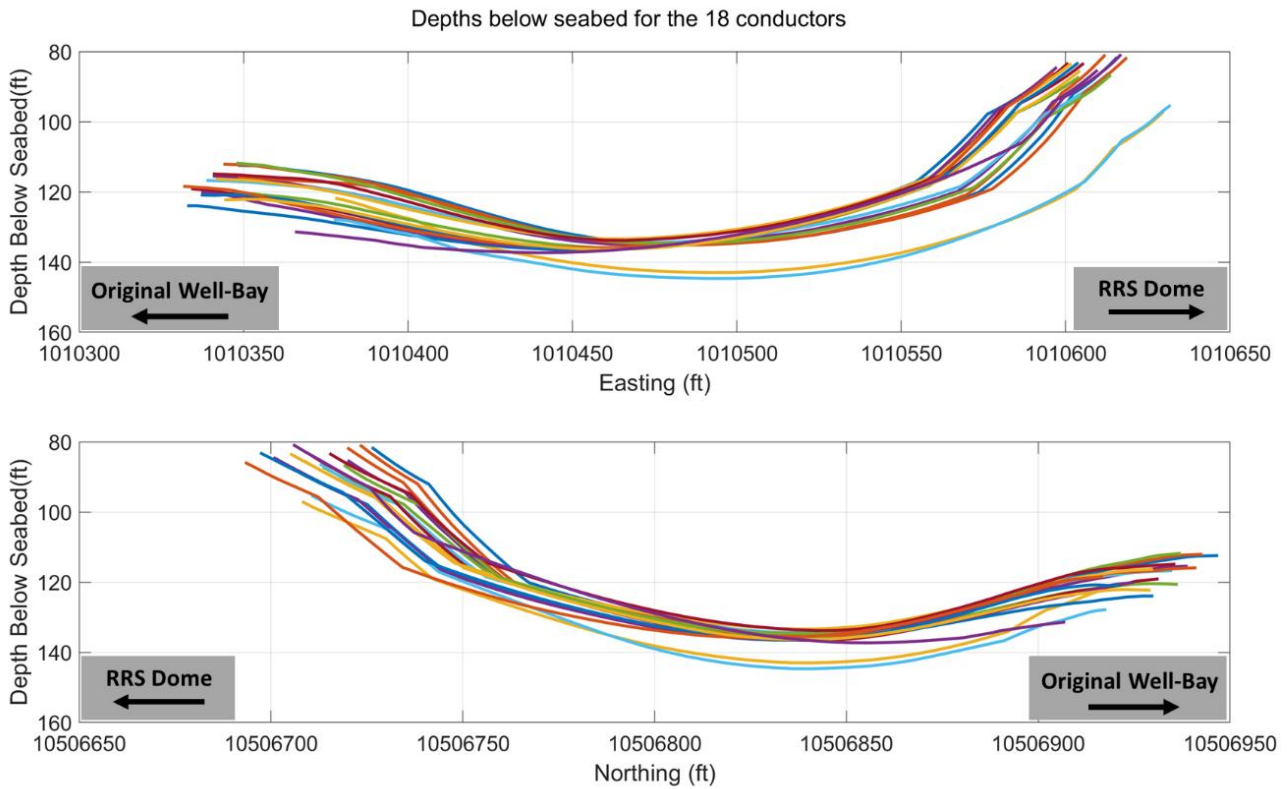
Figure 60 – Summary of all depths below seabed for the 18 conductors

- These conductors are found between approximately 91 - 158ft depth, with the greatest concentration appearing between 130ft to 155ft depth. The shallowest conductor appears at 91ft depth trending downwards from the collection dome.
