RELIABILITY OF CORRODED PIPES  
LABORATORY BURST TESTS

REPORT No. 96-3393  
REVISION No. 02

DET NORSKE VERITAS

This report is one of a serie of 4 reports in the JIP project "Reliability of Corroded Pipes", and describes the laboratory burst tests of pipes with simulated corrosion defects. This project is a continuation of the JIP project "Residual Strength of Dented and Corroded Pipes".

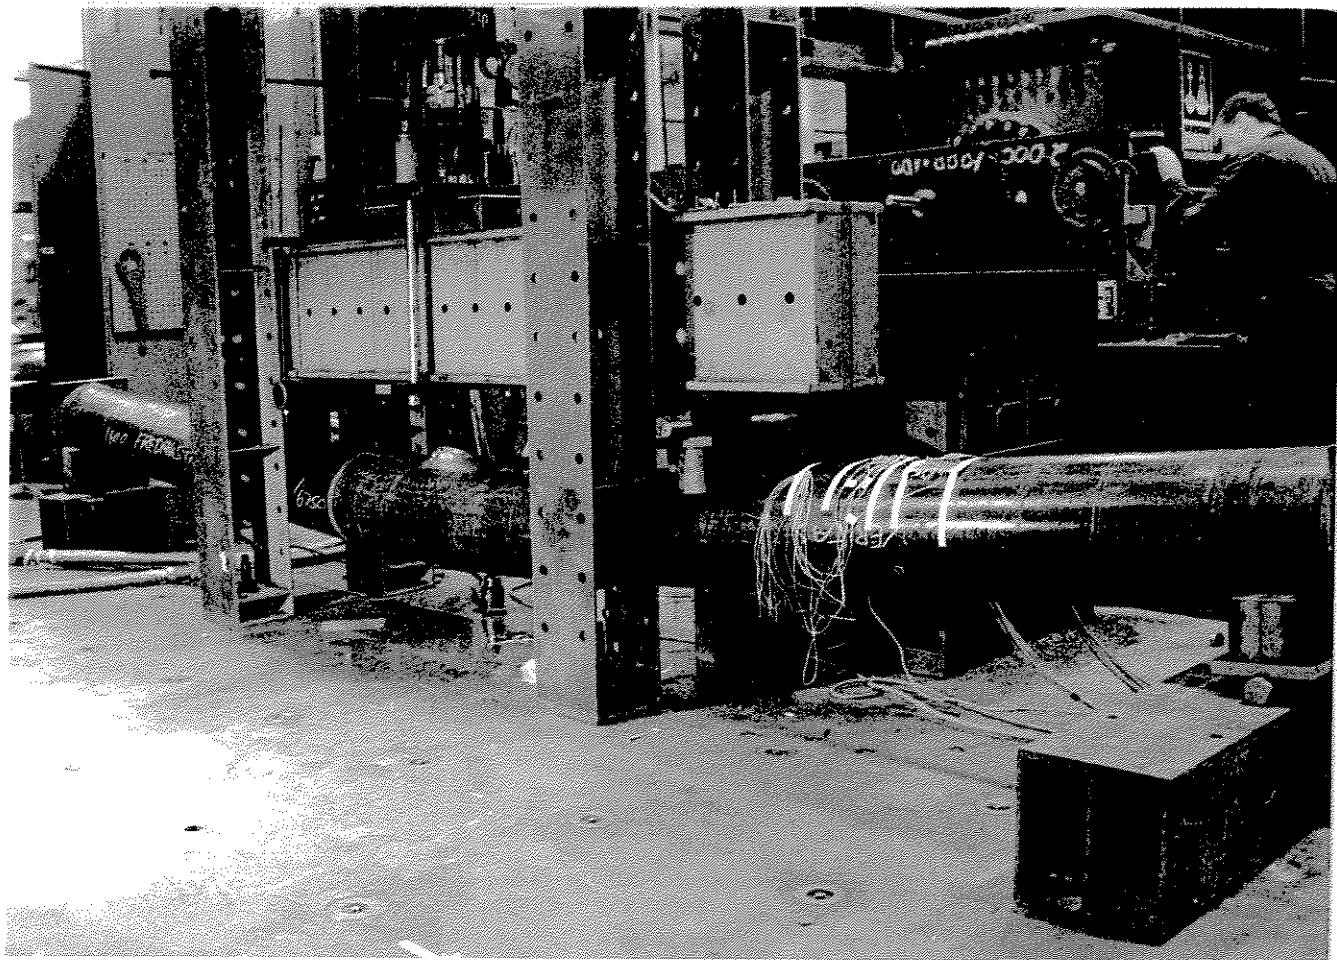
Figure 3-1 Picture of the test rig for 4-point bending test (after completion).

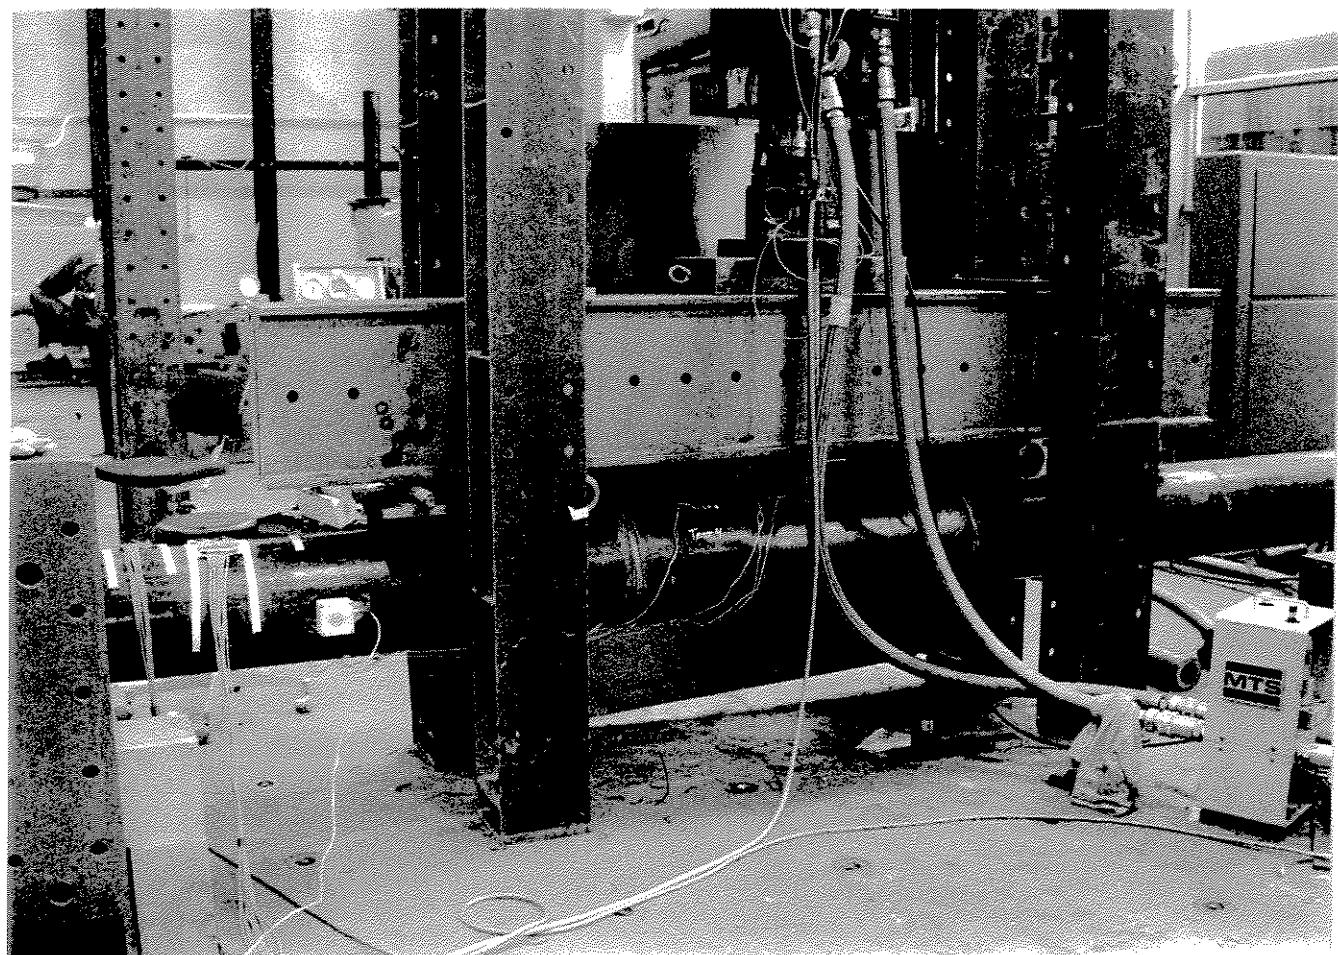
Figure 3-2 Picture of the test rig for 4-point bending test.

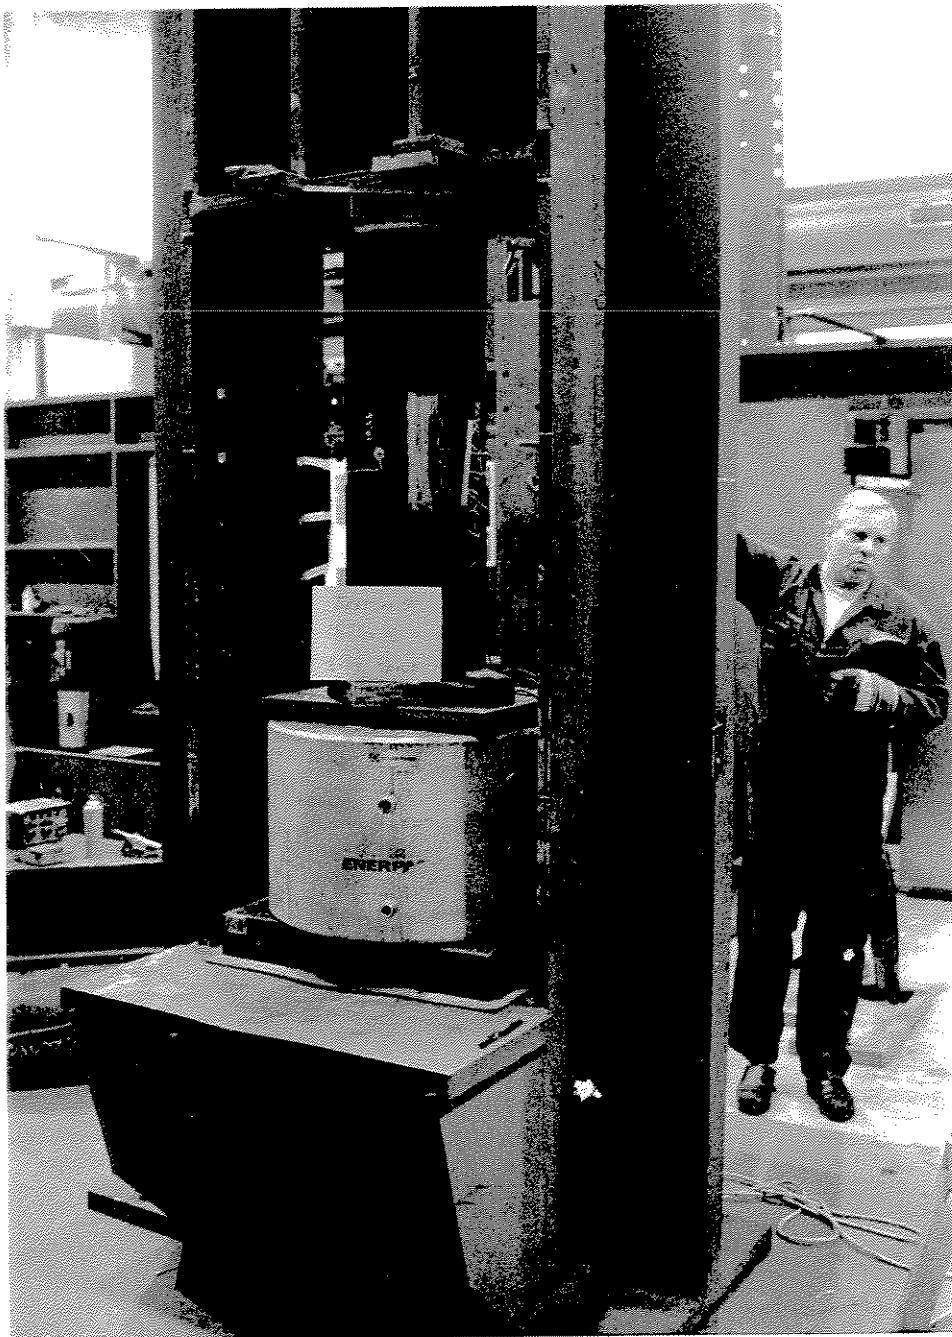
Figure 3-3 Picture of the test rig for axial compressive force

The tests with combined internal pressure and axial compressive force was performed in a test frame as shown in Figure 3-3. A 10000 kN static jack was applied. The length of the test specimens were all 1000 mm, plus 2\*50 mm for the end-plates. The maximum stroke of the jack was slightly less than 100 mm.

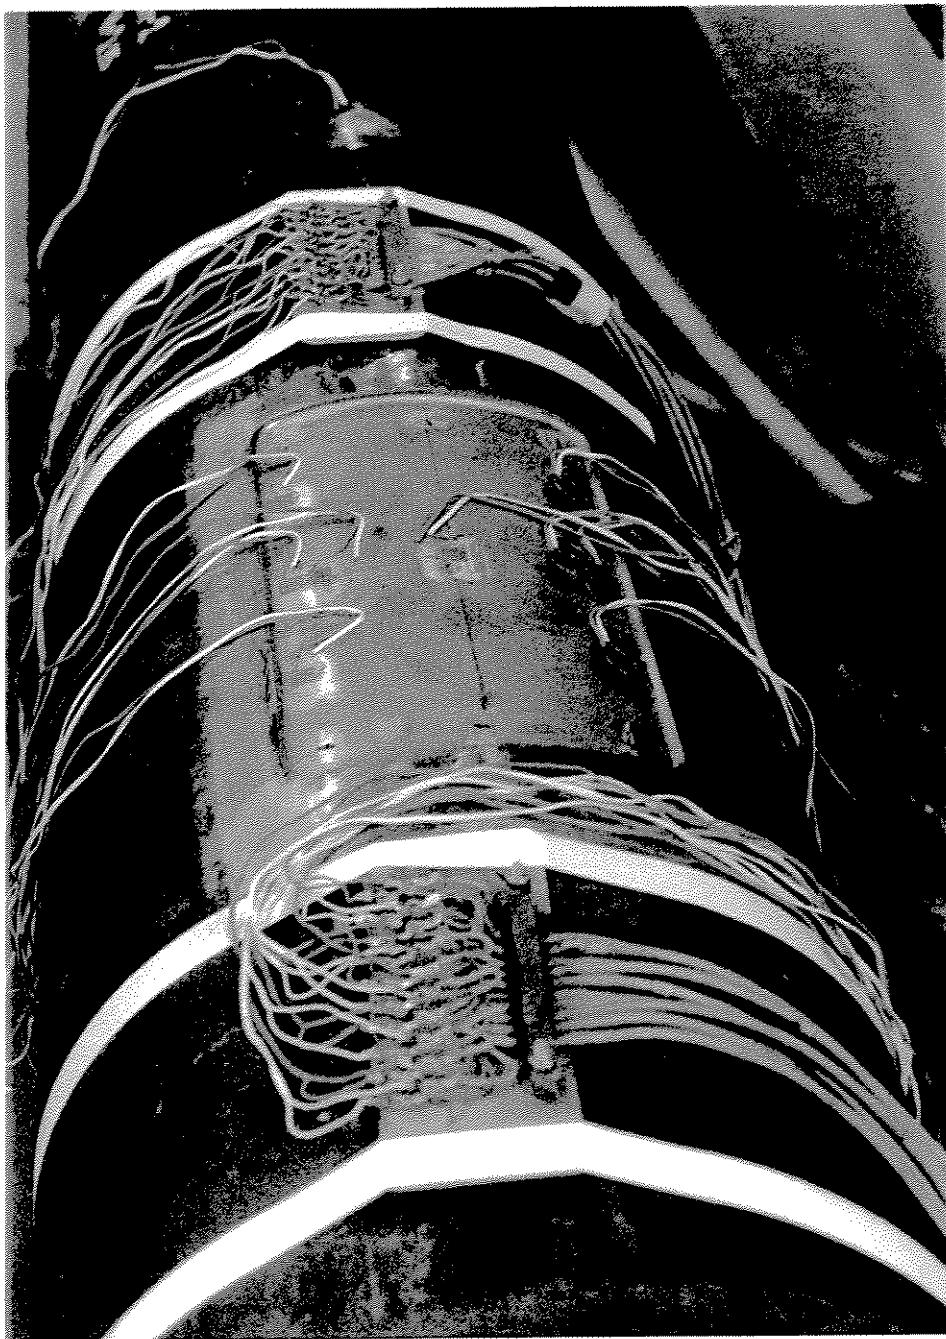
Figure 3-4 Picture of a corrosion defect with strain gauge instrumentation

The simulated corrosion defects were spark eroded at the outer surface. The defect similar to test 1 to 3 is shown in Figure 3-4. The defects had a smooth surface and all edges were made with a small radius. The surfaces were also grinded slightly to get a smoother surface for ease thickness measurements and application of strain gauges. At each end of the test specimen a 50mm thick end-plate was welded to the pipe. For the tests exposed to bending moment thicker extension pipes of approximately 2 meters were welded to each end of the test specimen, and the end-plate were welded to the end of these extension pipes. The inlet for internal pressure and mounting of the pressure transducer were in the end flanges.

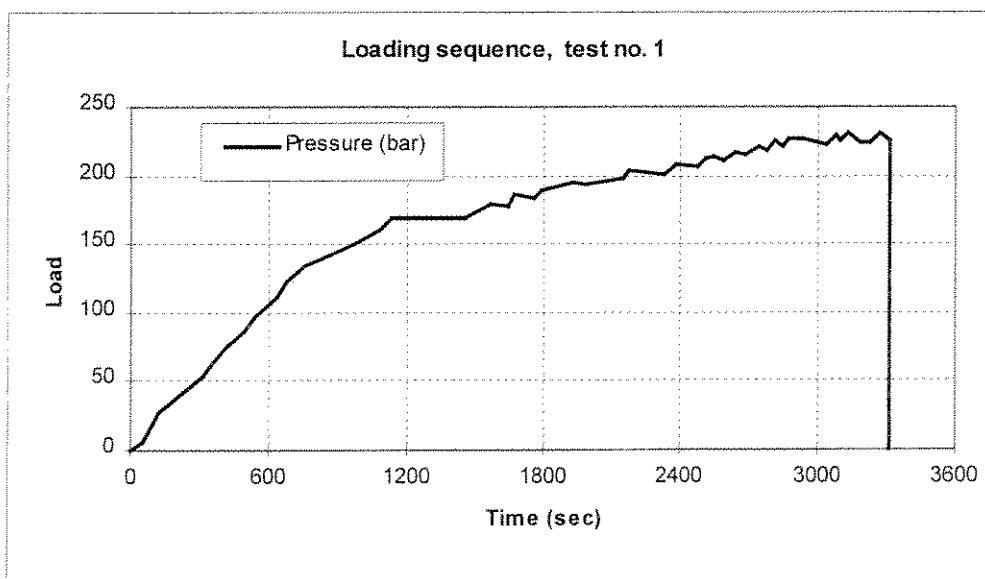
**Figure 4-1 Applied pressure versus time for test no. 1**

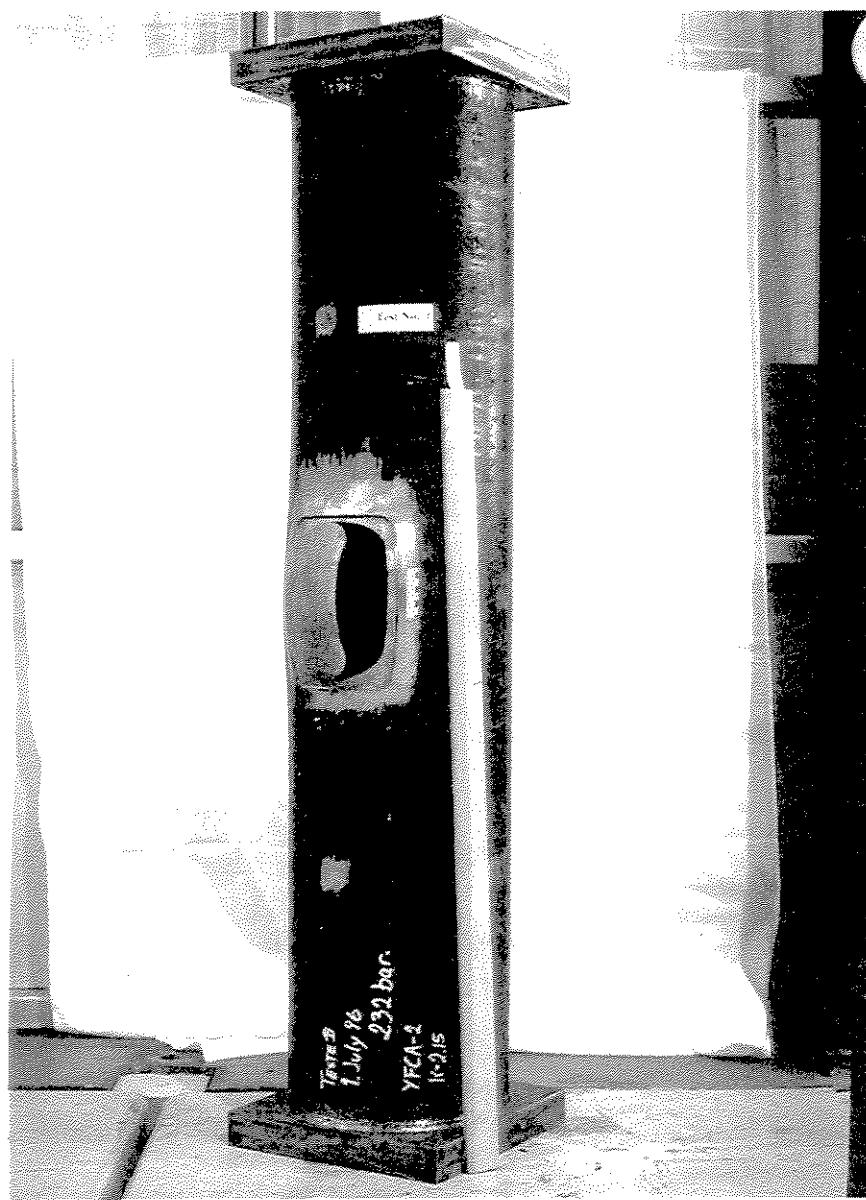
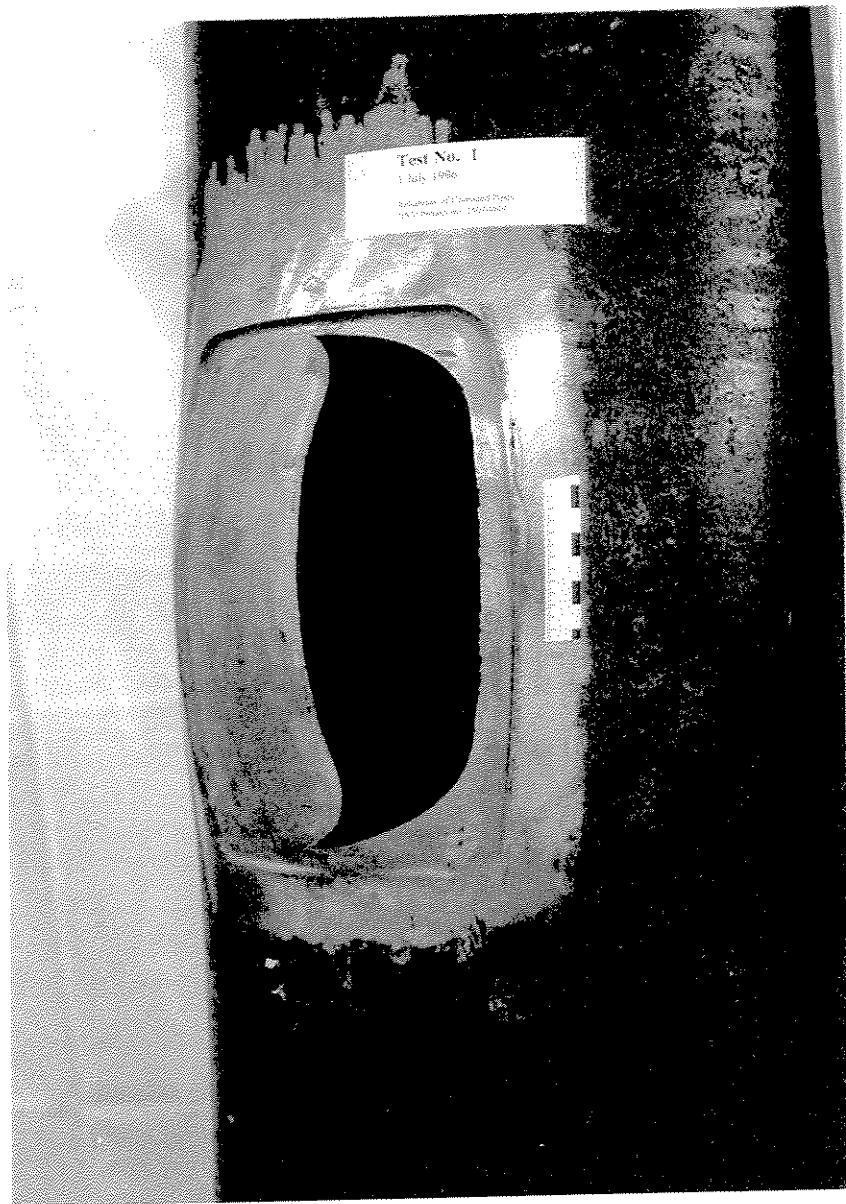
Figure 4-2 Picture of the test specimen no. 1 after the burst

Figure 4-3 Picture of the test specimen no. 1 after the burst

The test failed at 232 bar. The test specimen after burst is shown in Figure 4-2.

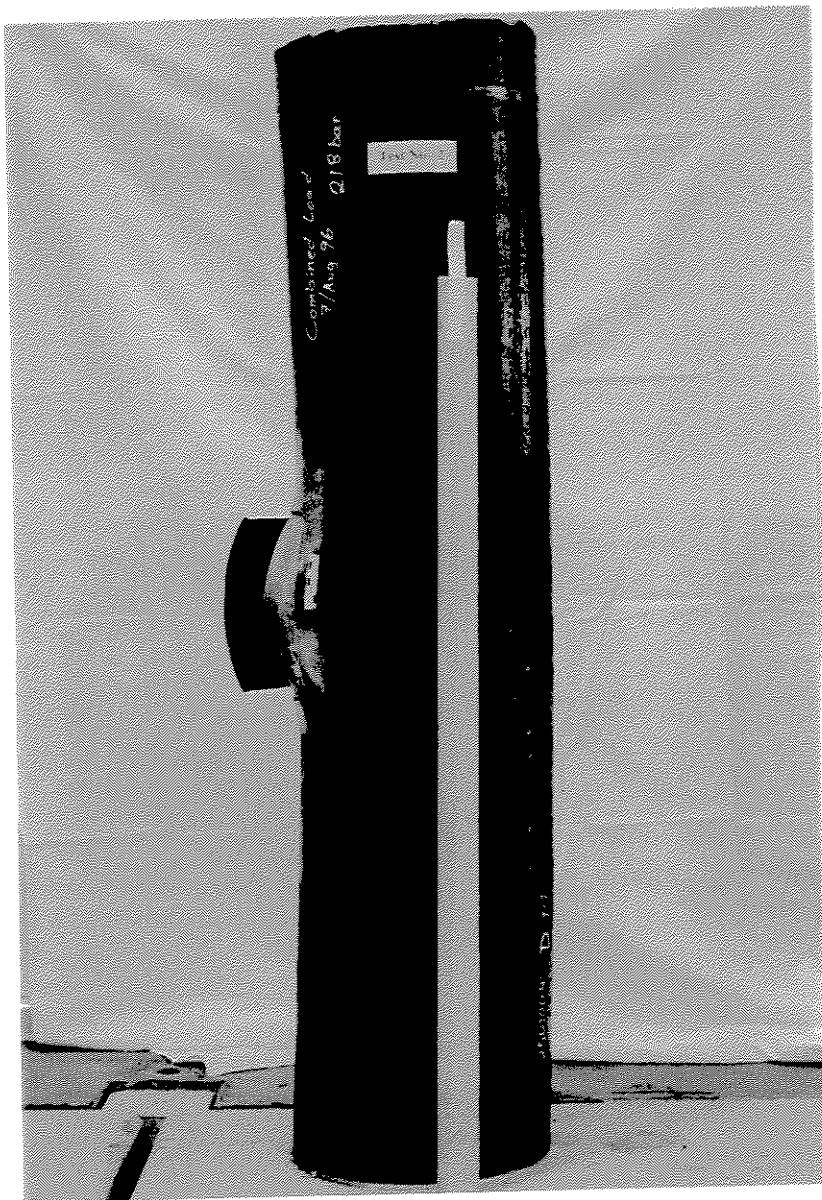
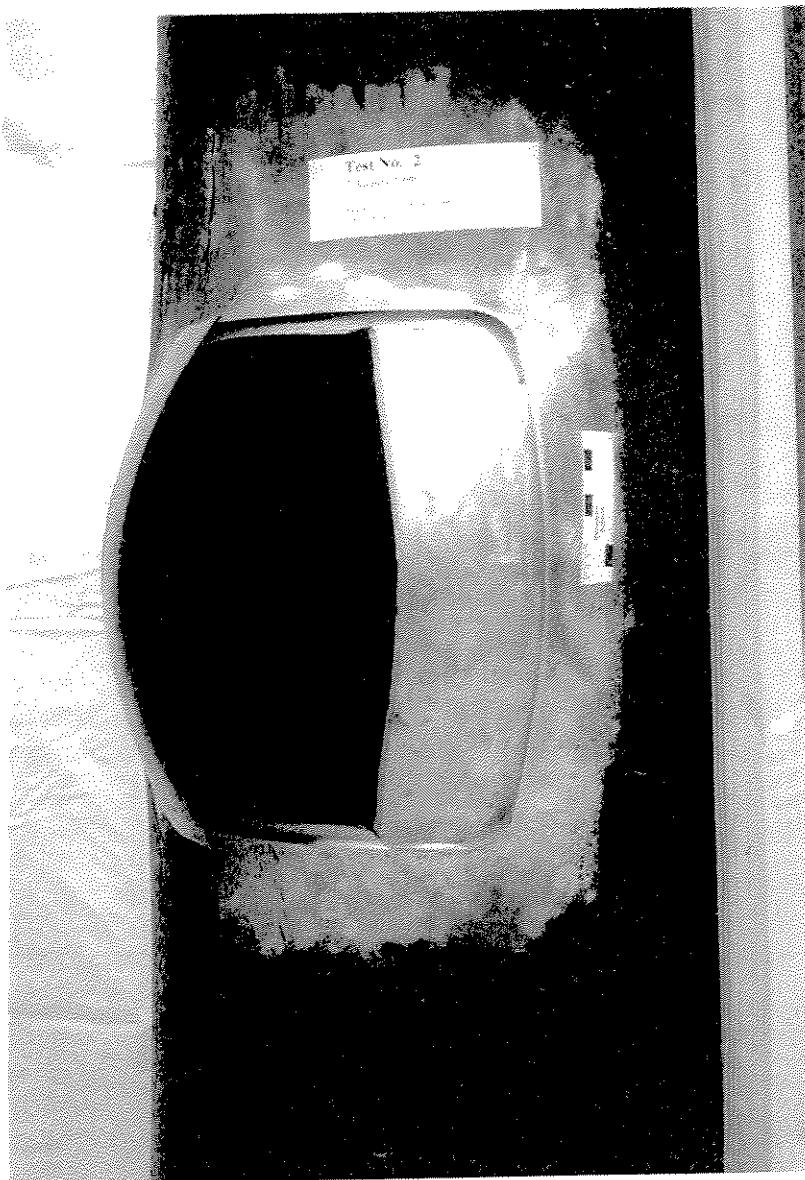
Figure 4-7 Picture of the test specimen no. 2 after the burst test

Figure 4-8 Picture of the test specimen no. 2 after the burst test

Excessive yielding was observed in the pipe, and it was not possible to maintain the maximum bending moment of approximately 220 kNm when the internal pressure was further increased. When the internal pressure was increased from 165 bar to rupture at 218.5 bar, the bending moment decreased from 220 kNm to 130 kNm.

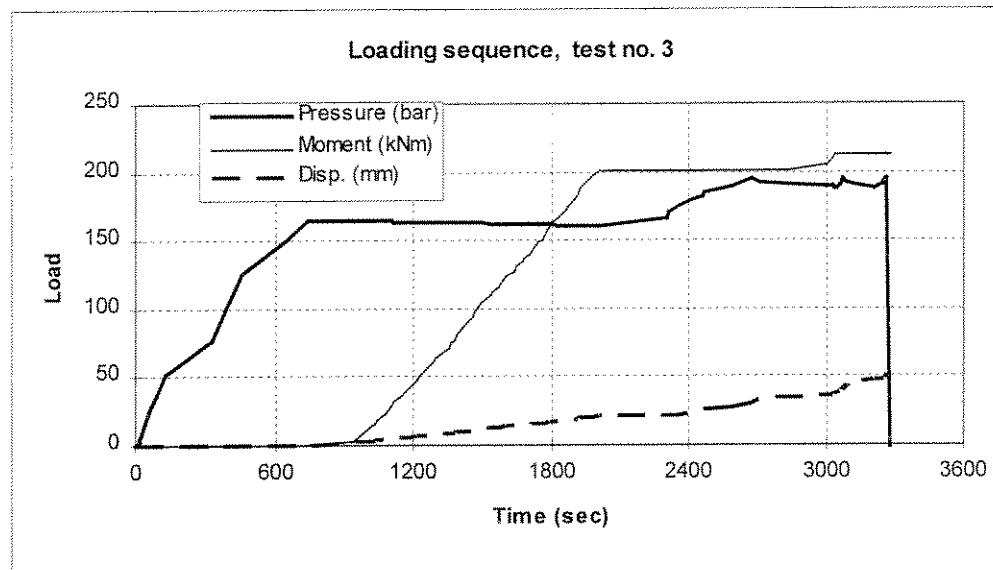
Figure 4-9 Loading sequence, test no.3

An internal pressure of 165 bar was applied during the first 12 minutes. The internal pressure was kept at 165 bar and bending moment was applied to the test specimen. Further, the bending moment was kept constant at 200 kNm, and the internal pressure was increased. The pipe was yielding extensively, which resulted in increased additional displacement in order to maintain the set bending moment of 200 kNm. A small increase in the bending moment up to 212.5 kNm was applied, and only marginal additional internal pressure was introduced before rupture.

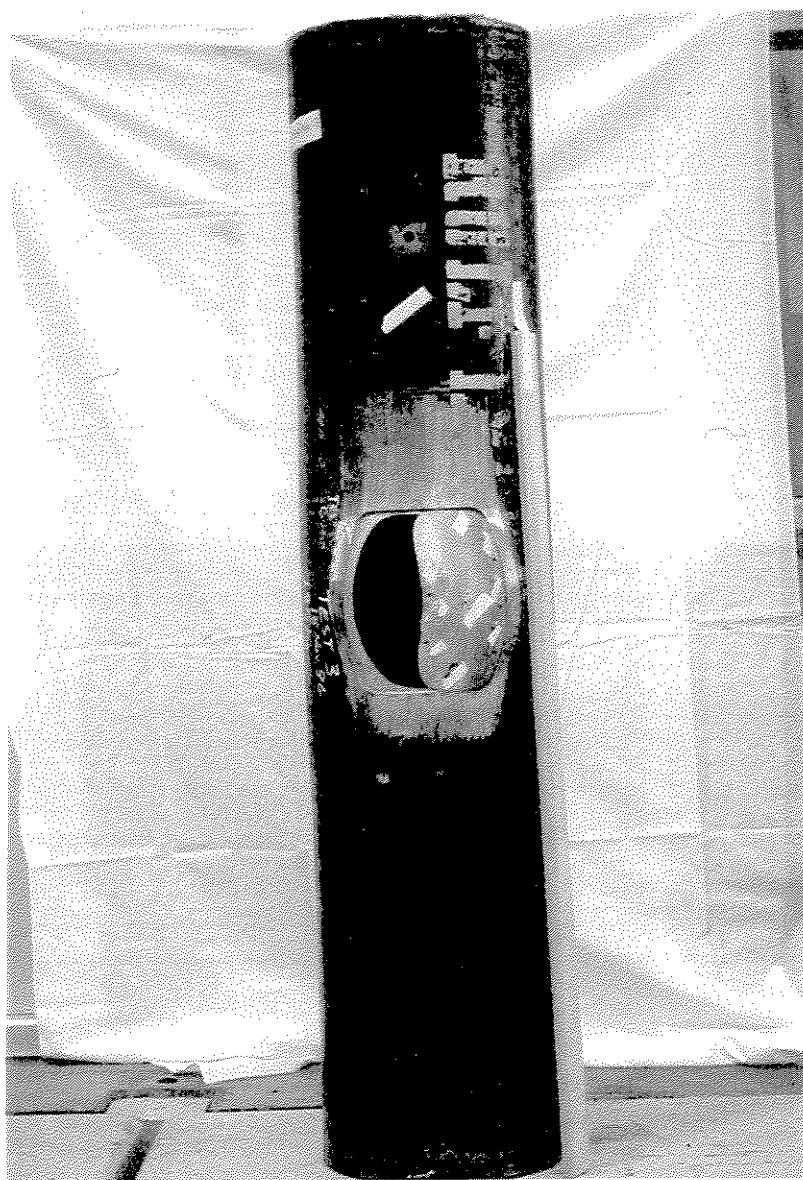
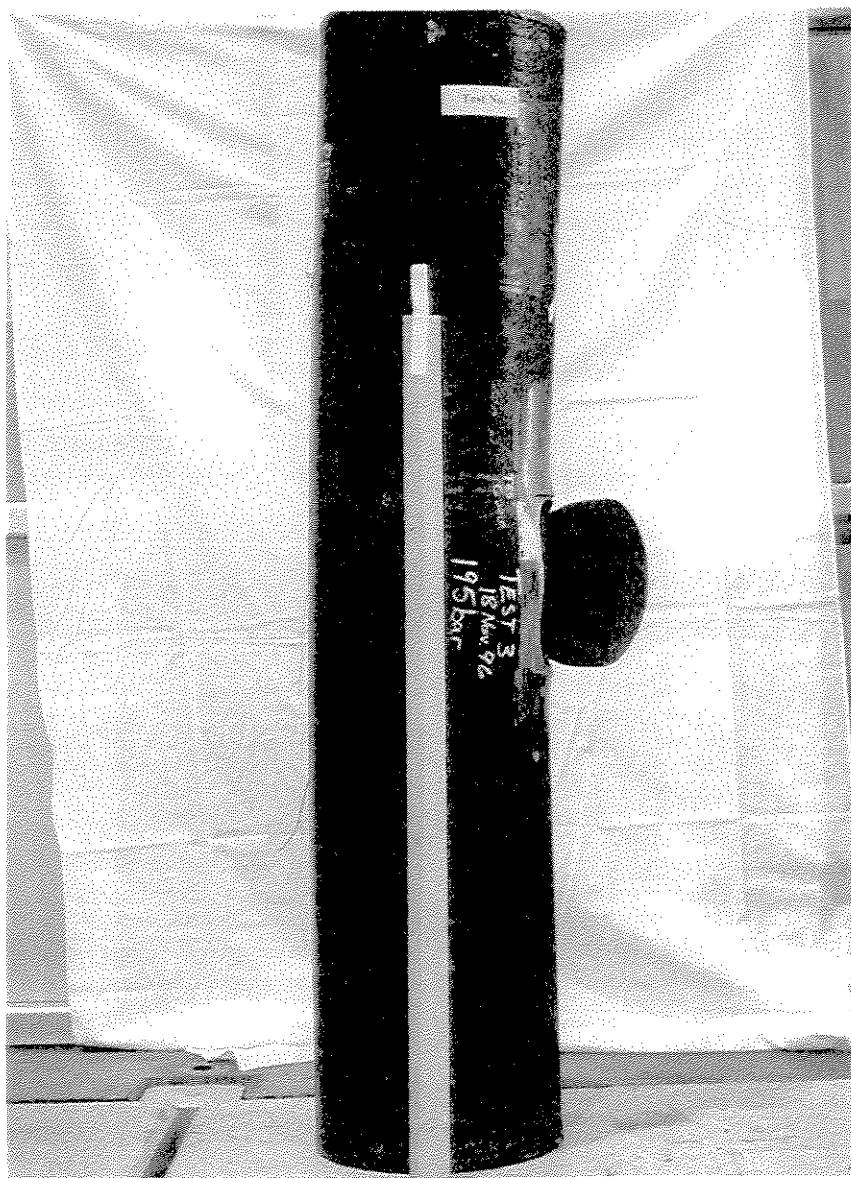
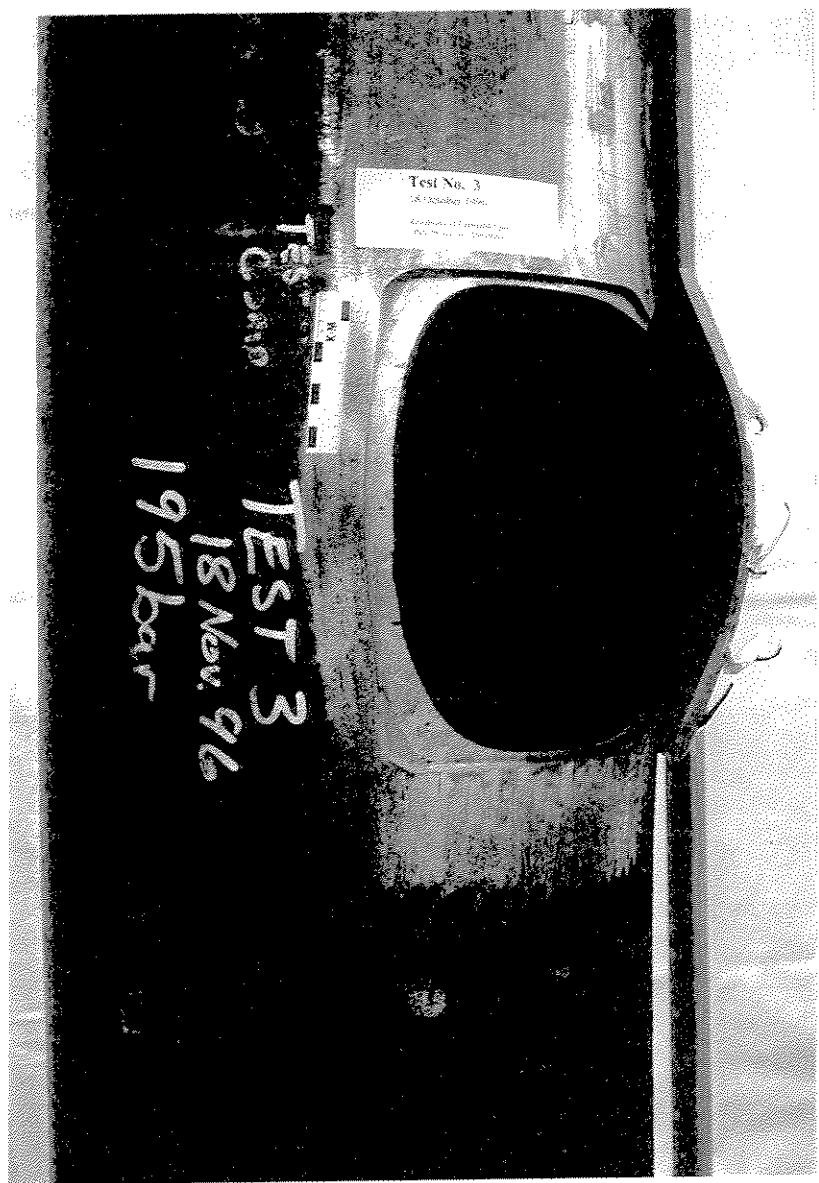
Figure 4-11 Picture of the test specimen no. 3 after the burst test

Figure 4-12 Picture of the test specimen no. 3 after the burst test

Figure 4-13 Picture of the test specimen no. 3 after the burst test

Excessive yielding was observed in the pipe before rupture in the corroded region. The test bursted at a bending moment of 212.5 kNm and an internal pressure of 195 bar.

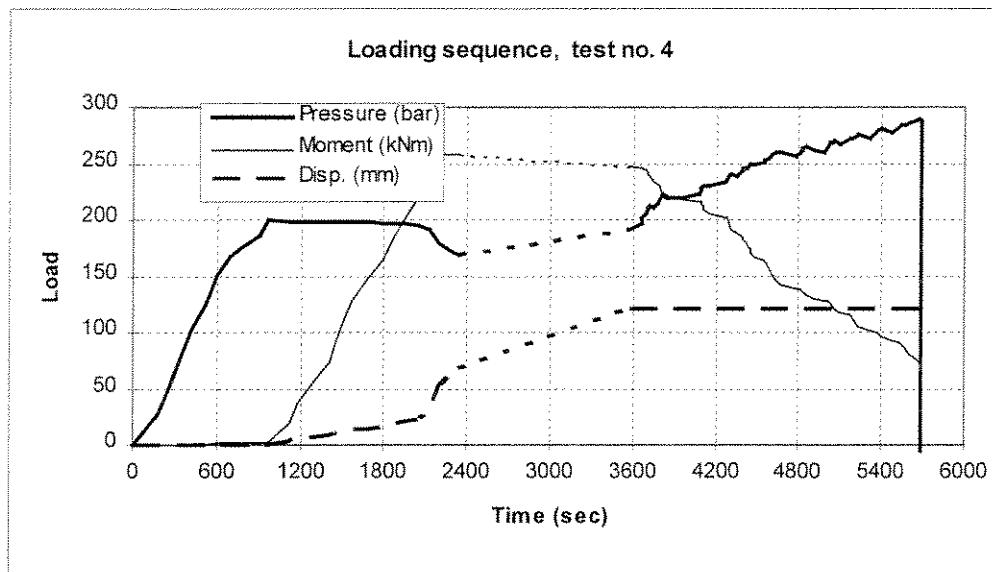
Figure 4-14 Loading sequence, test no.4

Excessive yielding was observed in the pipe before rupture in the corroded region. The test bursted at a bending moment of 73 kNm and an internal pressure of 290 bar. During the loading the test specimen had also been exposed to an internal pressure of approximately 200 bar and 250 kNm.

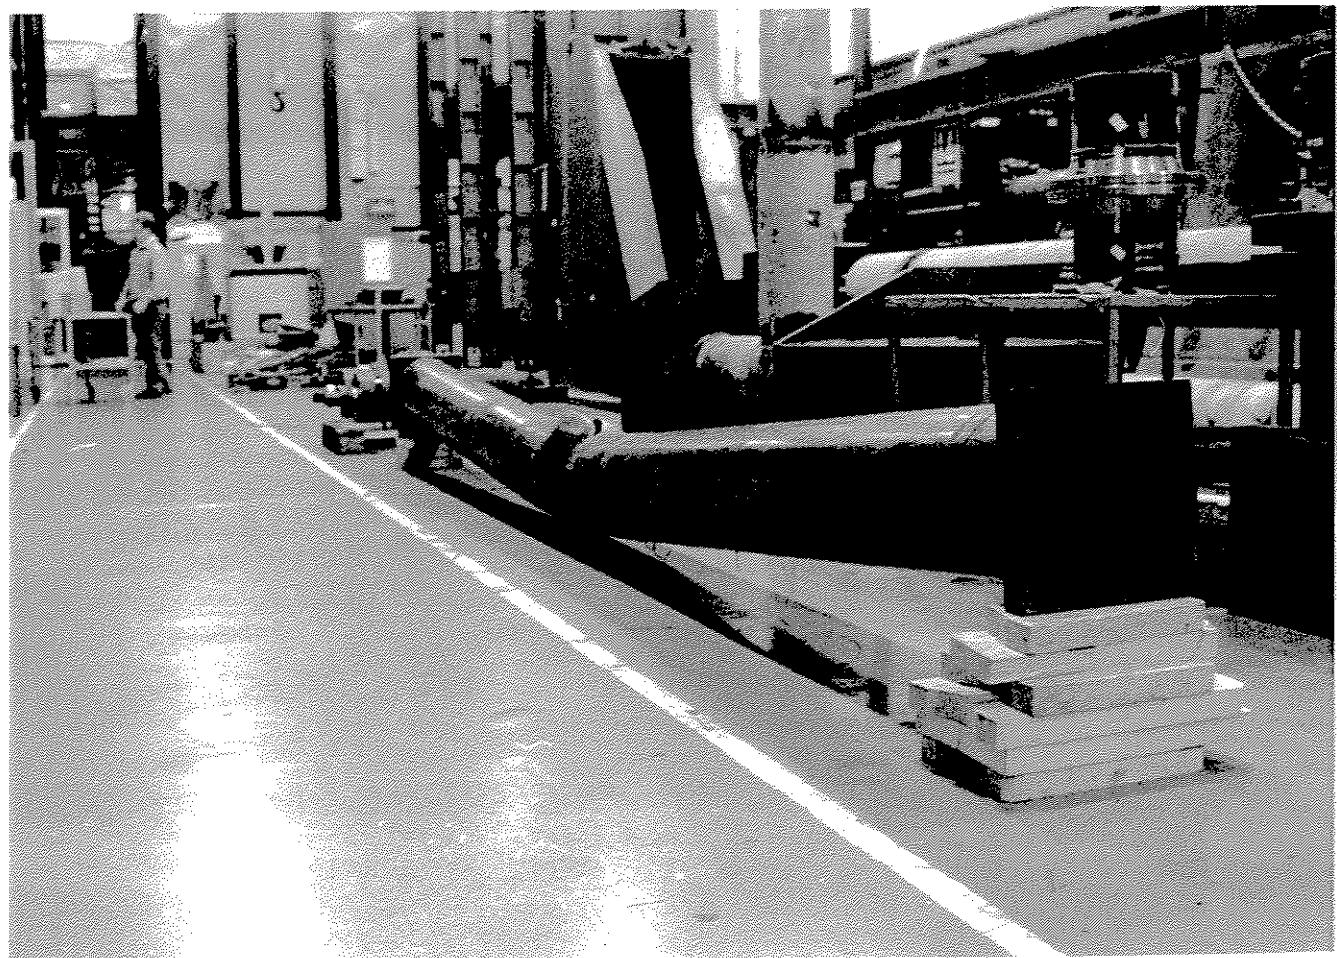
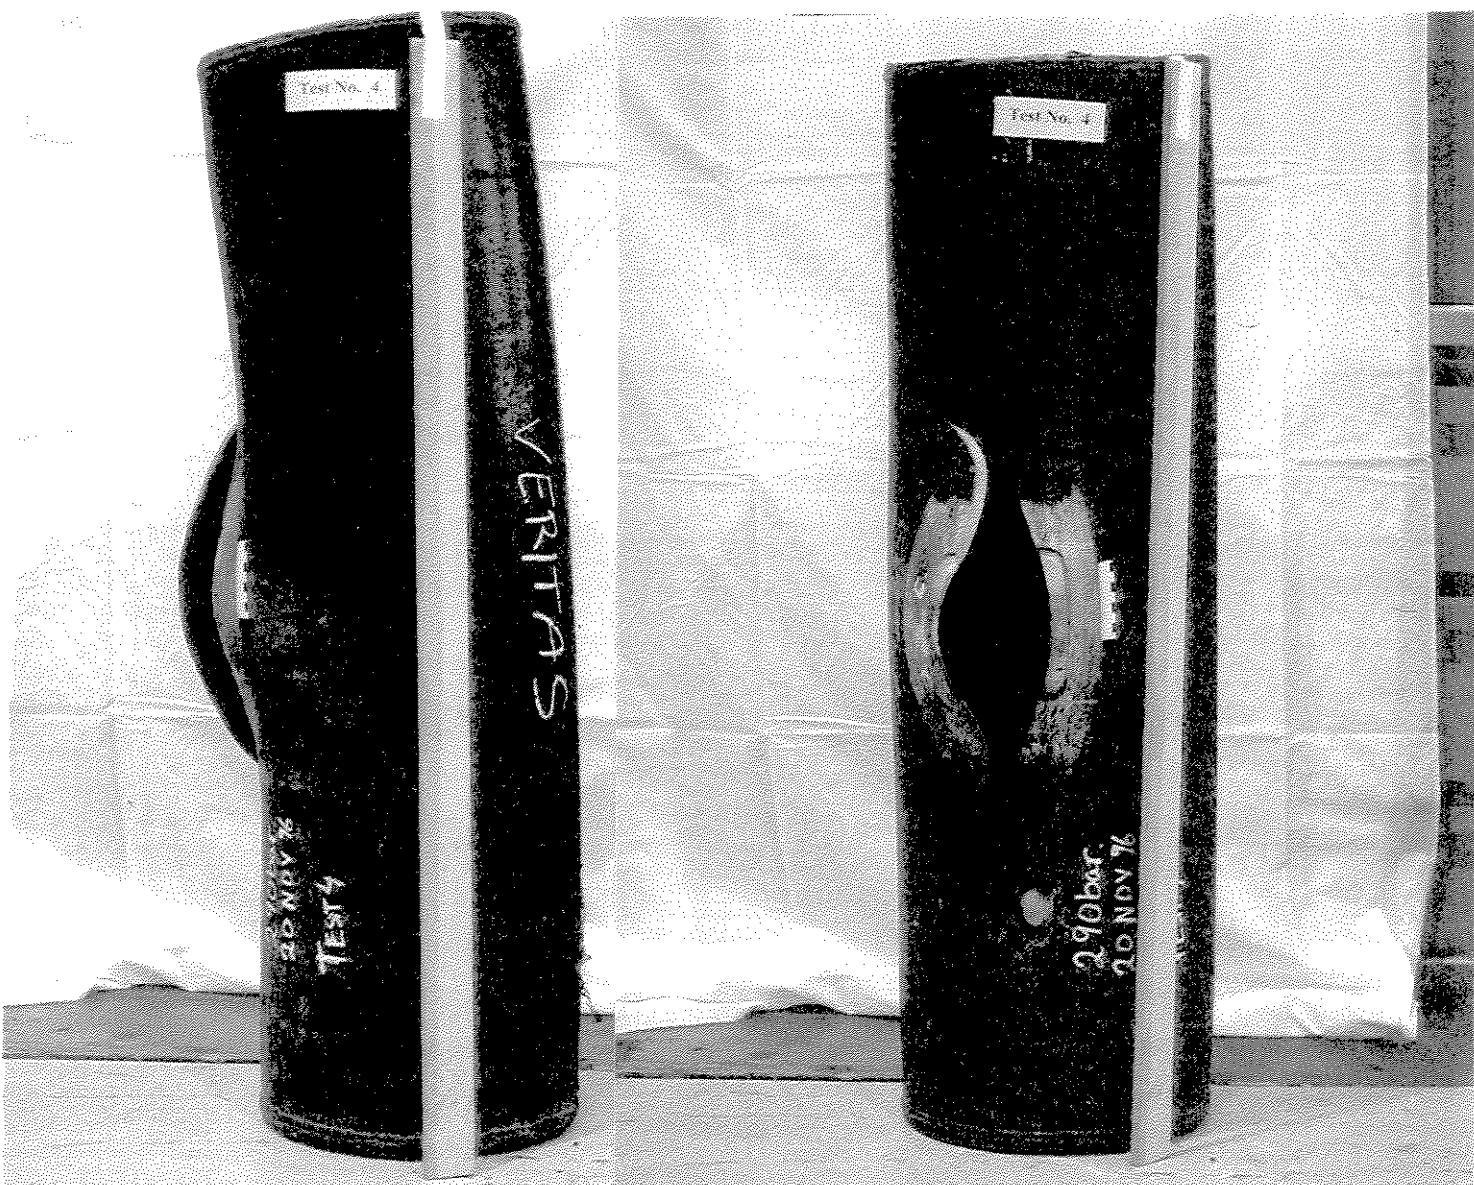
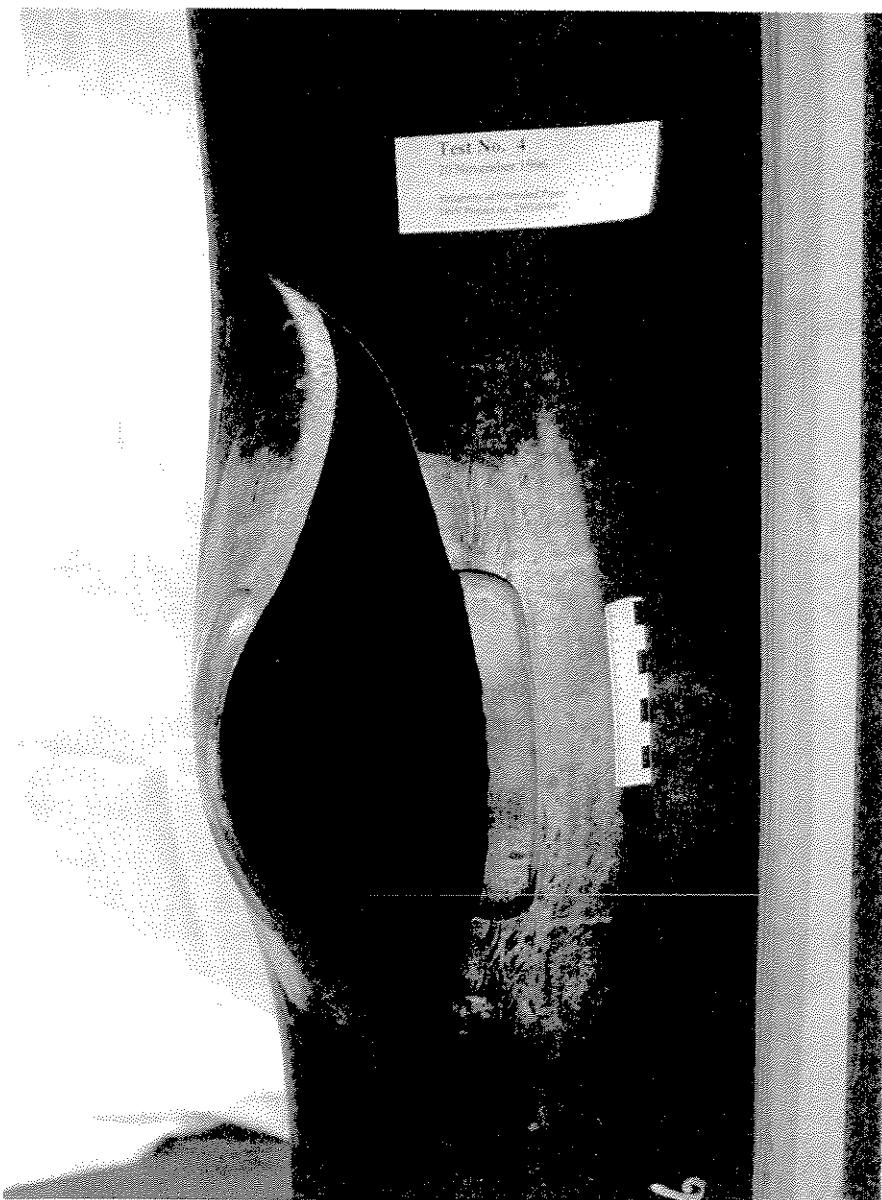
Figure 4-16 Picture of the test specimen no. 4 after the burst test

Figure 4-17 Picture of the test specimen no. 4 after the burst test

Figure 4-18 Picture of the test specimen no. 4 after the burst test

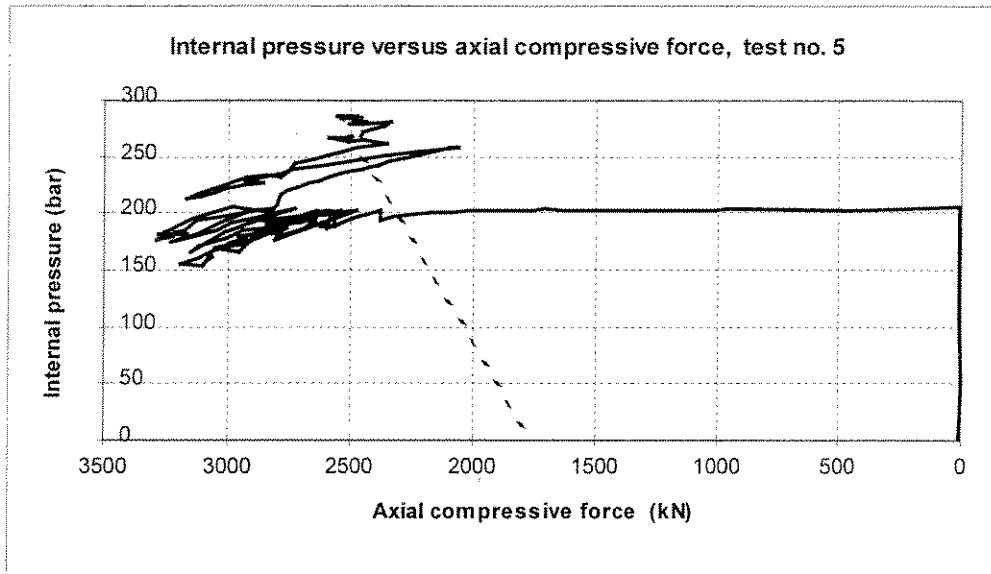
**Figure 4-20 Internal pressure versus axial compressive force, test no. 5**

Excessive yielding was observed in the pipe before rupture in the corroded region occurred. The test bursted at an internal pressure of 286 bar, and with an axial compressive external force of 2563 kN. The end cap force due to the internal pressure was 2060 kN, resulting in a compressive pipe wall force of only 503 kN, equivalent to 48 MPa in axial compression.

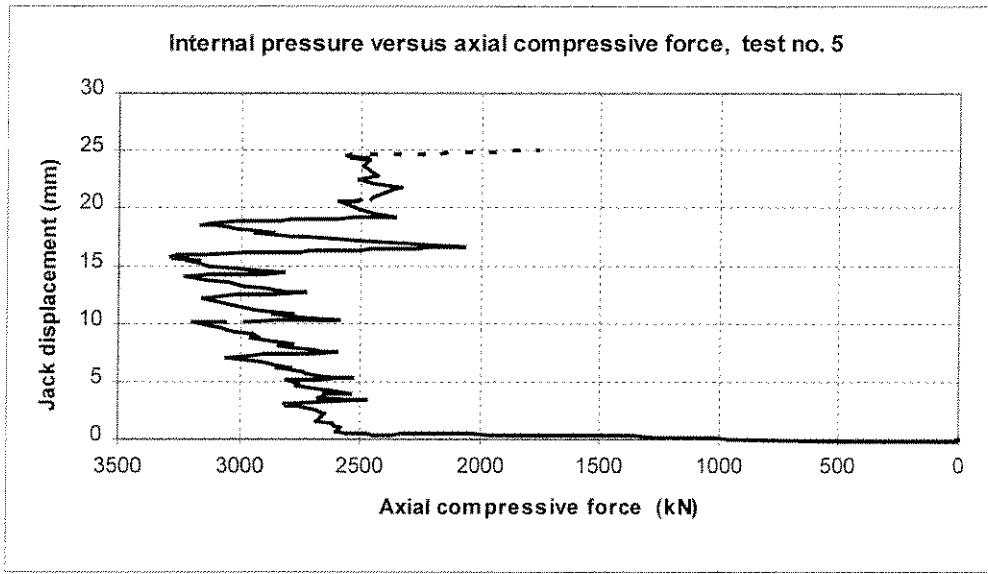
**Figure 4-21 Jack displacement versus axial compressive force, test no. 5****Results**

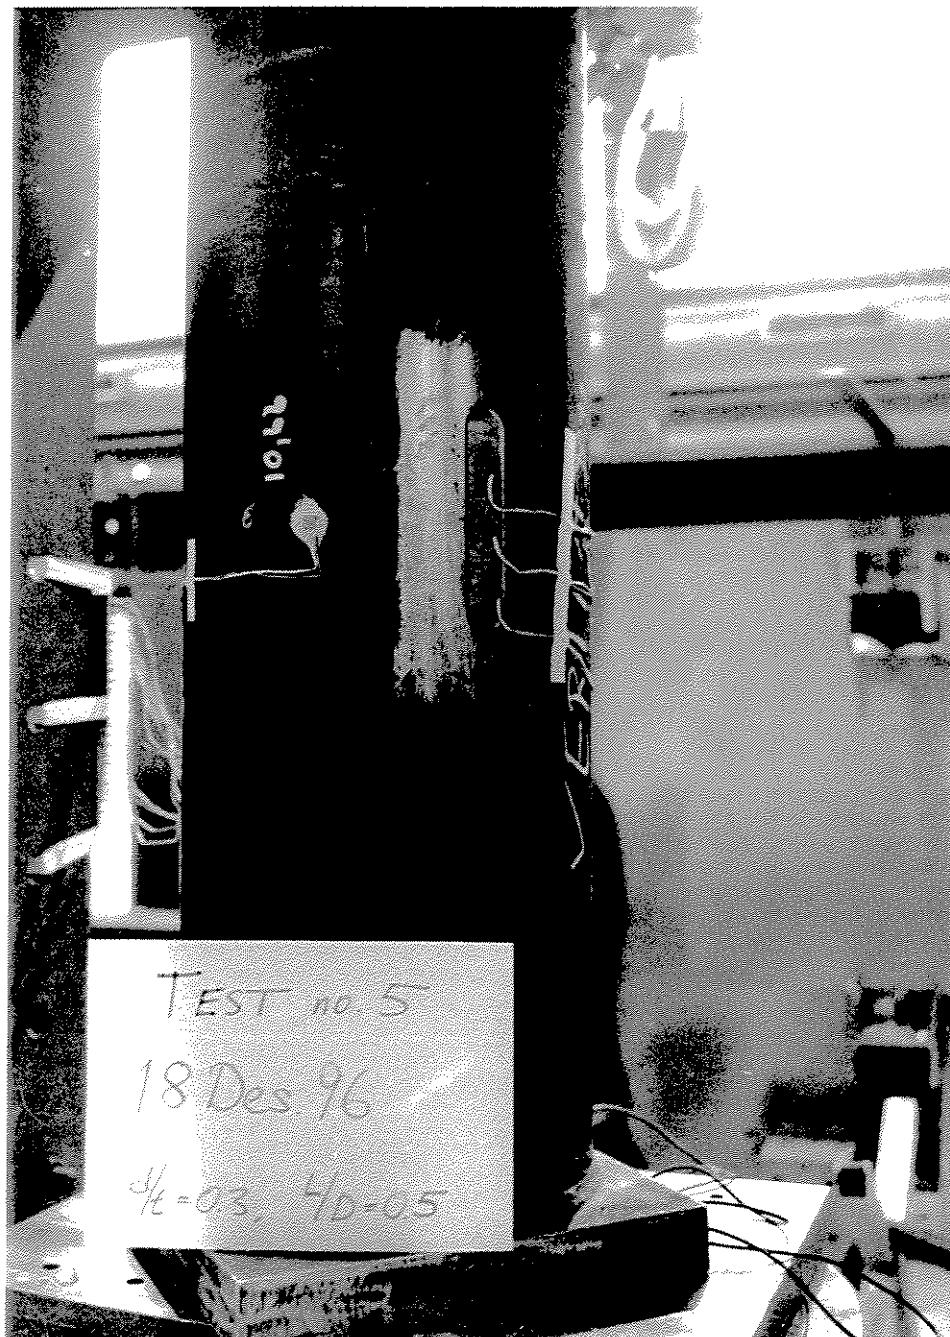
Figure 4-22 Picture of the test specimen no. 5 in the test rig before the burst test
