RELIABILITY OF CORRODED PIPES  
LABORATORY BURST TESTS

REPORT No. 96-3393  
REVISION No. 02

DET NORSKE VERITAS

This report is one of a serie of 4 reports in the JIP project "Reliability of Corroded Pipes", and describes the laboratory burst tests of pipes with simulated corrosion defects. This project is a continuation of the JIP project "Residual Strength of Dented and Corroded Pipes".

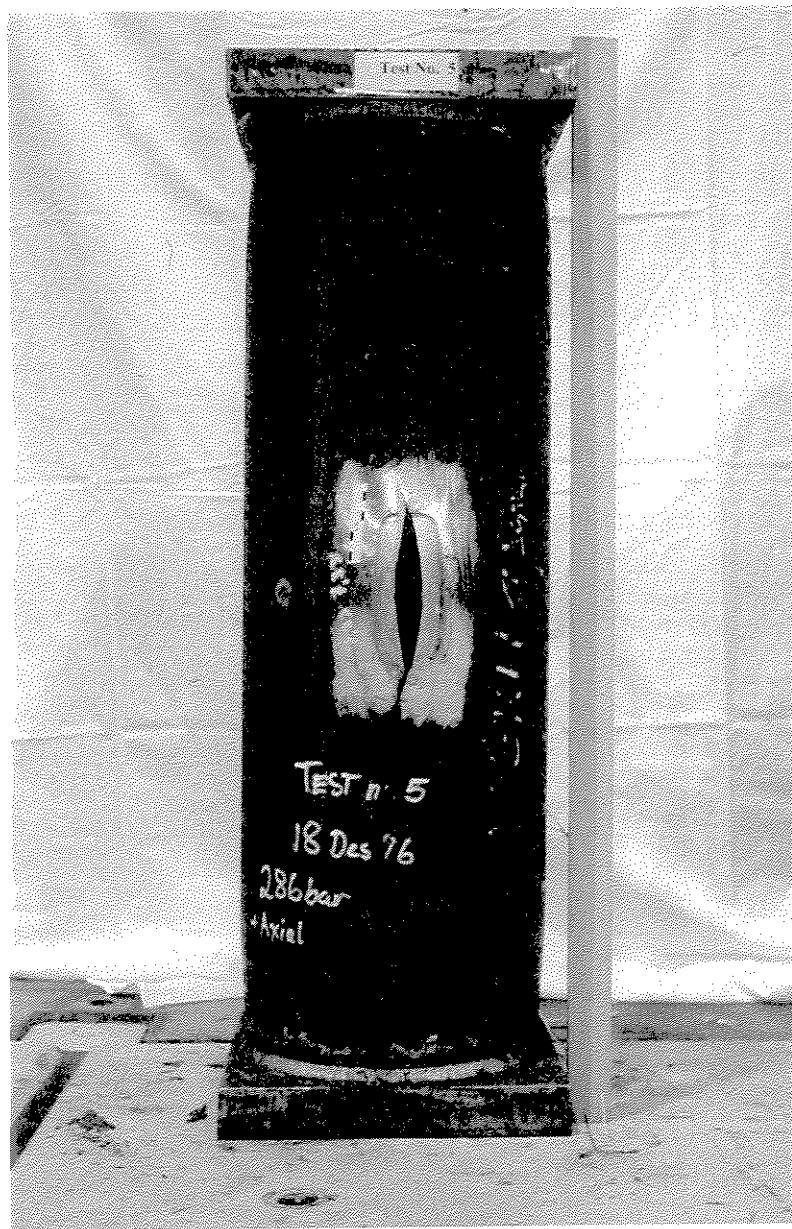
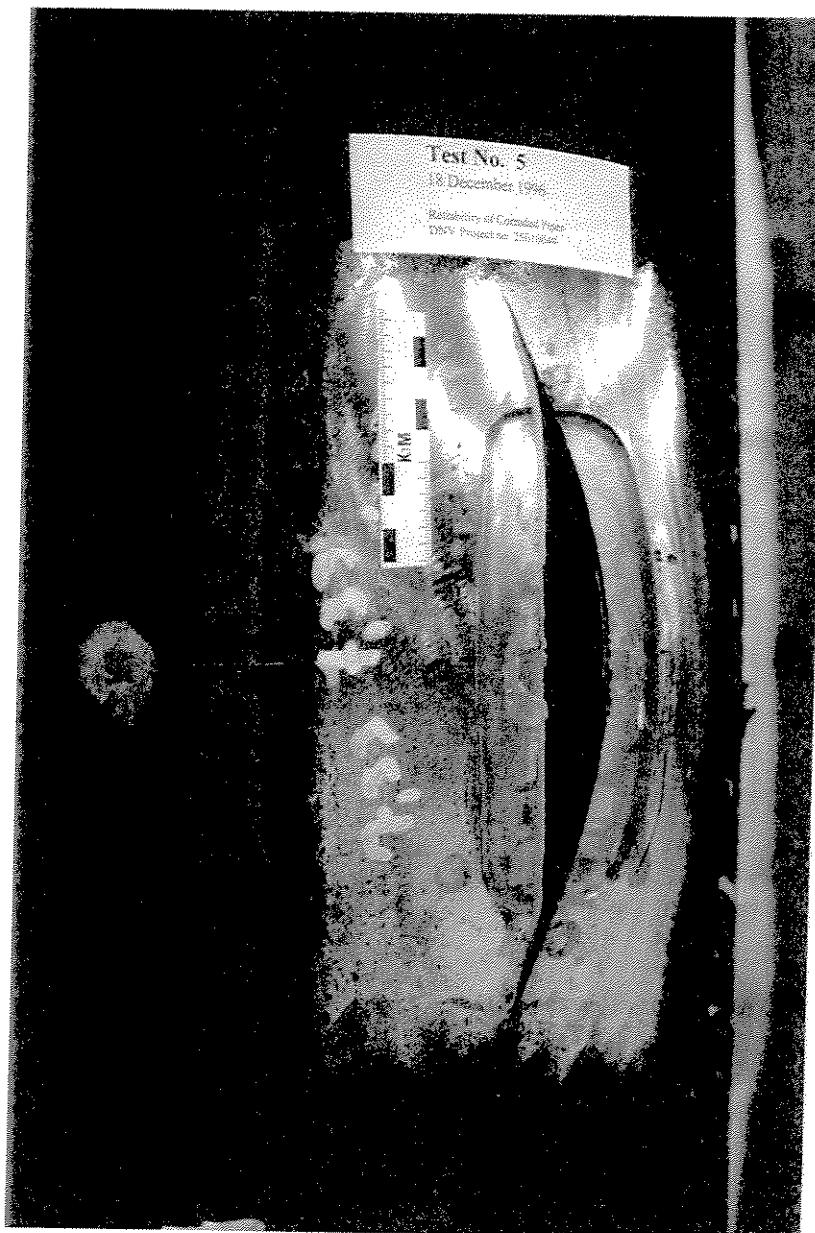
Figure 4-23 Picture of the test specimen no. 5 after the burst test

**Figure 4-24 Picture of the test specimen no. 5 after the burst test**

Excessive yielding was observed in the pipe before rupture in the corroded region occurred. The test bursted at an internal pressure of 286 bar, and with an axial compressive external force of 2563 kN. The end cap force due to the internal pressure was 2060 kN, resulting in a compressive pipe wall force of only 503 kN, equivalent to 48 MPa in axial compression.

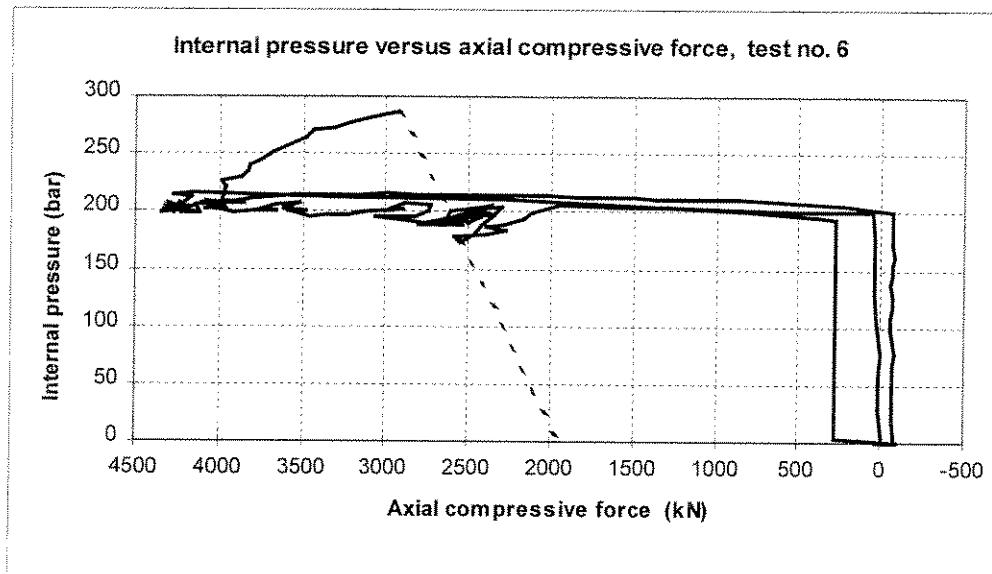
**Figure 4-26 Internal pressure versus axial compressive force, test no. 6**

Excessive yielding was observed in the pipe before rupture in the corroded region. The test bursted at an internal pressure of 287 bar, and with an axial compressive external force of 2943 kN. The end-cap force due to the internal pressure was 2067 kN, resulting in a compressive pipe wall force of only 876 kN, equivalent to 84 MPa. The test specimen had during the test experienced 205 bar and 4323 kN.

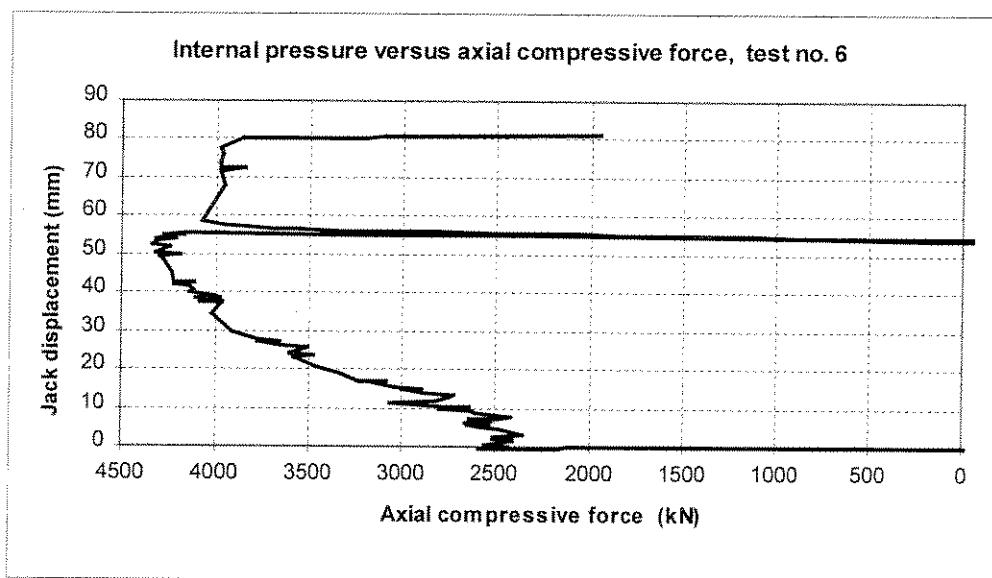
**Figure 4-27 Jack displacement versus axial compressive force, test no. 6****Results**

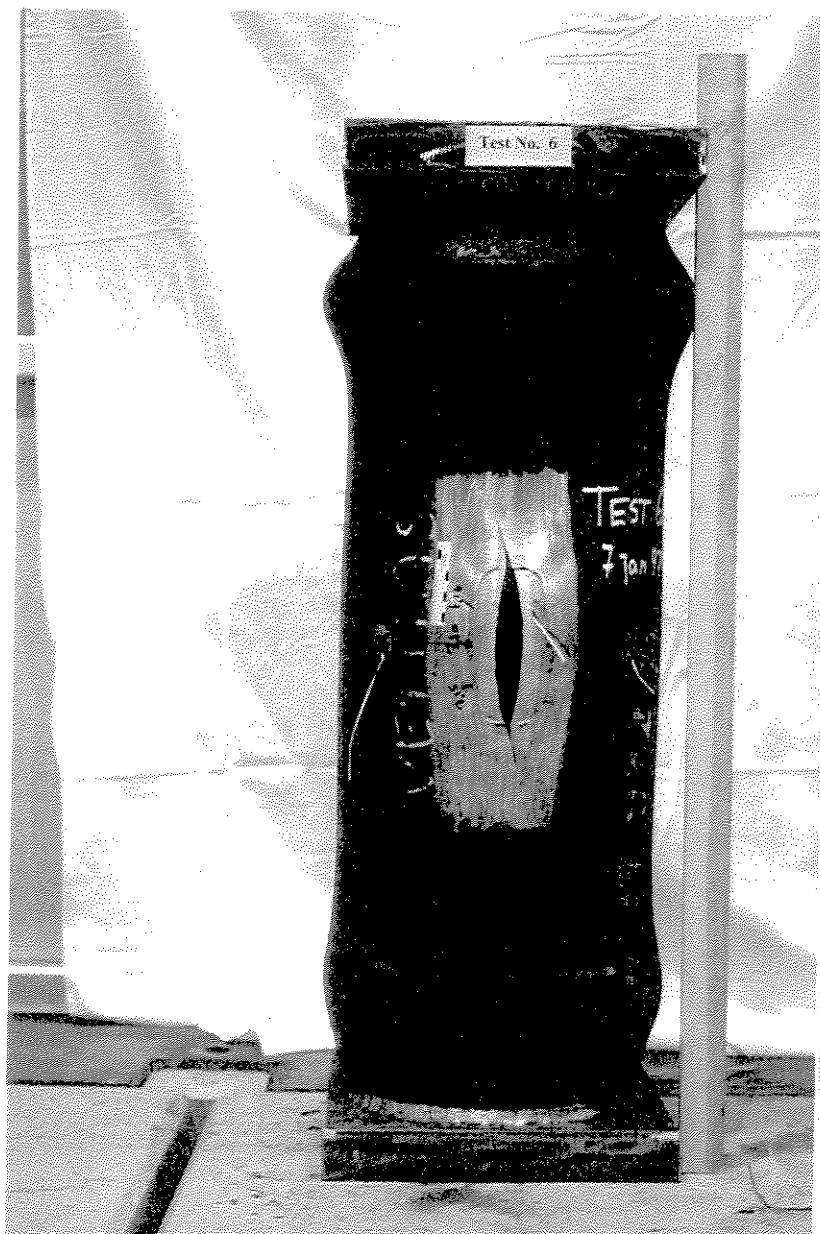
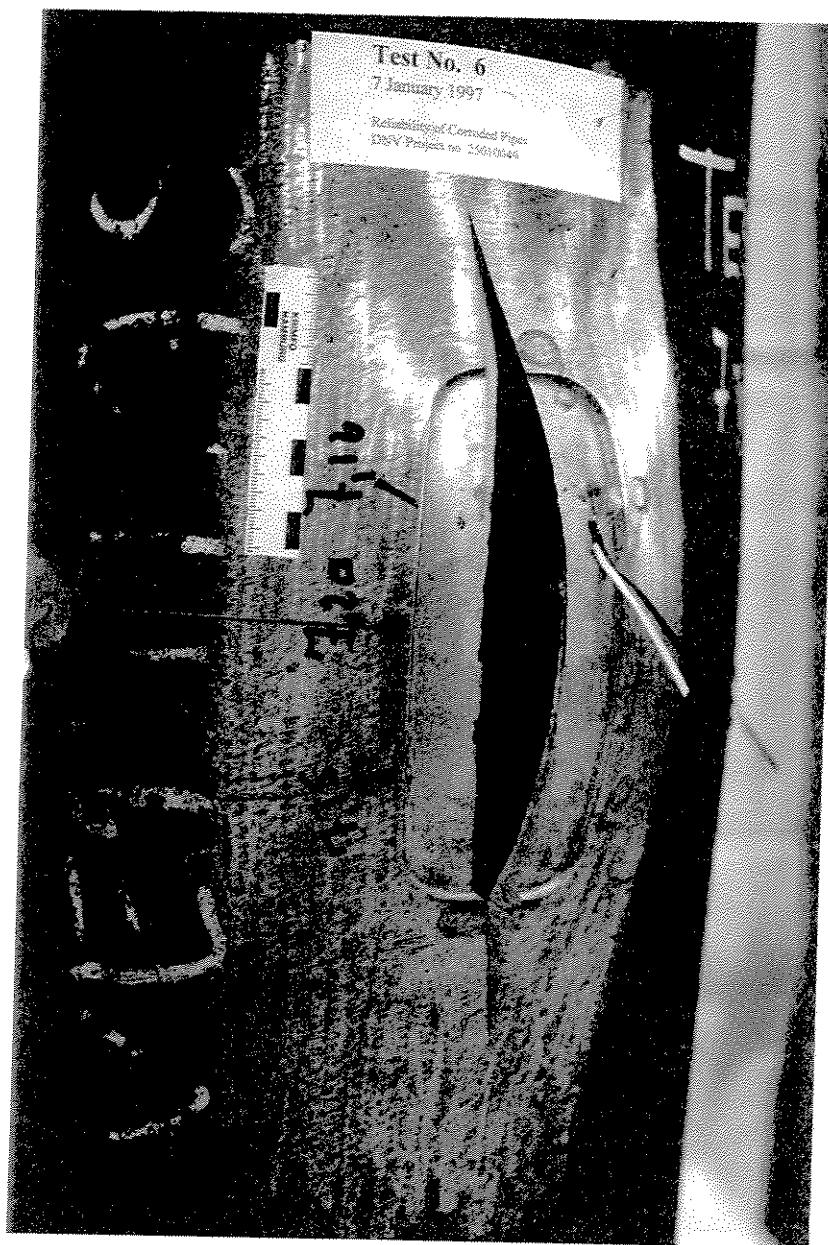
Figure 4-28 Picture of the test specimen no. 6 after the burst test

Figure 4-29 Picture of the test specimen no. 6 after the burst test

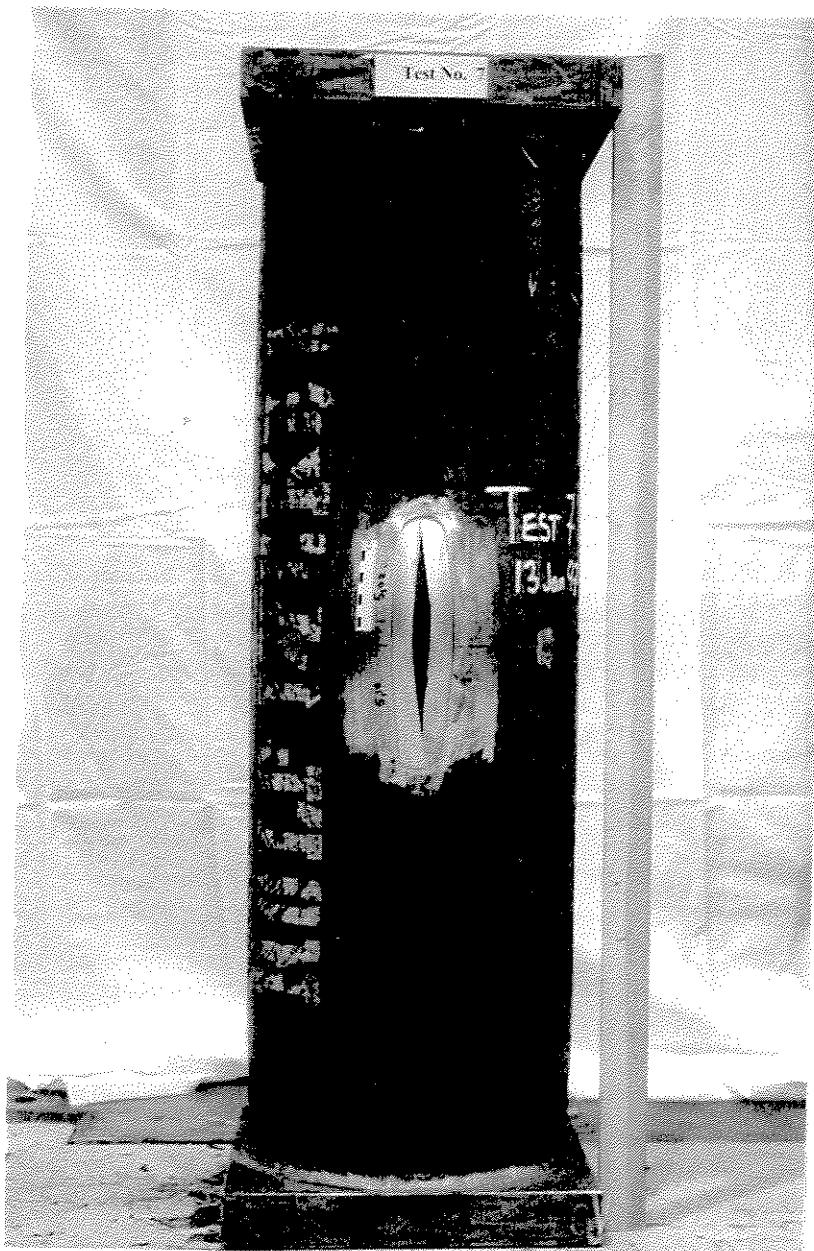
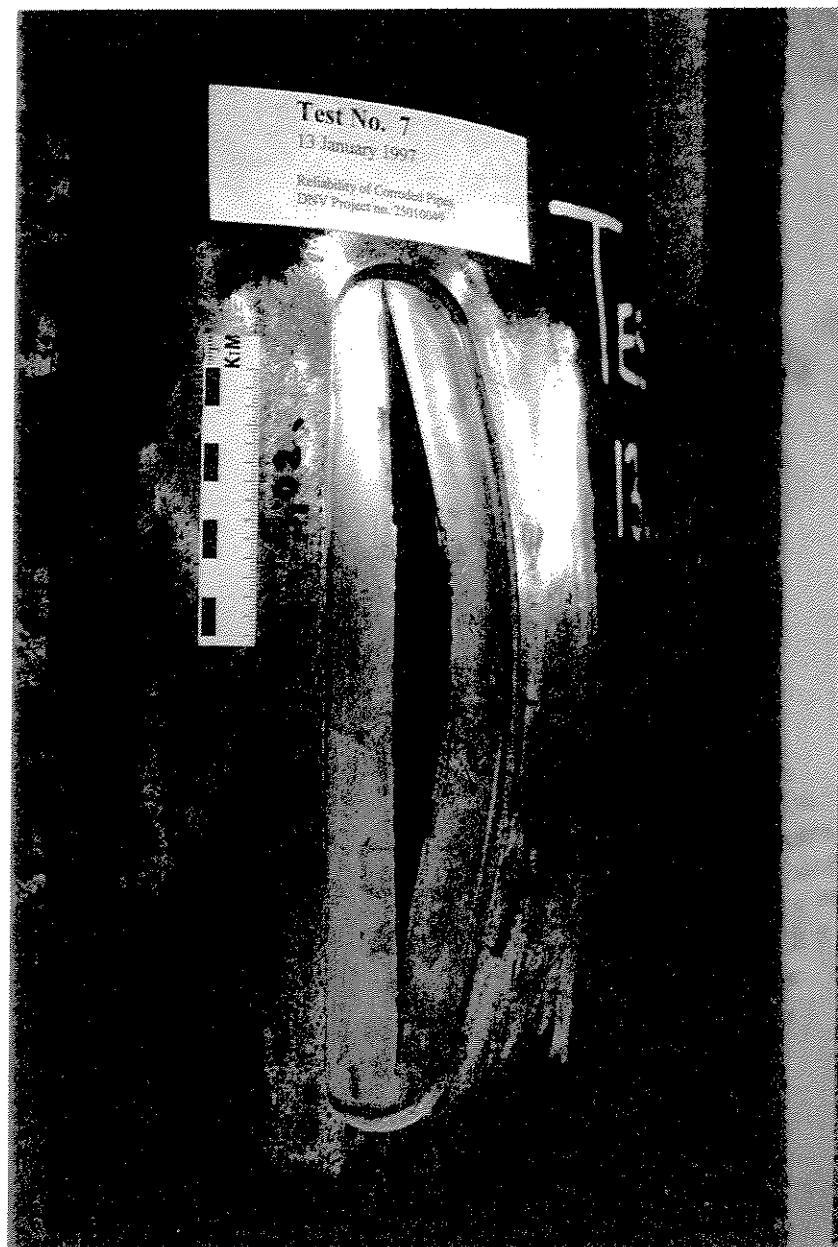
Figure 4-32 Picture of the test specimen no. 7 after the burst test

Figure 4-33 Picture of the test specimen no. 7 after the burst test

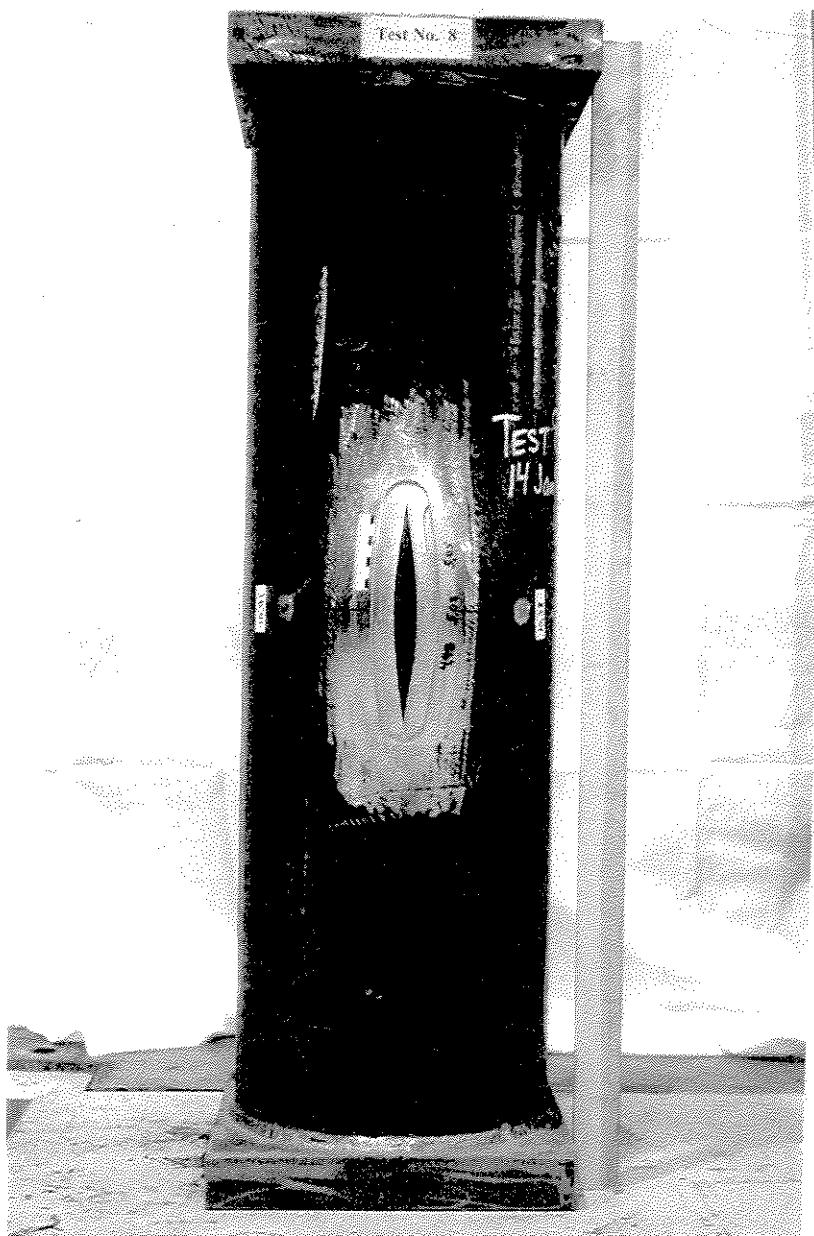
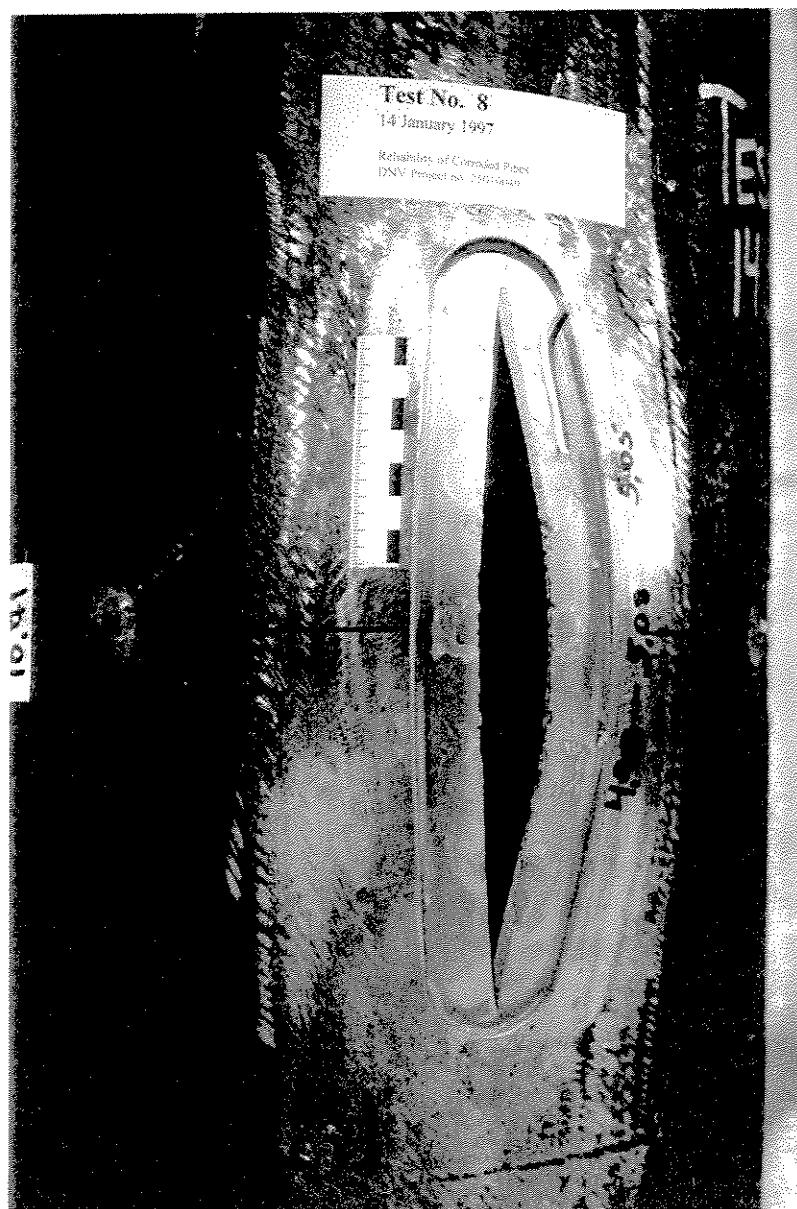
Figure 4-35 Picture of the test specimen no. 8 after the burst test

Figure 4-36 Picture of the test specimen no. 8 after the burst test

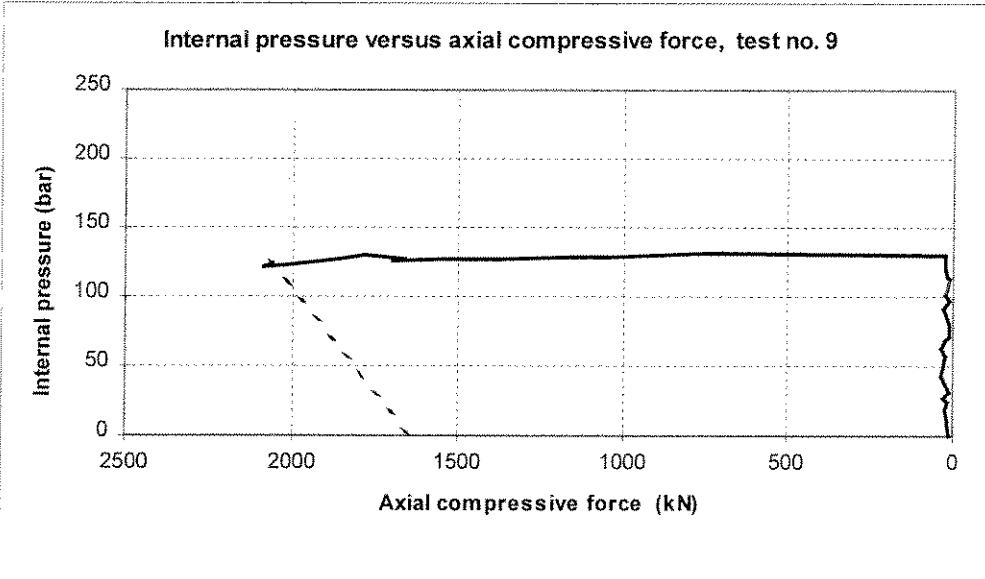
Figure 4-38 Internal pressure versus axial compressive force, test no. 9

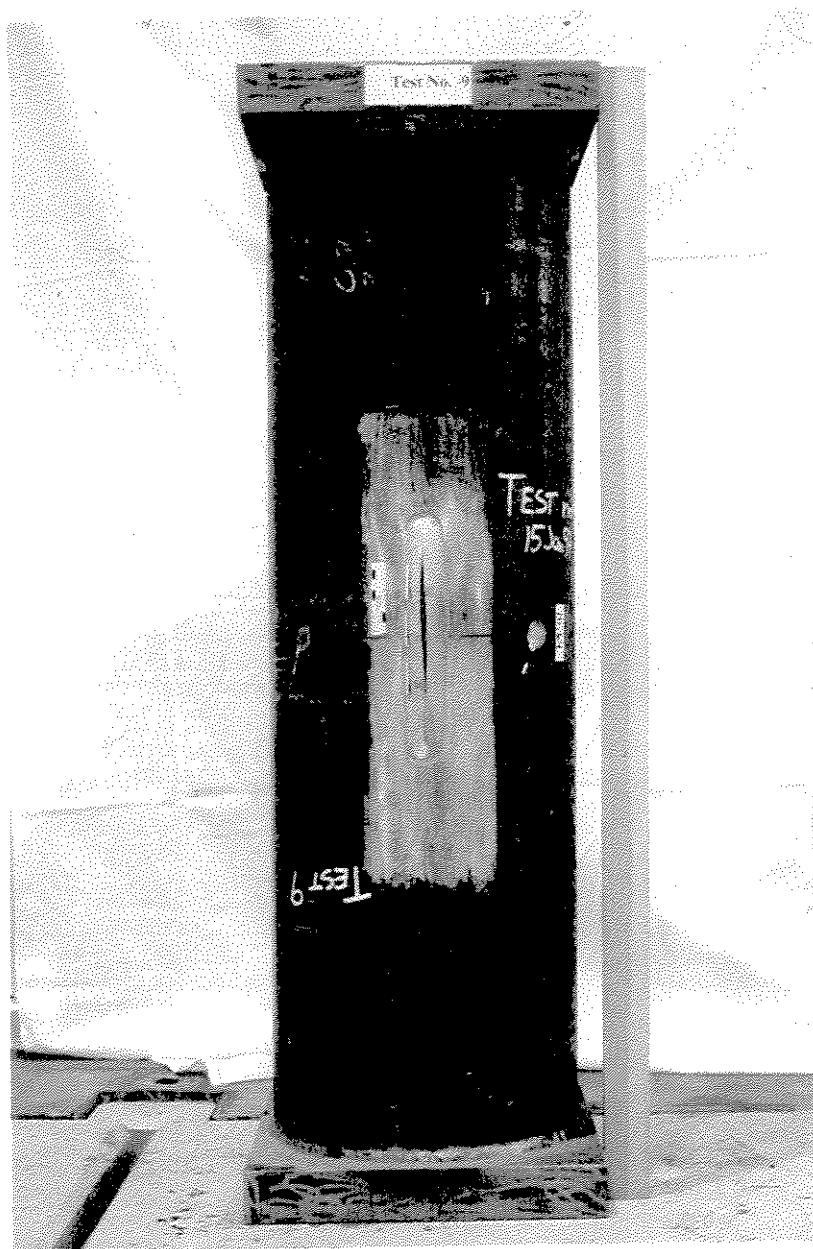
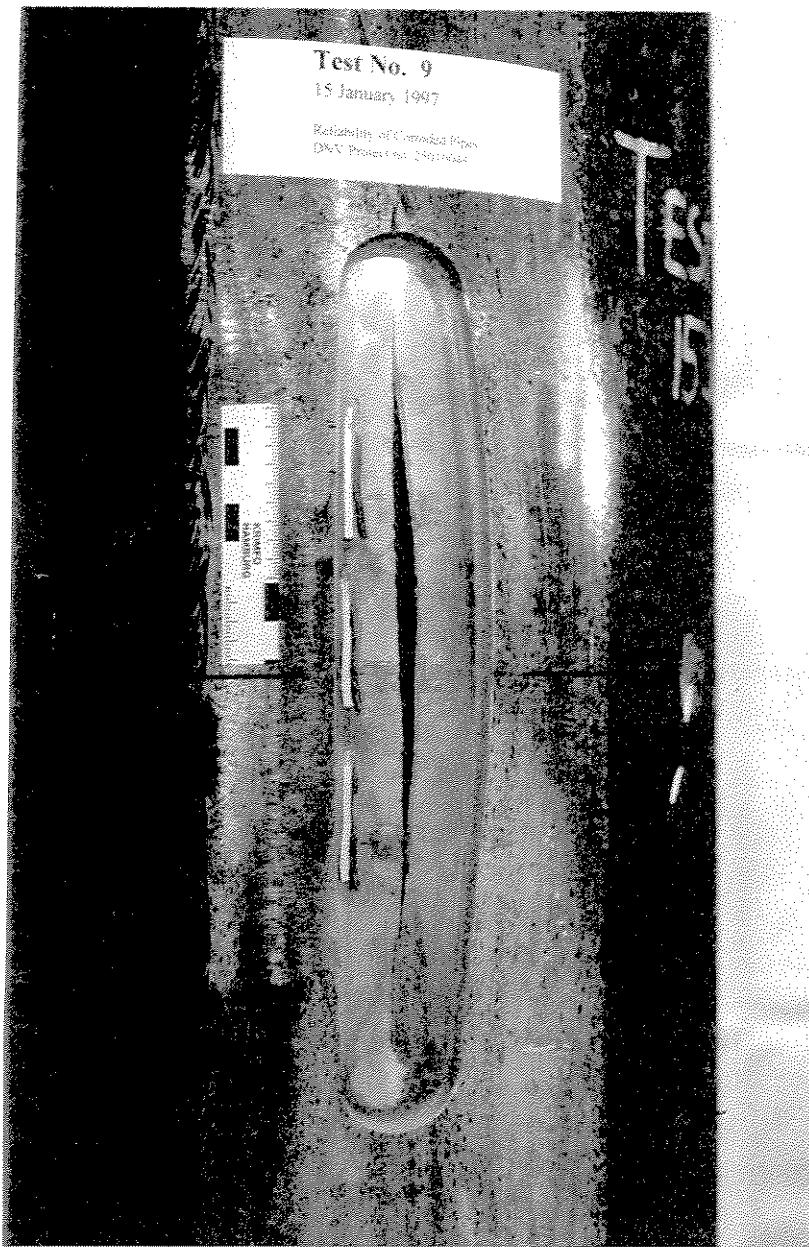
Figure 4-39 Picture of the test specimen no. 9 after the burst test

Figure 4-40 Picture of the test specimen no. 9 after the burst test

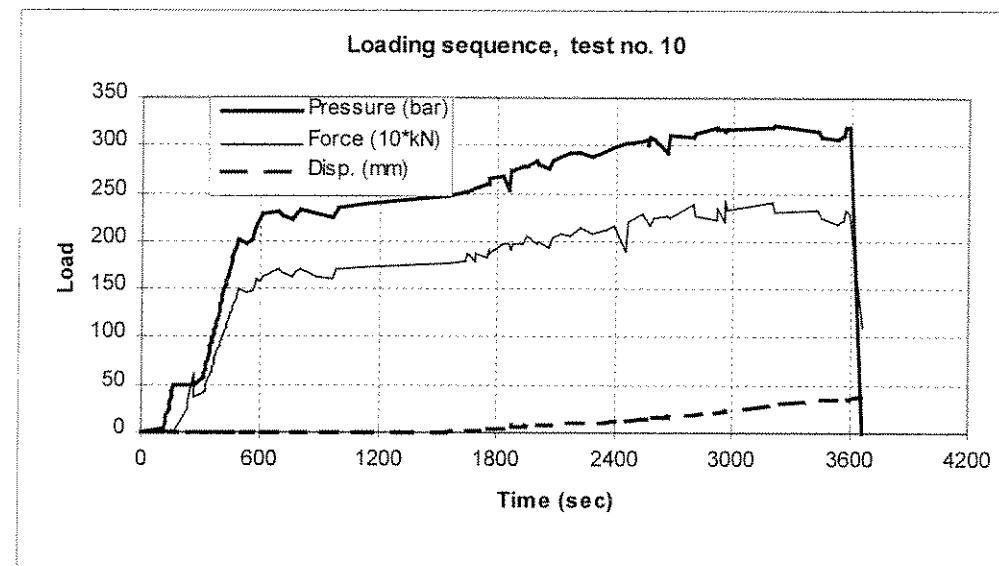
Figure 4-41 Loading sequence, test no. 10

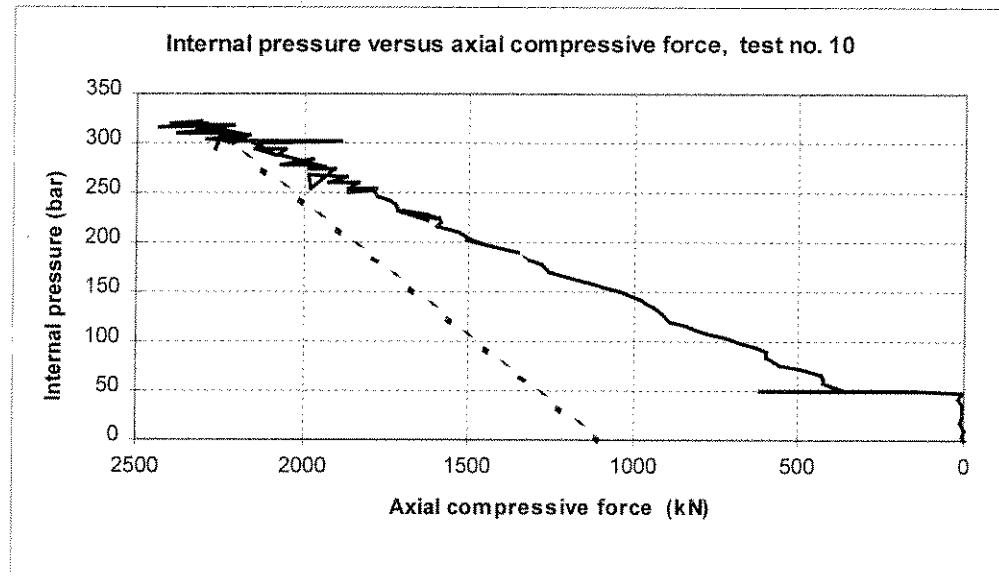
Figure 4-42 Internal pressure versus axial compressive force, test no. 10

Burst occurred at 320 bar and with an axial compressive force of 2289 kN. The rupture was in the longitudinal direction, even though the corrosion defect was in the circumferential direction.

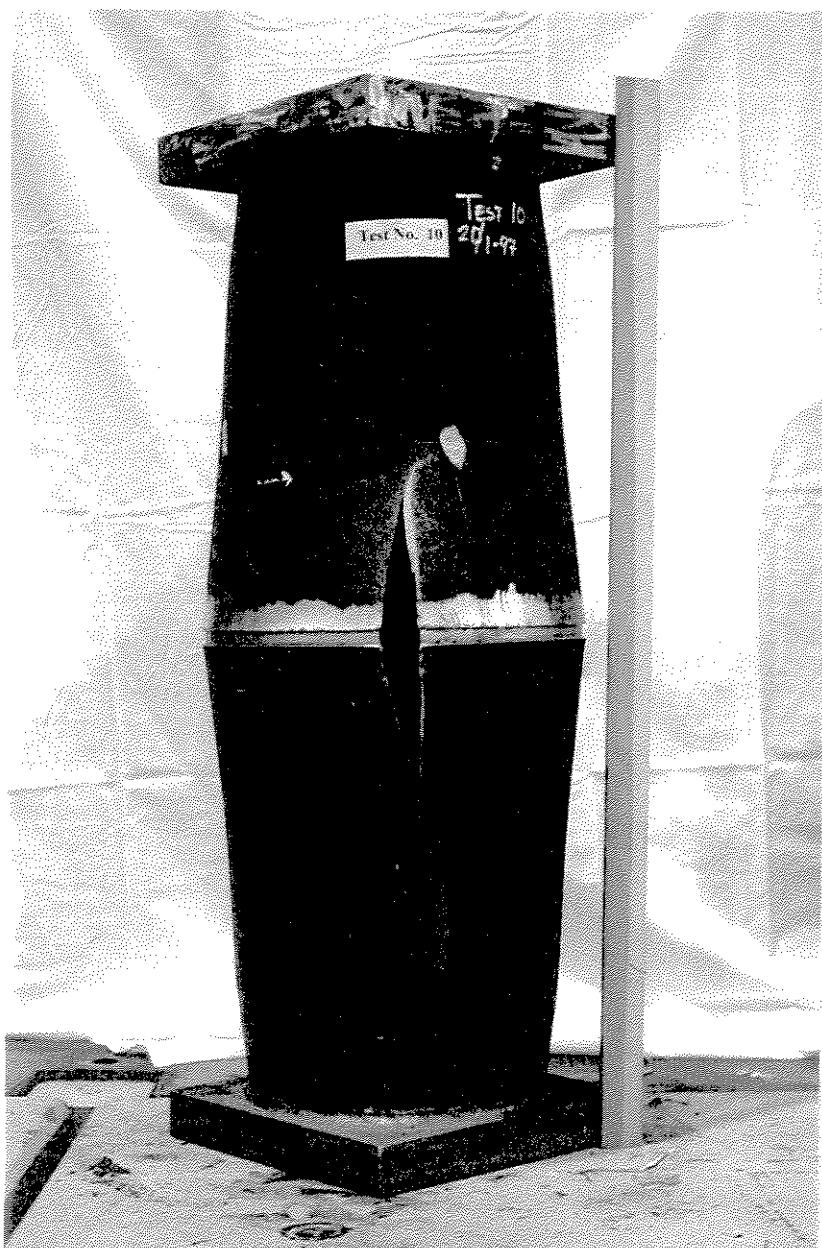
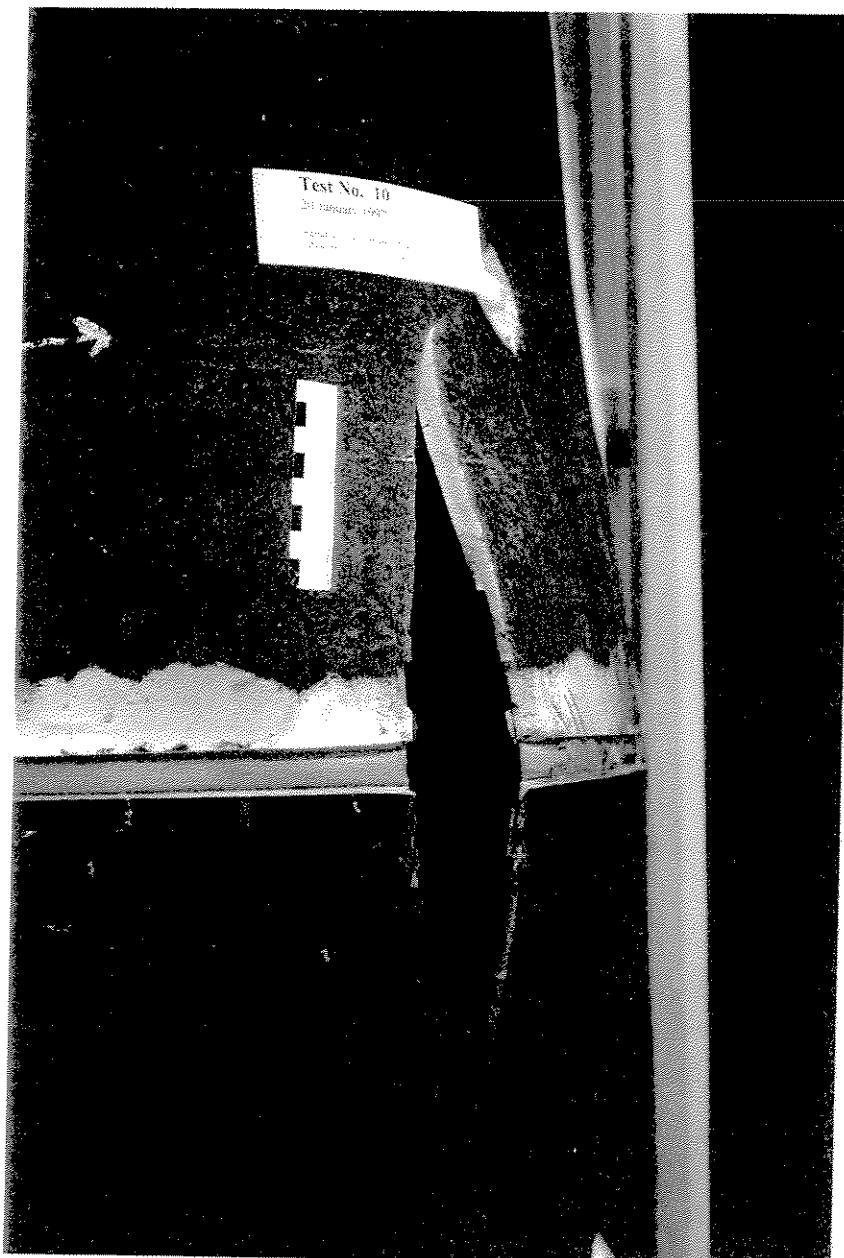
Figure 4-43 Picture of the test specimen no. 10 after the burst test

Figure 4-44 Picture of the test specimen no. 10 after the burst test

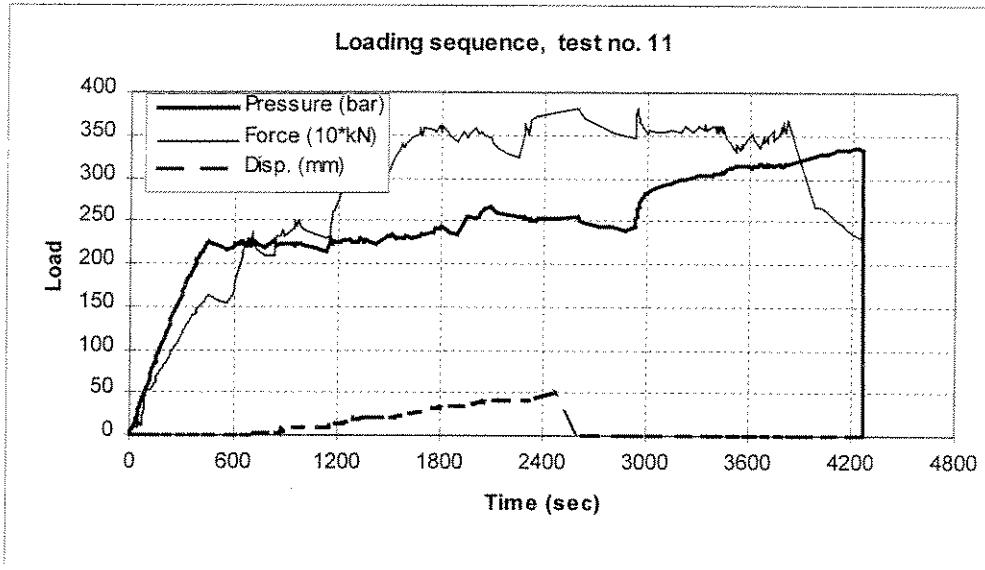
Figure 4-45 Loading sequence, test no. 11

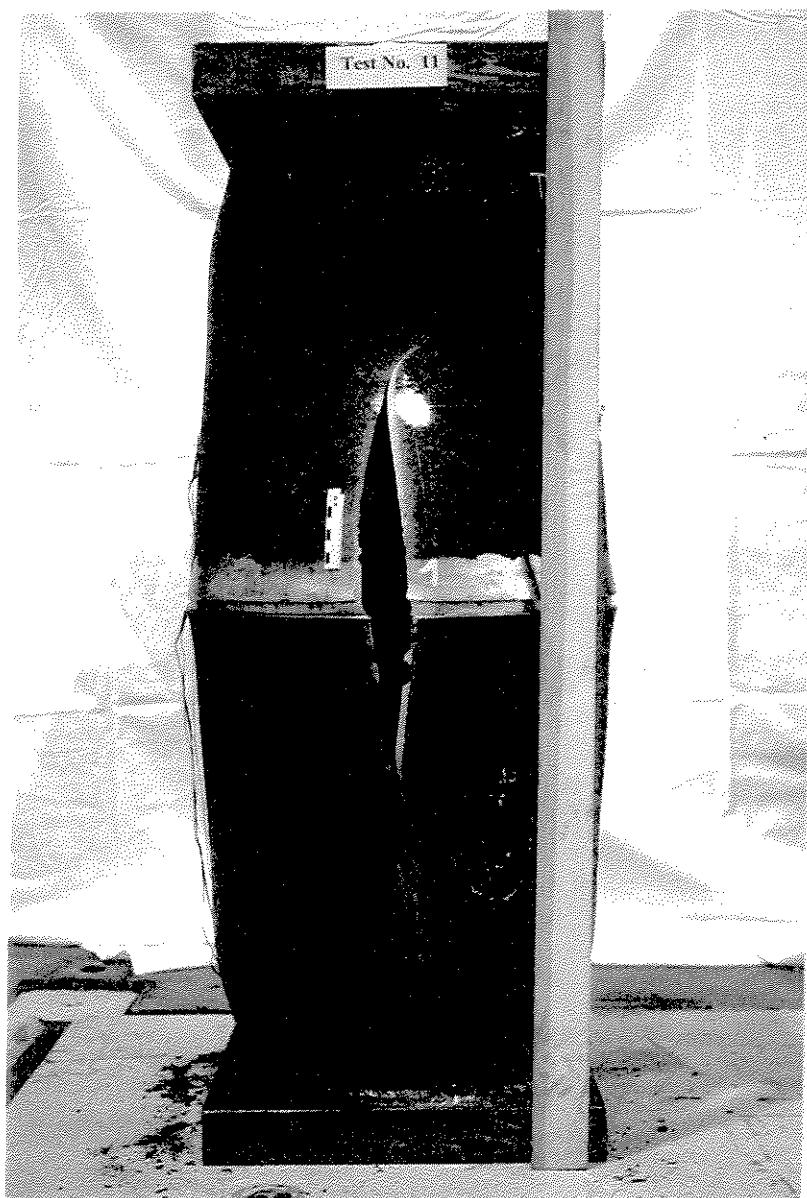
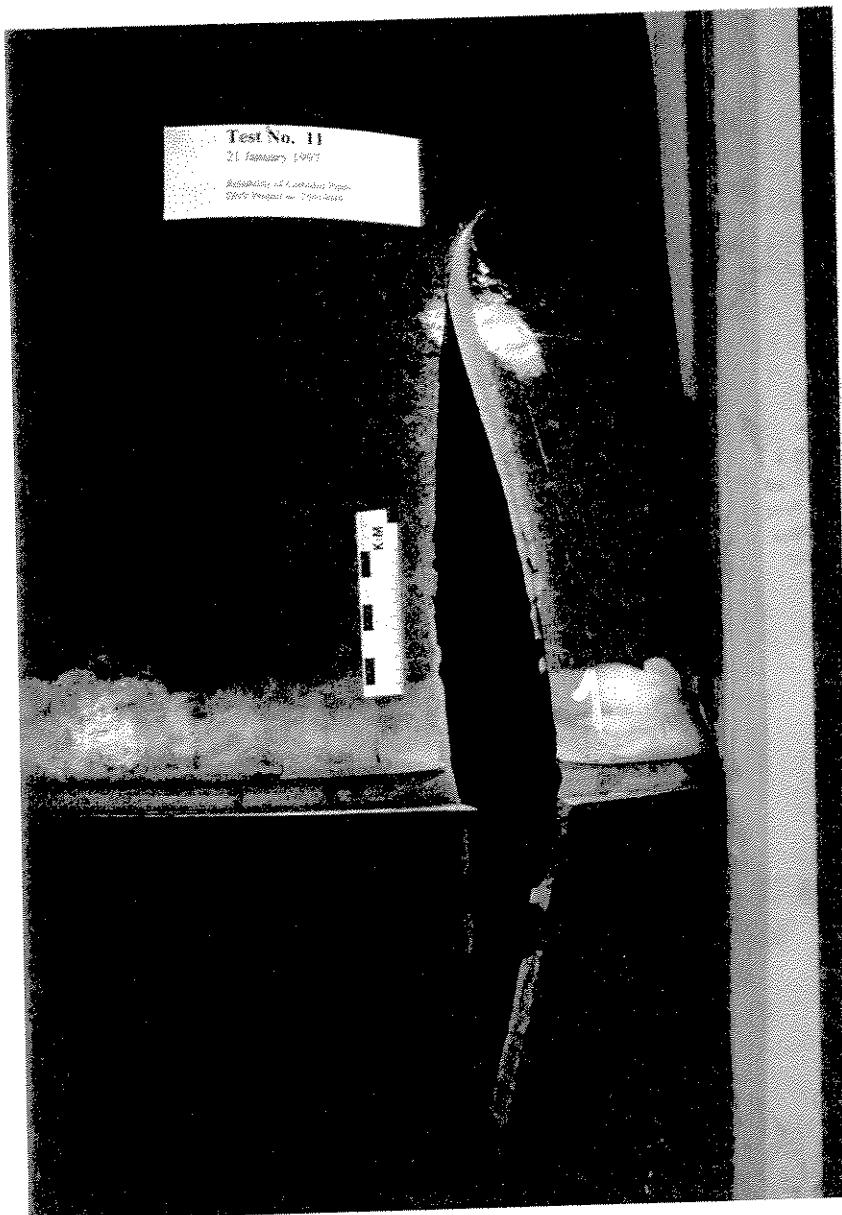
Figure 4-47 Picture of the test specimen no. 11 after the burst test

Figure 4-48 Picture of the test specimen no. 11 after the burst test

Burst occurred at 335 bar and with an axial compressive force of 2345 kN. The rupture was in the longitudinal direction, even though the corrosion defect was in the circumferential direction.

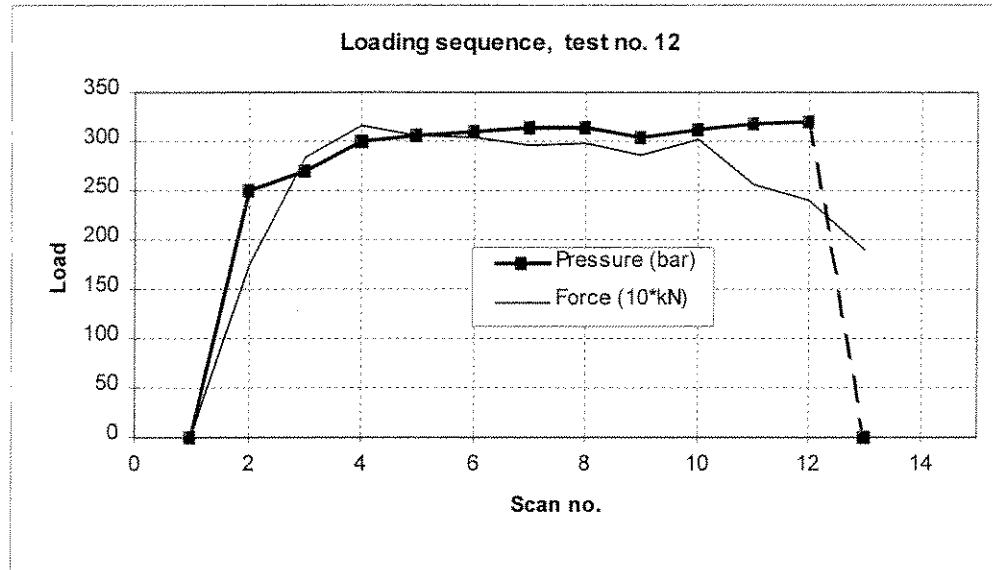
Figure 4-49 Loading sequence, test no. 12

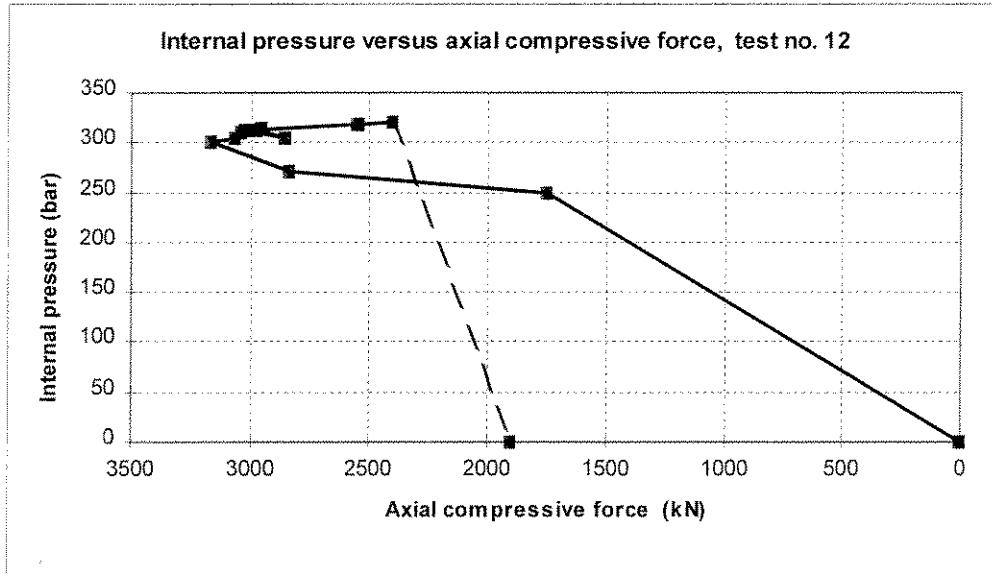
Figure 4-50 Internal pressure versus axial compressive force, test no. 12

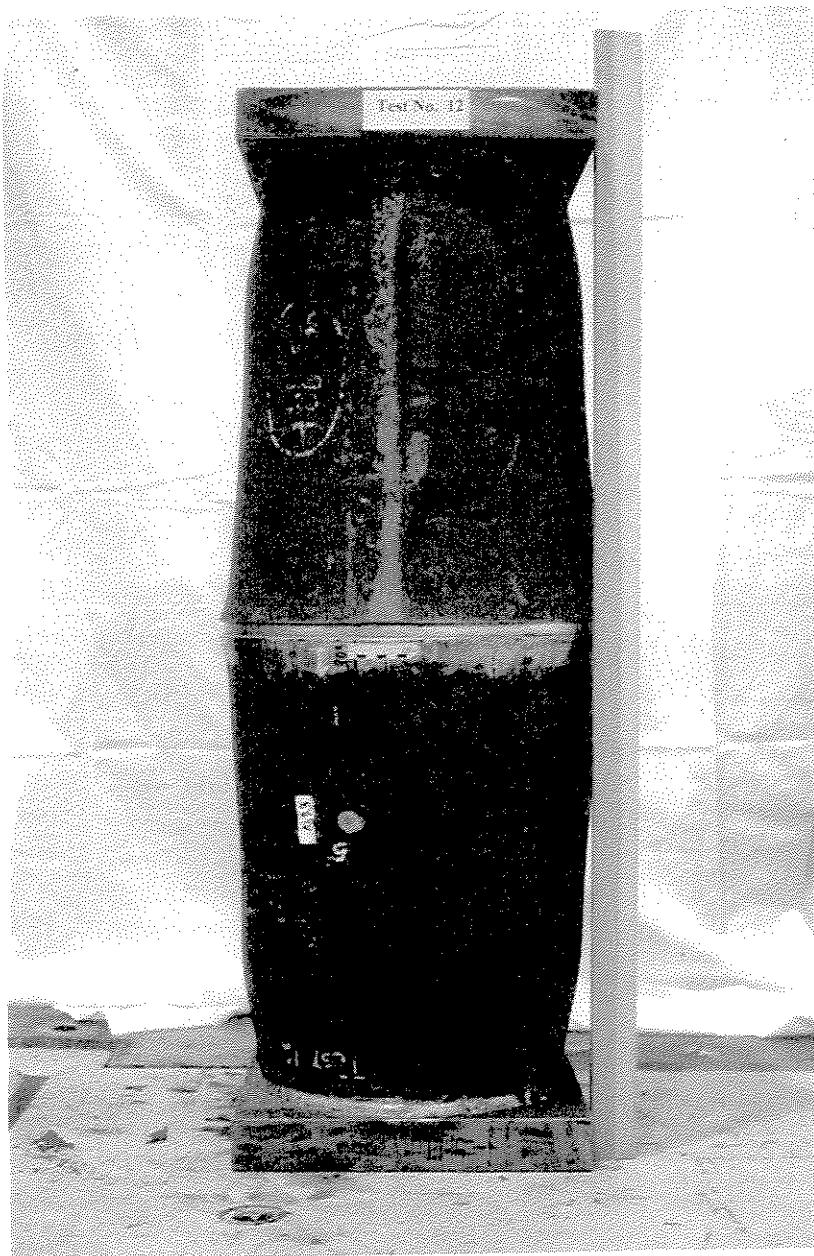
Figure 4-51 Picture of the test specimen no. 12 after the burst test

The test specimen bursted at 321 bar with an axial compressive force of 2399 kN. The rupture was in the bottom of the groove with a length of 70 mm.

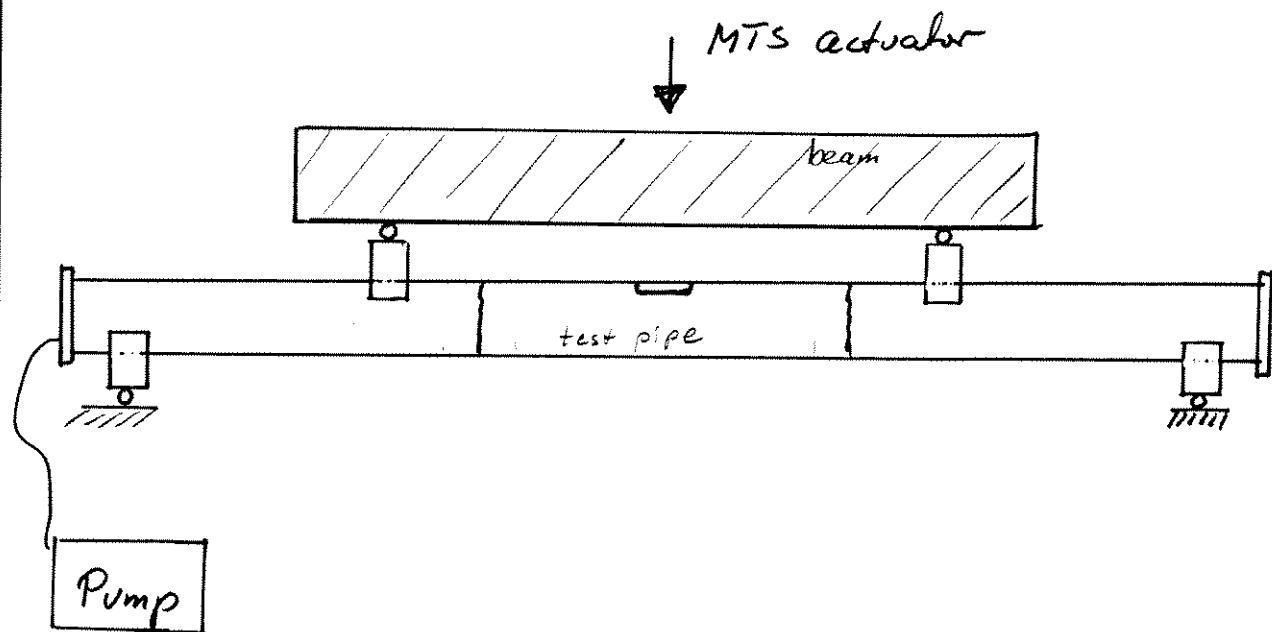
Test set-up for combined internal pressure  
and 4-point bending moment.

(not to scale)

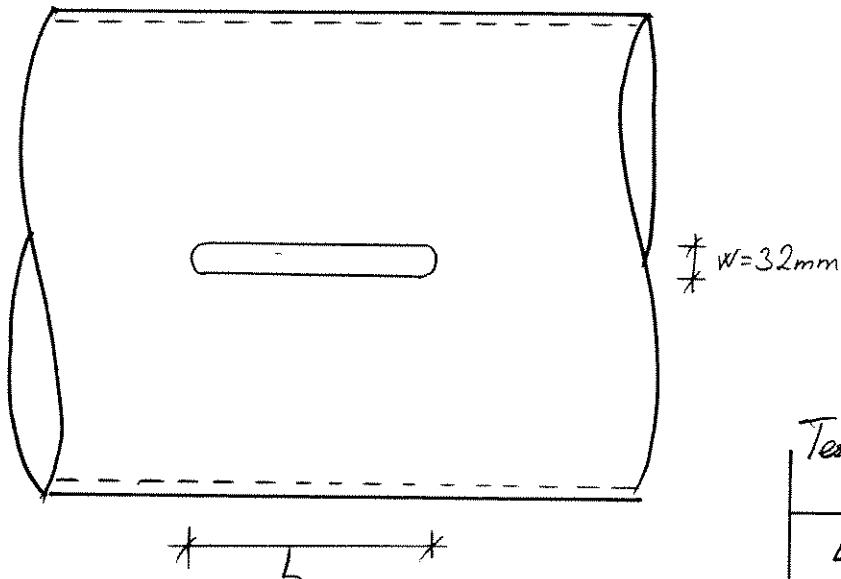
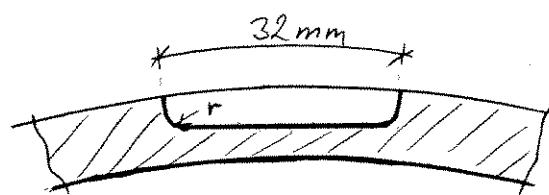
Spark eroded defects.

$D = 324 \text{ mm}$  defect :  $d$  - various $t \sim 10.5 \text{ mm}$  :  $L$  - various:  $w = 32 \text{ mm}$

Test no.	$L$ mm	$d$ mm	$r$ mm
4	162	3.2	3
5	162	3.2	3
6	162	3.2	3
7	245	5.3	3
8	245	5.3	3
9	245	7.5	3

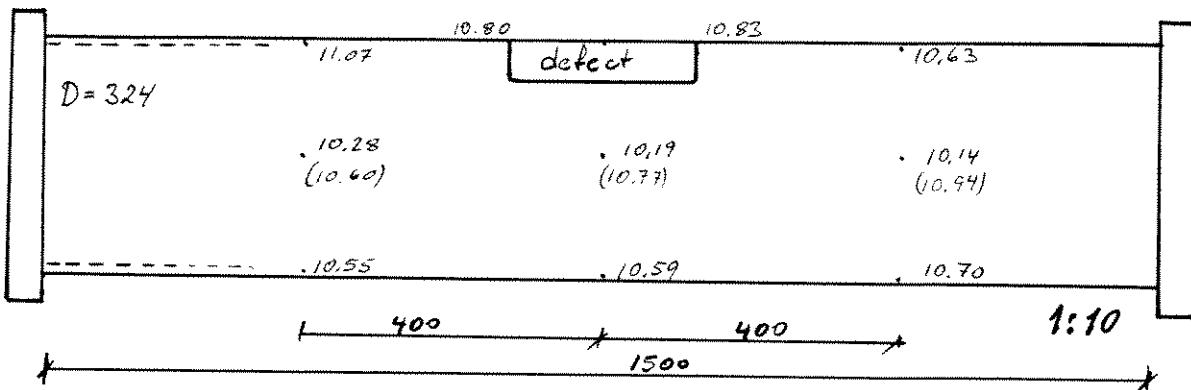
### Thickness measurements (mm)
