RELIABILITY OF CORRODED PIPES  
LABORATORY BURST TESTS

REPORT No. 96-3393  
REVISION No. 02

DET NORSKE VERITAS

This report is one of a serie of 4 reports in the JIP project "Reliability of Corroded Pipes", and describes the laboratory burst tests of pipes with simulated corrosion defects. This project is a continuation of the JIP project "Residual Strength of Dented and Corroded Pipes".

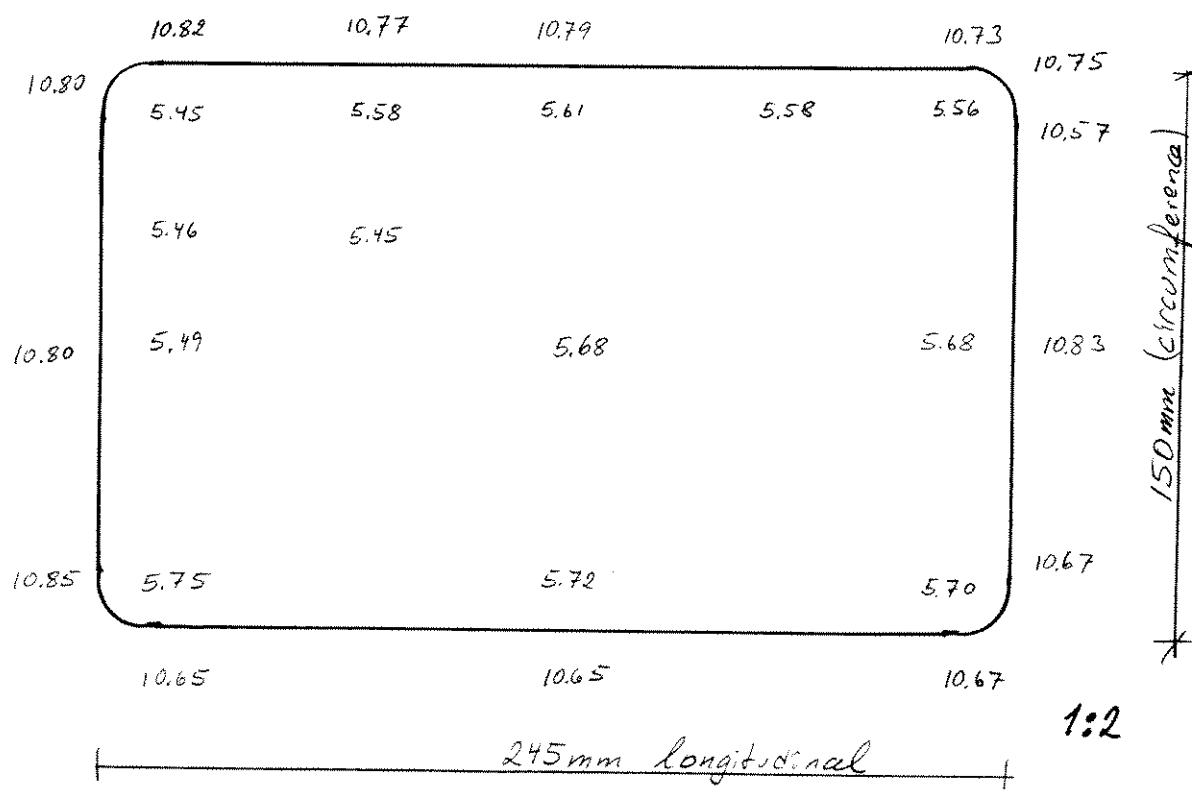
### Thickness measurements of the corrosion defect (mm)

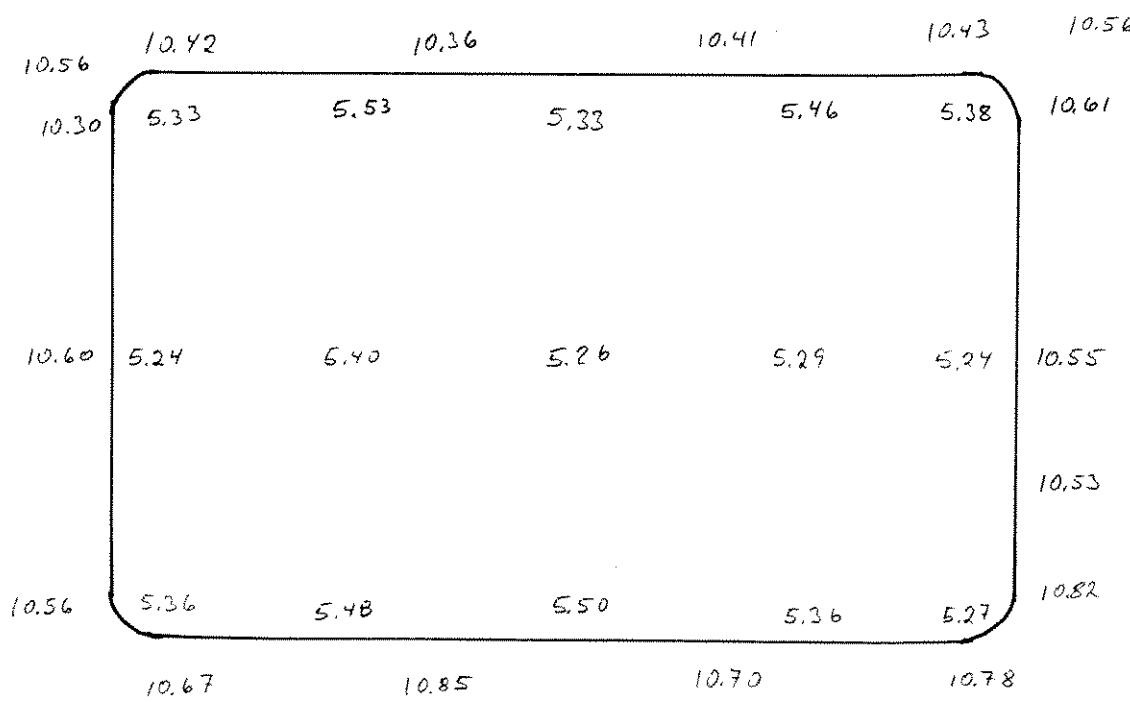
### Thickness measurements of the corrosion defect (mm)
