# Hurricane Ivan Pipeline Subcommittee

Pipeline Response Management in  
the wake of Hurricane Ivan

July 27, 2005

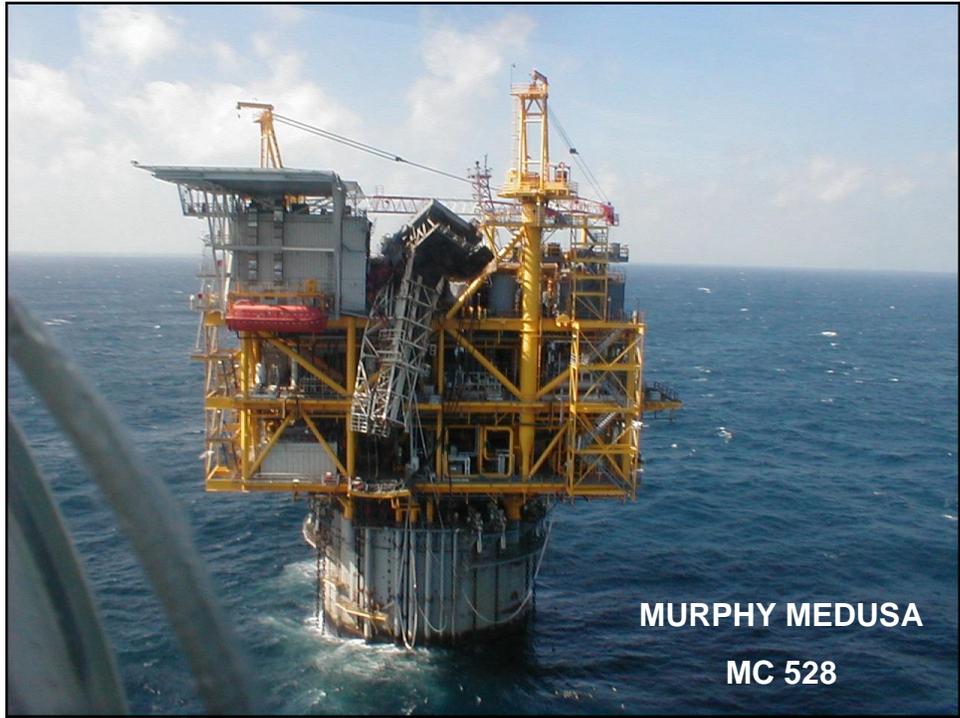
MC 528

MURPHY MEDUSA

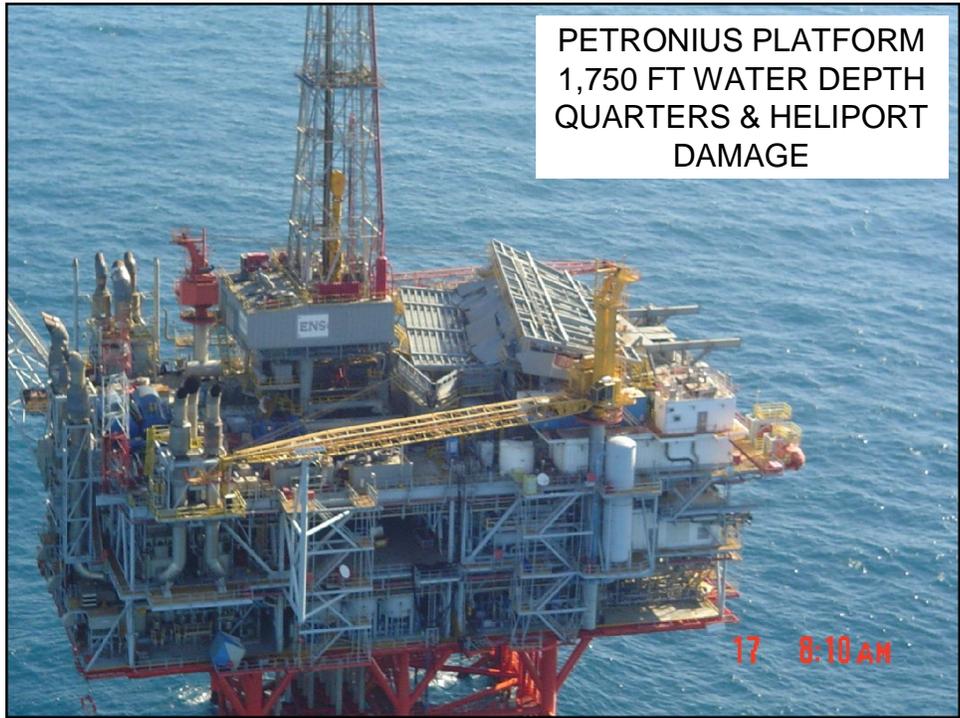
PETRONIUS PLATFORM  
1,750 FT WATER DEPTH  
QUARTERS & HELIPORT  
DAMAGE

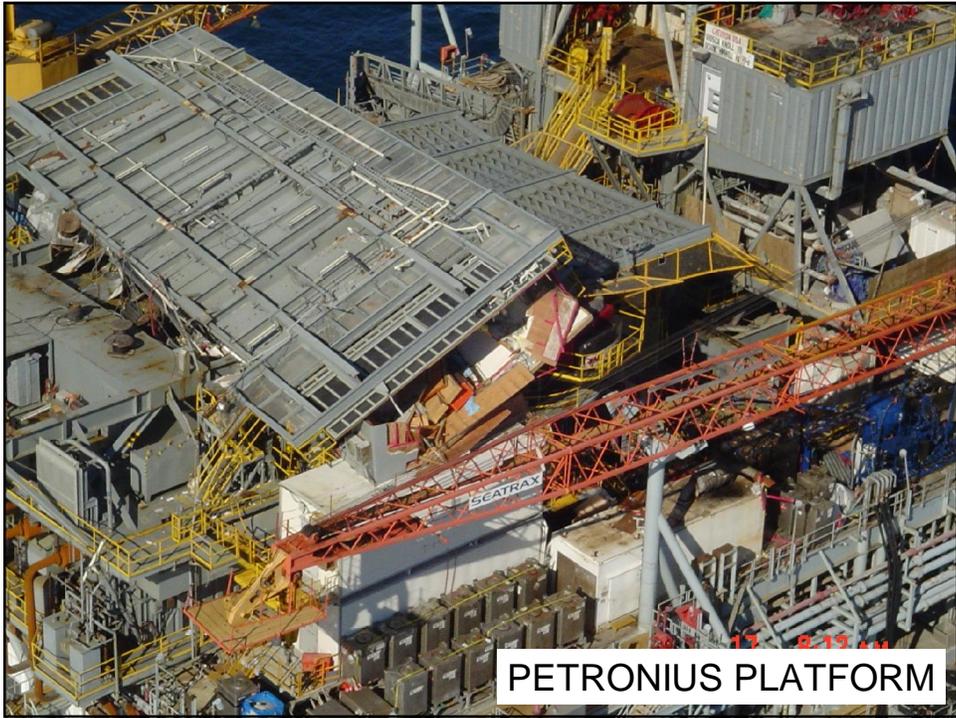
PETRONIUS PLATFORM

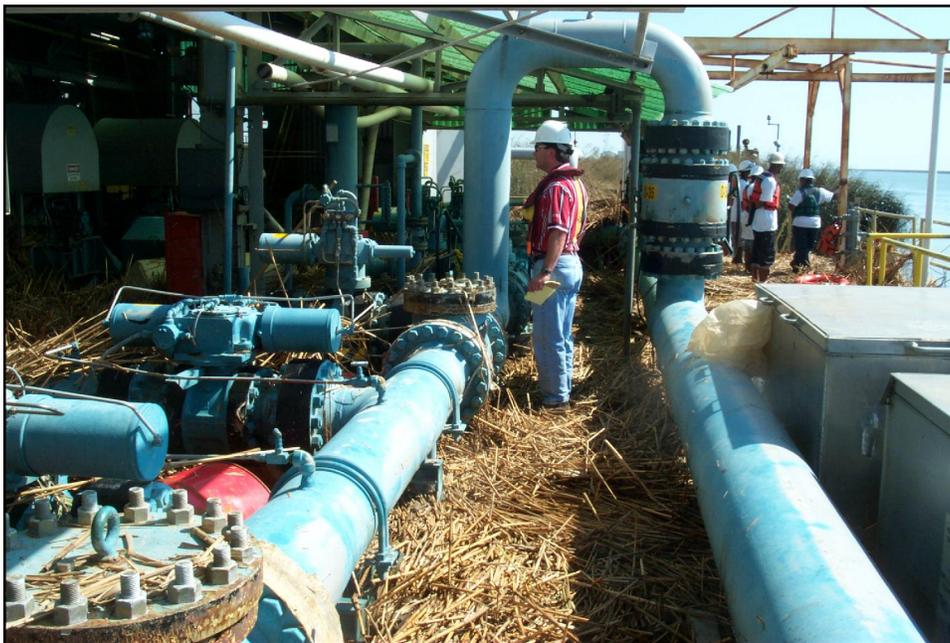
MP 69 PUMP STATION

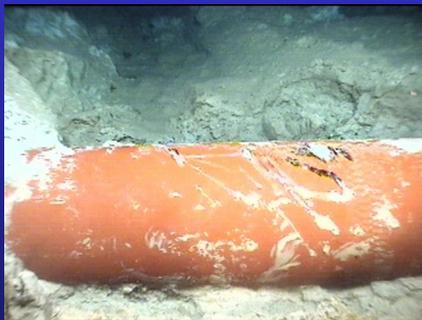
## Drilling Rig Broke Loose from Mooring Crossed Nakika Oil Line With Rig Dragging Three Anchor Cables

Nakika North Drag Mark - West Side

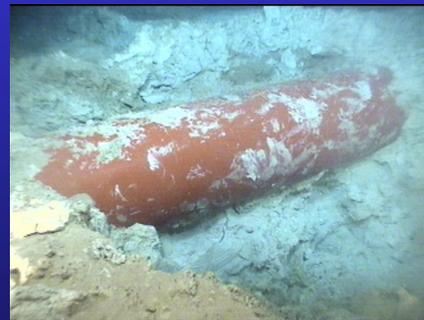
Nakika North Drag Mark – East Side

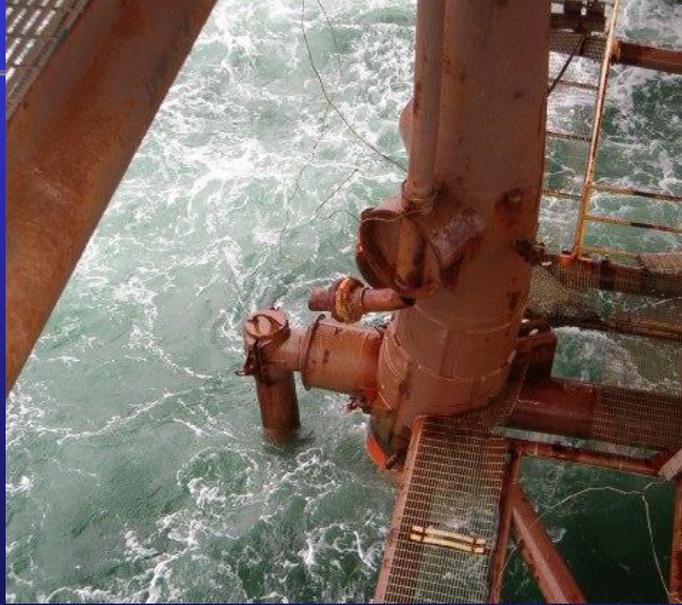
### South Pass 60 Severed 8-inch Riser – Site #6

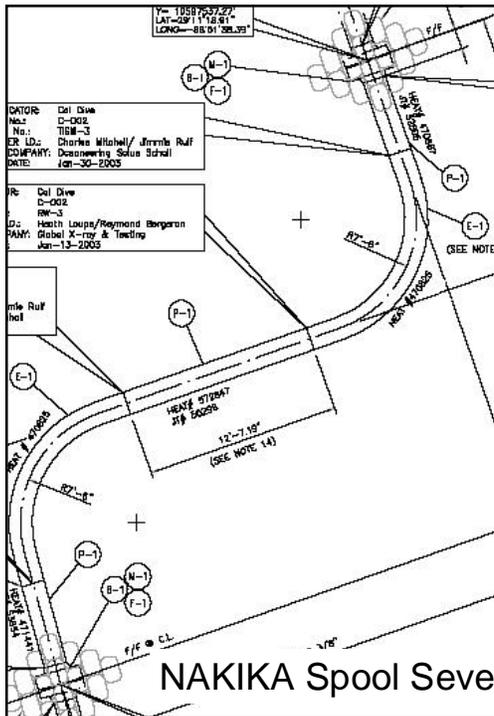
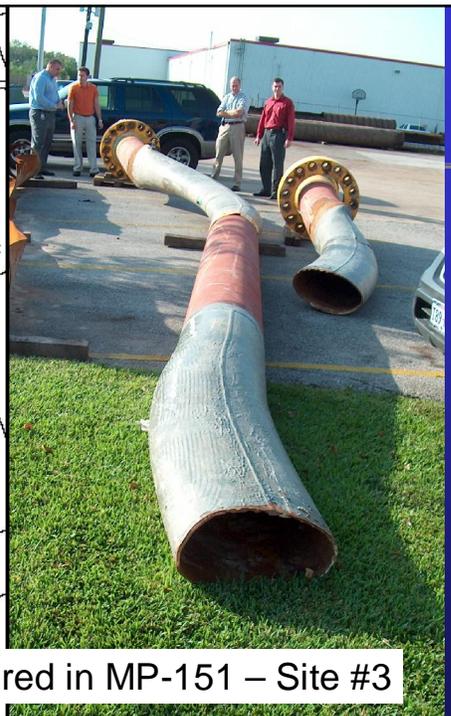
### NAKIKI Spool Severed in MP-151 – Site #3

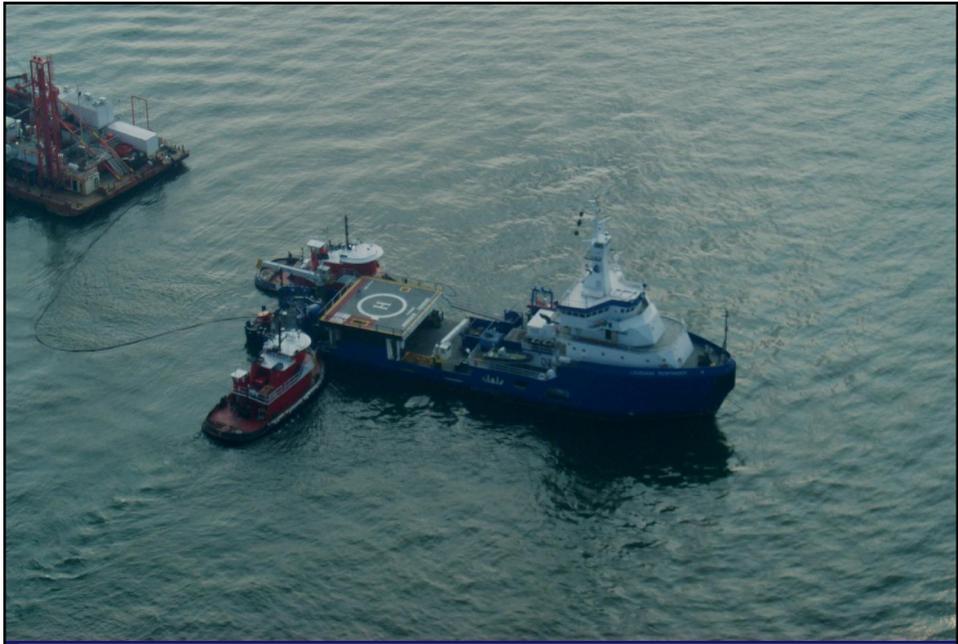
MSRC - LOUISIANA RESPONDER AT NAKIKA SITE 2

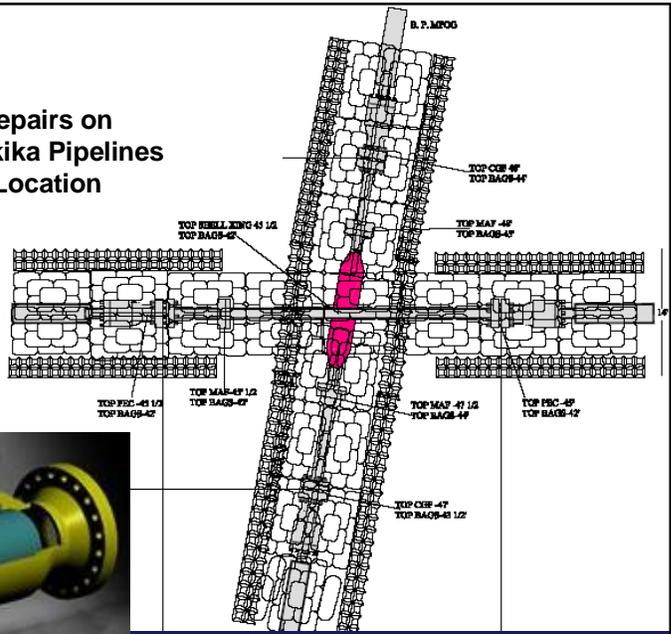
Nakika / MPOG Crossing – Site #2

Spool Piece Repairs on both MPOG & Nakika Pipelines at Crossing Location
