Safety Alert No. 339
3 AUGUST 2018

Running of Gas Sensing Line in Cable Tray Leads to Fire

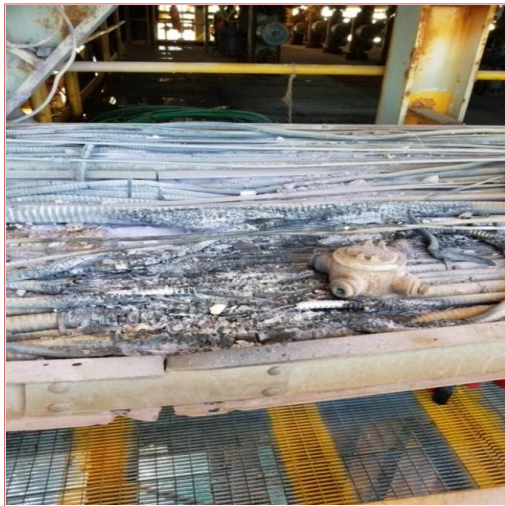
Damaged Area from Fire.

During the incident investigation, a defect was discovered in the electrical wiring within the cable tray. Deterioration appears to have occurred over time to the outer PVC jacket and inner aluminum armor. This condition may have caused internal conductors to be exposed. The defect in the wiring subsequently introduced a hazardous electrical arc. The electrical arc extended across the cable tray, which damaged the ¼ inch gas pressure sensing line that ran within the tray. As a result, the gas pressure sensing line began to leak fluid. The fluid leak in this line, combined with the source of ignition (the electrical arc), produced a small flame that scorched an area approximately one square foot. No injuries resulted from this incident.

- Review company and/or contractor operating procedures for electrical installations to confirm that the documentation includes verifying that raceways or cable trays containing electrical conductors do not also contain any pipe, tube, or equivalent for steam, water, air, gas, drainage, or any service other than electrical as per API RP 14F that reference NEC 300.8.

- Inspect all raceways or cable trays with electrical conductors to ensure they do not also contain any pipe, tube, or equal for steam, water, air, gas, drainage, or any service other than electrical as per API RP 14F that reference NEC 300.8. Install or reroute non-electrical piping in areas away from trays containing electrical conductors.

- To avoid potential defects in wiring, ensure that personnel (direct and/or contractor employees) have adequate knowledge and skills for the proper installation of electrical conductors within raceways and cable trays.

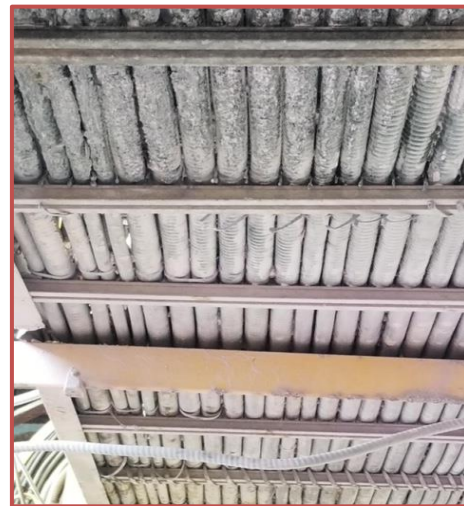
Bottom-view of Cable Damage.
