**2020 BREAK-UP STUDY  
OF ARCTIC SEA ICE IN THE  
ALASKAN BEAUFORT AND CHUKCHI SEAS  
APPENDIX A: DRAWINGS**

**2019-20 Freeze-Up and 2020 Break-Up Studies of Arctic Sea Ice  
in the Alaskan Beaufort and Chukchi Seas**

**Post-Remote Imaging Acquisition Progress Report No. 11**

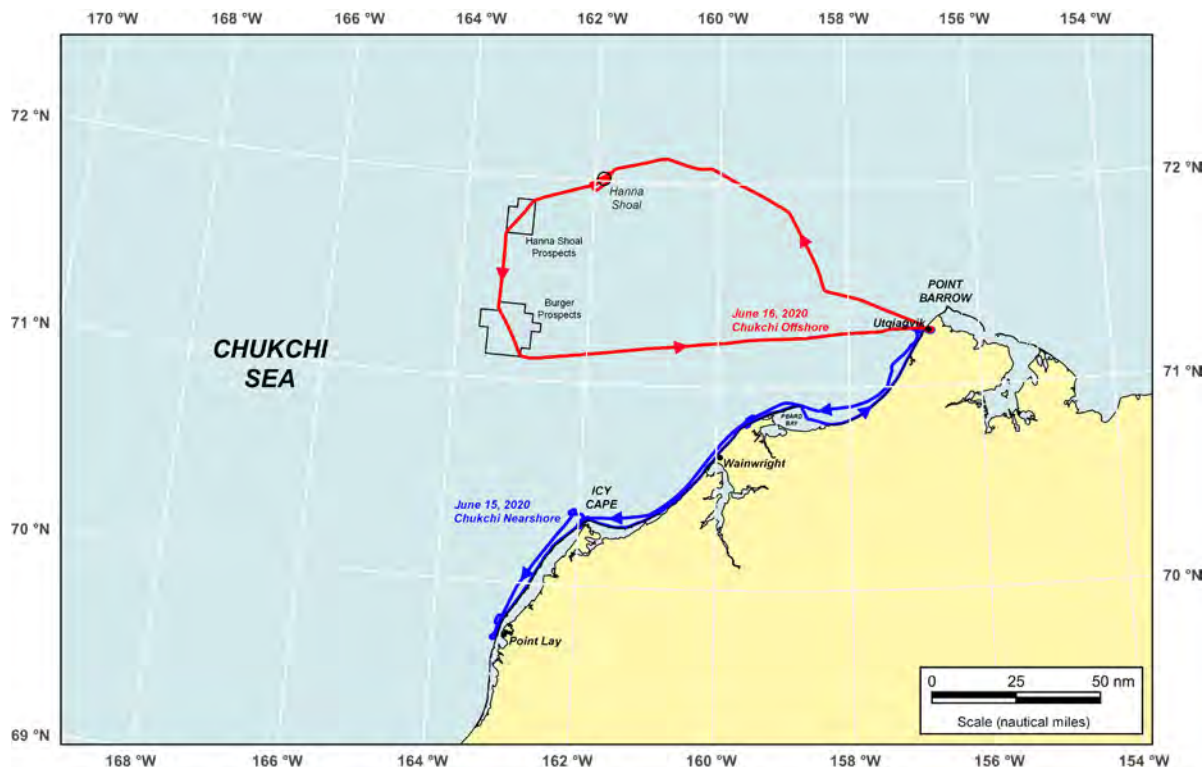
**Figure 1. Flight Paths in Alaskan Chukchi Sea**

*Nearshore Chukchi Sea (June 15<sup>th</sup>):* After departing from Utqiagvik, the aircraft headed southwest over the retreating strip of landfast ice. The aircraft reversed direction at Point Lay, returning to Utqiagvik along the coastline to facilitate the observation of shoreline pile-ups. The flight was conducted under clear skies with excellent visibility until just prior to landing, when dense fog was encountered.

*Offshore Chukchi Sea (June 16<sup>th</sup>):* The flight path consisted of a counterclockwise loop that began and ended at Utqiagvik and included Hanna Shoal, the Hanna Shoal Prospects, and the Burger Prospects along with several small deviations to observe the edge of the retreating pack ice as well as pieces of landfast ice that had been dislodged and drifted offshore. With the exception of the region north and west of the Burger Prospects, where fog was present, clear skies and excellent visibility prevailed.

*Katie's Floeberg:* Katie's Floeberg, which forms each winter when ice rubble accumulates on Hanna Shoal (Figure 1), measured 5.5 km long and 2.5 km wide, with the major axis oriented northeast-southwest. It was composed of about 80% first-year ice and 20% multi-year ice (Plate 8). The maximum rubble height, 20 m, was located on the southwest side of a multi-year floe near the center of the floeberg. An open-water wake was present on the downwind (west) side, indicating that the feature remained well-grounded at the time of the flight.

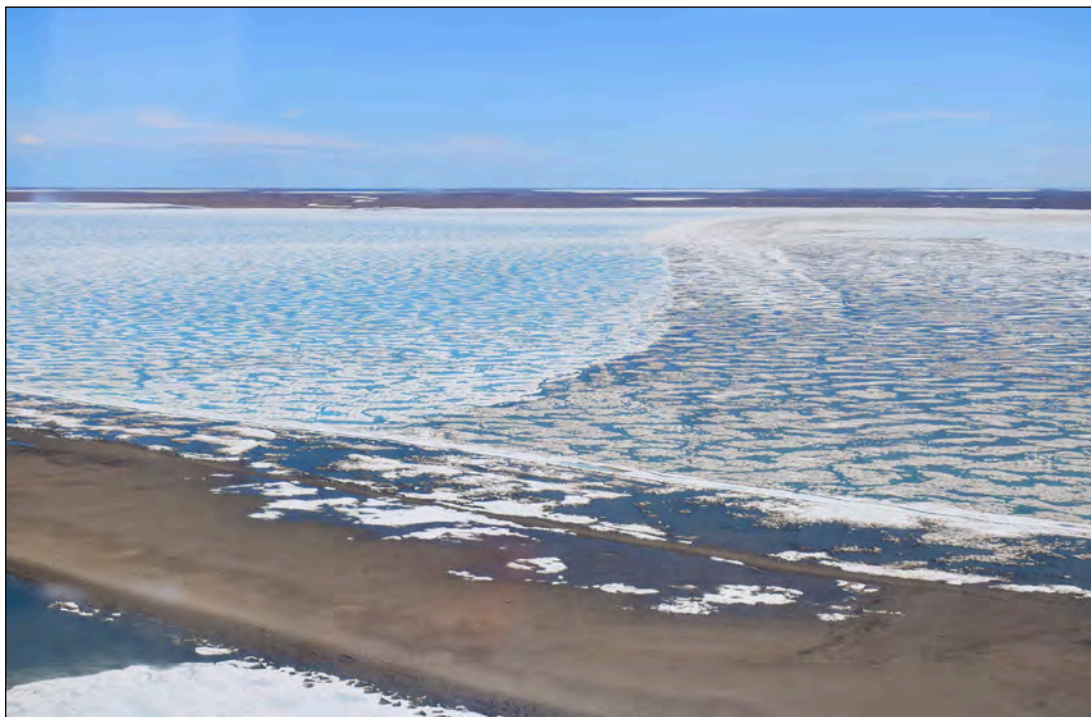
*Lagoon Ice:* Ice coverage in the semi-protected lagoons ranged from negligible in portions of South Kasegaluk Lagoon and the Kuk River Entrance Channel to 10/10s in Peard Bay. In all instances where ice was present, it was badly deteriorated as evidenced by numerous melt ponds and through-ice holes (Plate 1).

**Plate 1. Rotten Ice in Peard Bay  
(June 15, 2020)**

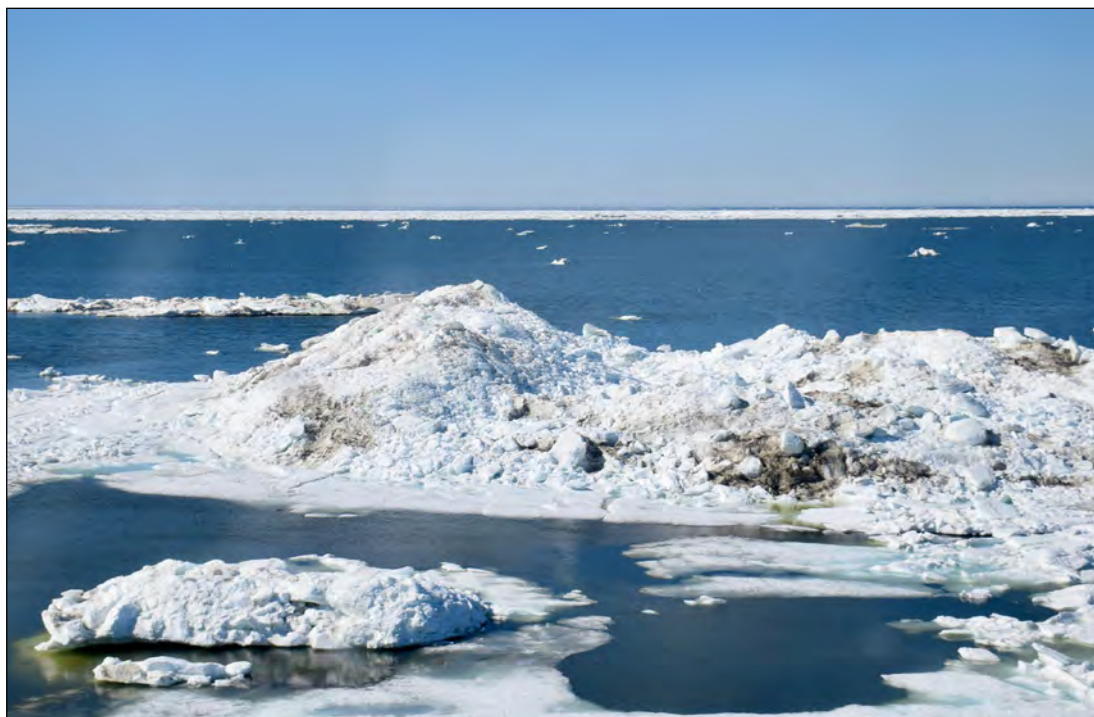
**Plate 2. 20-m Rubble Pile on Blossom Shoals  
(June 15, 2020)**

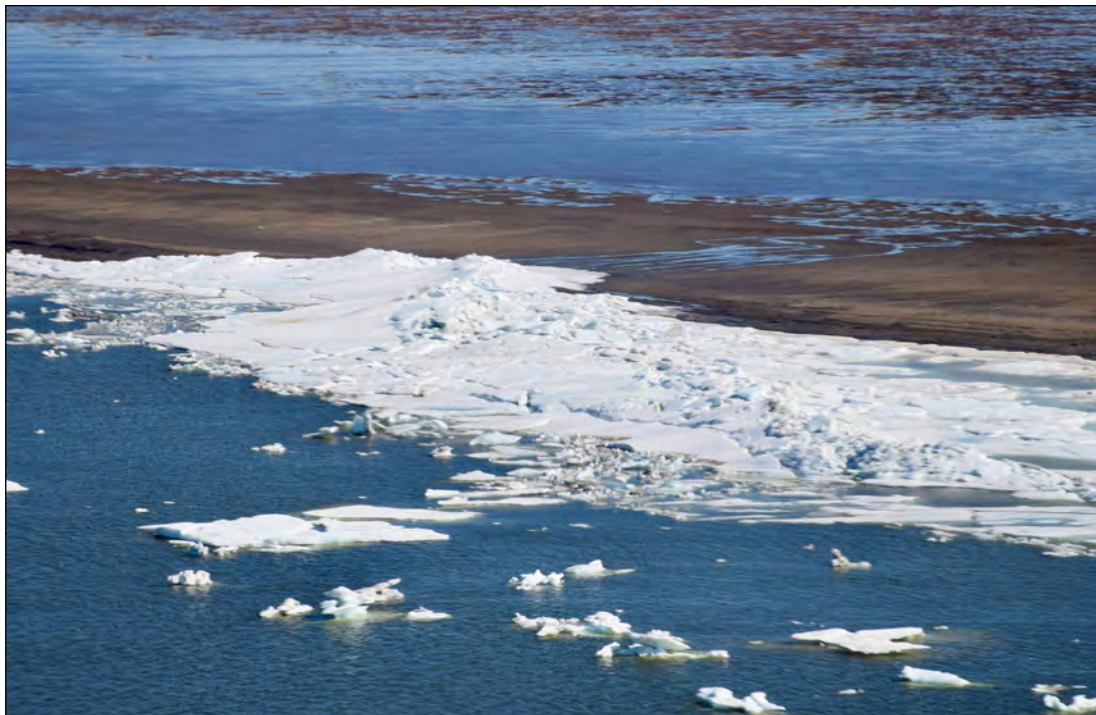
*Ice Pile-Ups:* Of the 57 ice pile-ups observed on the coast between Point Lay and Utqiagvik during the freeze-up reconnaissance flights in late February, 53 were evident when the nearshore break-up flight was conducted on June 15<sup>th</sup>. As illustrated in Plate 5, which displays a pile-up that formerly extended 5 m above sea level and encroached 20 m onto the barrier island to the east of Icy Cape, the dimensions of these relict pile-ups had been substantially reduced by melting. The remaining four pile-ups observed during the freeze-up flights were no longer discernible, but five new pile-ups that appeared to have formed during break-up were discovered (Plate 6). The heights ranged from 2 to 5 m and the encroachment distances from 3 to 5 m.

**Plate 5. Relict Ice Pile-Up on Barrier Island East of Icy Cape (June 15, 2020)**

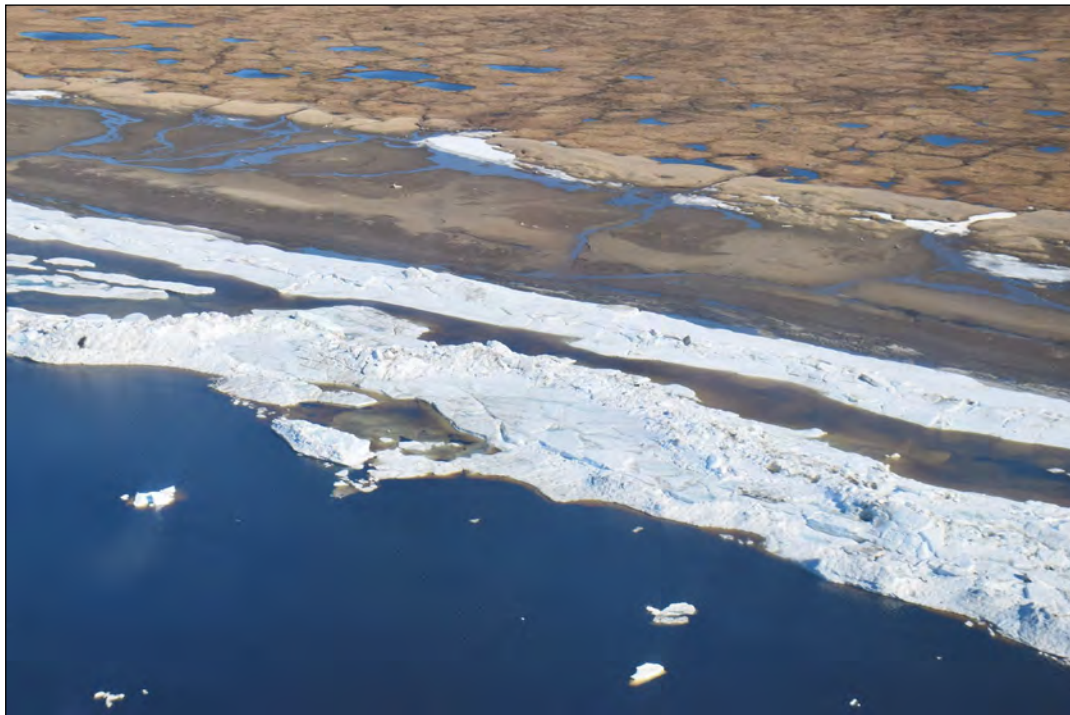
**Plate 6. 5-m Pile-Up that Occurred 4 nm Northwest of Point Belcher during Break-Up (June 15, 2020)**

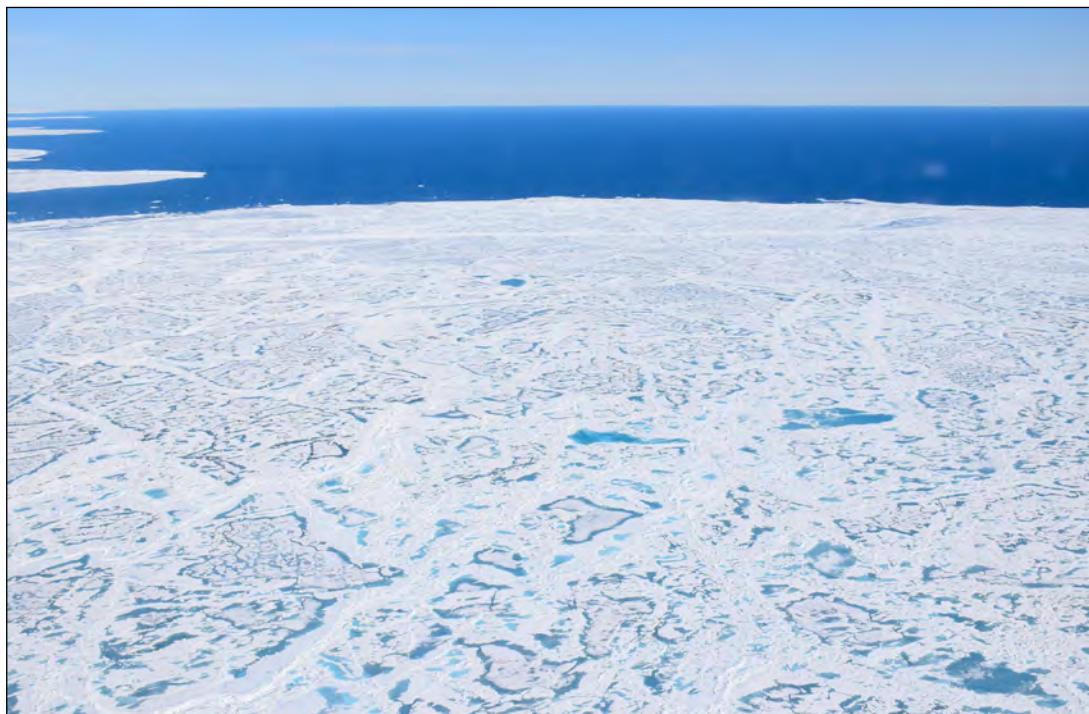
*Pack Ice:* The pack ice contained a mixture of first-year and multi-year ice, with the concentration of the latter typically ranging from 10 to 30%. Melt ponds were omnipresent. The largest multi-year floe, with an approximate diameter of 12 km, was located at the eastern edge of the pack ice 75 nm west of Utqiagvik (Plate 7).

**Plate 7. Large Multi-Year Ice Floe 75 nm West of Utqiagvik (June 16, 2020)**

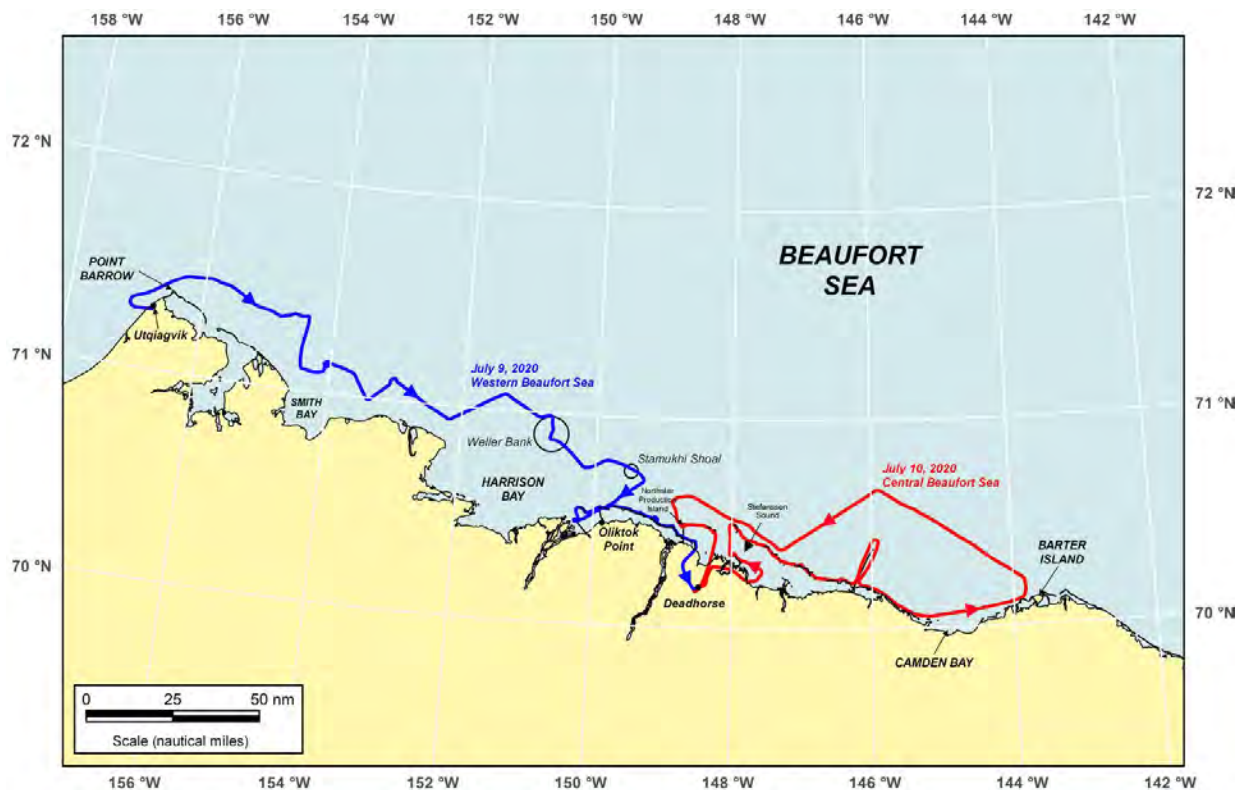
**Figure 1. Flight Paths in Alaskan Beaufort Sea**

*Western Beaufort Sea (July 9<sup>th</sup>):* The aircraft departed from Utqiagvik, cleared Point Barrow, and then proceeded in a southeasterly direction at distances of 10 to 40 nautical miles offshore. After passing over Weller Bank and Stamukhi Shoal, the two customary anchor points for landfast ice in the vicinity of Harrison Bay, it turned southwest into the southeastern portion of the Bay. It then headed east-southeast along the barrier islands between Harrison Bay and Deadhorse. The dense fog that prevailed at the beginning of the flight diminished as the aircraft travelled east, but intermittent fog and poor visibility were encountered on numerous occasions.

*Central Beaufort Sea (July 10<sup>th</sup>):* The flight covering the Central Beaufort Sea consisted of a counterclockwise loop that began and ended at Deadhorse. After crossing Stefansson Sound, the aircraft proceeded in an easterly direction along the barrier island chain and across Camden Bay to Barter Island. It then turned back toward the west at distances that typically ranged from 2 to 30 nautical miles off the barrier islands. When the aircraft approached Northstar Production Island, the visibility was severely reduced by fog that prevailed for the remainder of the flight to Deadhorse.

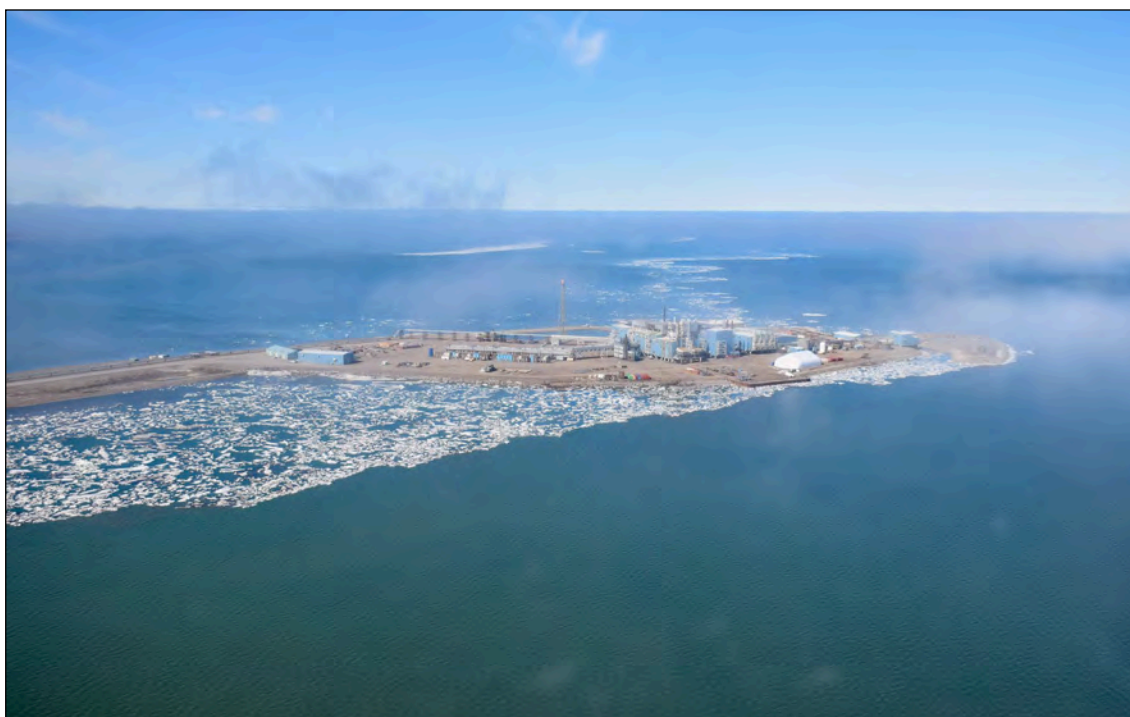
**Plate 2 Accumulation of Floating Ice on East Side of Endicott Causeway (July 10, 2020)**

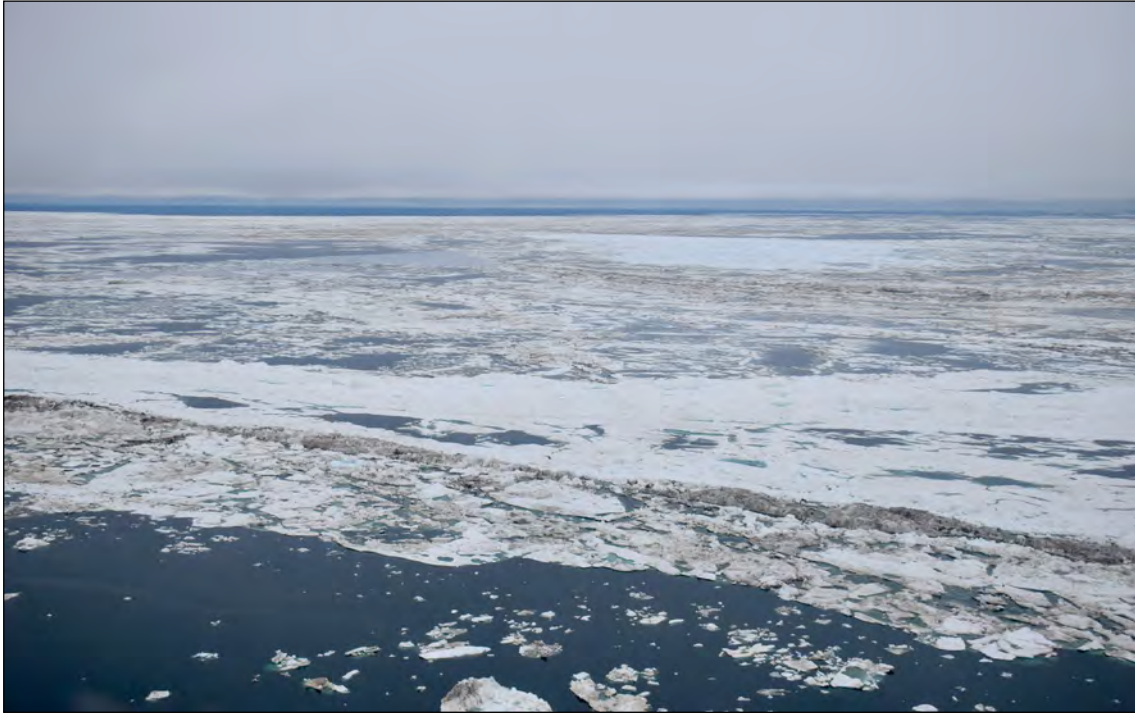
*Landfast Ice:* Although the landfast ice had been partially removed from some areas and totally removed from others prior to the flights, substantial expanses remained grounded on Weller Bank (Plate 3), where the ridge and rubble heights reached 7 m, and Stamukhi Shoal, where the ridge and rubble heights reached 4 m. In both cases, multi-year ice comprised approximately 20% of the ice that remained. Patches of grounded ice that had become surrounded by open water also were observed immediately east of Point Barrow, between Smith and Harrison Bays, and off Barter Island (Plate 4).

**Plate 3. Landfast Ice Grounded on Weller Bank (July 9, 2020)**

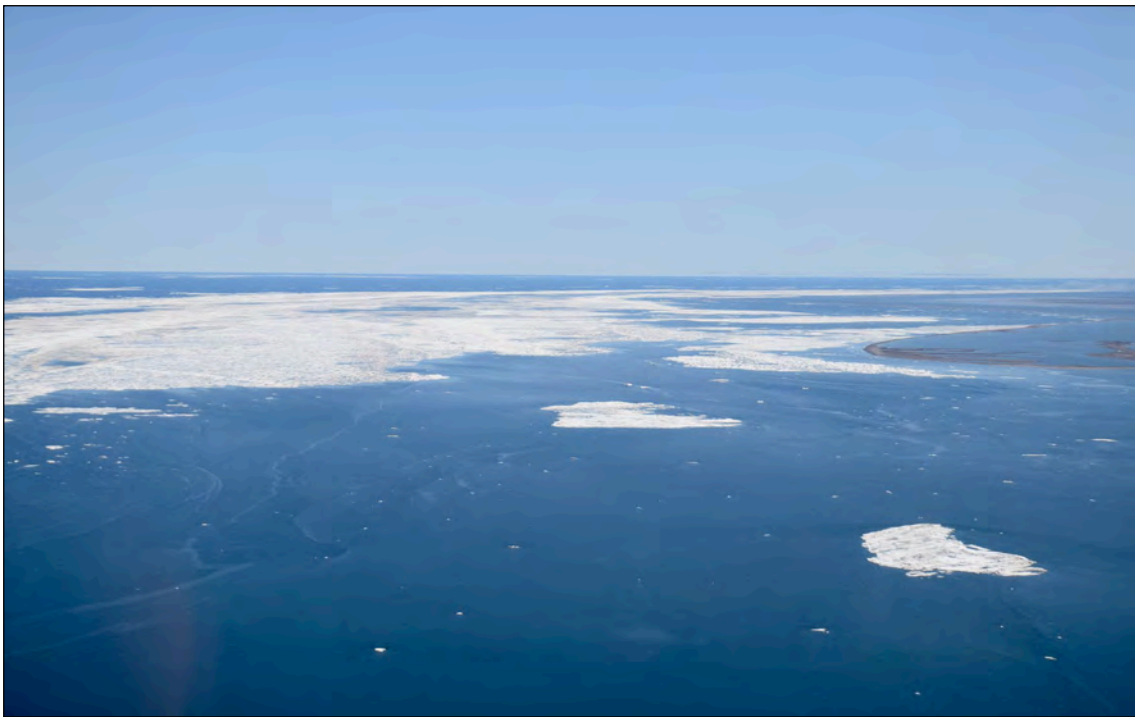
**Plate 4. Landfast Ice Surrounded by Open Water off Barter Island (July 10, 2020)**

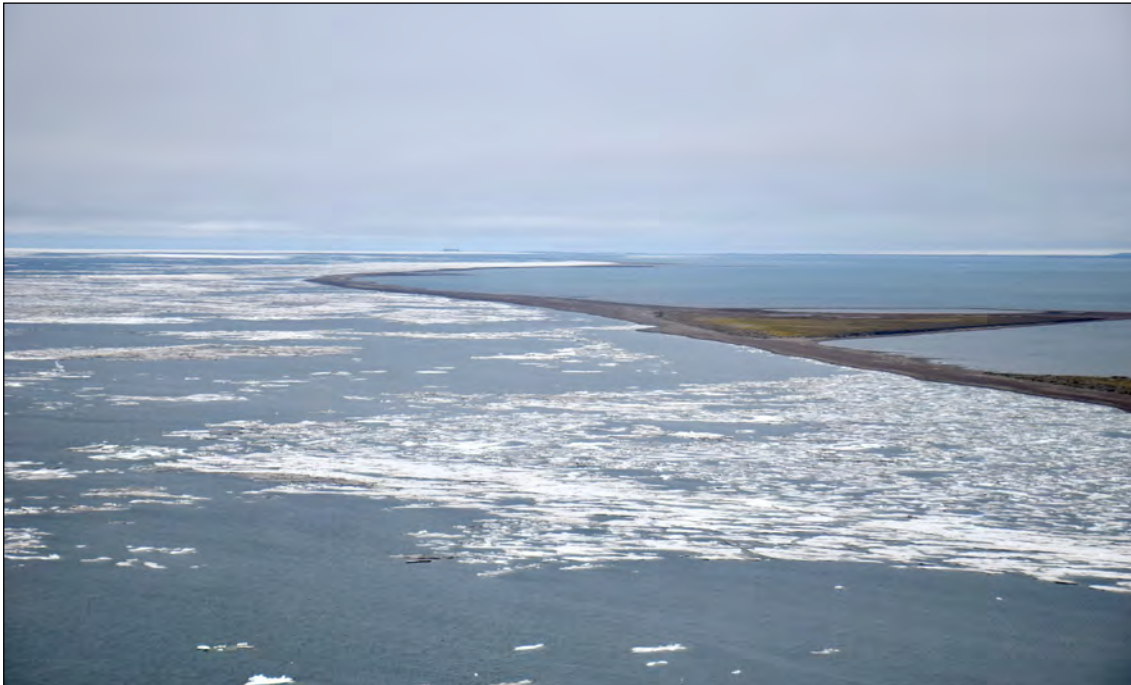
**Plate 5. Rotten Ice Floating on Seaward Side of Barrier Islands between Oliktok Point and Prudhoe Bay (July 9, 2020)**

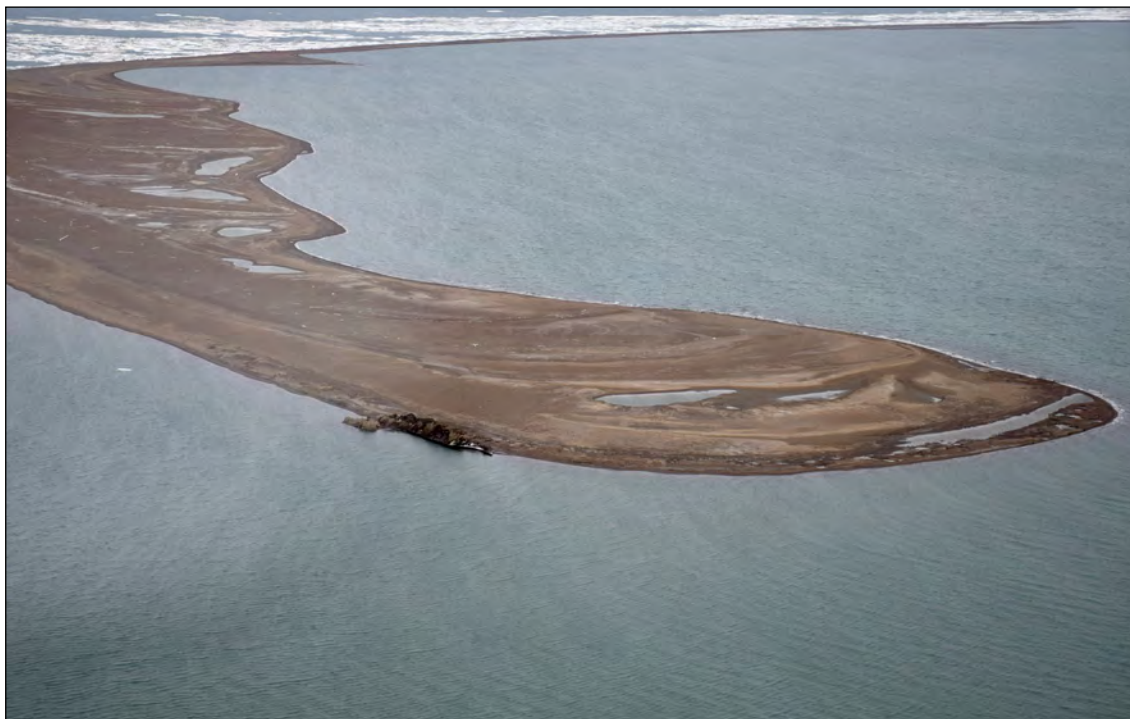
*Ice Pile-Ups:* Of the 32 ice pile-ups observed in the Central Beaufort Sea in late February, 16 were evident when the break-up flights were conducted on July 9<sup>th</sup> and 10<sup>th</sup>. As illustrated in Plate 6, which displays a pile-up that formerly extended 7 m above sea level and encroached 5 m onto the subaerial beach of Thetis Island, the dimensions of these pile-ups had been substantially reduced by melting. The remaining 16 pile-ups observed during the freeze-up flights were no longer discernible, and new pile-ups or ride-ups that could have formed during break-up were conspicuously absent.

**Plate 6. Relict Ice Pile-Up on Thetis Island (July 9, 2020)**

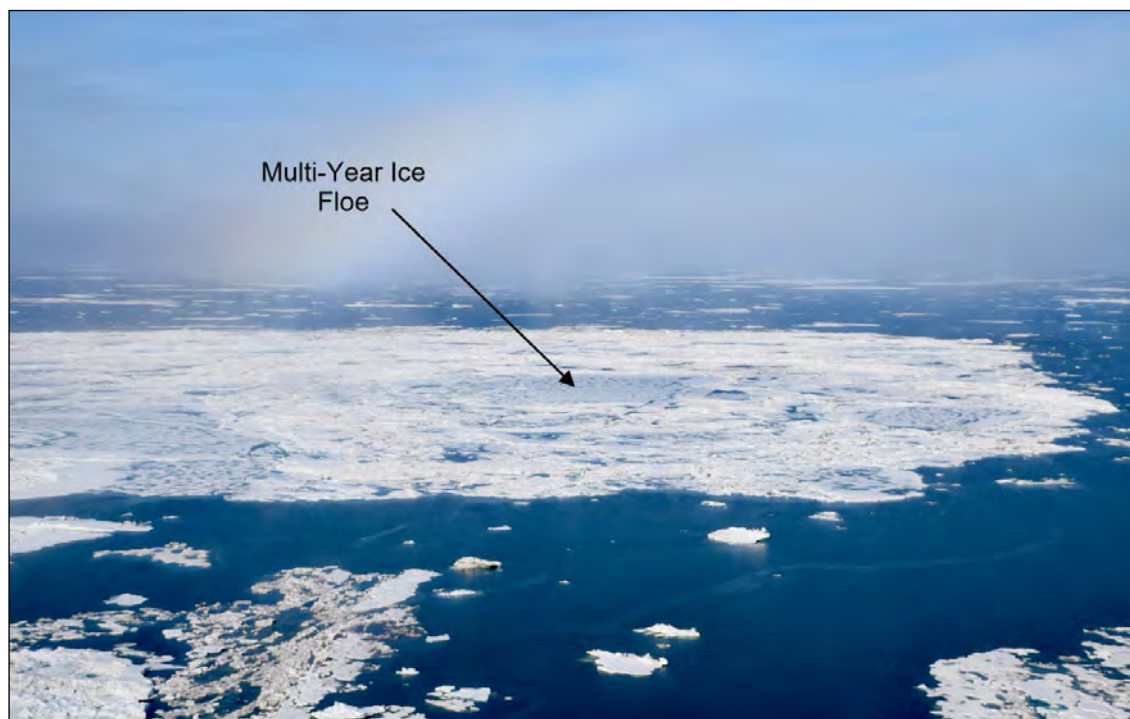
*Multi-Year Ice:* As indicated above, multi-year ice floes at concentrations peaking at 30% were observed in the pack ice near Weller Bank. Widely-scattered multi-year floes also were noted between Smith Bay and Weller Bank (Plate 7), seaward of the barrier islands east of Oliktok Point, in the vicinity of Northstar Production Island, and approximately 25 nautical miles north of Camden Bay.

**Plate 7. Multi-Year Ice Floes Embedded in First-Year Ice 15 nautical miles North of Smith Bay (July 9, 2020)**
