Phone: (800) 200-4853

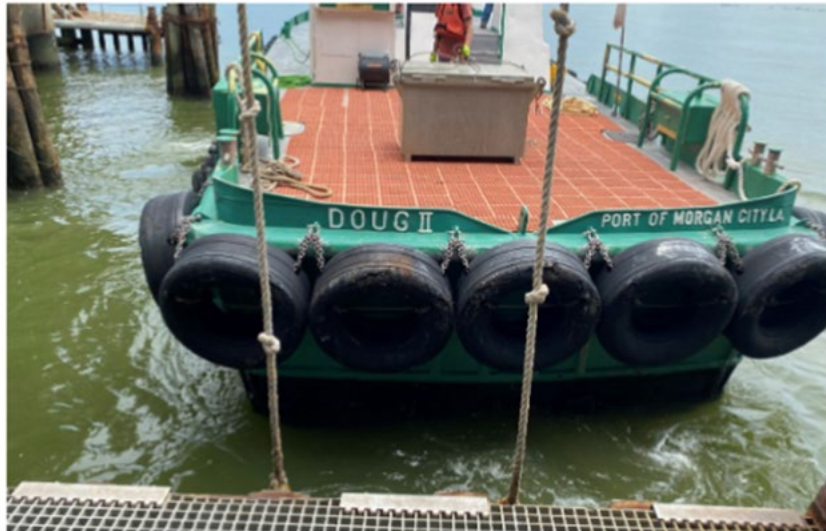
View of Boat Stern Where Swing Rope Injury Has Occurred.

Personnel transfers using swing ropes and baskets present a considerable risk for offshore workers. The most recent example is a fractured foot sustained by a worker attempting to use a swing rope to board a satellite platform from a work boat. As the captain maneuvered the boat, the worker placed his foot on a bumper tire to position himself for the swing. The worker's foot slipped between the tire and the boat when the tire hit the platform, resulting in injury.

- Treat all offshore personnel transfers as stand-alone operations and conduct a formal risk assessment before a transfer occurs. A stop work authority should be initiated. If there are any concerns regarding the safety of the operation,
- Verify personnel competencies regarding the proper utilization of swing ropes on offshore assets where swing ropes are used to ensure all personnel understand and recognize the applicable safety aspects.

- Ensure Master has clear visibility of the transfer area directly or via closed-circuit television (CCTV).
- Ensure deck space in the transfer area is free from obstructions.
- Ensure there is clear space for vessel crew members to assist transferring personnel.
- Install non-slip deck coatings at and around the transfer location.
- Ensure functionality of personnel locator beacon (PLB) system for man overboard incidents.
- Determine ability to recover a person from the water using only the minimum number of persons onboard.

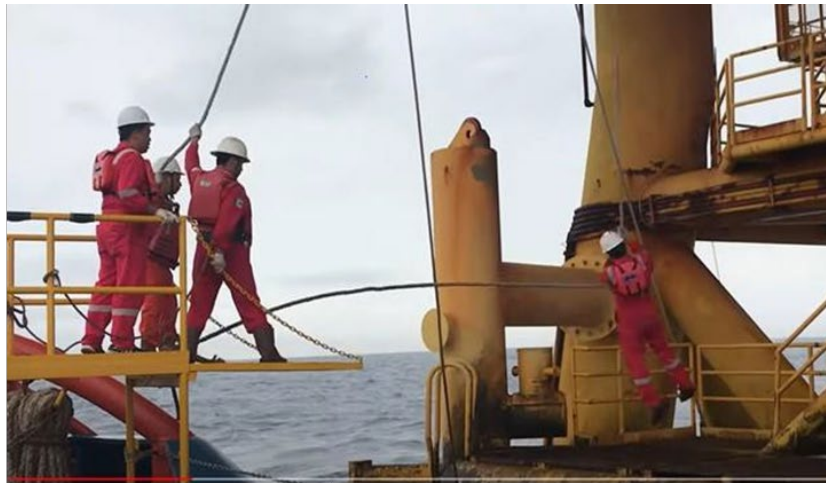
Elevated Platform Structure.

- Verify functionality of Offshore Personnel Transfer Systems (OPTS) that are installed on-board platforms and vessels for the purpose of providing safe transfer of personnel.
- Consider using gangway systems or elevated structures (Jump Box) to equalize or elevate personnel so they never have to swing upward to a vessel or platform.

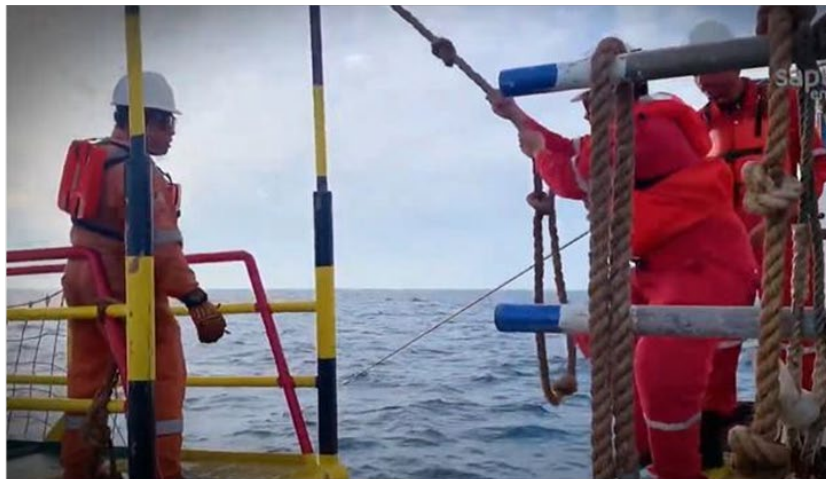
Gangway Systems.
