Laboratory Testing and Technical Assessments of Corrosion-Resistant Alloys for High-Pressure, High-Temperature Subsea Applications

Mechanical Property and Corrosion Performance Testing and Assessments of Nickel Alloys 725, 825, 945X, 955, and C22HS

ANL-19/30

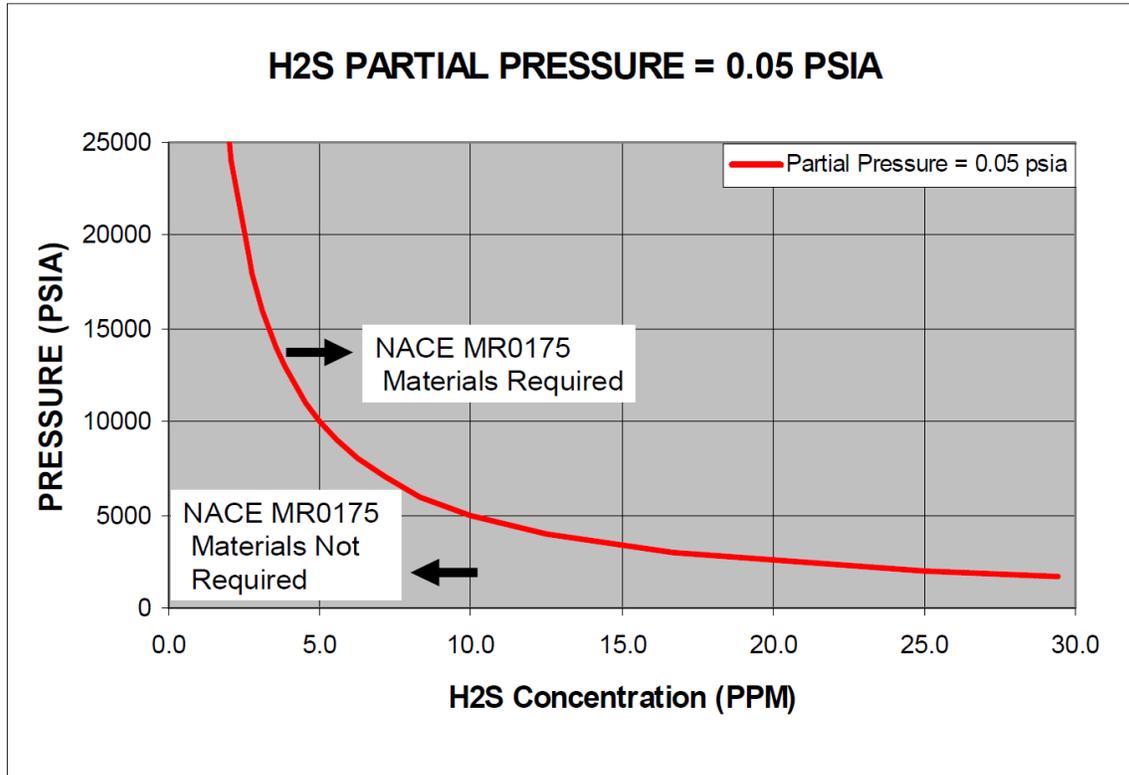
FIGURE 1 H2S Concentration vs. Pressure Illustrating Sour Conditions in Parts per Million (PPM)

The past operational limit for high-pressure offshore production equipment has been around 10,000 psi. Newer deep-water discoveries have pushed this value to about 15,000 psi and 350°F. These temperature and pressure values present economic challenges for materials of construction. The key for reliable component design in such pressure and temperature conditions is to find materials of construction that are both robust and yet affordable. It also is a benefit to the design team if they have more than one material and more than one supplier that can provide the properties needed for the given application. Temperature and pressure are addressed in C-Ring and corrosion coupon testing in autoclaves at HCS.

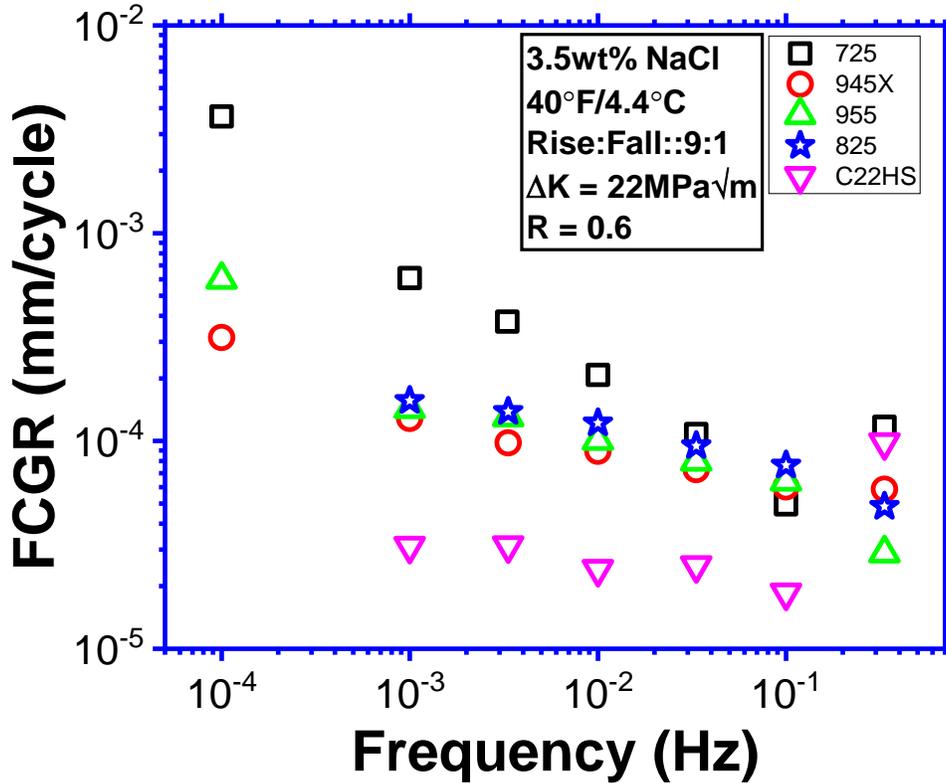
FIGURE 10 Fatigue Crack Growth Rate vs. Loading Frequency in Simulated Seawater with Cathodic Protection

All three of the precipitation hardening alloys in this study (i.e., 725, 945X, and 955) showed crack growth rates that were dependent on the loading frequency. In contrast, the two cold worked alloys (C22HS and 825) were loading frequency independent. This was demonstrated for two loading R ratios of 0.2 and 0.6 (where R = minimum load/maximum load during a loading cycle); Figure 10 illustrates this for the R ratio of 0.6.

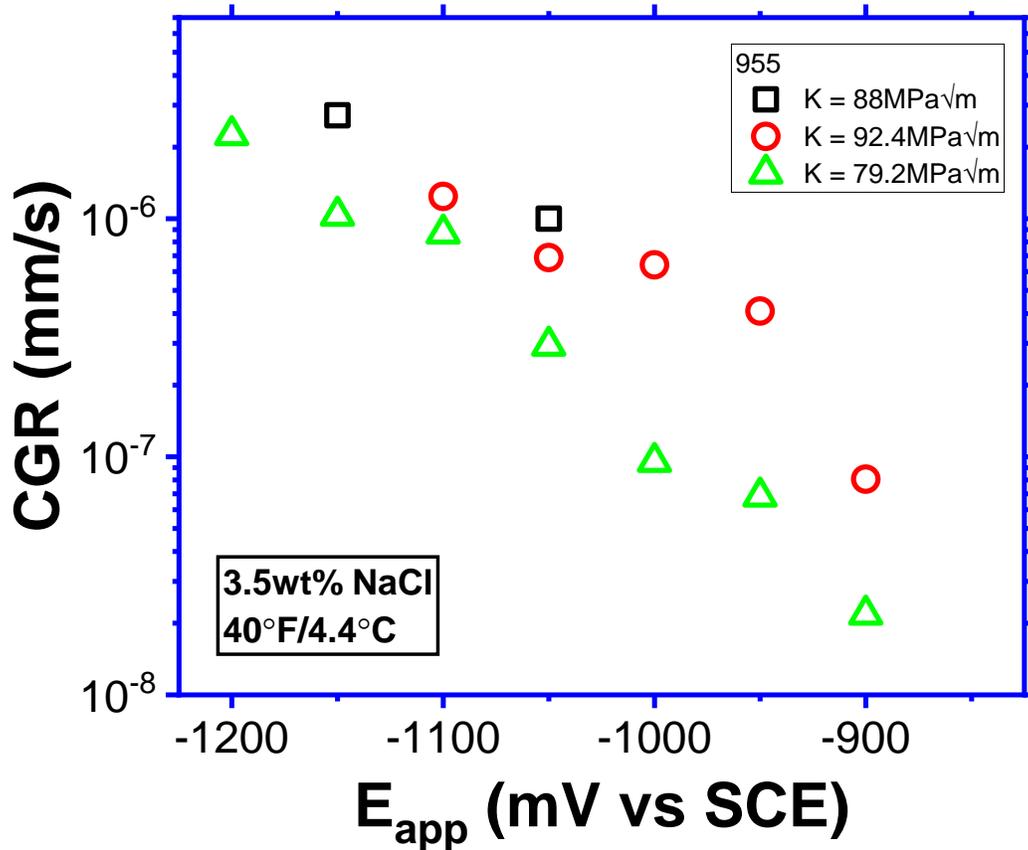
FIGURE 11 Static Crack Growth Rate of 955 in Simulated Seawater vs. Applied Potentials

An effect of applied potential was noted for Alloys 945X and 955; the greater the applied potential, the greater the static crack growth rate. An example of this effect between -900 and -1,200 mV is shown as Figure 11 for Alloy 955.

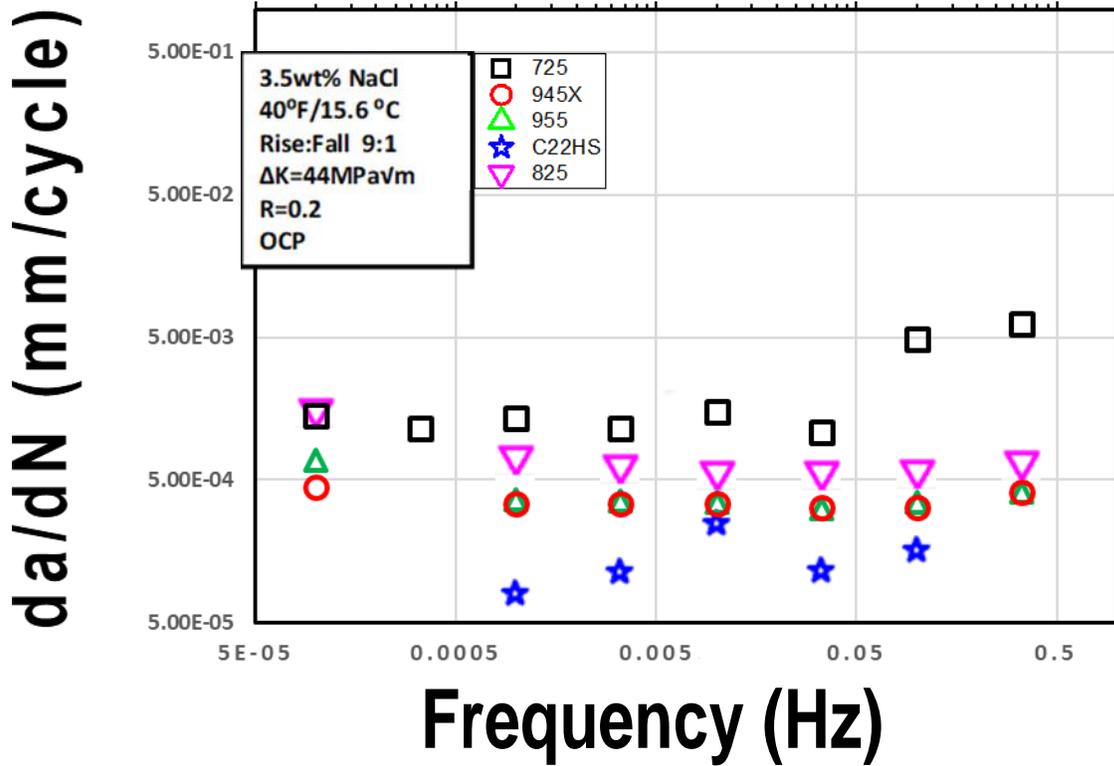
FIGURE 13 Cyclic Crack Growth Rate Versus Loading Frequency in Simulated Seawater for Five Alloys

Similar to the test results in the sour production environment, cyclic crack growth rate experiments conducted at 60°F showed no effect of loading frequency. This is true for all five of the alloys tested and suggests that materials under specified test conditions displayed no environmental effects. Figure 13 illustrates this point.

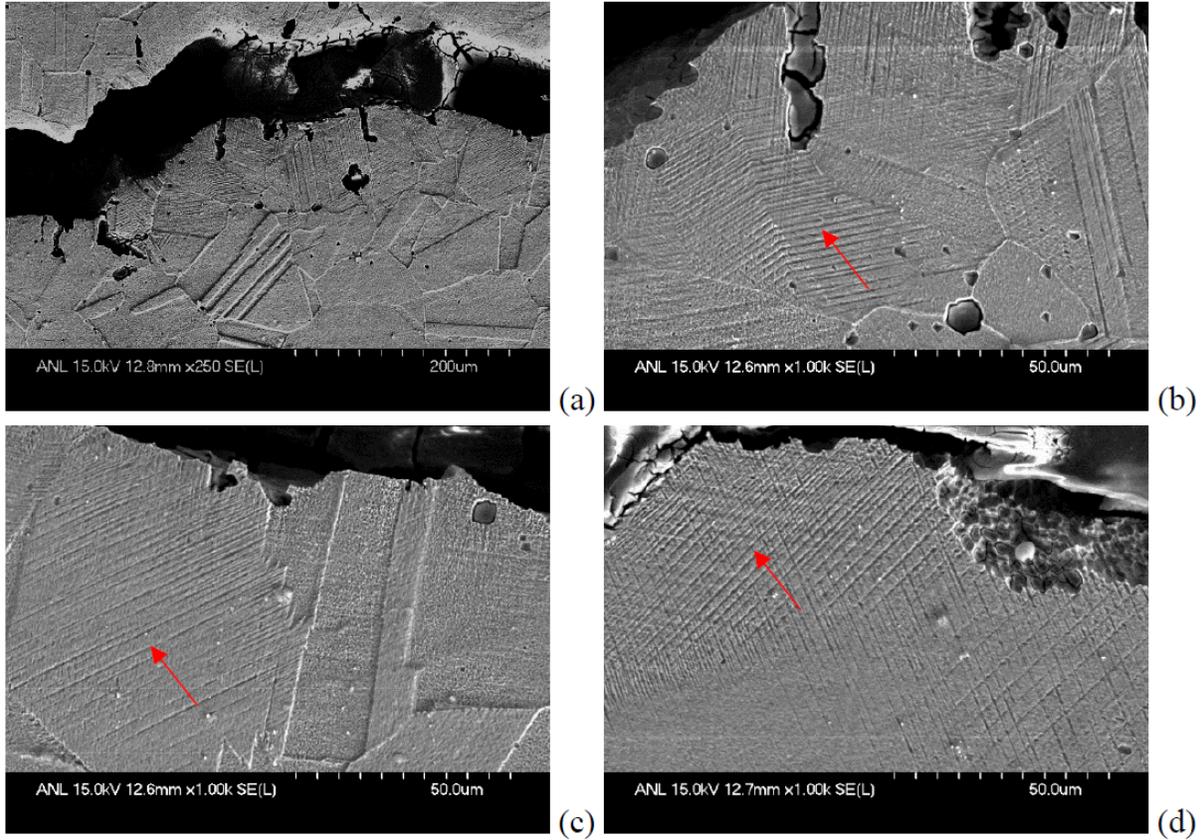
FIGURE 18 SEM Images Revealing Slip Bands (indicated by arrows) Formed within Grains along the Crack in Alloy 945X

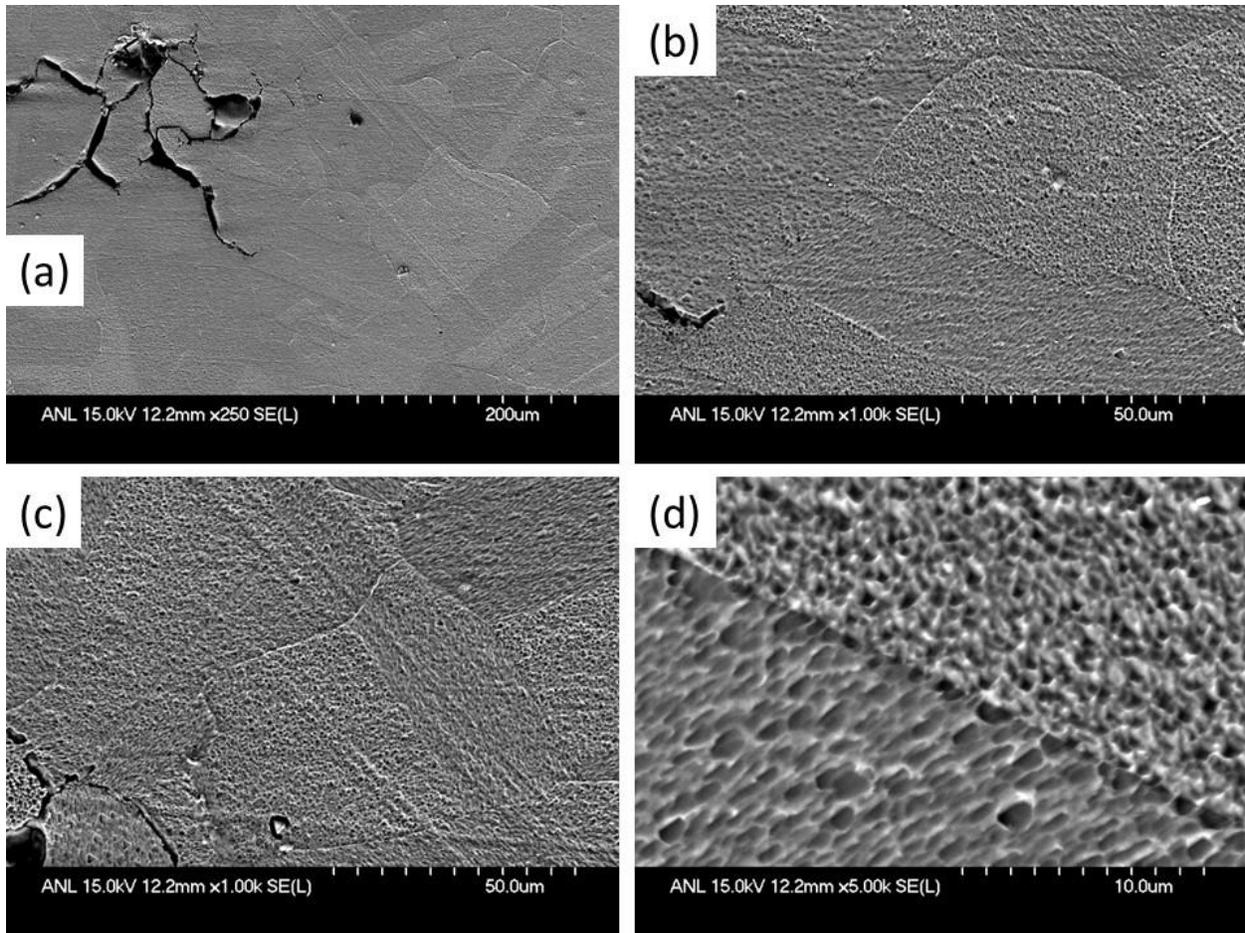
FIGURE 20 SEM Images of Alloy 955 after Etching

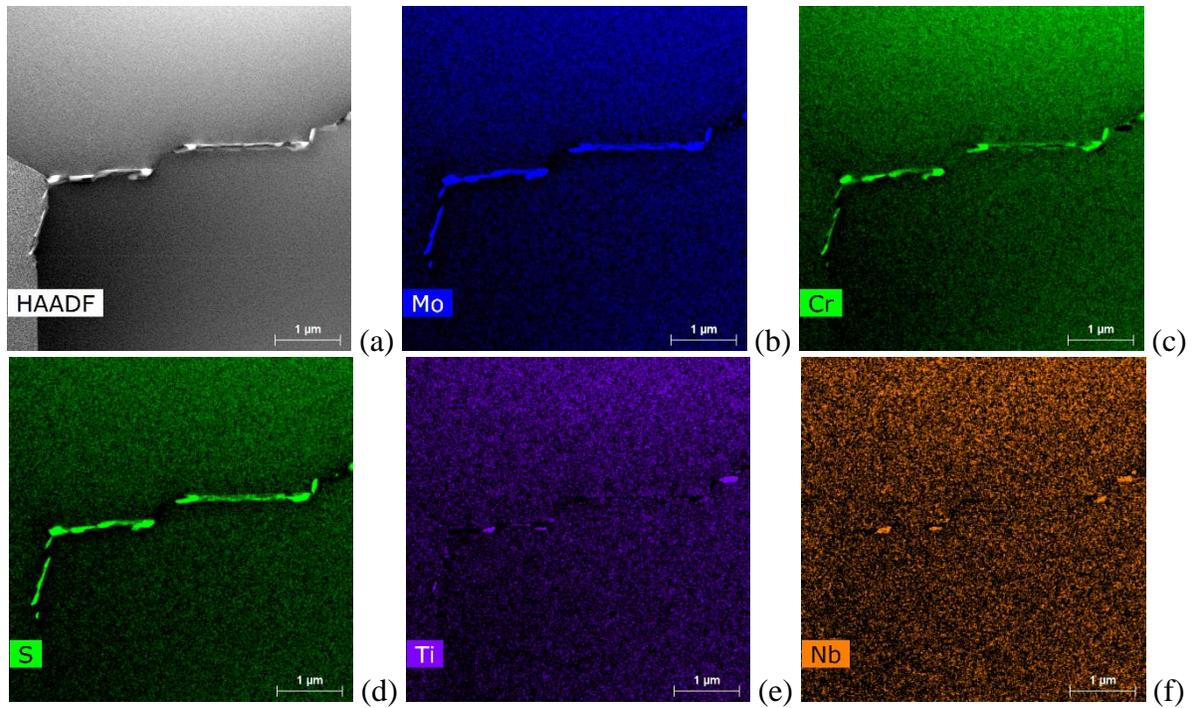
FIGURE 21 (a) TEM HAADF Image Showing Grain Boundary Precipitates; (b)–(f) EDS Elemental Mapping of Mo, Cr, S, Ti, and Nb in the Same Area in Alloy 725

TEM was carried out to examine the microstructure of the alloys. Figure 21a shows the high-angle annular dark field (HAADF) image at the low-magnification. A high density of precipitates was observed at grain boundaries. The EDS elemental mapping of the same area indicates that these grain boundary precipitates are a mixture of $M(Cr,Mo)_{23}C_6$ carbides, $M(Nb,Ti)X(C,N)$ carbon-nitrides, and MoS sulphides. These precipitate particles were also observed inside grains with a lower number density (Figure 22). A high density of nano-size (~ 10 nm) precipitates of γ'' and γ' were observed within the grains in Alloy 725, as shown in Figure 23. The chemistry and crystal structure of the precipitates were verified by both EDS mapping and electron diffraction.

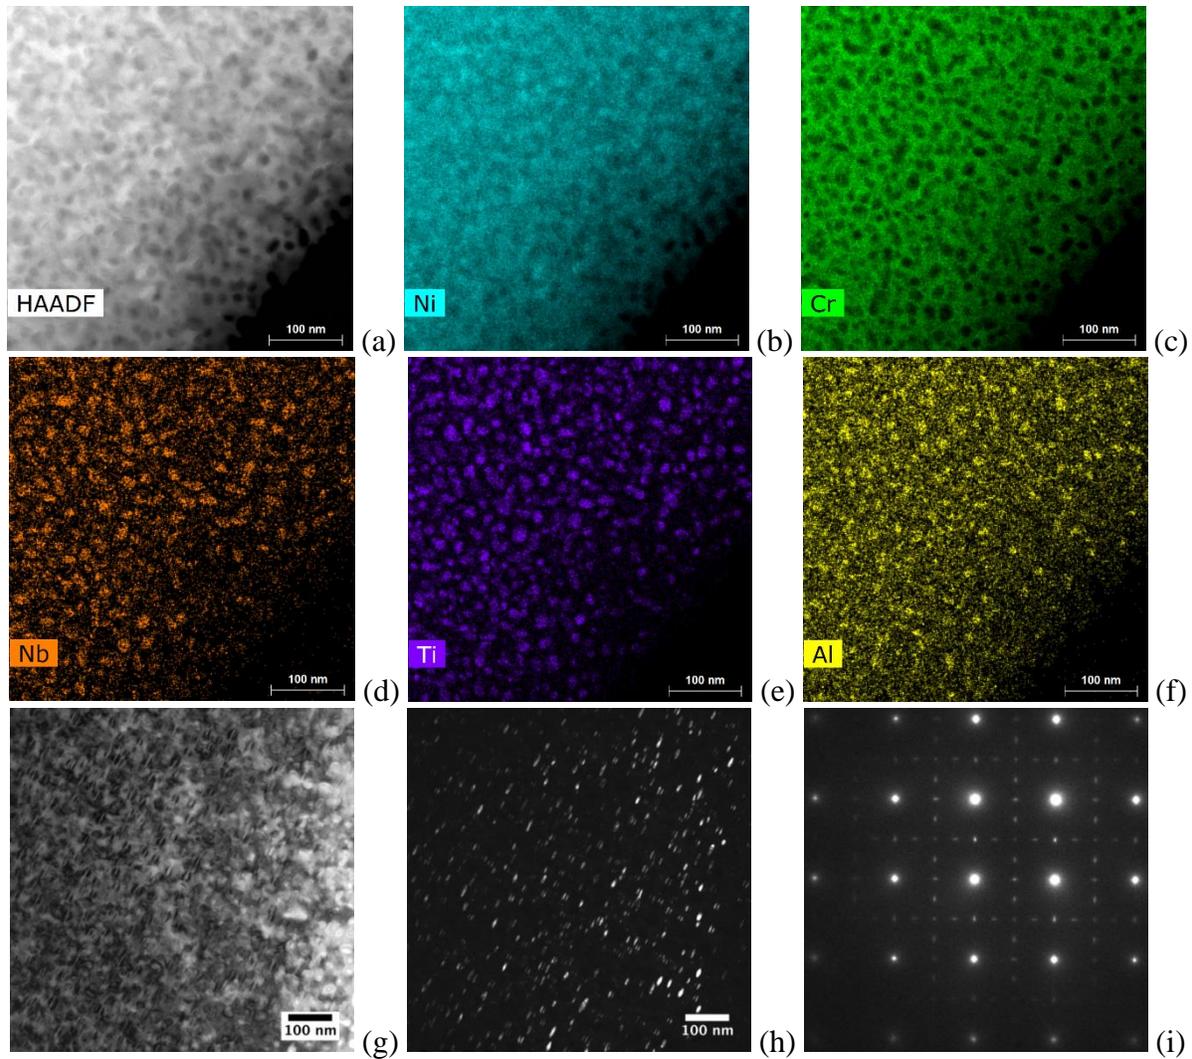
FIGURE 23 (a) TEM HAADF Image Showing Nano-Sized Precipitates in the Matrix; (b)–(f) EDS Elemental Mapping of Ni, Cr, Ti, Nb, and Al in the Same Area of (a); (g) Bright-Field Image; (h) Dark-Field Image; and (i) Electron Diffraction Pattern Showing the Precipitates in the Matrix in Alloy 725

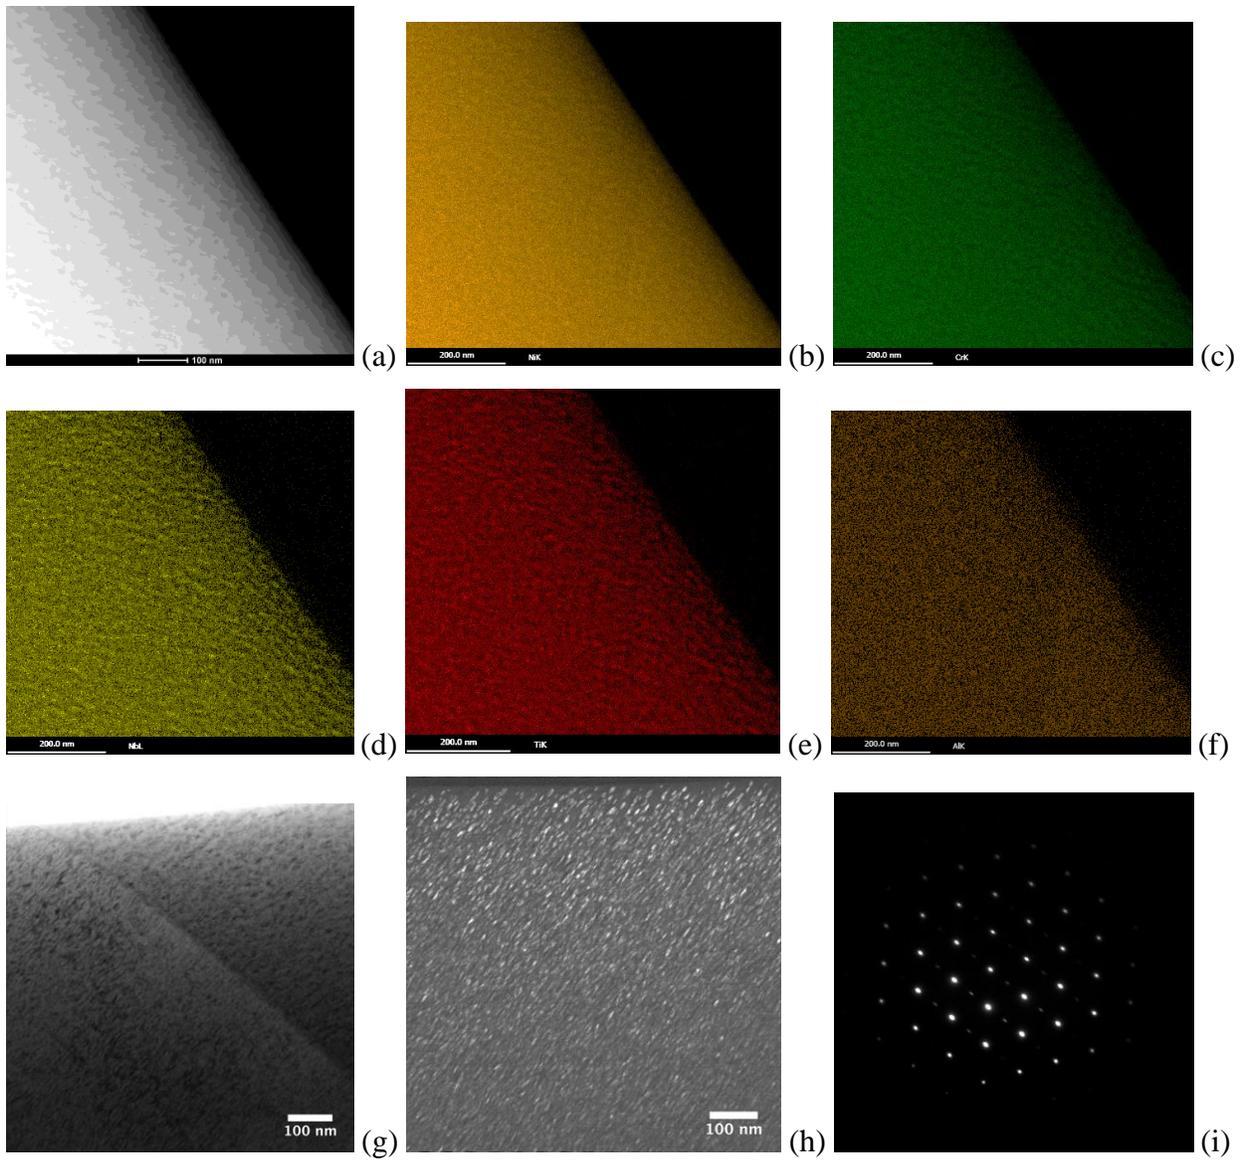
FIGURE 24 (a) TEM HAADF Image Showing Nano-Sized Precipitates in the Matrix; (b)–(f) EDS Elemental Mapping of Ni, Cr, Ti, Nb, and Al in the Same Area of (a); (g) Bright-Field Image; (h) Dark-Field Image; and (i) Electron Diffraction Pattern Showing the Precipitates in the Matrix in Alloy 945X

Alloy 955 and Alloy 945X show similar precipitation of γ' and γ'' within the grains. The grain boundary precipitation in Alloy 945X and Alloy 955 is significantly less than in Alloy 725. Figure 24 shows the nano-sized precipitates in the matrix in Alloy 945X. Figures 25 and 26 show the nano-sized precipitates observed in the matrix and grain boundary precipitates in Alloy 955. The grain boundary precipitation in Alloy 945X and Alloy 955 is significantly less than in Alloy 725.

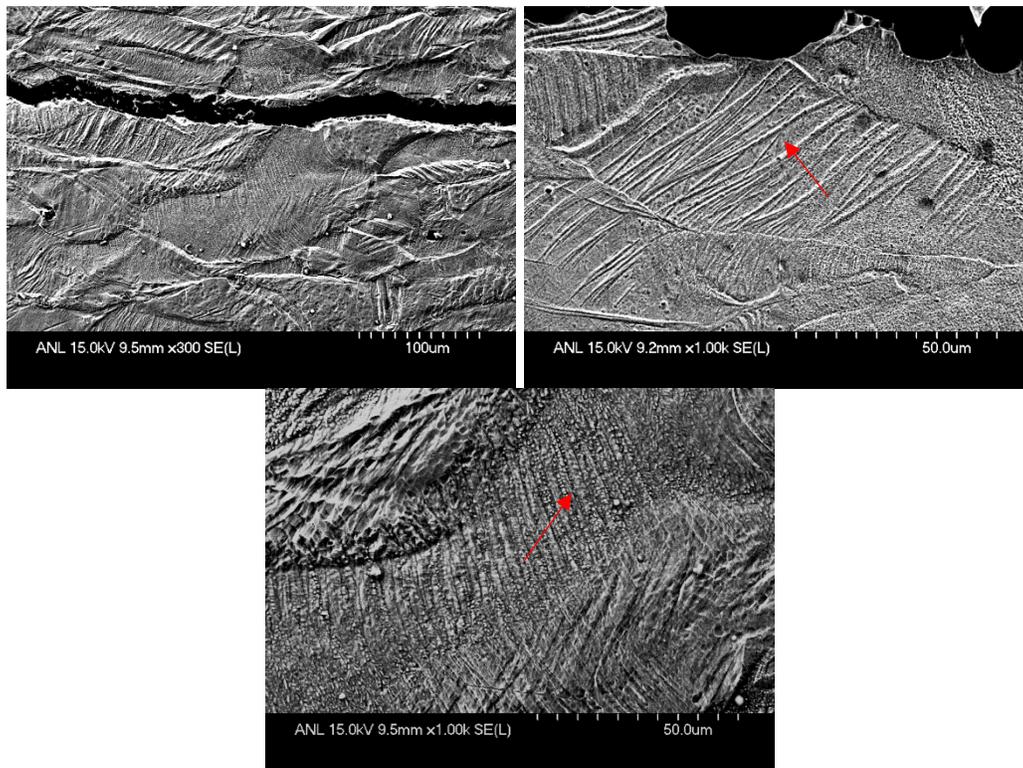
FIGURE 28 SEM Images Showing the Slip Activities (indicated by arrows) along the Crack in Alloy 825

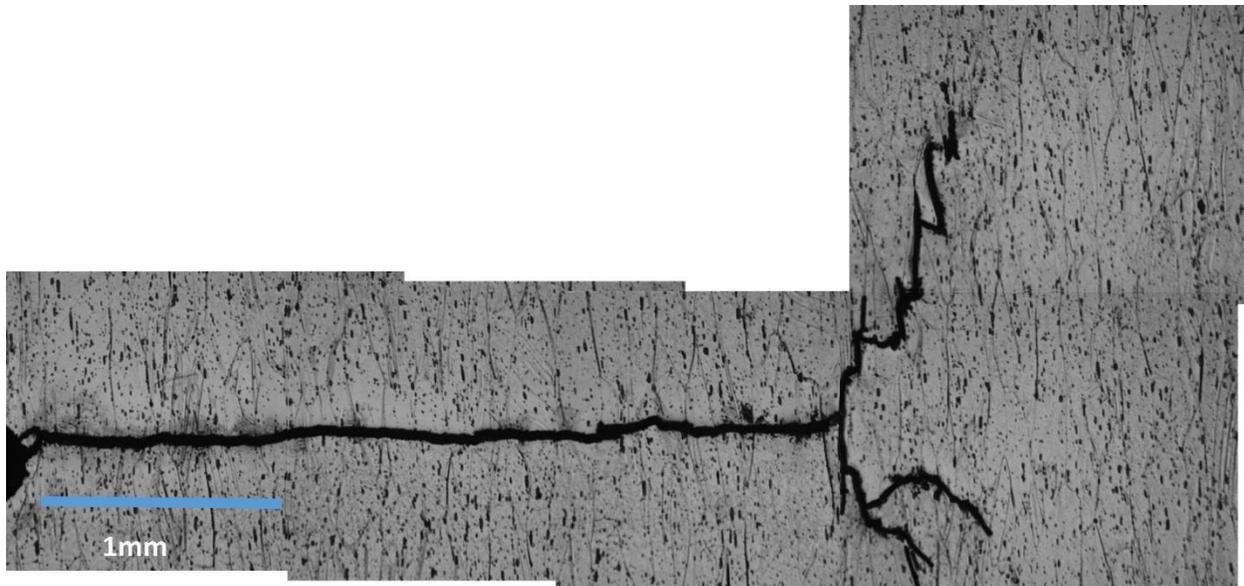
FIGURE 30 Overview of the Crack Developed During the SCC Test in Alloy C22HS

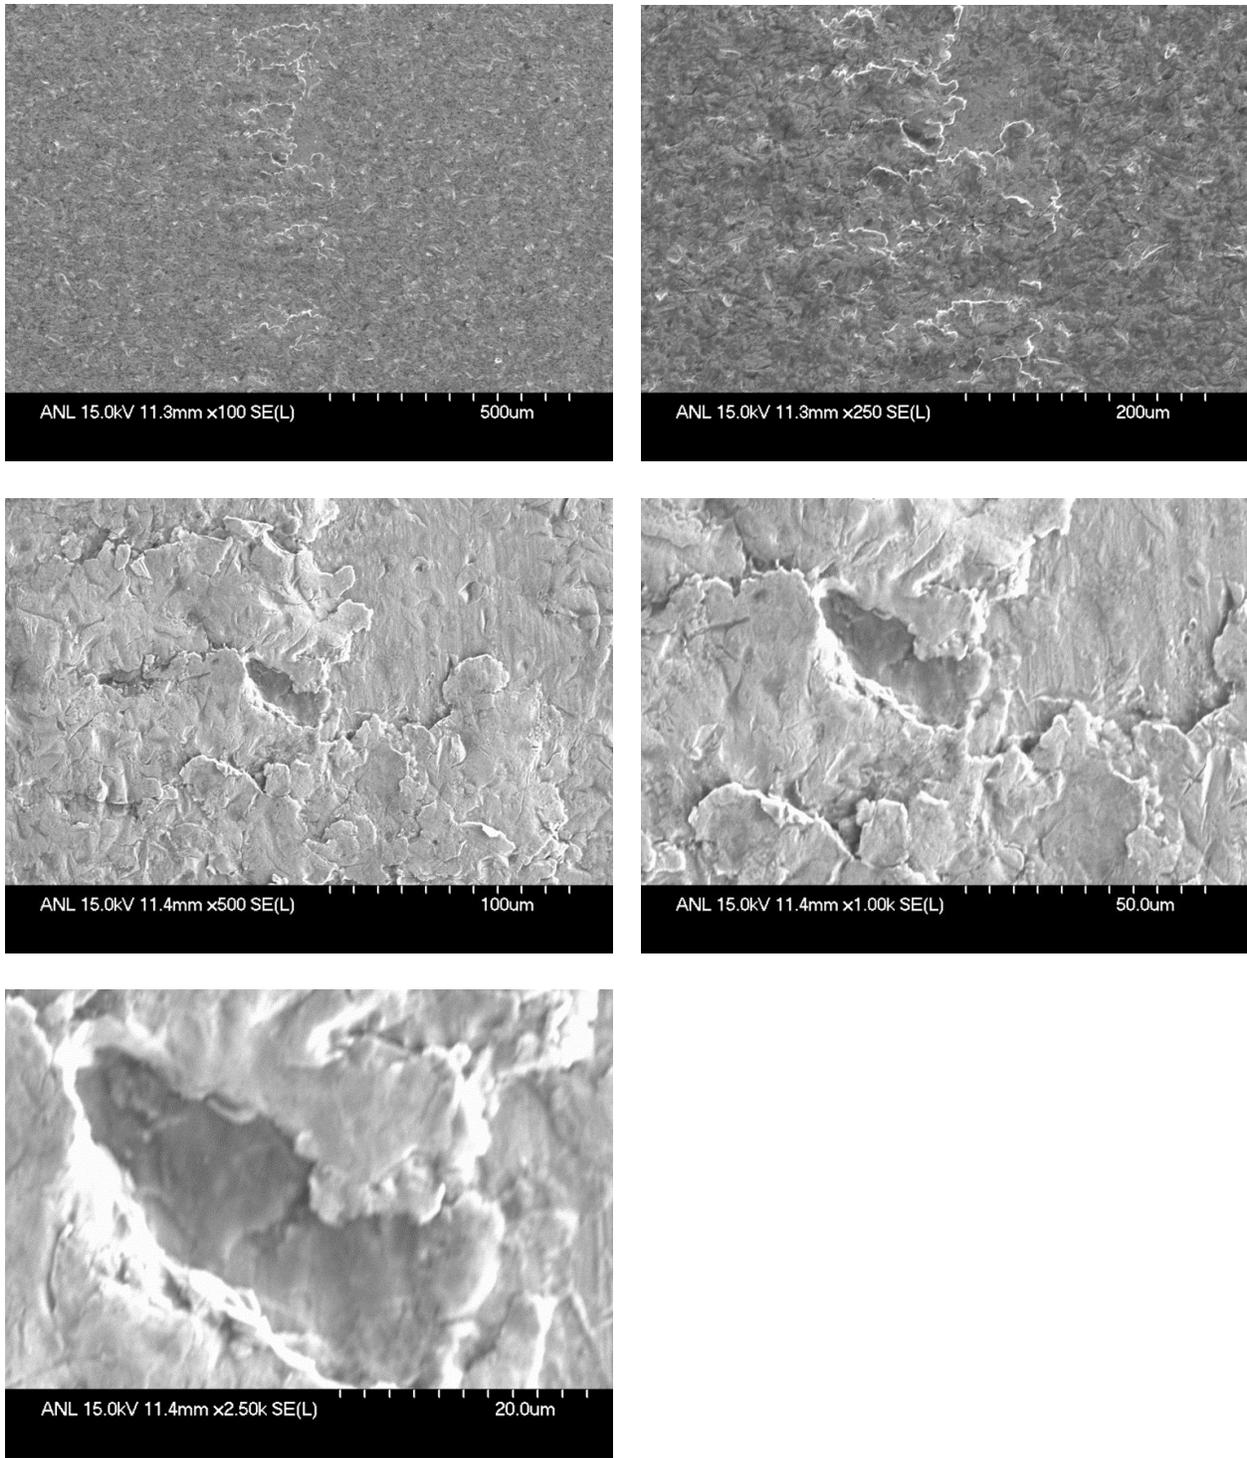
FIGURE 37 Alloy 725 Surface Images at Various Magnifications (Sample 8C)

The pitting standard HCS used was based on visual examination of the exposed surface under 45X and 100X. Since no corrosion was observed at these levels, Argonne obtained images at higher magnification, Figures 37 through 41, to better characterize the surface after cleaning and to provide more information about the surface anomalies not visible at the lower magnifications.

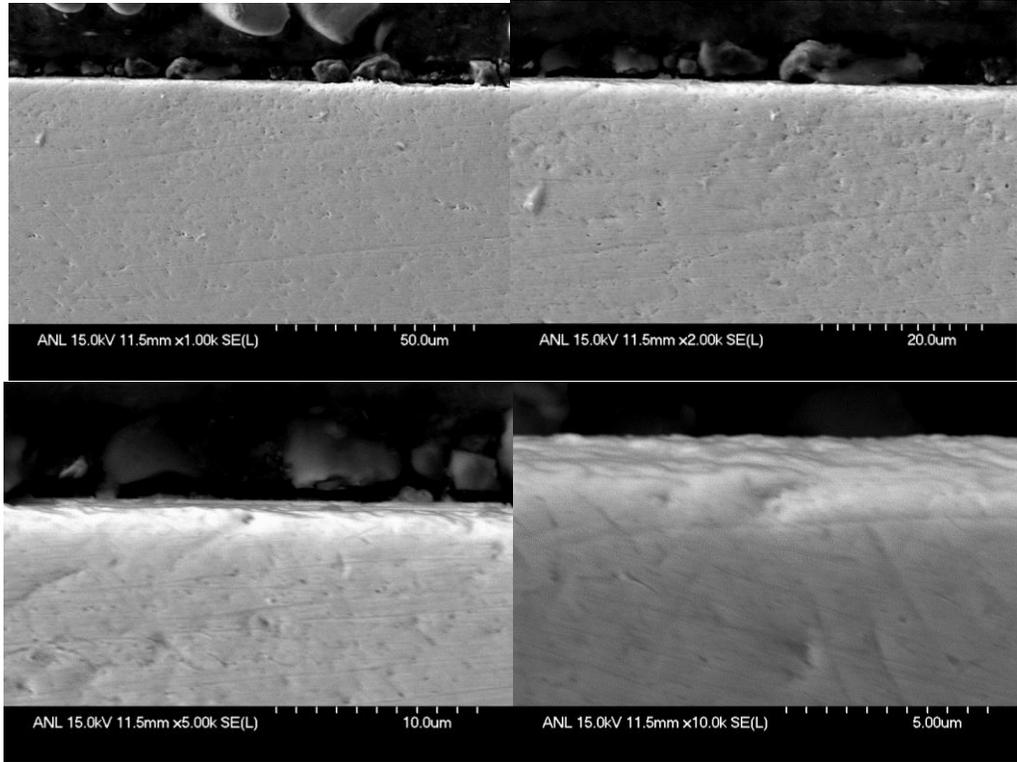
FIGURE 46 SEM Images of the SCC C-Ring 14149.3R from 12-Week Exposure

No oxide scale was observed on any of the samples from 12 week exposure. There is the possibility there may be some scale at 12 weeks because of the random nature of scale formations in such alloys.

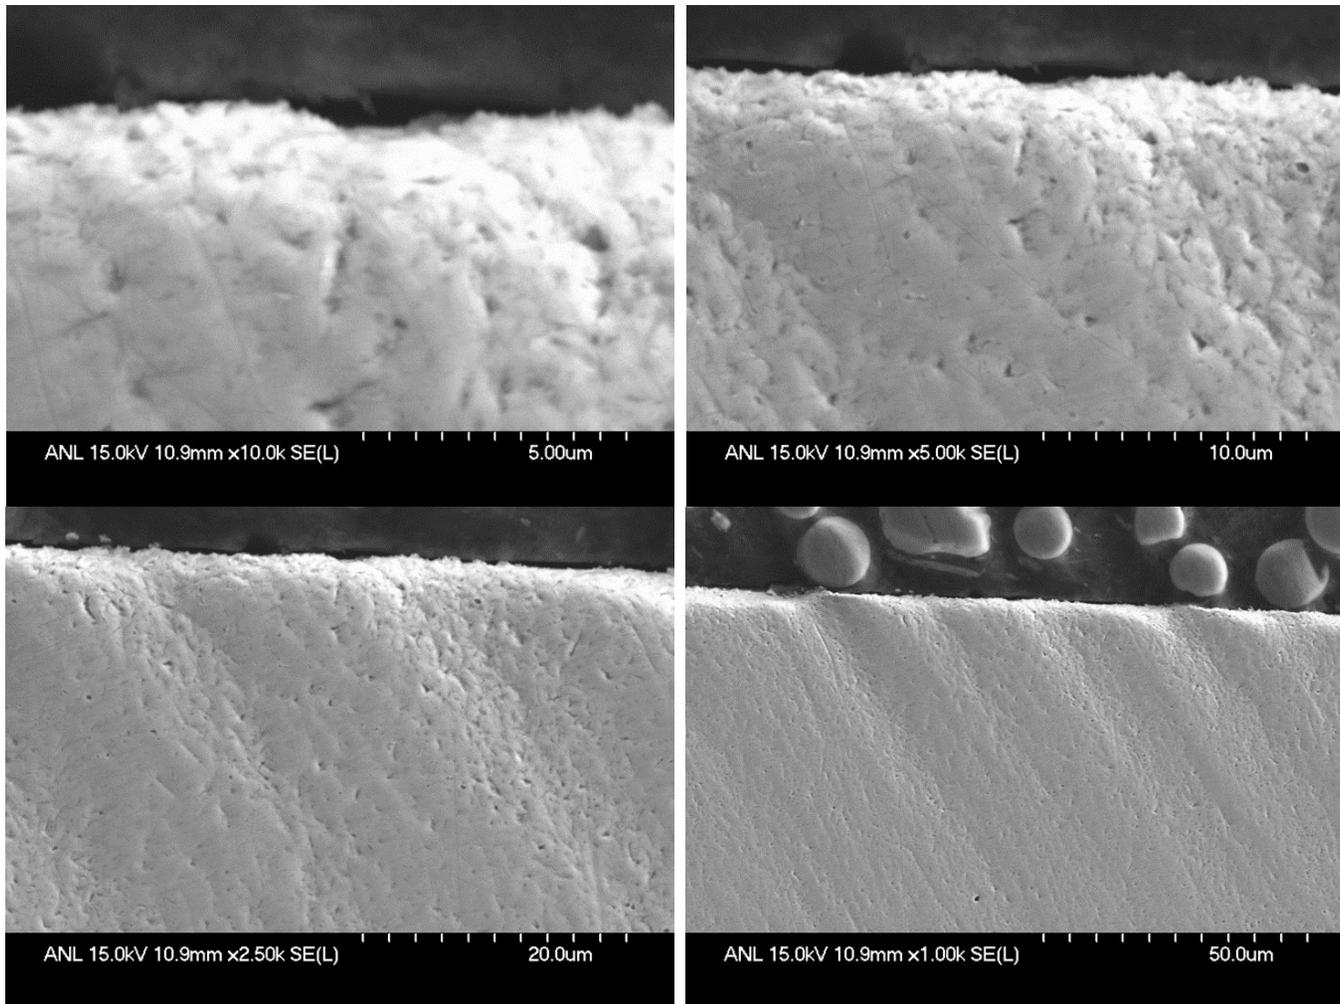
FIGURE 49 SEM Images in Areas without Oxide Scale for 18-Week Exposure SCC C-Ring 14149.5R

Figures 49 through 53 are SEM and EDS mappings for SCC C-Ring 14149.5R from 18-week environmental exposure. Oxide scale appears in some areas but not others. Figures 49 and 50 show details for an area where there was no oxide scale. The remaining figures show areas with oxide scale in the range or 5 micron which is about the same as was observed for 48 weeks. A thinner scale might be anticipated but this may be related to the fact that the 18-week samples were not introduced to the test environments immediately after machining as there was a nearly 1-year interim period without testing. In contrast, the 6- and 48-week samples were introduced to the autoclave environment within just a few weeks of machining. From Argonne's experience with similar alloys, full characterization of scale formation requires evaluation of more samples than were done here because pitting corrosion and SCC cracks generally occur randomly.

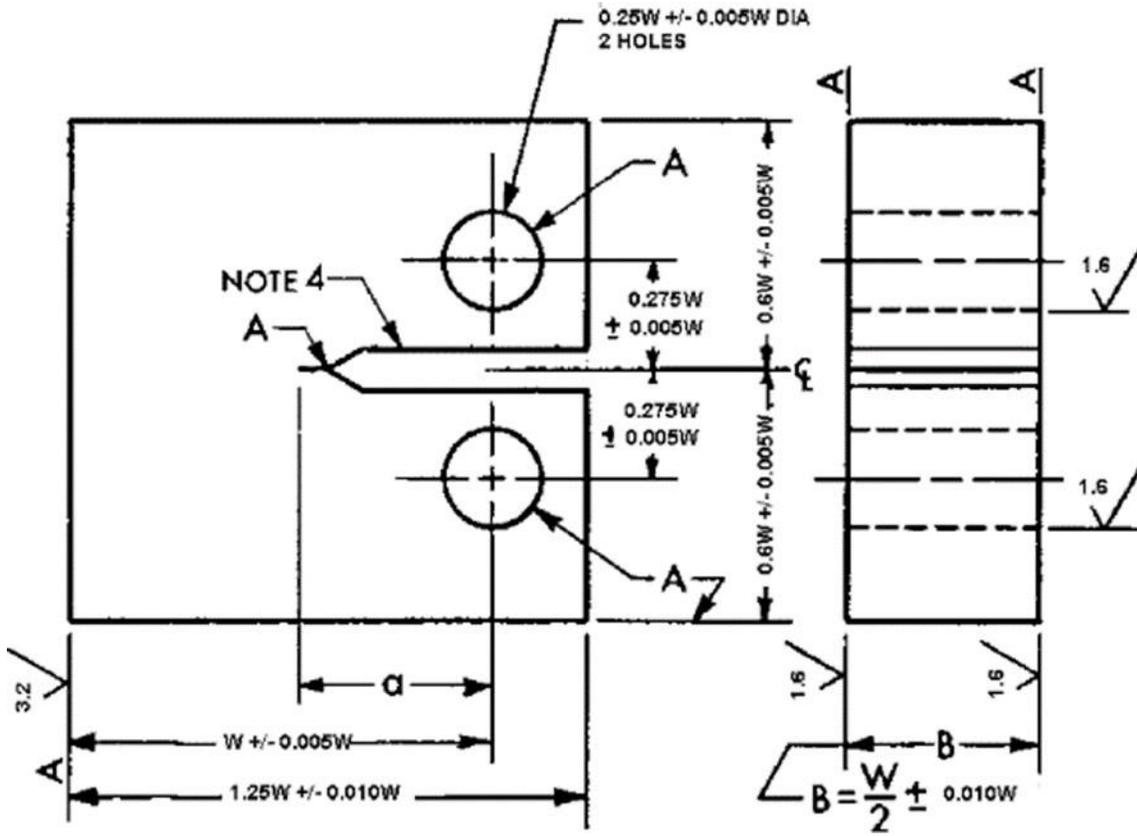
Figure 1: Schematic of the compact tension (CT) sample used in this test program.

Samples were side grooved 5%. Samples tested in sour service were tested in the L-C orientation, while samples tested in seawater + CP were tested in the L-R orientation with the crack running from the OD to the ID. Representative specimen drawings for the CT specimens are shown in Figure 1.

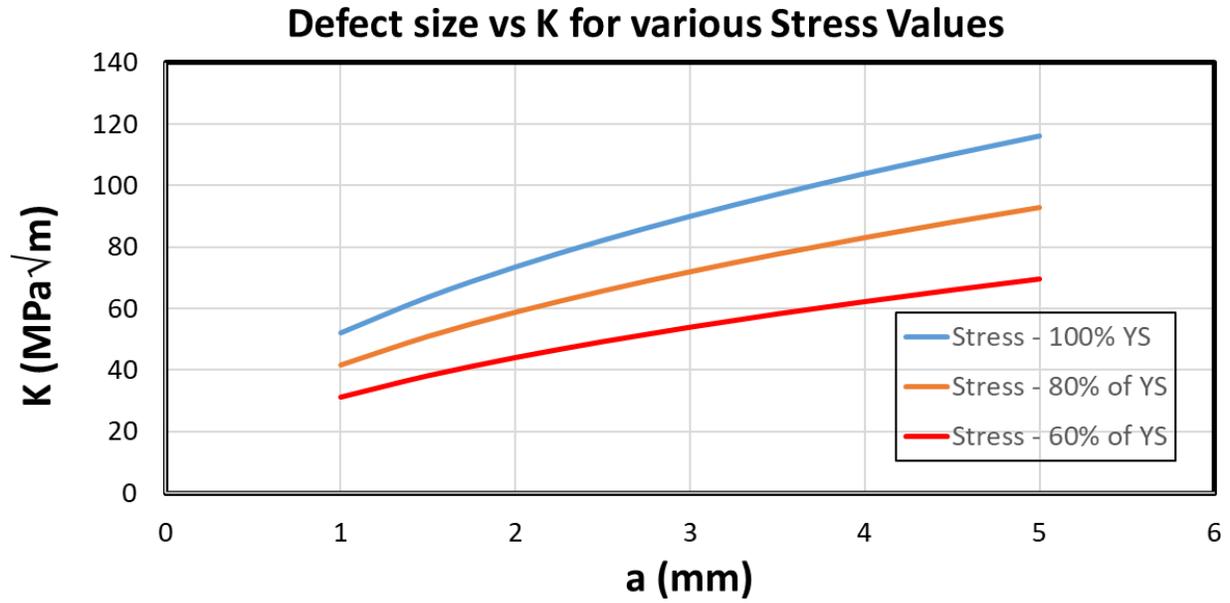
Figure 3: Effect of stress level, and crack length on the resulting K value assuming a YS of 120ksi (828MPa).

Where K is the stress intensity factor ($\text{MPa}\sqrt{\text{m}}$), σ is the applied stress (MPa), and a is the crack/defect length (mm). The effect of crack size, and stress on the resulting K values is shown in Figure 3. The assumption made in this calculation is that the YS of the material is 120 ksi (828 MPa).

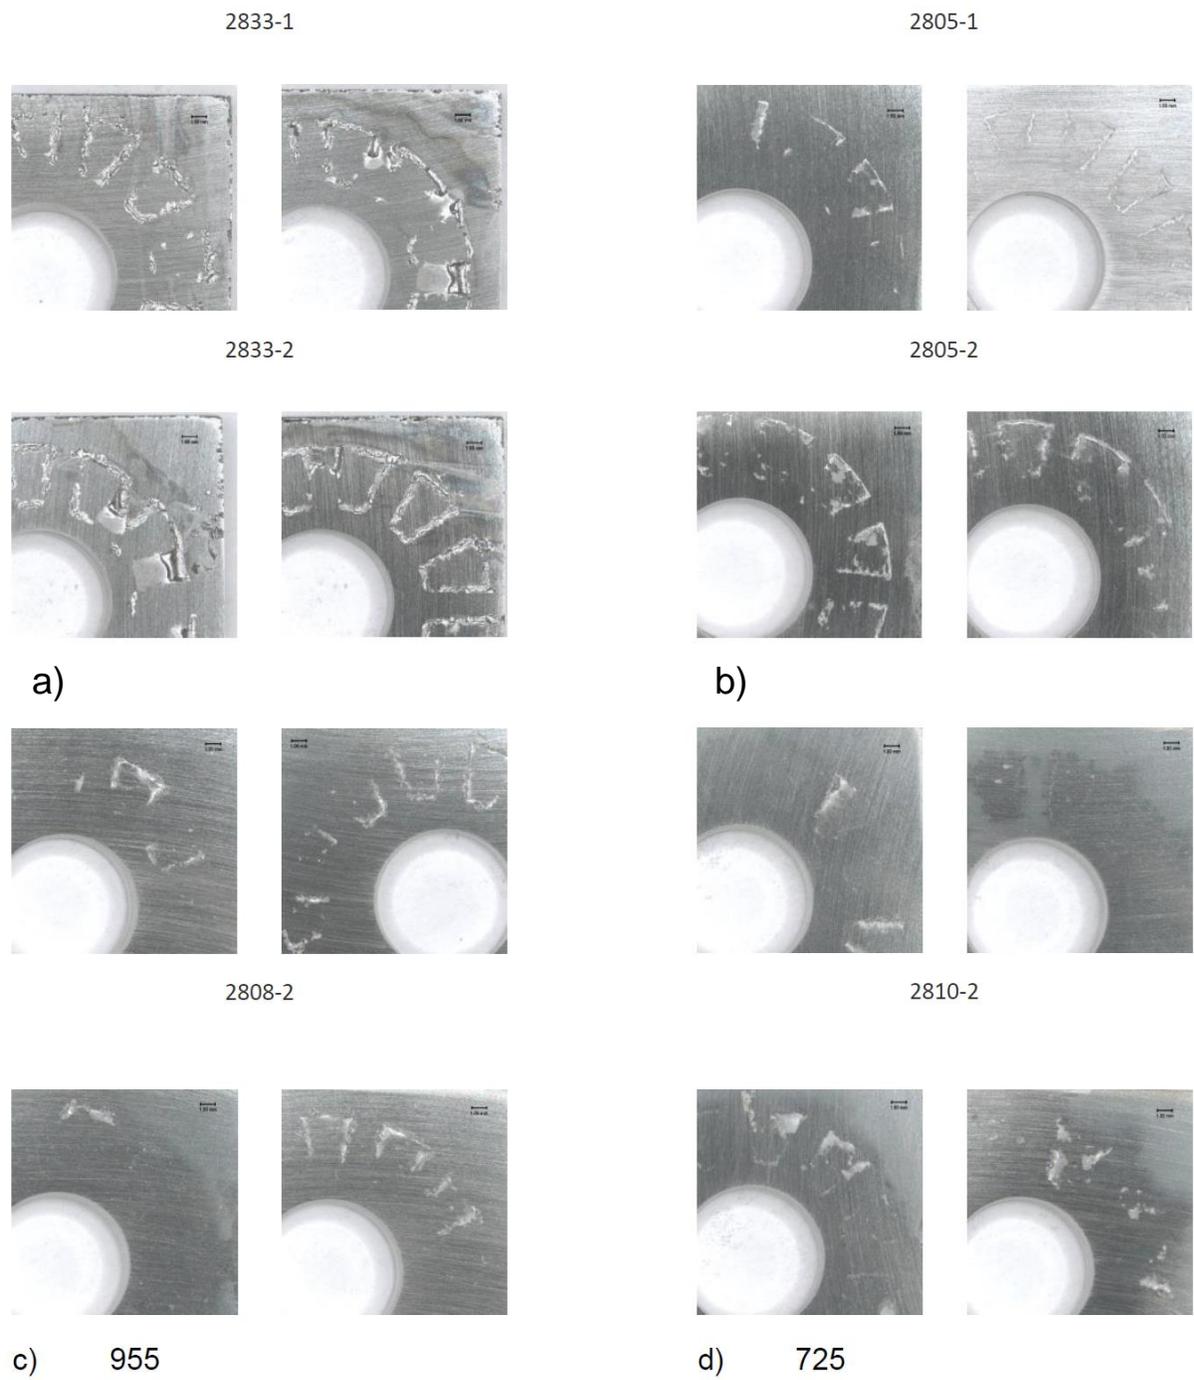
Post tests of the samples are shown in Figure 5 and there is clear evidence of crevice corrosion on all the samples, except C22HS. The extent of attack on 825 is significantly more than that observed on 955 and 725. It is also evident from the photographs, that there is no evidence of crevice corrosion on C22HS, consistent with the idea that the increase in current is associated with the transpassive dissolution of chromium. This is consistent with the measured critical crevice temperatures.

The results of the critical crevice temperature are summarized in Table 5. The temperature at which the current density is higher than 100 $\mu\text{A}/\text{cm}^2$ is shown and identified as the critical crevice temperature in all cases except for C22HS. In the case of C22HS there was no evidence of crevice corrosion, and the increase in current is likely associated with the transpassive dissolution of chromium.

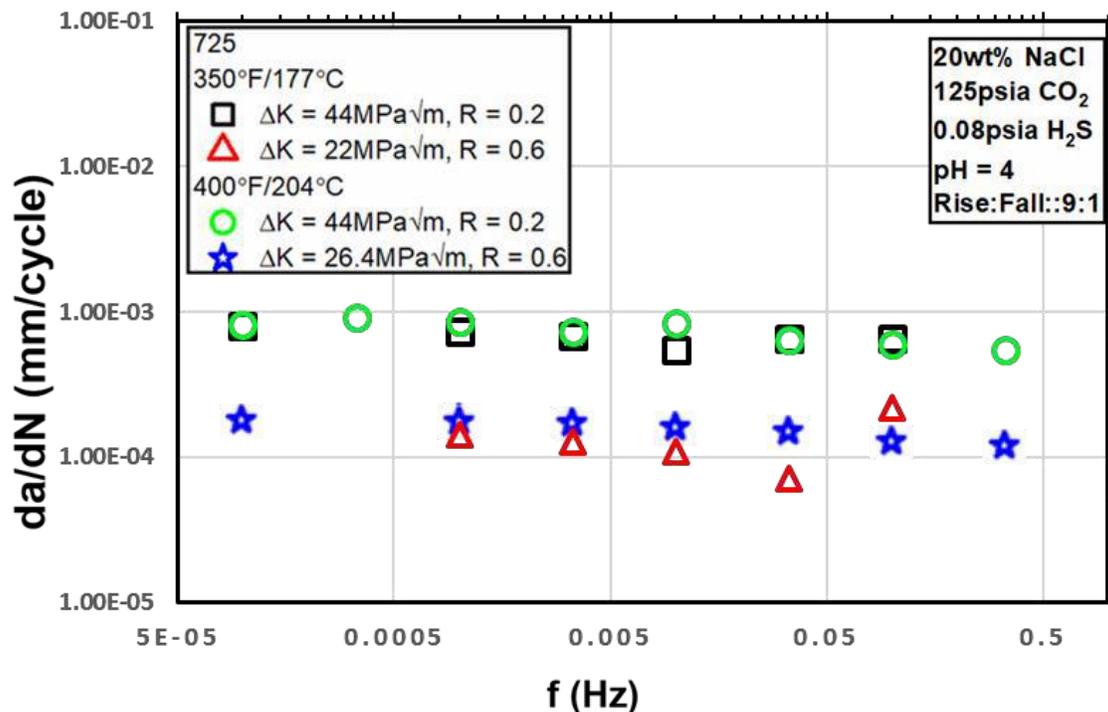
Figure 7: FCGR frequency scans on 725 (2810-CL3) in sour environment over a range of ΔK values at 350°F and 400°F.

The results of the frequency scan on 725 at 350°F (177°C) and 400°F (204°C) are shown in Figure 7. There is no significant effect of frequency on the fatigue crack growth at either temperature. There also appears to be no significant effect of ΔK on the frequency dependence. These results suggest that in the studied sour service environments do not have significant impact on the FCGR under the ΔK conditions evaluated. These results are consistent with data in literature where FCGR and fracture toughness tests performed on 625+ in sour environments containing similar chloride levels but at much higher partial pressures of H₂S, did not show any susceptibility to environmentally assisted fatigue[1].

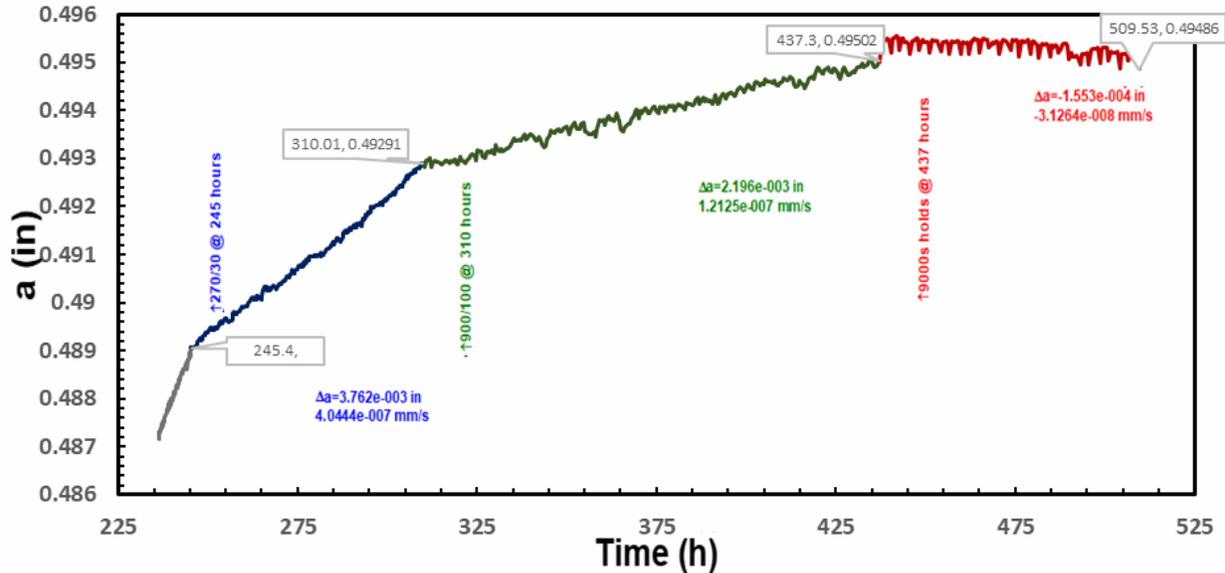
Figure 8: Crack length vs time as a function frequency and hold time of 725 (2810-CL3) in sour environment at 400°F (204°C) and K_{max} of 60 ksi√in (66 MPa√m).

data clearly indicates that no stable crack growth was possible at 9000 s (2.5 h) holds suggesting that stable static crack growth was not possible under these conditions. The test was then terminated, with the conclusion that no stable crack growth was possible in 725 at 400°F (204°C) at a high K_{max} value of 60 ksi√in (66 MPa√m).

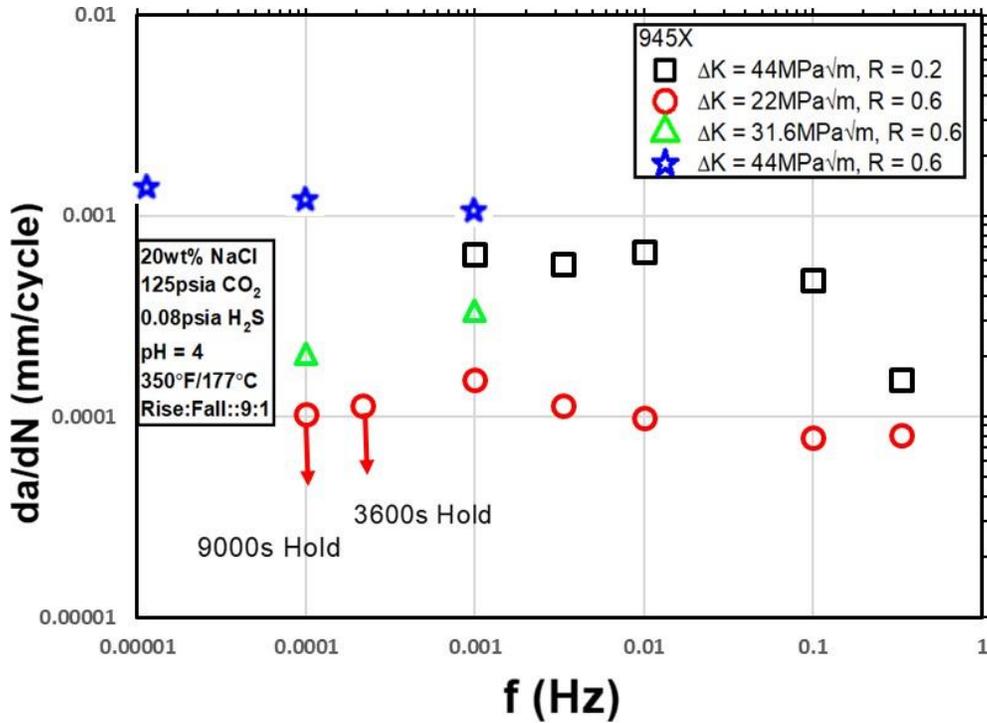
Figure 9: FCGR frequency scans on 945X (2805-CL1) in sour environment at 350°F (177°C) over a range of ΔK values.

The results of the FCGR frequency scan tests on 945X are shown below in Figure 9. The results suggest that over a range of ΔK conditions there is no effect of frequency on the FCGR behavior. This would suggest that there is little or no environmental effect in these conditions. 718 did not exhibit susceptibility to environmentally assisted fatigue and exhibited high values of K_{int} (120 MPa√m) measured in the rising displacement tests in similar environments[1]. These results are consistent with results on 718, which has lower Cr content compared to 945X.
