Laboratory Testing and Technical Assessments of Corrosion-Resistant Alloys for High-Pressure, High-Temperature Subsea Applications

Mechanical Property and Corrosion Performance Testing and Assessments of Nickel Alloys 725, 825, 945X, 955, and C22HS

ANL-19/30

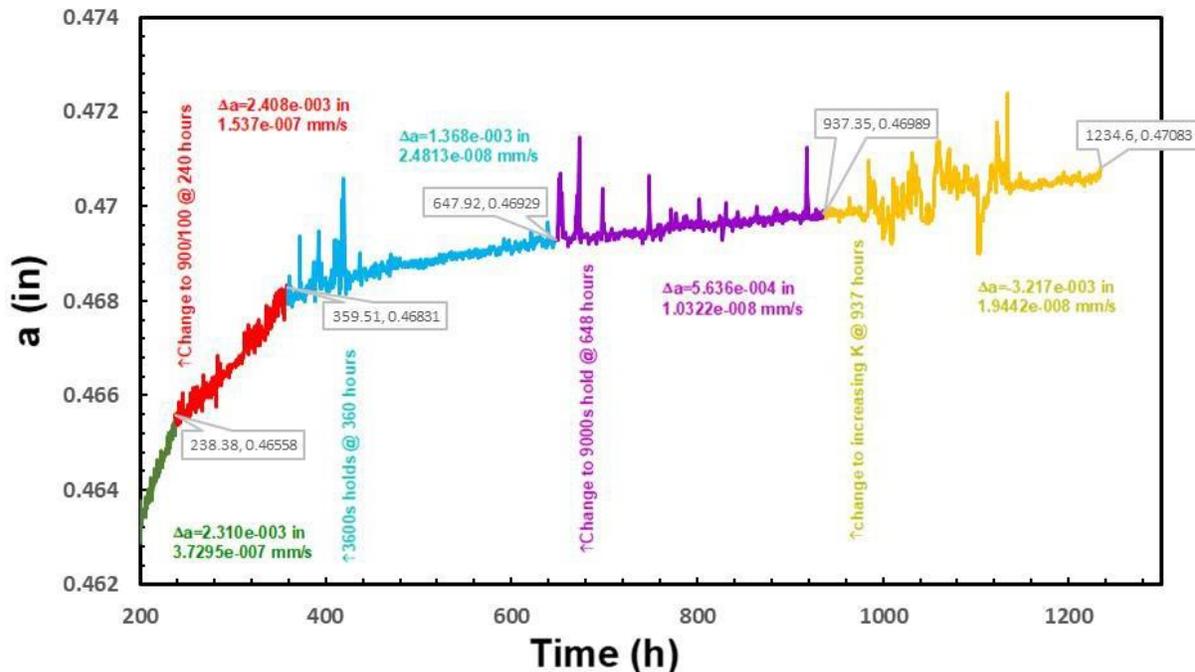
Figure 10: Crack length as a function of time for 945X (2805-CL1) at 350°F (177°C) under 9000 s holds at 50 ksi√in (55 MPa√m) and transitioning to 72 ksi√in (79.2 MPa√m).

An attempt was made to transition to constant K at 50 ksi√in (55 MPa√m) by introducing hold periods of 9000 s (Figure 10). The changes made in the test during this period are indicated in the plot with vertical comments. The comments along with the time stamp are located on the plot when the change was made. The measured crack growth rate was 1×10^{-8} mm/s, a very low value. It was then decided to increase K under 9000 s hold from 50 ksi√in (55 MPa√m) to 72 ksi√in (79.2 MPa√m). The crack growth rate during the increasing K portion even under cycling with 9000 s hold periods was 2×10^{-8} mm/s, which is not significantly higher compared to these measured under constant K and 9000 s hold periods. This suggests that at these K-levels even in the presence of a positive K- gradient there is no significant increase in the crack growth rate.

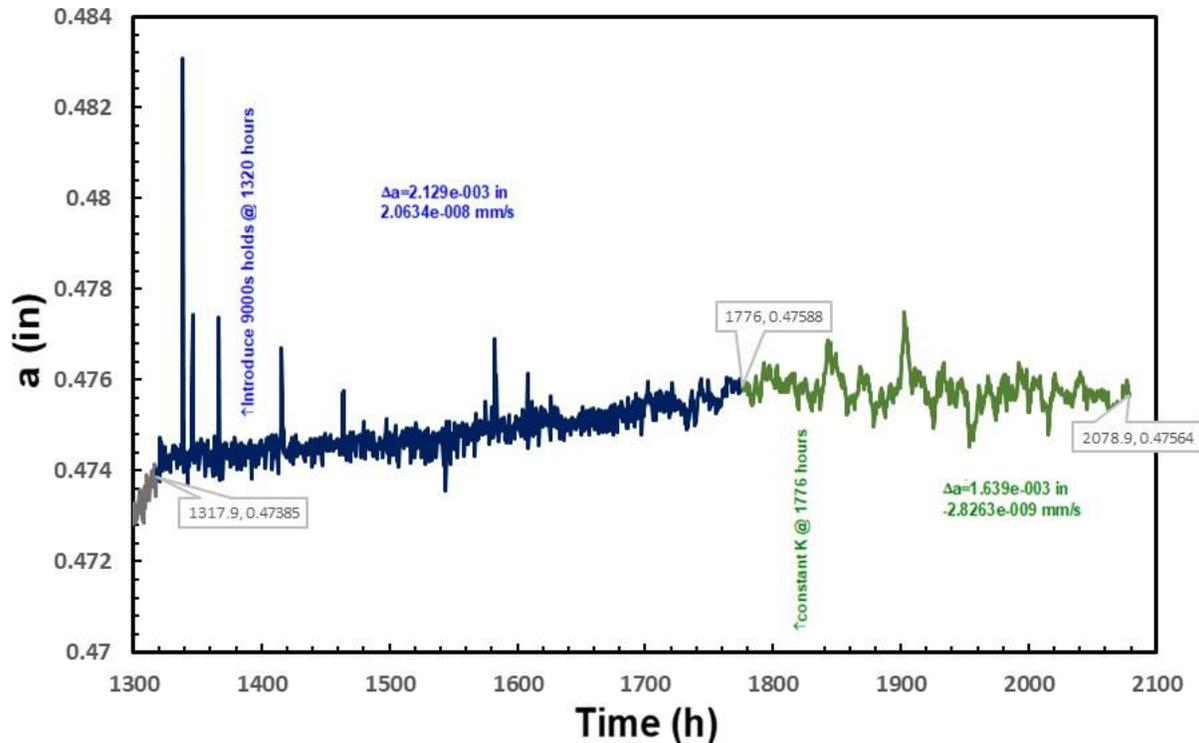
Figure 11: Crack length as a function of time for 945X (2805-CL1) at 350°F (177°C) under 9000 s holds and constant K at 72 ksi \sqrt{in} (79.2 MPa \sqrt{m}).

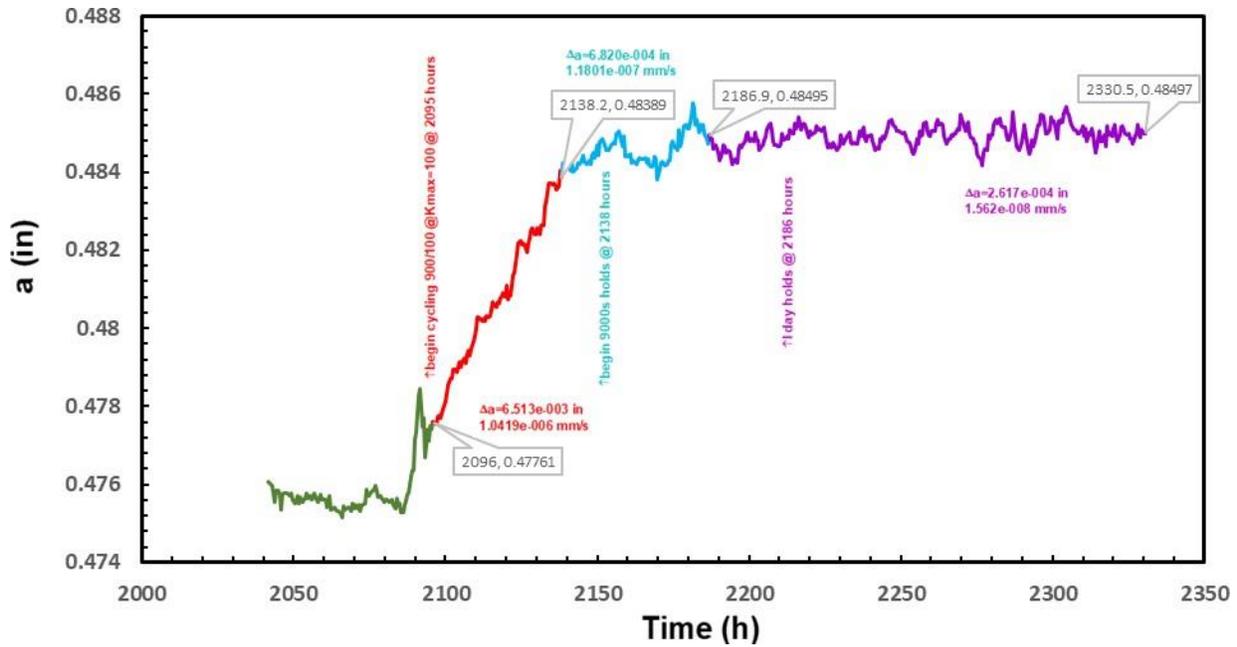
Figure 12: Crack length as a function of time for 945X (2805-CL1) at 350°F (177°C) under 9000 s and 1 day holds at 100 ksi√in (110 MPa√m).

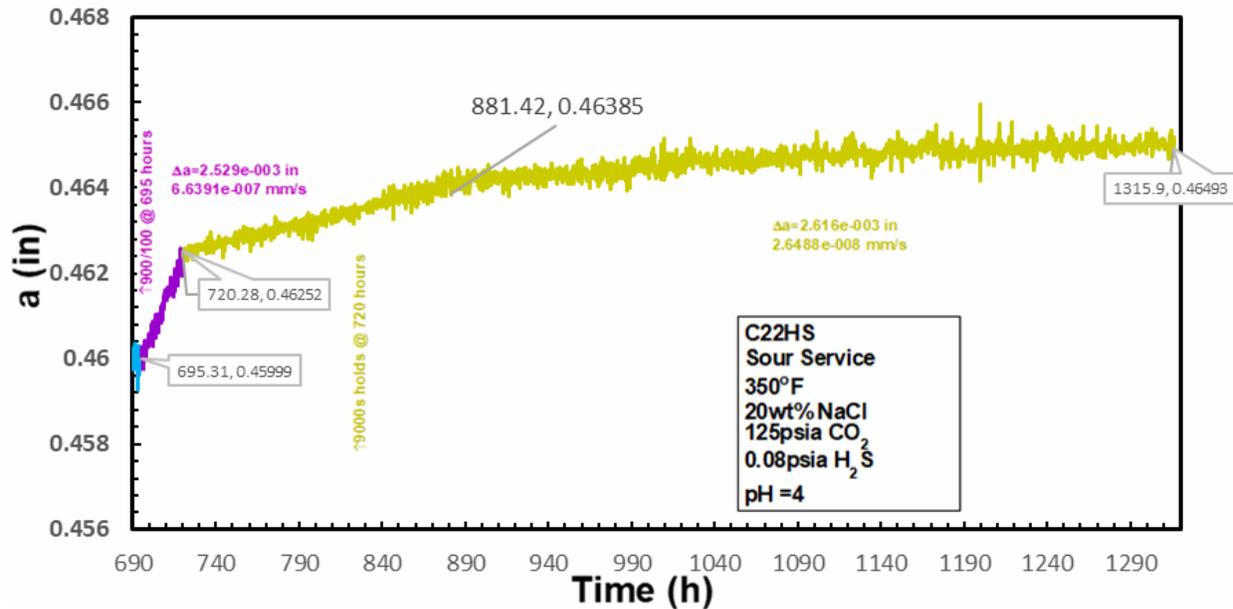
Figure 15: Crack length vs time for C22HS (2785-CL3) in sour environment at 350°F (177 C) 72 ksi√in (79.2 MPa√m), R = 0.6 and 9000 s holds.

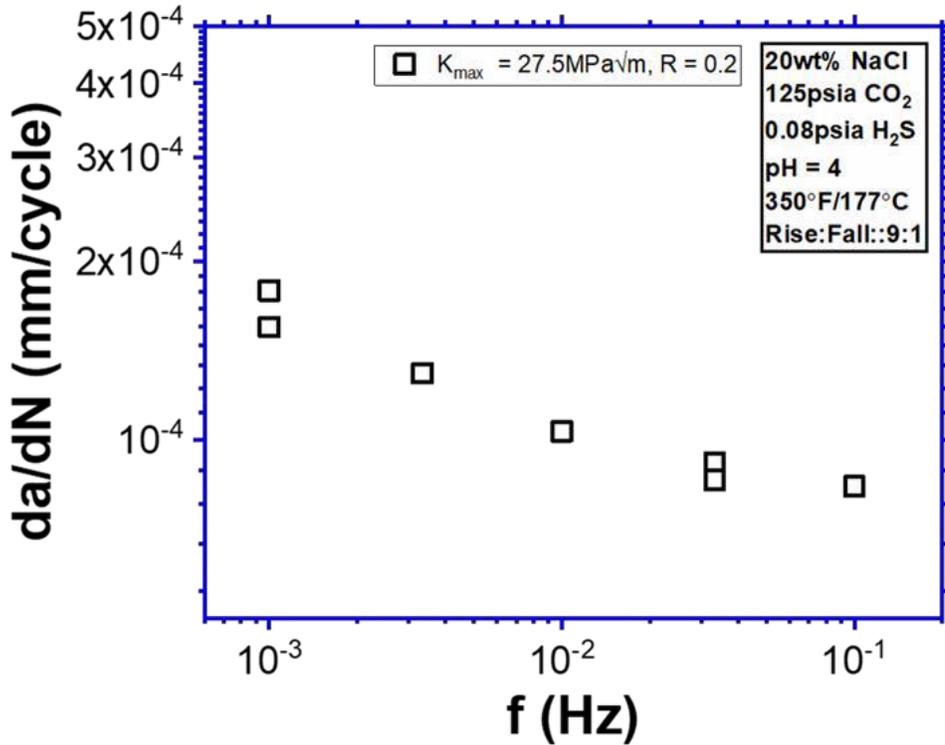
Figure 16: FCGR frequency scans on 825 (2835-CL4) in sour environment at 350°F (177°C) at 20 ksi/in (22 MPa√m).

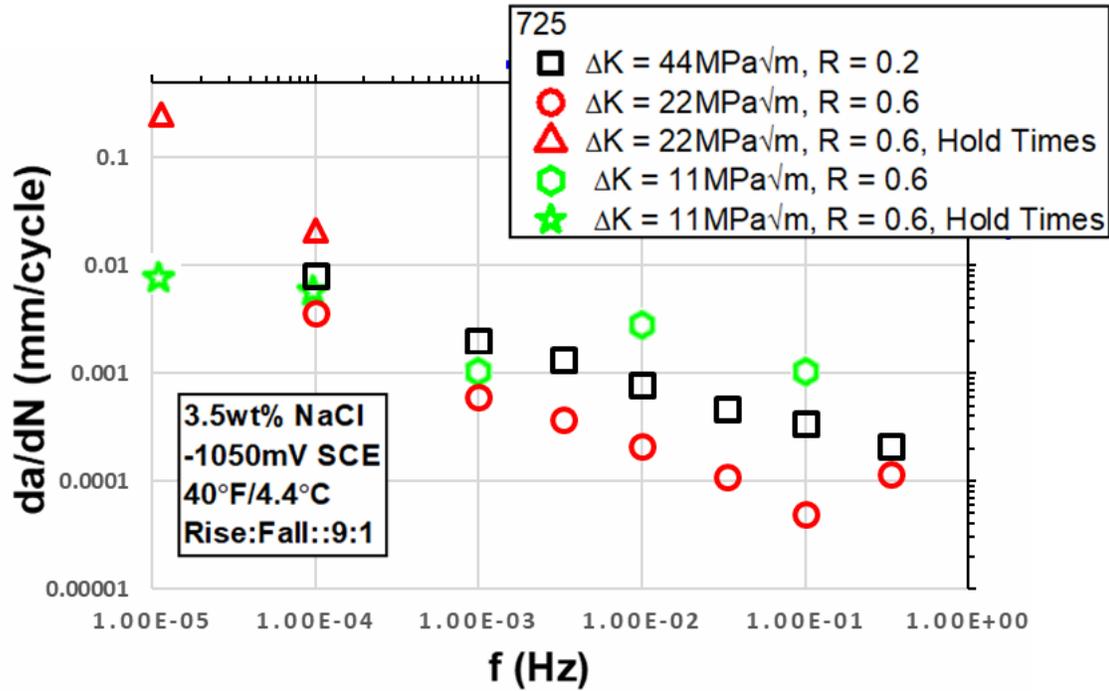
Figure 17: FCGR as a function of ΔK and frequency for 725 (2810-LR1) in seawater + CP at -1050 mV SCE.

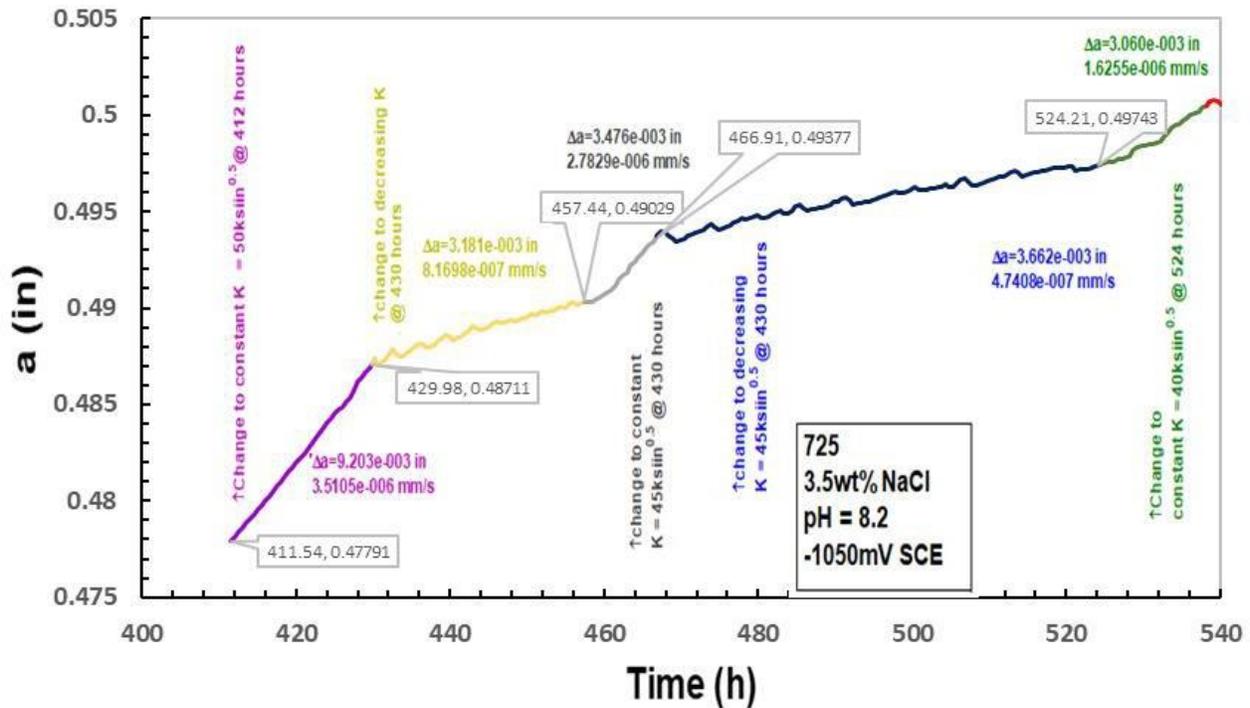
Figure 18: Crack length vs time under constant K and varying K for 725 (2810-LR1) in seawater + CP at -1050 mV SCE.

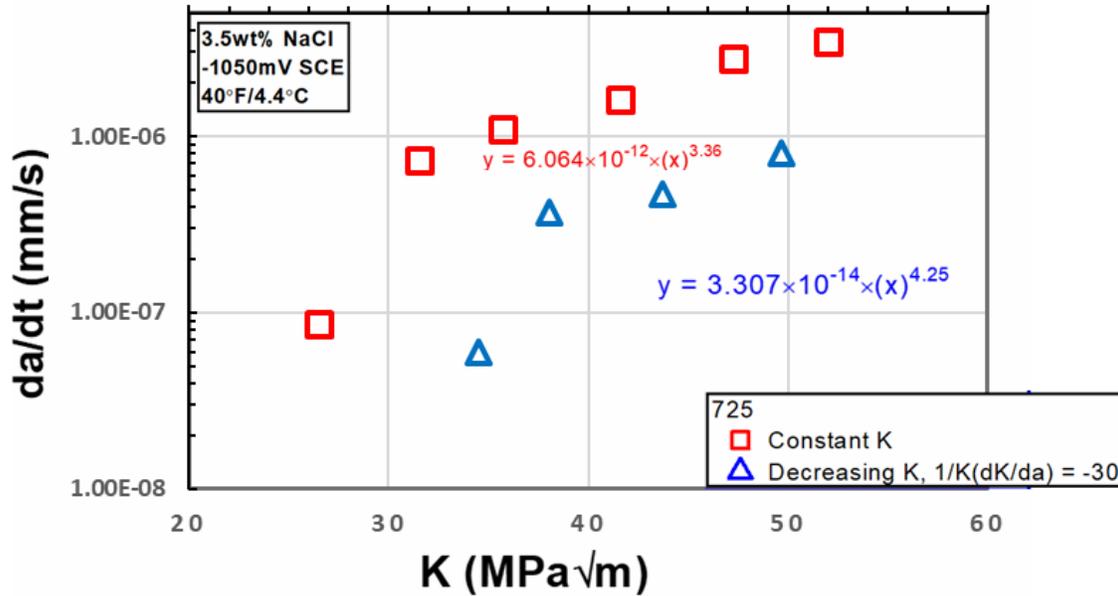
Figure 19: Crack growth rate as function of K and loading mode for 725 (2810-LR1) in seawater at -1050 mV SCE.

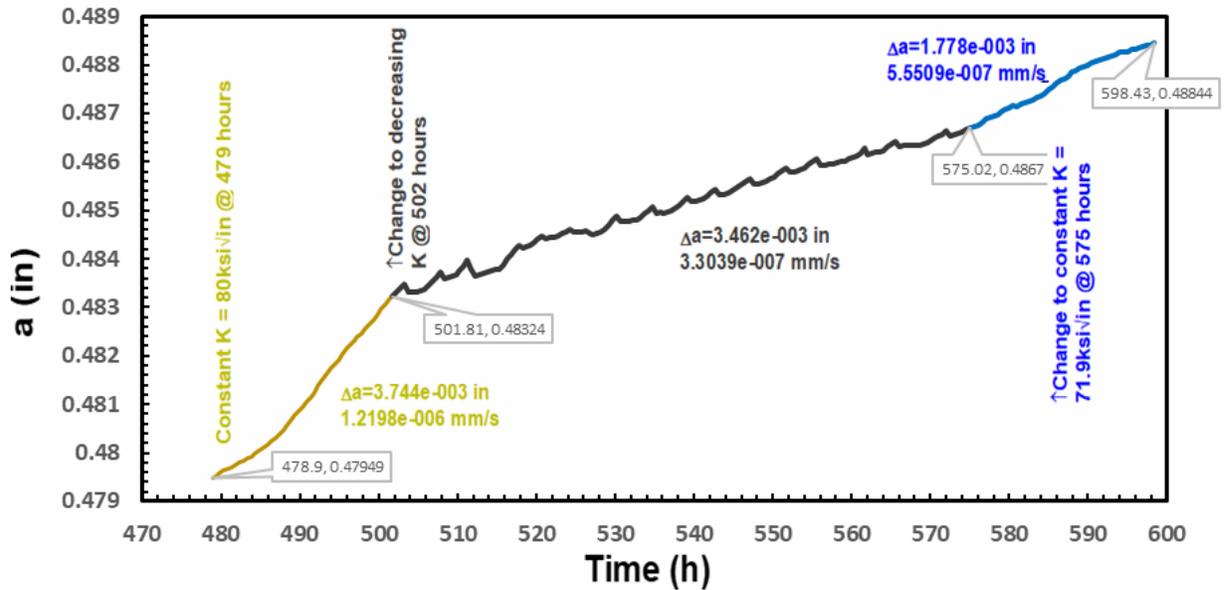
Figure 21: Crack length vs time under constant K and varying K for 945X (2805-LR1) in seawater + CP at -1050 mV SCE.

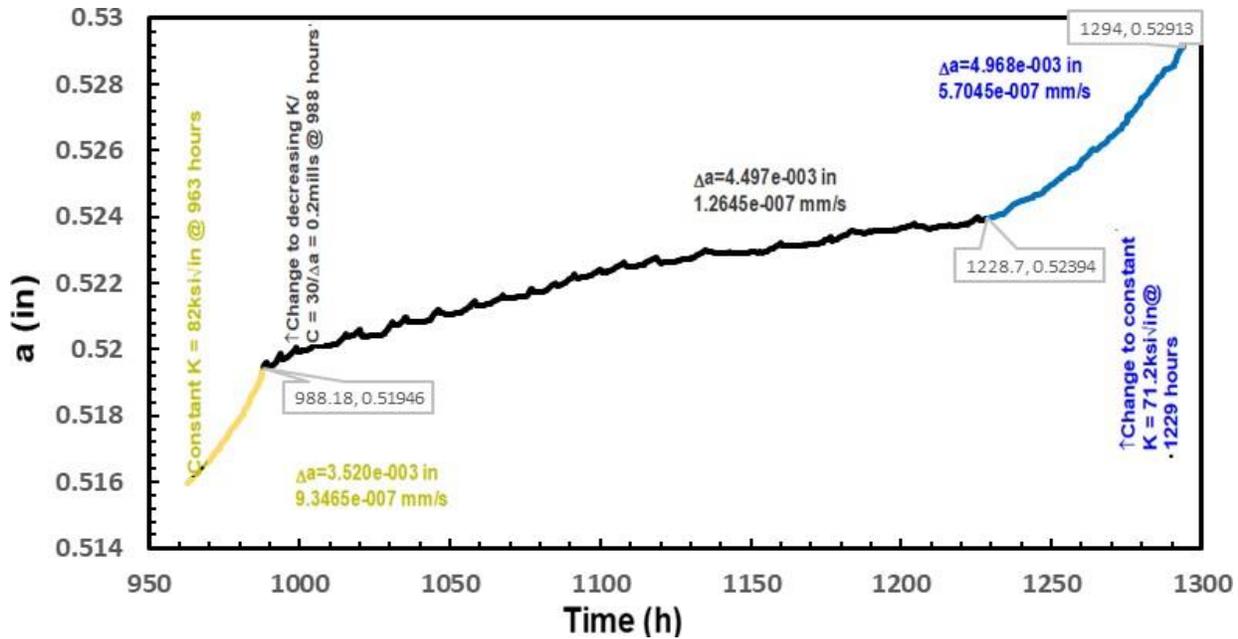
Figure 22: Crack length vs time under constant K and varying K for 945X (2805-LR1) in seawater + CP at -1050 mV SCE.

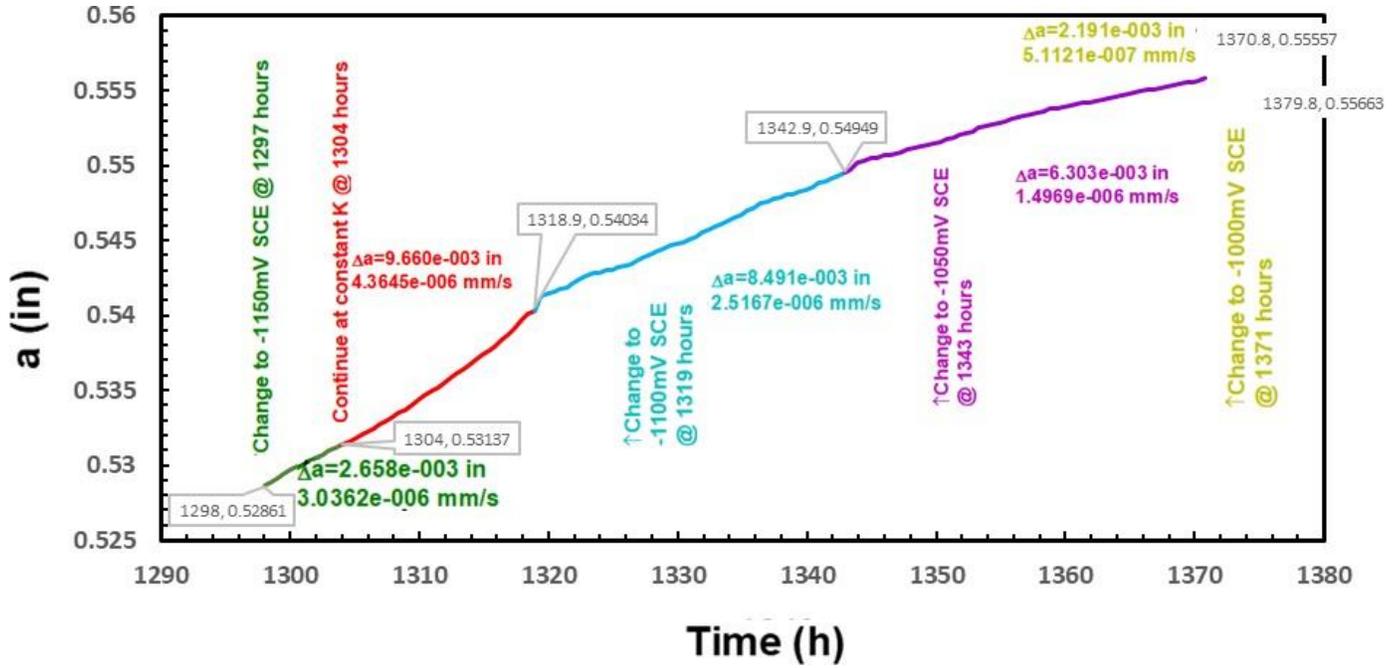
a) Crack length vs time from -1150 mV SCE to -1000 mV SCE

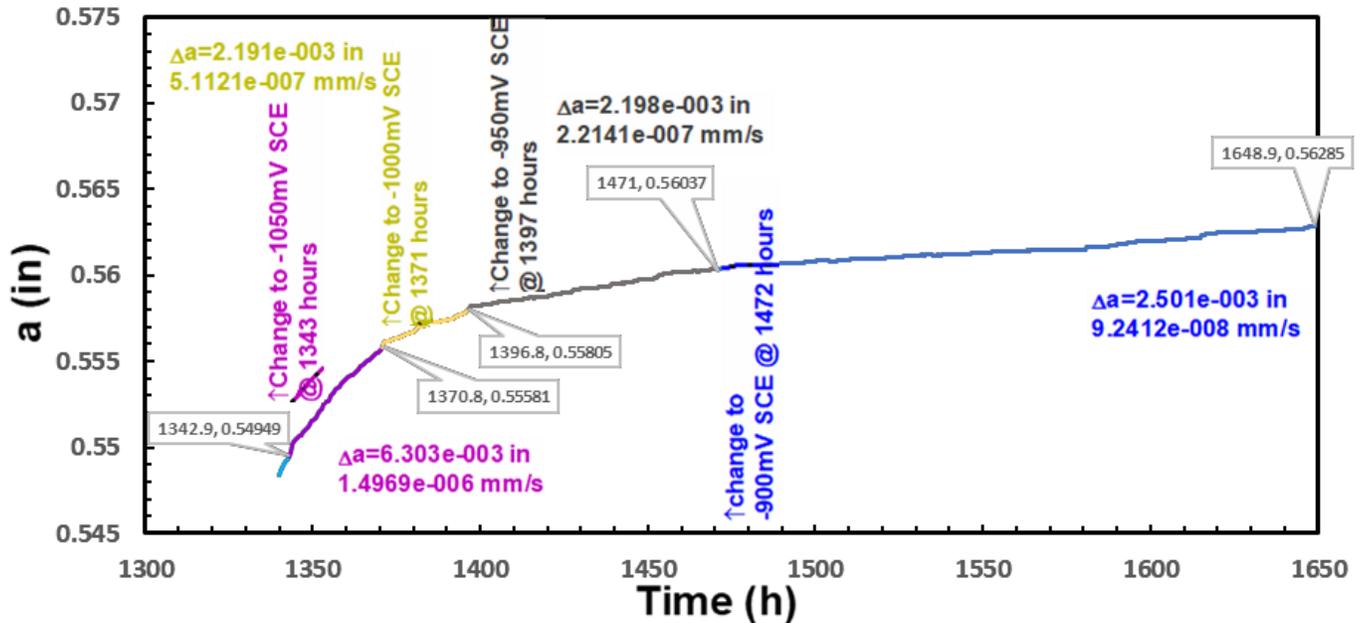
b) Crack length vs time from -1050 mV SCE to -950 mV SCE

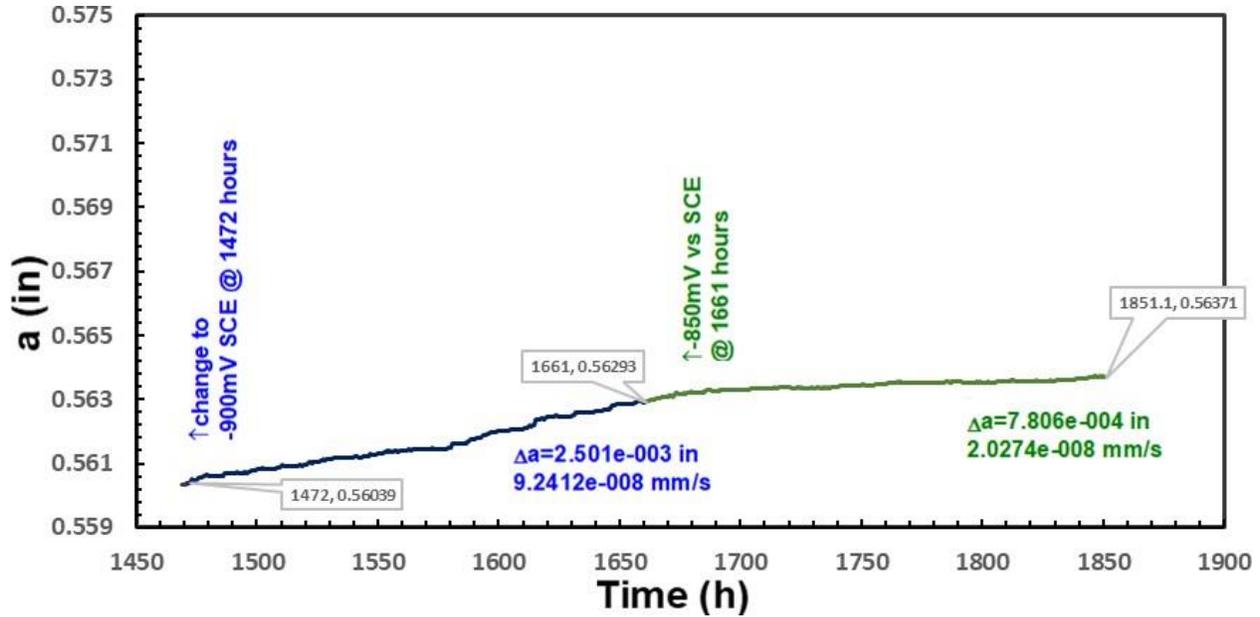
d) Crack length vs time from -900 mV SCE to -850 mV SCE.

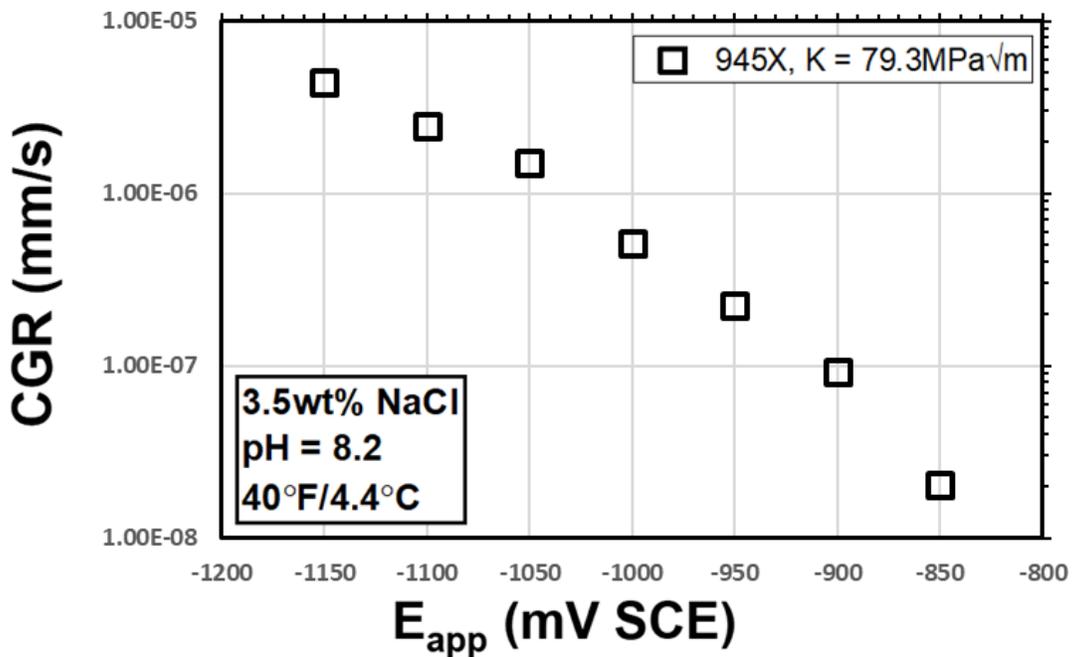
Figure 25: CGR of 945X (2805-LR1) as a function of applied potential at 71.2 ksi√in (78.3 MPa√m).

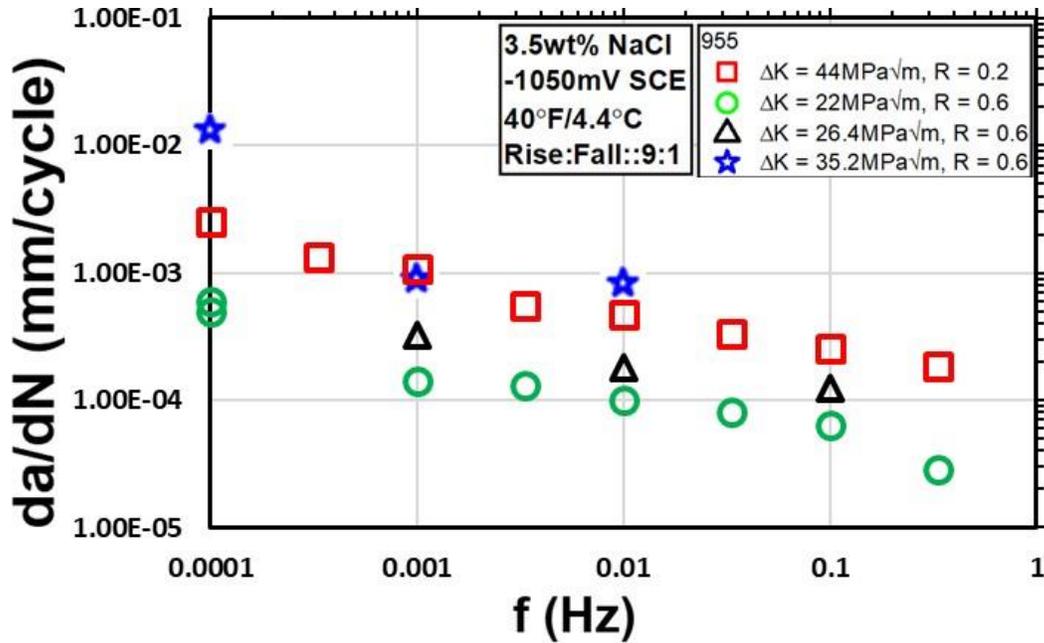
Figure 26: FCGR as a function of frequency and ΔK of 955 (2808-LR3) in seawater under cathodic polarization of -1050 mV SCE.

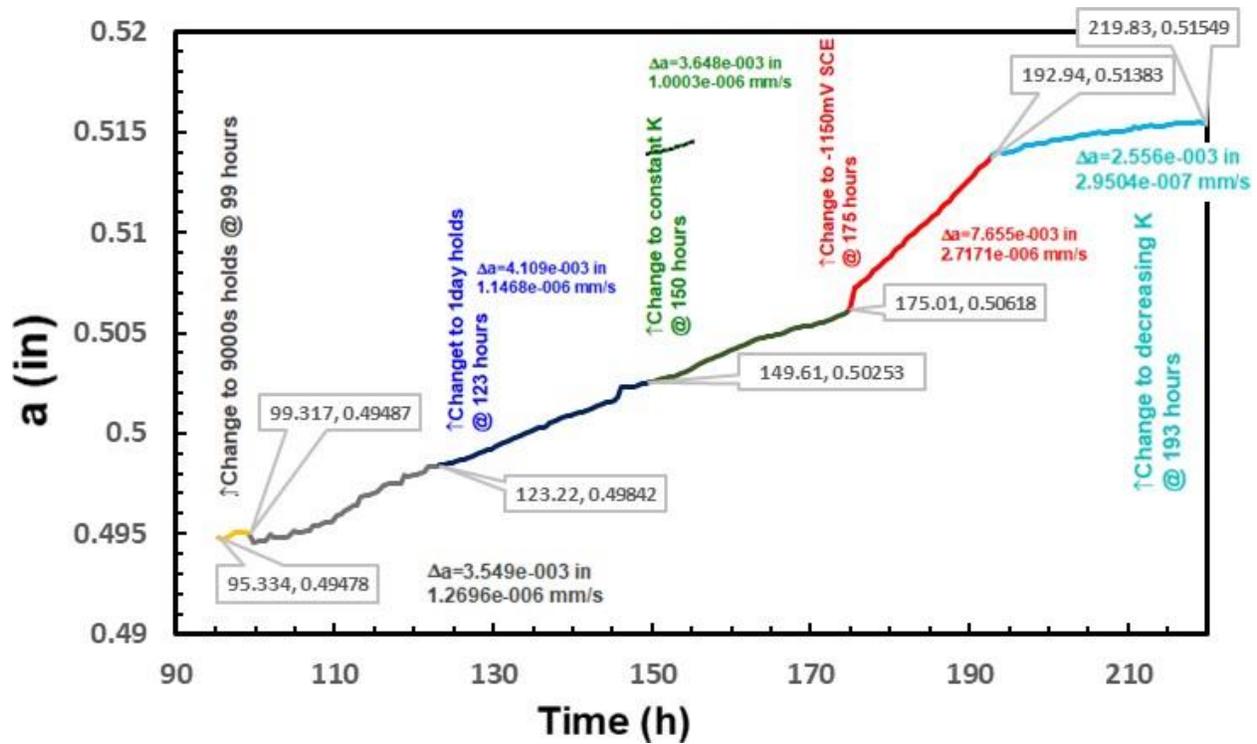
Figure 27: Crack length vs time for 955 (2808-LR3) at constant K and under decreasing K conditions.

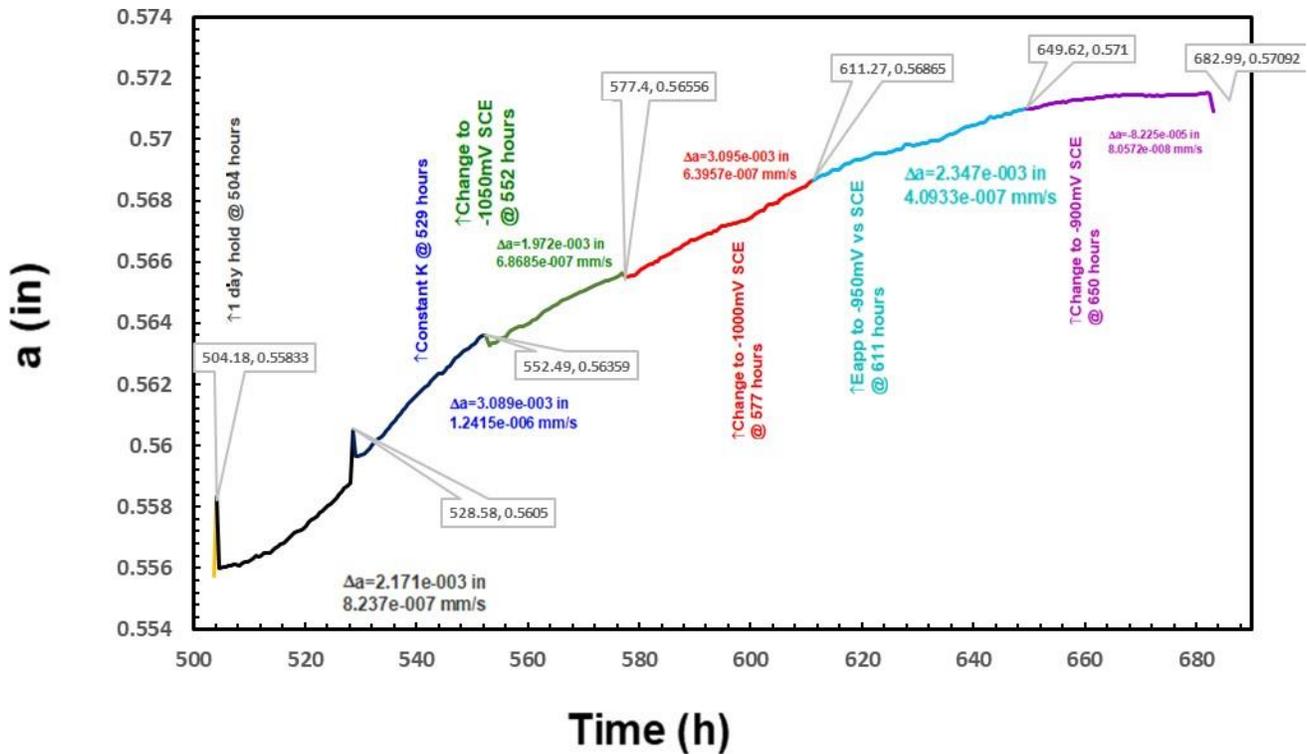
Figure 28: Crack length vs time for 955 (2808-LR3) as a function of applied potential at $K = 84 \text{ ksi}\sqrt{\text{in}}$ ($92.4 \text{ MPa}\sqrt{\text{m}}$).

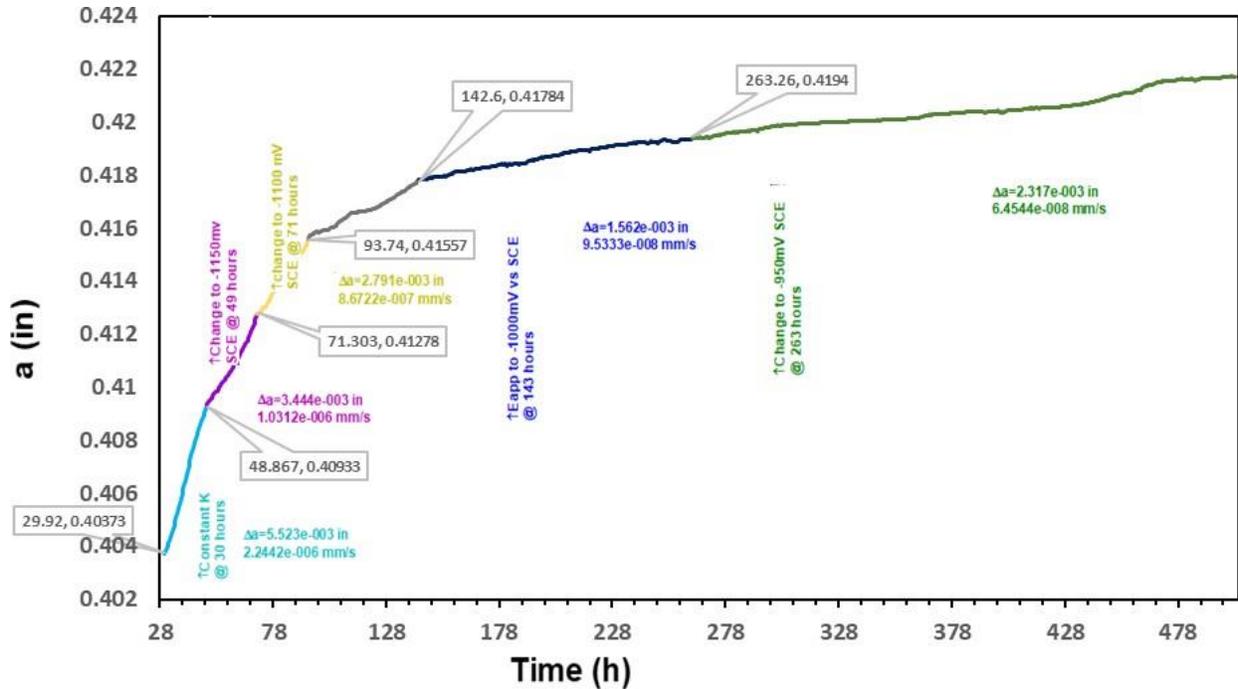
Figure 29: Crack length vs time for 955 (2808-LR5) as a function of applied potential at 72 ksi√in (79.2 MPa√m).

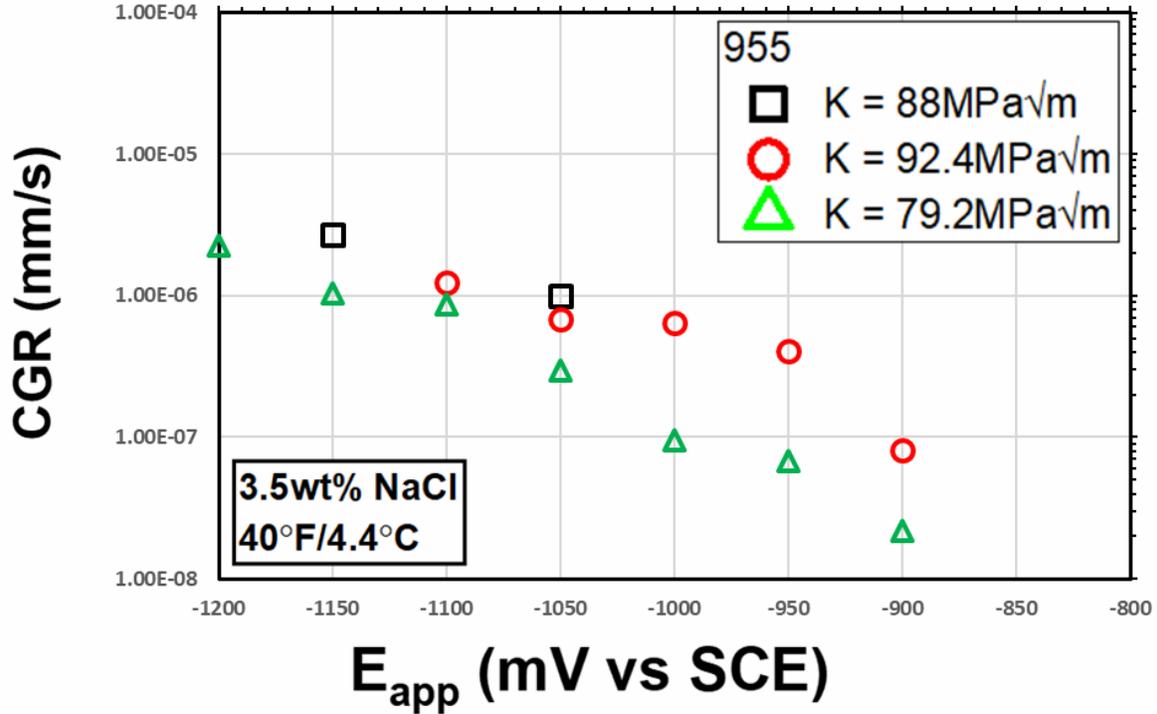
Figure 30: Effect of applied potential on crack growth rate for 955 over a range of K values.

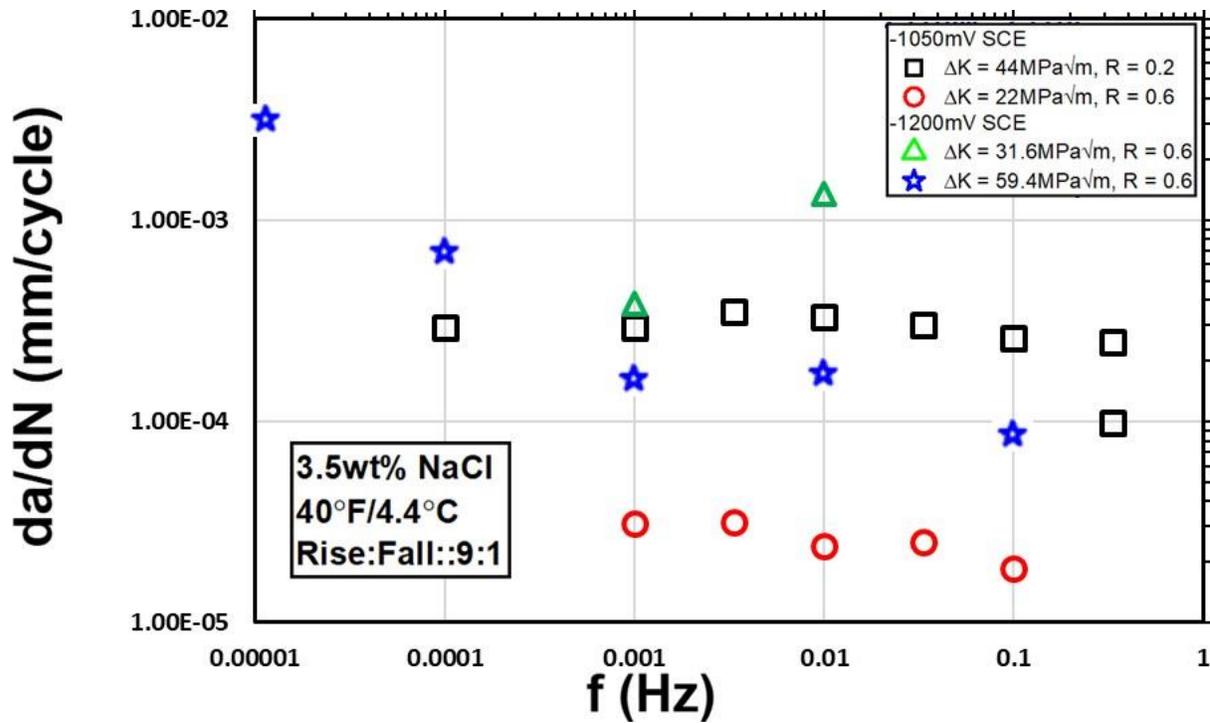
Figure 32: FCGR as a function of frequency for C22HS (2785-LR4) over a range of ΔK values, and potentials

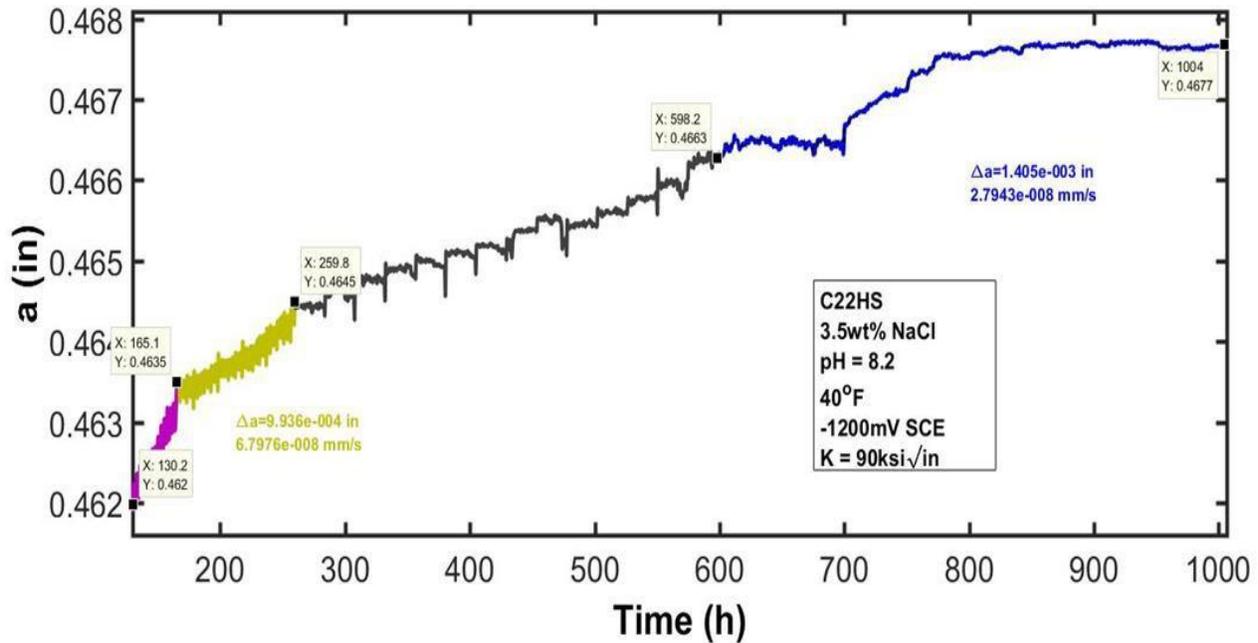
Figure 33: Crack growth rate at constant K of 90 ksi√in (99 MPa√m) and -1200 mV SCE for C22HS (2785-LR1).

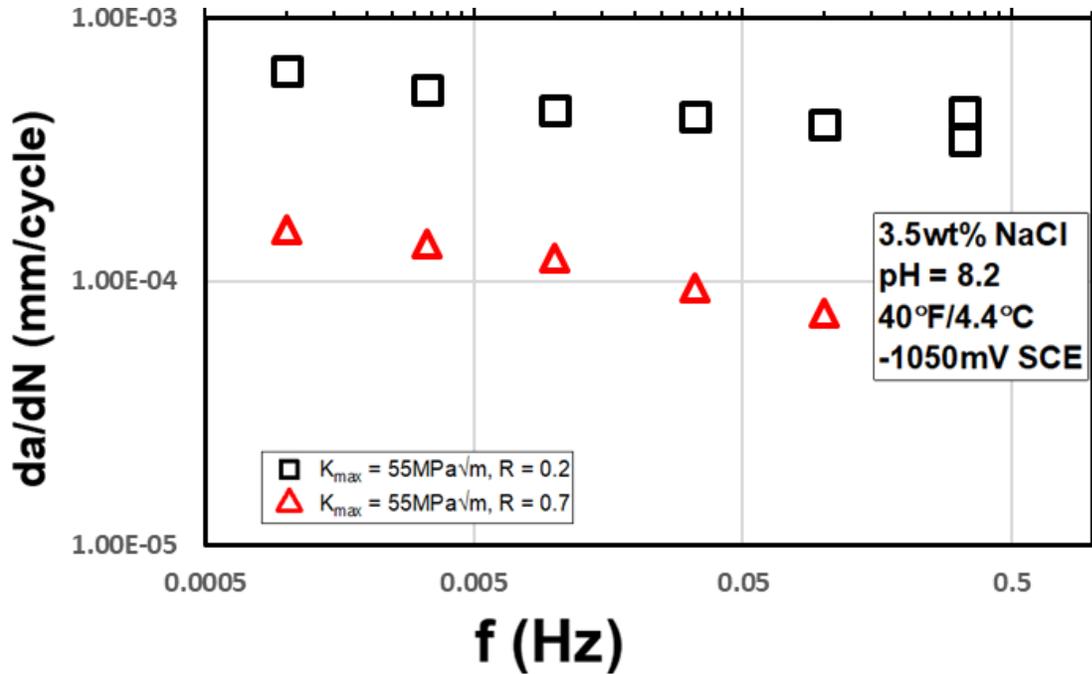
Figure 34: FCGR as a function of frequency for 825 (2833-CL3) over a range of K values.

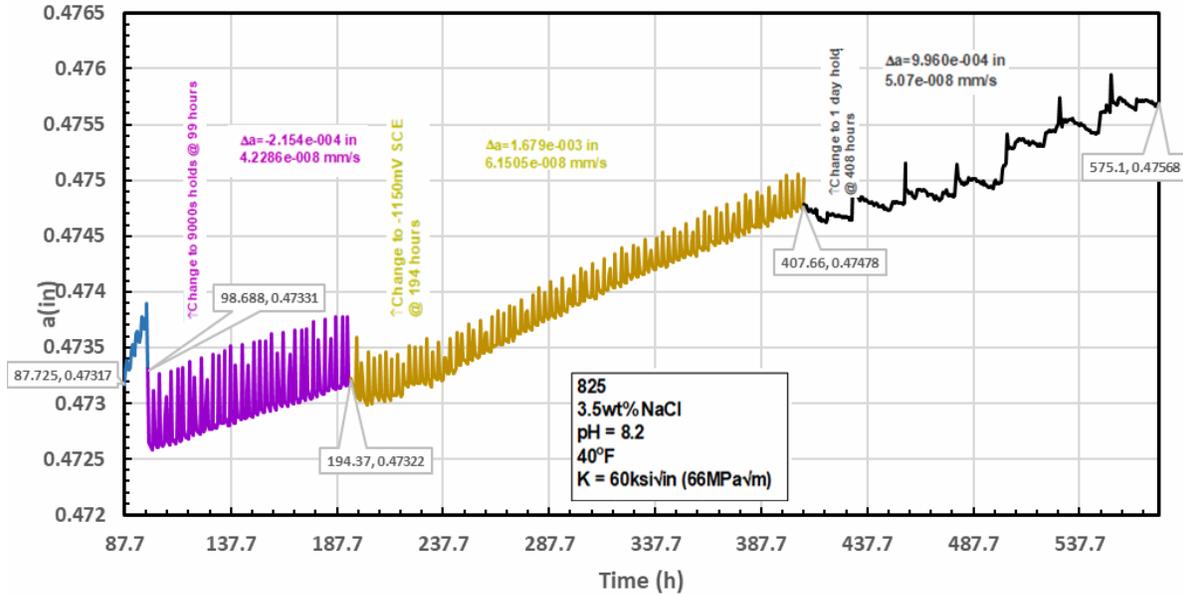
Figure 35: Crack length vs time for 825 (2833-CL3) at 60 ksi in (66 MPa√m) to determine behavior under constant K conditions.

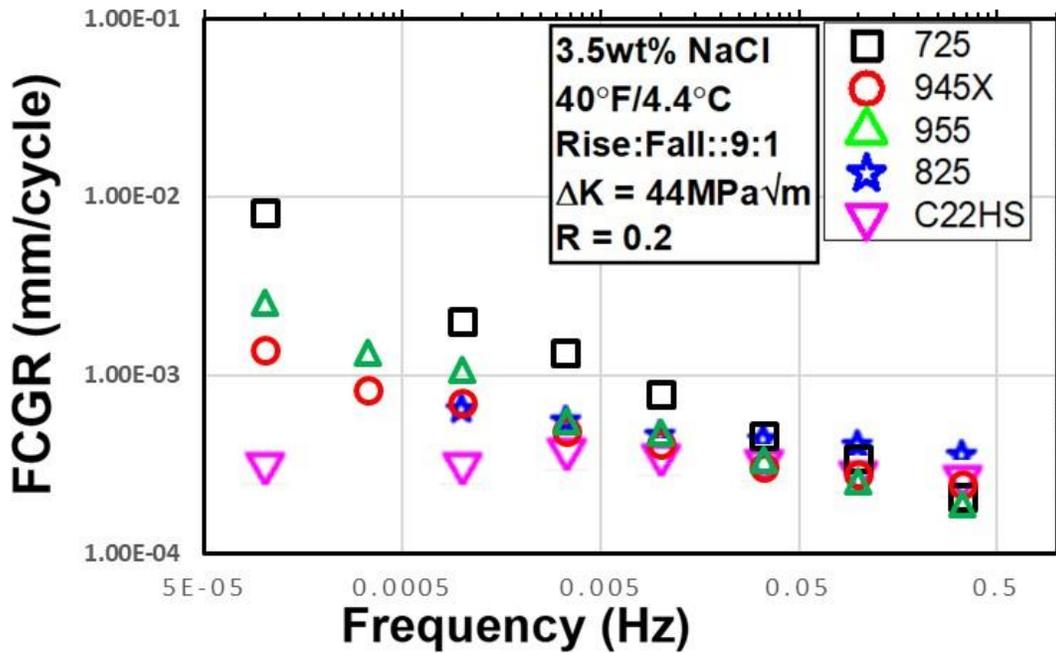
a) Rate for various alloys under CP at an R- ratio of 0.2 and ΔK of 44 MPa√m
Effect of frequency on the fatigue crack growth.

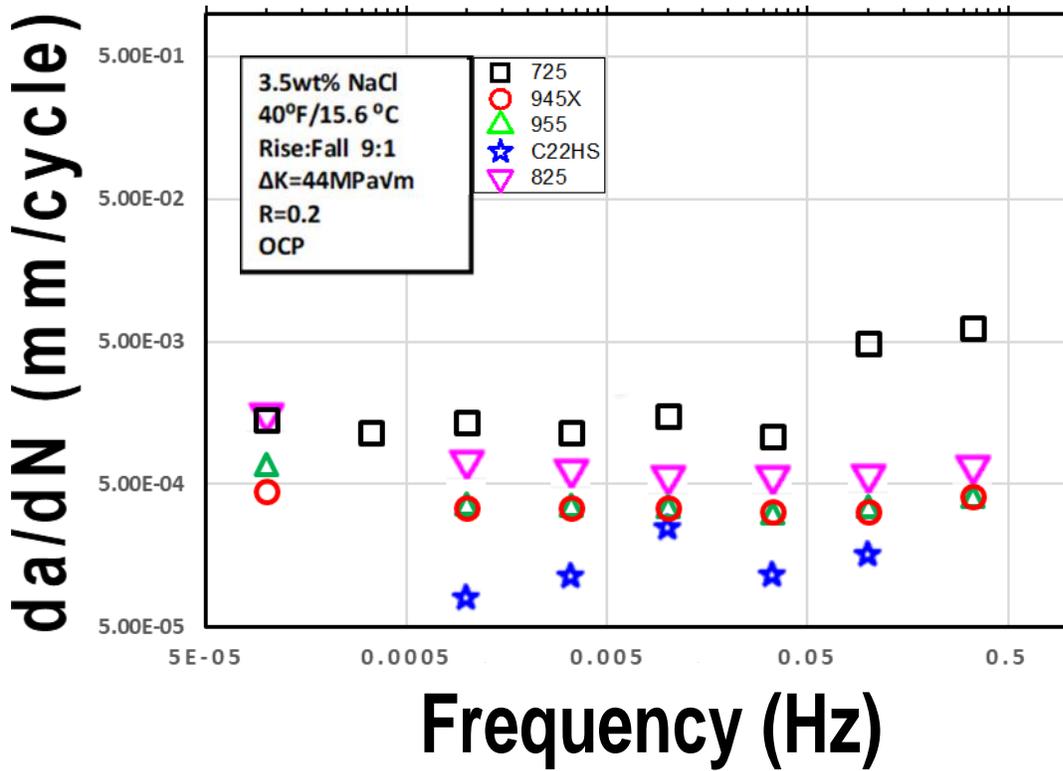
Figure 39: FCGR as a function of frequency for all the alloys in seawater under OCP conditions.

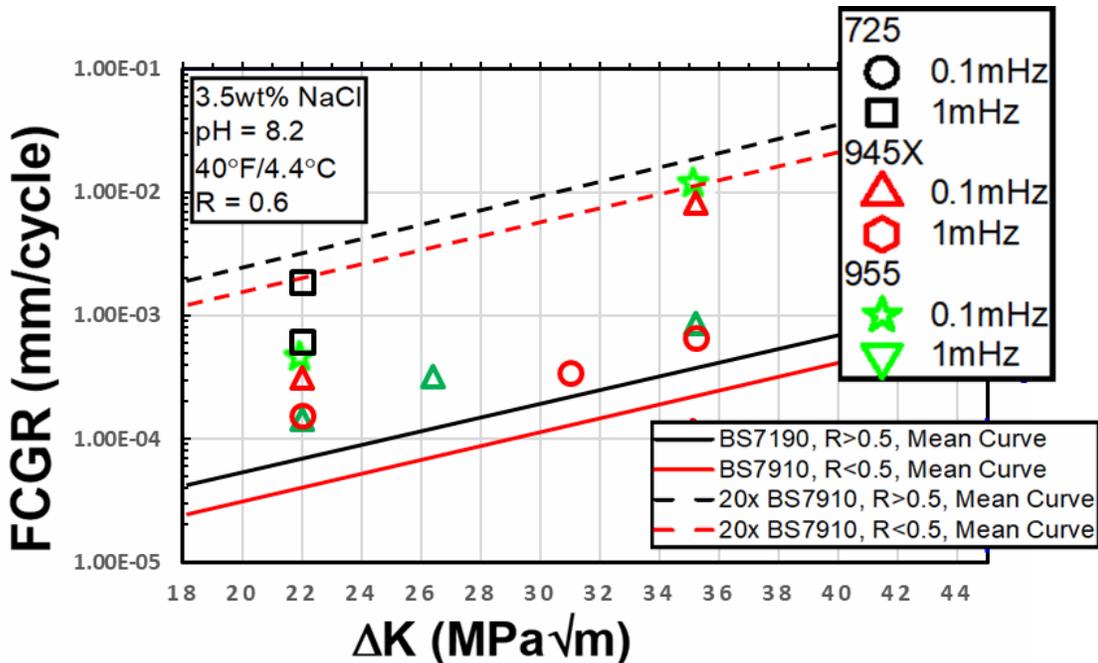
Figure 40: FCGR as a function of ΔK for 725, 955, and 945X at 1 mHz and 0.1 mHz.

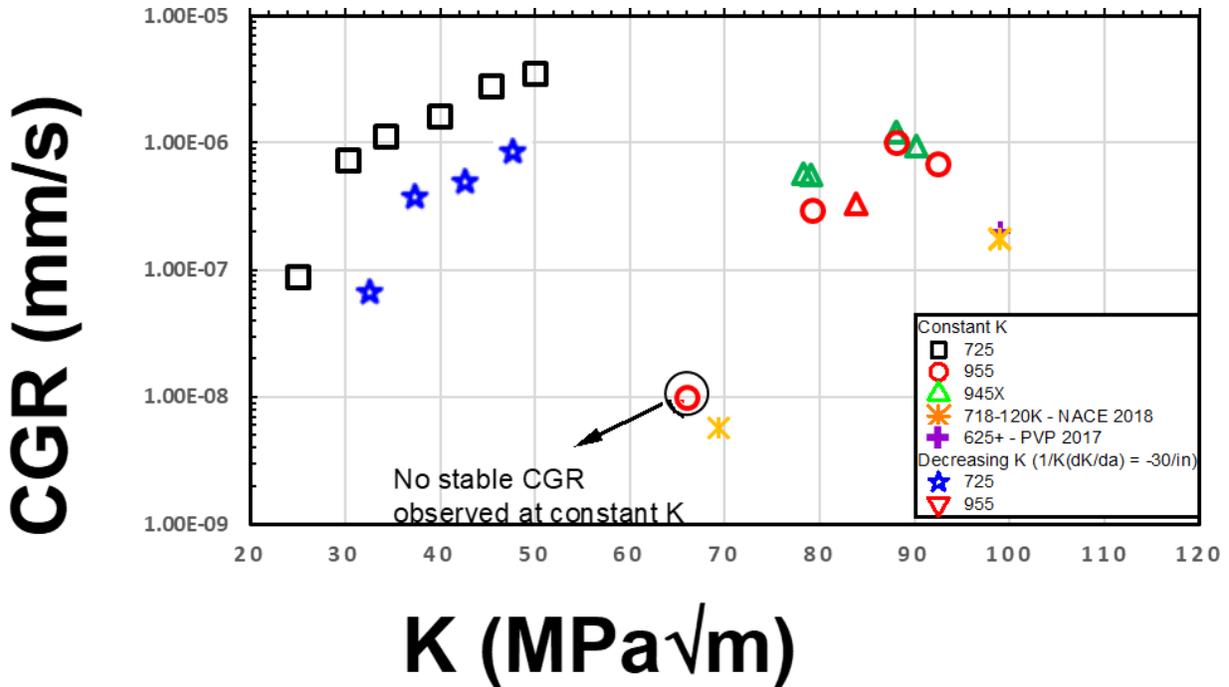
Figure 42: Crack growth rate as a function of K at constant K and under decreasing K for 725, 955, 945X, 718, and 625+ in 3.5 wt% NaCl at -1050 mV SCE.
