Laboratory Testing and Technical Assessments of Corrosion-Resistant Alloys for High-Pressure, High-Temperature Subsea Applications

Mechanical Property and Corrosion Performance Testing and Assessments of Nickel Alloys 725, 825, 945X, 955, and C22HS

ANL-19/30

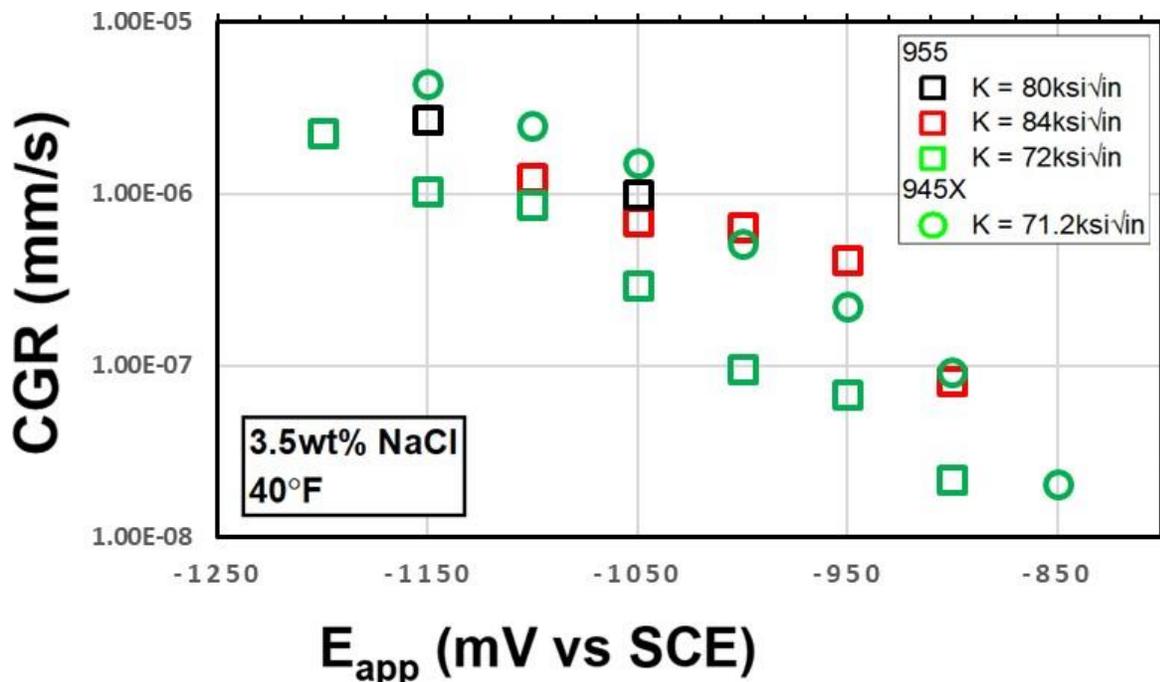
Figure 43: Effect of applied potential on crack growth rate for 955 and 945X.

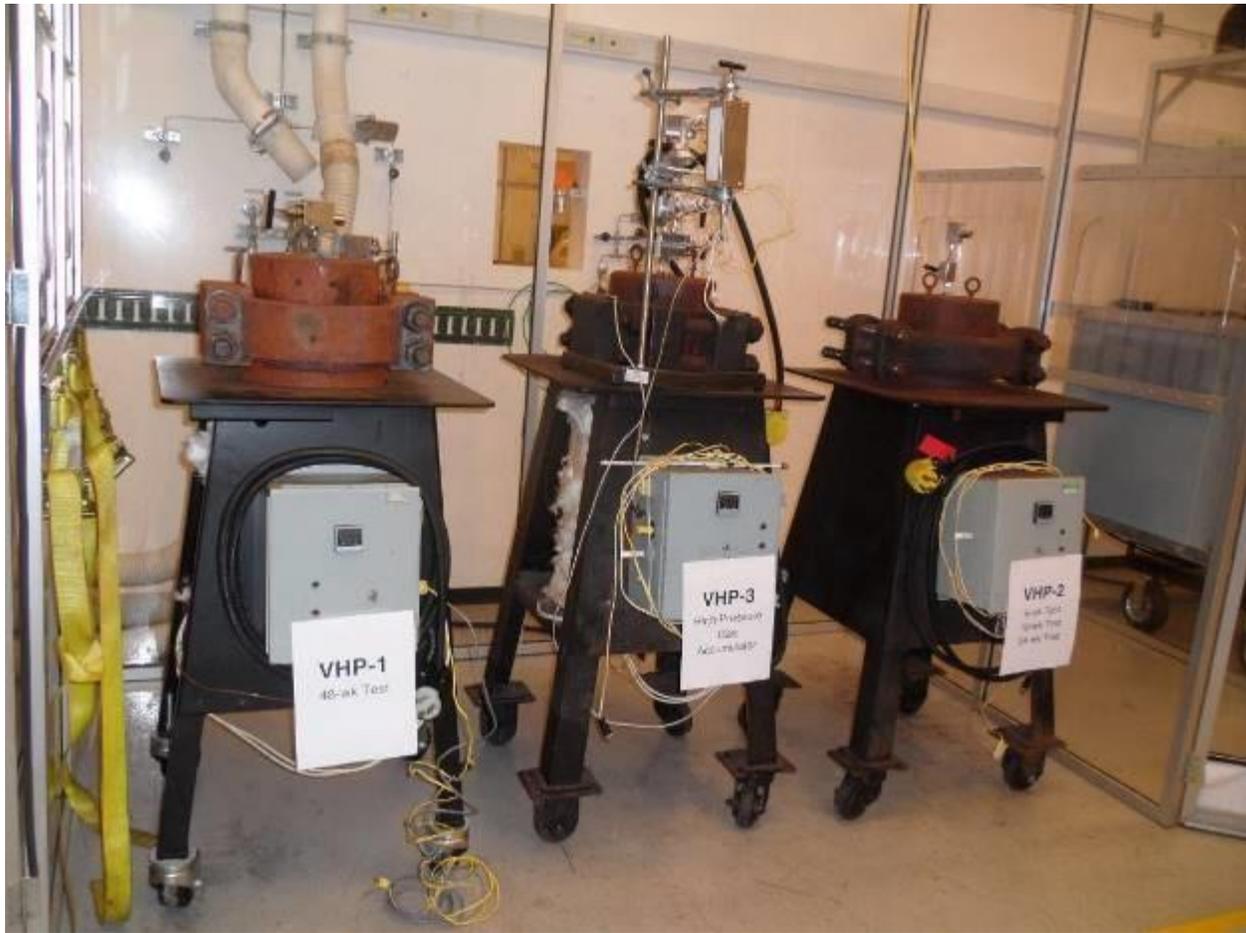
Figure 1. The three Very High Pressure (VHP) Autoclaves Used for Experimental Evaluation of Cracking Susceptibility

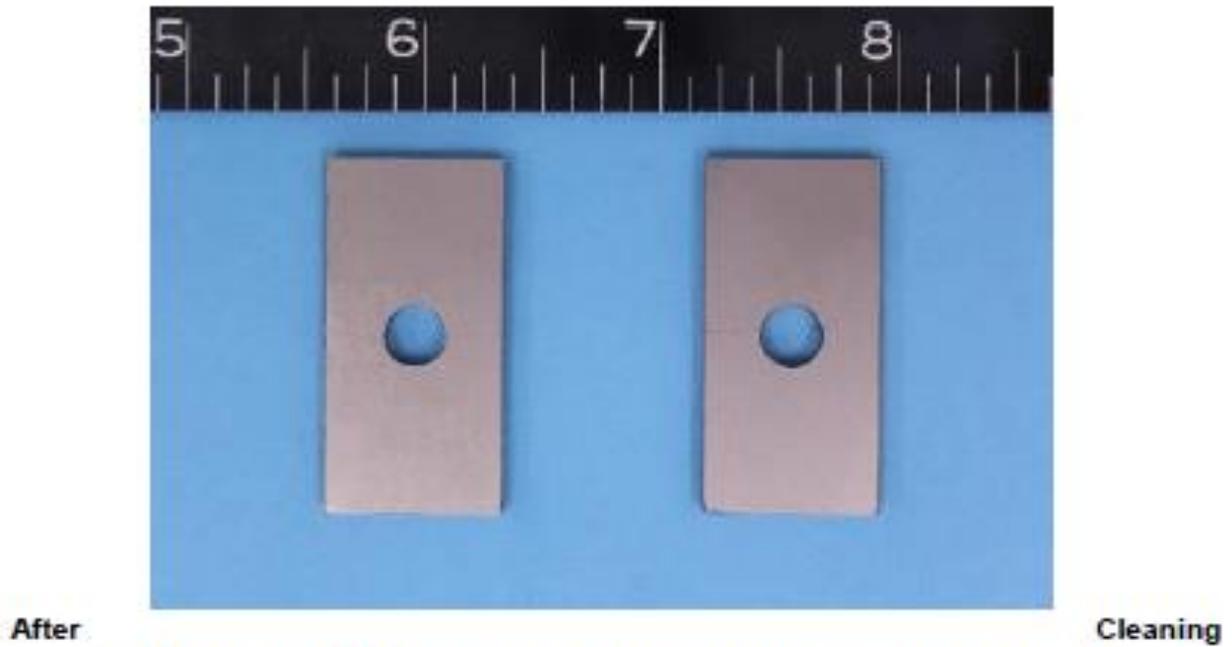
Figure A-6. Alloy 825 coupons, 6-week exposure, no pitting detected.

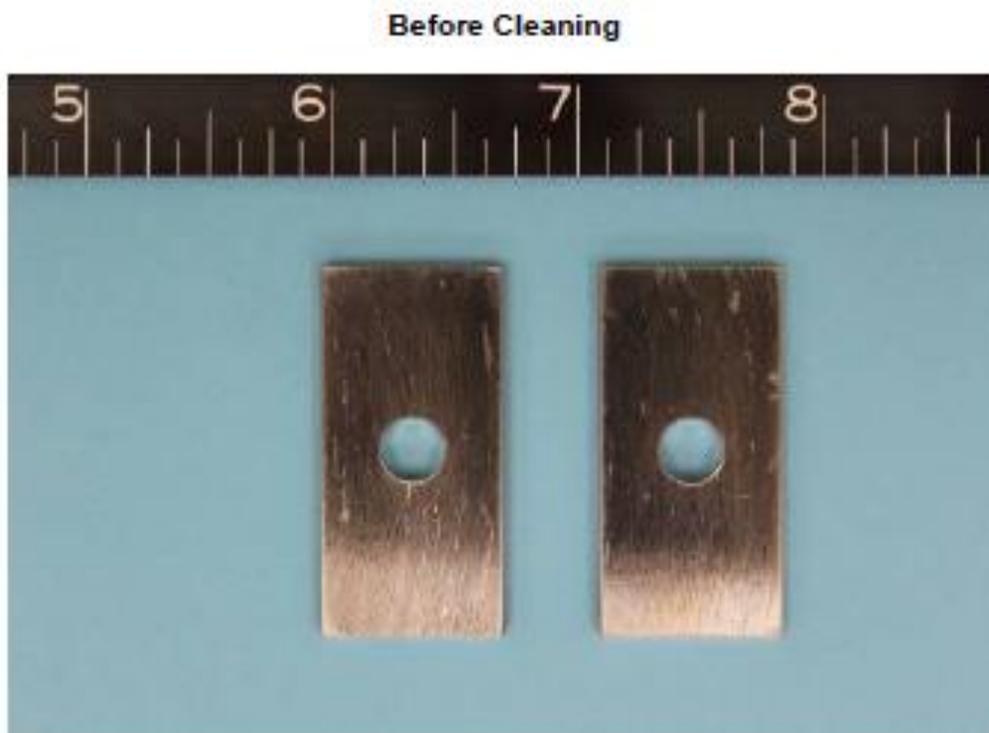
Figure C-1. Alloy 725 Coupons after 18-week exposure and cleaning, pitting not observed.

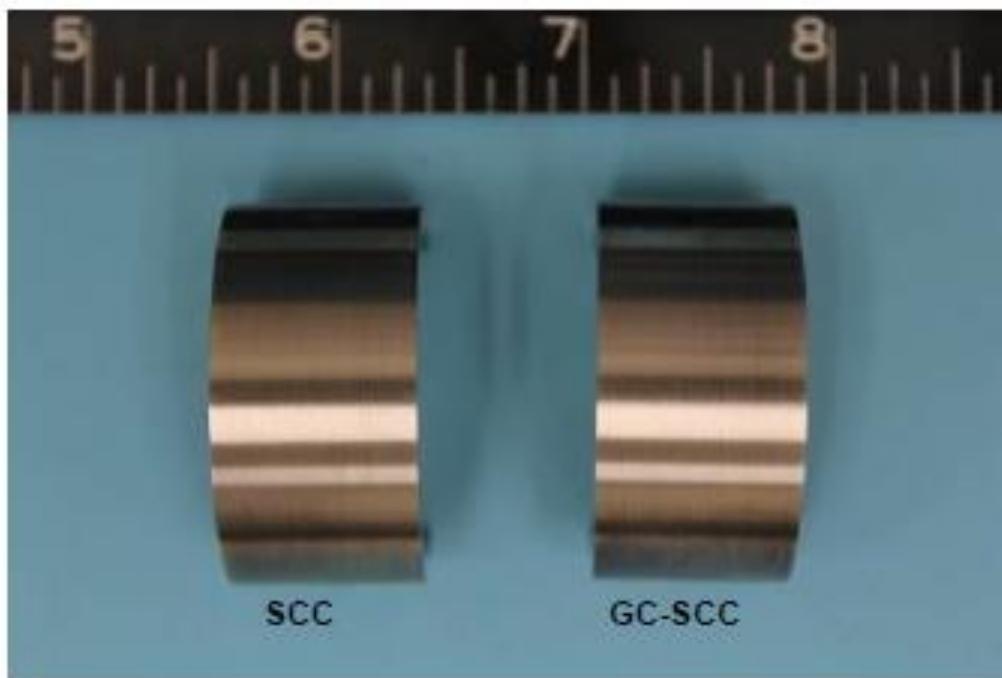
Figure C-7. Alloy 945X C-rings after 18-week exposure and cleaning, no evidence of cracking.

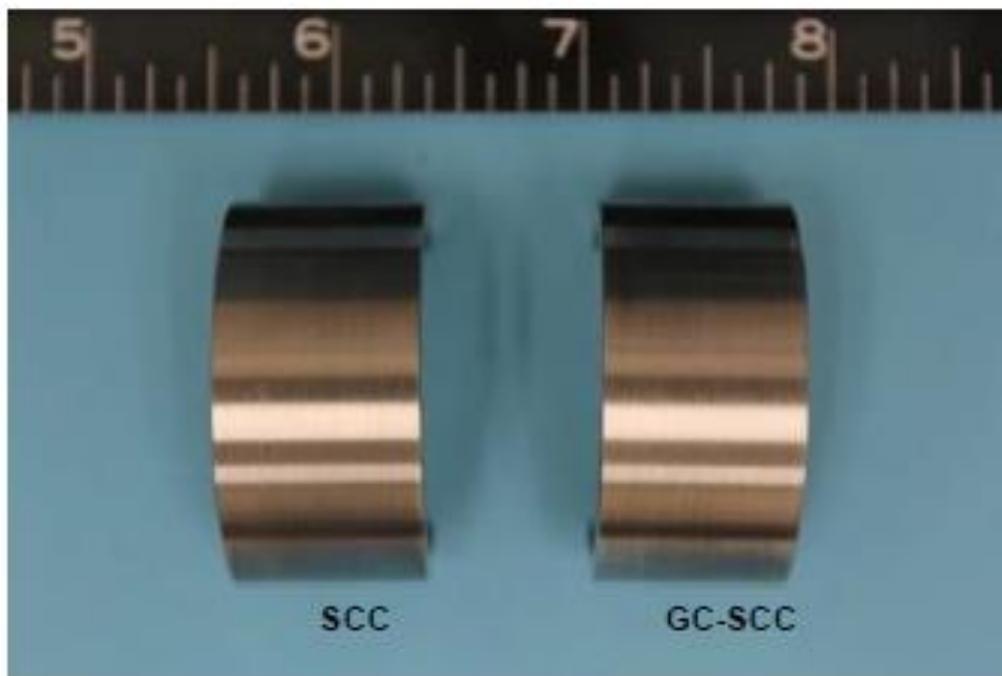
Figure C-8. Alloy 955X C-rings after 18-week exposure and cleaning, no evidence of cracking.

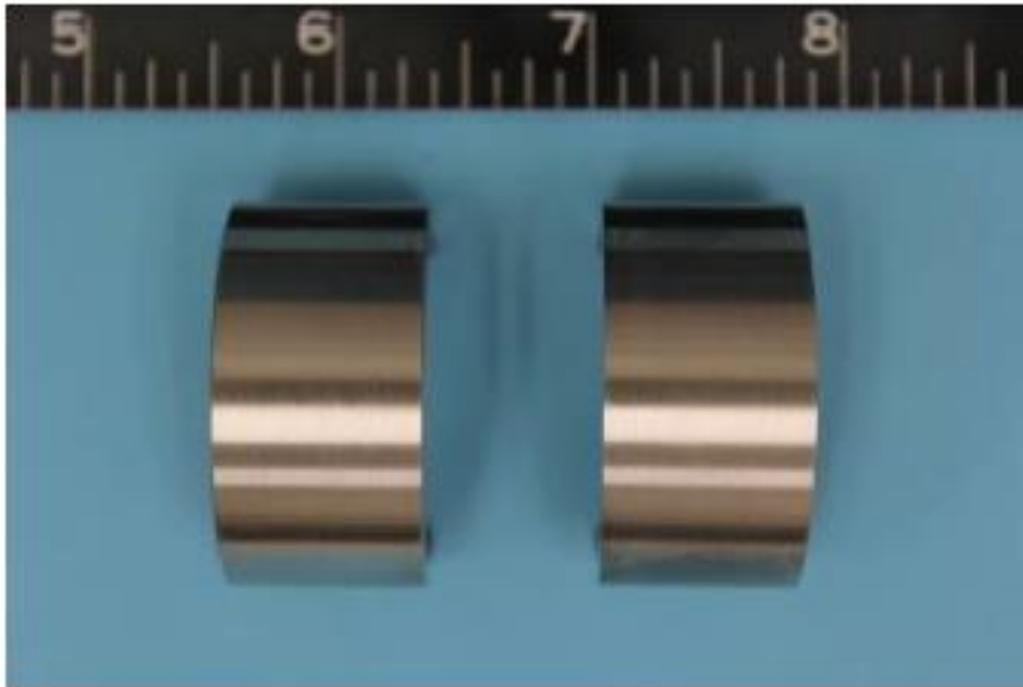
Figure C-9. Alloy C-22HS C-rings after 18-week exposure and cleaning, no evidence of cracking.
