Safety Alert No. 502

Fatigue Cracking of ¾-Inch Pipe Nipple Results in Gas Release

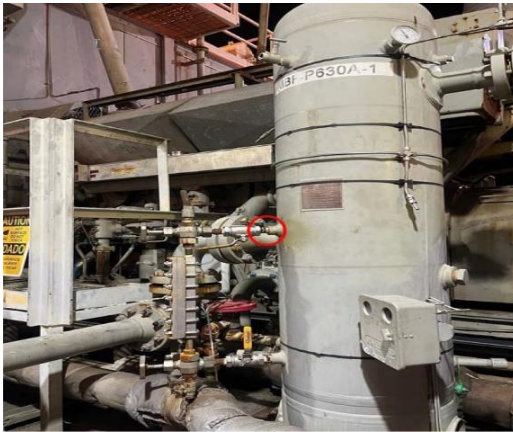
Figure 2-Photo shows 3/4-inch unsupported pipe nipple on suction scrubber.

- **Over-tightening:** Excessive torque during installation may have introduced stress concentrations, weakening the pipe.
- **Vibration:** Continuous vibration from compressor operations likely accelerated fatigue.
- **Unsupported Weight:** The nipple also supported a sight glass level bridle, potentially adding stress to the connection.
- **Component Loosening:** Vibration may have contributed to the loosening of the connection over time, compounding mechanical stress.

- Add structural support for sight glass level bridles attached to compressor suction scrubbers to reduce weight and vibration loads on small-diameter pipe nipples.
- Apply proper tightening techniques to avoid over-stressing threaded connections during installation.
- Regularly inspect critical components—including pipe nipples, fittings, and supports—for signs of fatigue, corrosion, wear, or loosening. Initiate timely corrective actions as needed.
- Implement vibration monitoring on compressor packages to detect and manage vibration levels that may affect connected piping and equipment.
- Ensure vibration dampers are properly installed and maintained to reduce the transmission of vibration from compressor units to piping components.

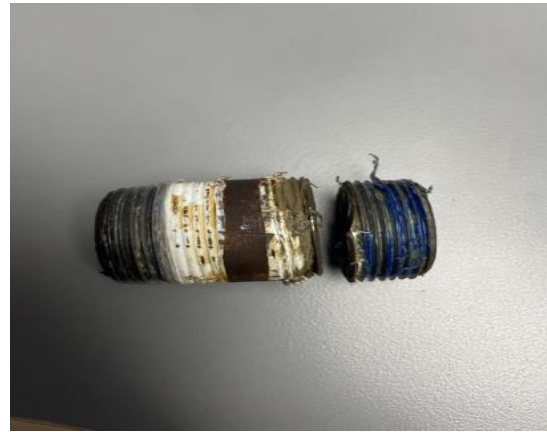
Figure 1-Photo shows damaged 3/4-inch pipe after incident.

The Bureau of Safety and Environmental Enforcement (BSEE) has investigated a recent offshore gas release incident resulting from the failure of a ¾-inch pipe nipple connected to a compressor suction scrubber (Figure 1). The failure led to an immediate platform shut-in and a full muster of personnel onboard.

Post-incident inspection revealed that the threaded ¾-inch pipe nipple failed due to fatigue cracking, which had likely developed progressively over time (Figure 2). The fatigue cracking was consistent with long-term exposure to mechanical stress and cyclical loading in a high-vibration environment. Threaded connections of this size are especially vulnerable to fatigue when installed on vibrating equipment such as compressors.
