Safety Alert No. 503

## Improper Gas Starter Installation Causes Flash Fires Resulting in Multiple Injuries

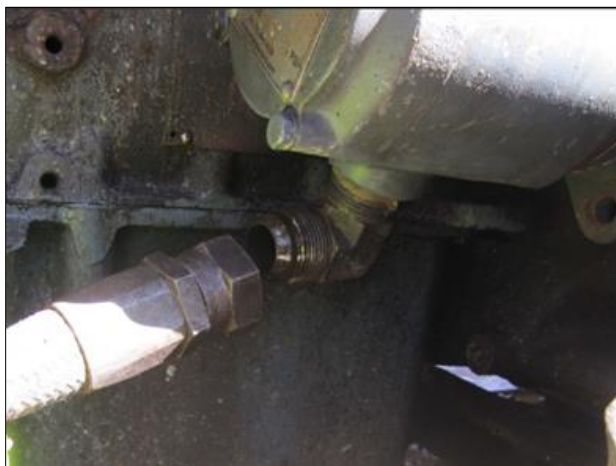
*Figure 1: Gas starter vent line, shown post incident, was only partially connected. (Incident 1)*

**Incident 1:** An operator was attempting to start the gas engine of a pipeline pump while another worker operated the nearby manual starter valve. The starter exhaust vent line was not properly secured (Figure 1), resulting in gas accumulation in the pump skid and engine enclosure. During the start cycle, the engine backfired and ignited the accumulated gas, causing a flash fire that enveloped the workers (Figure 2). Both sustained burns to the hands, arms, and face. BSEE investigators discovered that the engine's air intake hose was disconnected, which may have allowed the gas-enriched atmosphere to be drawn into the carburetor and caused the backfire.

- When using fuel gas to start prime movers, ensure the starter exhaust gas is vented to a safe location.
- Implement and/or modify existing mechanical integrity awareness training for personnel to ensure checks of equipment before startup.
- Review gas engine startup procedures to include equipment checks verifying the proper installation of components.
- Utilize gas detectors when performing startup procedures on engines with gas as a fuel source and/or as a pneumatic supply for starters.

- Review engine maintenance logs, schedules, and procedures to see if previously observed mechanical issues have been addressed.
- Ensure proper maintenance procedures are followed to verify the proper installation of components.
- Conduct mandatory checks on engines with gas as a fuel source and/or as a pneumatic supply for starters to ensure proper installation of starter exhaust piping.
- Consider implementing a temporary fire watch when performing troubleshooting, startup, or post-maintenance operations on gas-fueled engines, particularly those using gas starters.

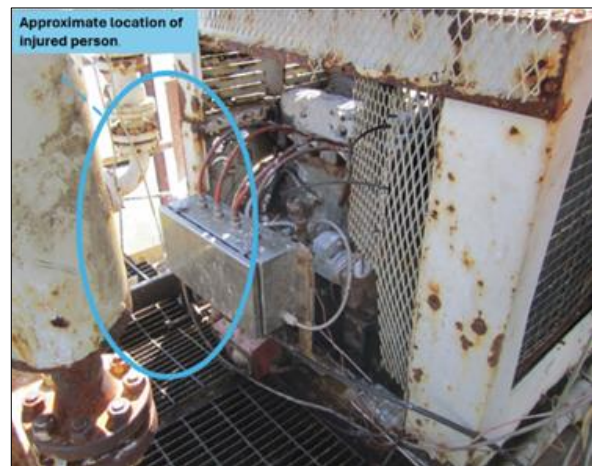
*Figure 2: Position of an injured worker during time of incident. The worker was adjacent to the engine observing the magneto while another worker operated the start valve. (Incident 1)*
