Safety Alert No. 505

Date: Aug. 11, 2025

## BSEE Risk-Based Inspections Reveal Increase in Slip-Trip-Fall Hazards on Offshore Facilities

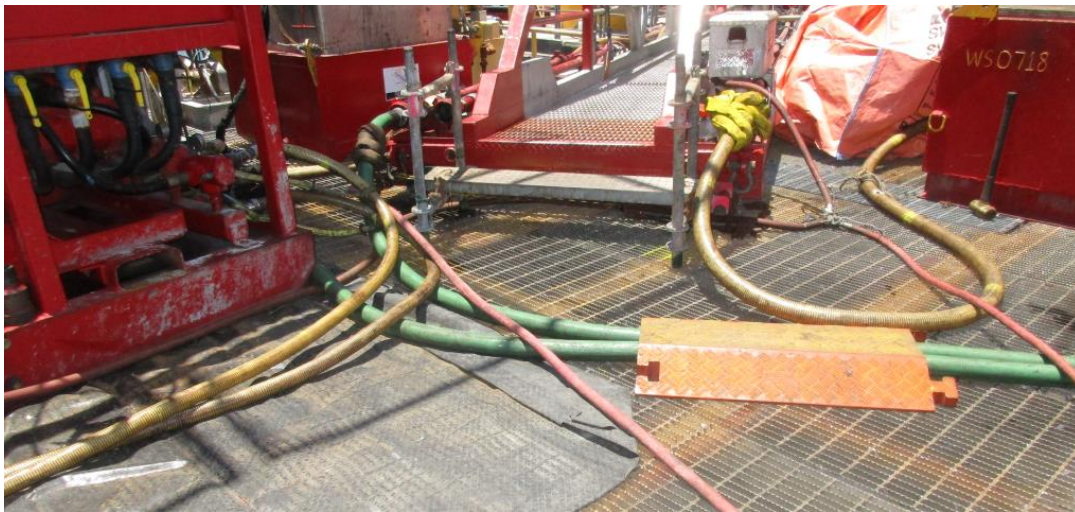
*Figure 1: An example of tripping hazards aboard an offshore facility.*

- **Simultaneous Operations** – On facilities where simultaneous operations were underway, such as construction and well-related activities, working surfaces and walkways were inundated with hazards. Inspectors found wet floors with loose, flakey rust; hoses and tubing on the ground in front of an egress route and life vest box; areas with uneven grating; temporary electrical lines without proper tagging; scaffolding and a ladder in the path of an egress route; and metal pipe and tubing on the deck floor that was not anchored down or properly stored. BSEE inspectors identified all these hazards, not contract or operator personnel, during pre-job hazard hunts, toolbox talks, or in job-specific Job Safety Analysis (JSA).

- Ensure that high-traffic areas are kept clear of obstruction and maintained in a safe condition. Consider utilizing IOGP’s Start Work Checks to ensure safeguards are implemented to prevent STF’s by workers at the job location before work commences.

- Review the work activities on all OCS facilities and bring awareness to walkways with a larger equipment presence (generators, pumps, scaffolding, hoses, etc.). Additionally, operators on fixed and floating offshore facilities should review United States Coast Guard Regulations 33 CFR Part 142 - Workplace Safety and Health.
