Bureau of Safety and Environmental Enforcement

SAFETY ALERT

Safety Alert No. 512

Crane Incident During Well Abandonment Operations Injures Worker, Reveals Safety Gaps

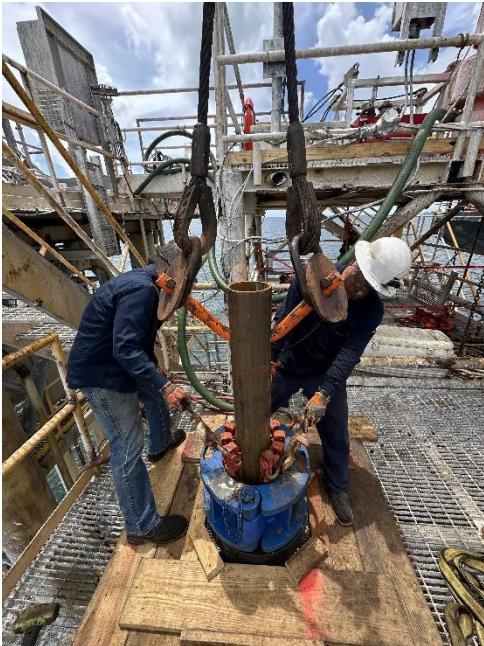
Reenactment of position of injured person and other worker at time of incident.

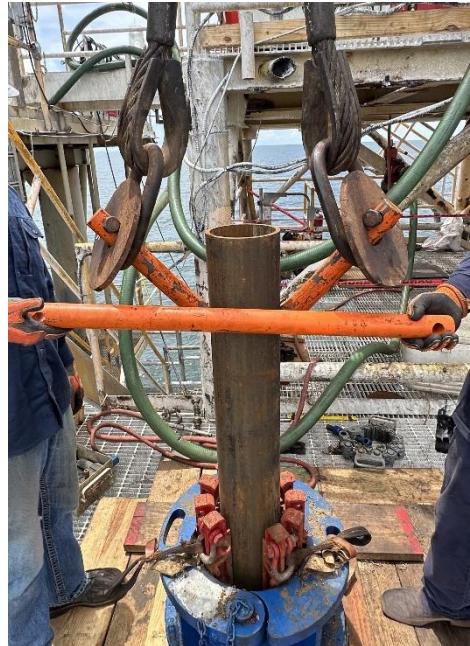
Proper condition of pin.

- The crew did not place the D-rings of the sling right next to the casing; they were about 2 inches away. Procedures require the pull linkages to be as close as possible to reduce bending on the pin.

- Operators should always check that the load is free before starting crane operations to lift a work string during well abandonment. Never use a crane to pull or lift a load that is not free.
- Make sure the equipment used is clearly identified in procedures. Do not change procedures if they do not match the situation or equipment.
- Ensure the right equipment is available and installed during well abandonment. The lifting pin should be the correct length, since a pin that is too long can bend and fail early.
- Encourage workers to use stop work authority if they see or suspect unsafe conditions.
- Make sure proper rigging is used for all lifts and that it is installed as described in the lifting plan.

- Make sure that procedures for lifting operations properly cite safe working loads for all rigging and devices.
- Make sure everyone is aware of hazards and keeps a safe distance from equipment during lifts.
