Safety Alert No. 515

Prevent Fires by Inspecting Cords, Plugs and Welding Leads Before Use

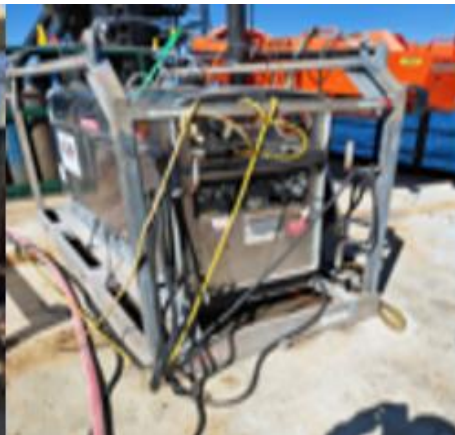
Figure 1-Small Flames on Left Side of Plug during Welding Operations

Incident 2: During routine construction operations, personnel noticed flickering at an electrical cord connection. At first, it appeared the light inside the clear head connection was flickering. Small flames then appeared at the side of the plug. Personnel told the welder to stop working, and as he turned to inspect the cord, it began to smoke. Personnel quickly unplugged the cord from the welding machine. They red-tagged the cord and removed it from service. They also inspected all other cords for visible damage and found no other problems.

- Use only UL-, FM- or CSA-listed extension cords, plugs, and welding leads rated for hard or extra-hard usage.
- Ensure all cords are three-wire types with intact grounding conductors and secure terminations. Inspect cords, plug prongs, strain reliefs, and terminations before each use.

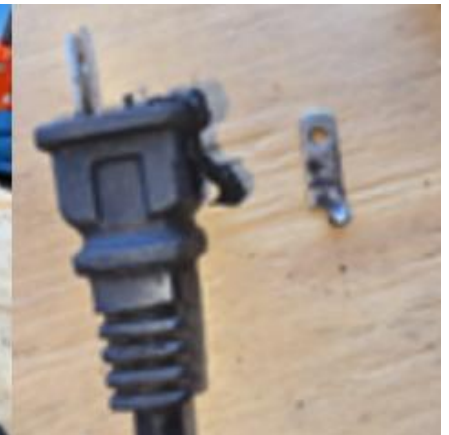
Figure 3-Melted Plug to Tubing Bender

Incident 3: Instrumentation and electrical crews connected their "Rothenberger Tubing Bender" to bend one-inch tubing for two sample sinks. When they plugged it in, they saw the plug begin to melt. They quickly unplugged the equipment and notified platform management. An investigation found that the platform receptacle and extension cord were not the source of the problem. Instead, the tubing bender plug had a loose prong that was not detected during the pre-job inspection. The prong fell onto the workbench when the plug was removed. The tubing bender was taken out of service. This incident underscores the need to verify plug integrity and prong security during equipment inspections, not just the condition of the cord and receptacle.
