Safety Alert No. 517
Date: June 6, 2026

Poorly Maintained Crane Components Result in Multiple Injured During Personnel Transfers

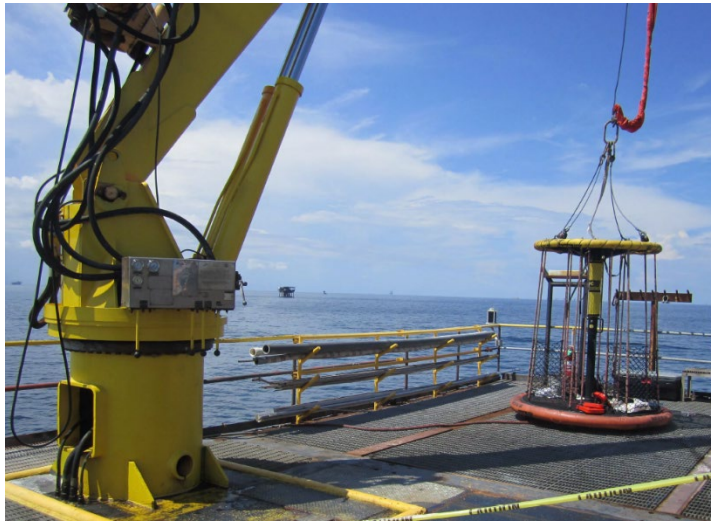
Figure 1: (Incident 1) Crane and personnel basket type involved in incident.

Incident 1: During a personnel transfer, a crane operator was lowering a worker in a rigid-type personnel basket (Figure 1) to the deck of a motor vessel when the crane's auxiliary line suddenly and uncontrollably dropped 6 to 15 feet before coming to an abrupt stop approximately 25 feet above the water. The worker remained in the basket but suffered injuries to his back and leg.

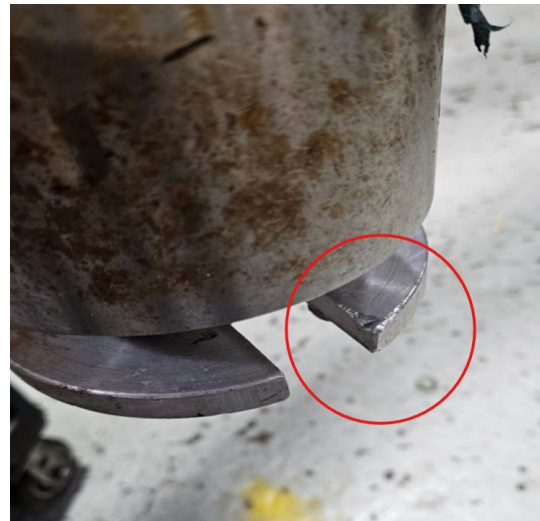
Figure 2: (Incident 1) Scarring observed on the anti-two block.

BSEE's investigation found multiple contributing factors, including improper maintenance of previously identified and uncorrected deficiencies of the auxiliary boom tip sheave and bearing assembly; possible fouling of the auxiliary wire rope's dead-end loop on the anti-two block (ATB) device (Figure 2); failure to properly document and correct previously identified crane deficiencies; and inadequate emergency planning and procedures.

- Conduct thorough pre-use inspections before personnel transfers, including verification that brakes respond properly under load.
- Verify during pre-use inspections that the auxiliary wire rope's dead-end loop is not fouling on the anti-two-block device. Consider installing a striker plate on the auxiliary line above the dead-end loop to help prevent fouling and damage to the anti-two-block device or wedge socket. Reinforce stop-work authority. Stop operations immediately after any uncontrolled or abnormal crane movement, and resume lifts only after qualified personnel inspect the crane and correct any deficiencies.
