Bureau of Safety and Environmental Enforcement

Program Update OOC Meeting

Lars Herbst. P.E.
Gulf of Mexico Region Director
Dec. 5, 2018

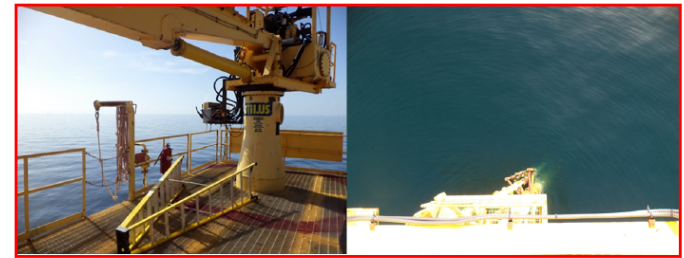
Location of crane mechanic at the time of the incident (left) and view over the handrail (right)

On 7 July 2018, a contract crane mechanic (CCM) fell 81 feet into the water below as he was replacing the platform crane's anti-two block control valve. A 10-ft ladder had been positioned between the overboard handrail and the crane for the CCM's use. As the CCM was positioned on the crane skid located seven feet above the deck, he realized that he needed to descend the ladder to retrieve additional tools. As the CCM repositioned himself onto the ladder in order to descend, he either lost his grip or his footing, which caused him to fall backwards over the handrail and into the water.

- Establish minimum requirements for working at unguarded, elevated work locations
- Review job pre-planning procedures to ensure response plans, fall rescue plans, emergency response numbers, and fast response craft are included
- Consider equipment position and hazards when completing job pre-planning in order to minimize risk
- Verify company and contract personnel working at heights near or above water are knowledgeable and experienced in the work practices
- Review alert with offshore crews

The safe work practices in effect at the time of the incident required the CCM to use fall protection for heights that exceed six feet above the deck. Additionally, Coast Guard Regulation 33 CFR 146.20 requires the wearing of work vests when working near or over water. The CCM was using neither item, nor did the JSA identify falling as a potential hazard that necessitated mitigation.
