BSEE

NORBIT Report BSEE contract E17PC00013

TN-170148 Final

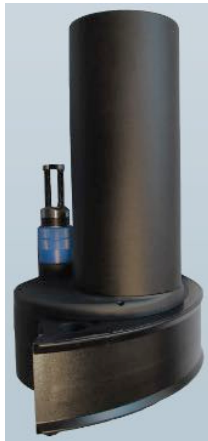
The STX 3D&4D imaging sonar is shown in Fig. 2. is based on a proven WBMS platform but the transmitting antenna has a new capability of electronically changing the direction of the emitted sound wave. That process is called beam steering or similarly to the receiving beamforming called transmit beamforming operation. The transmit and receive beamforming processes are outlined in Fig. 3.

Fig. 2, NORBIT STX - 3D&4D multibeam

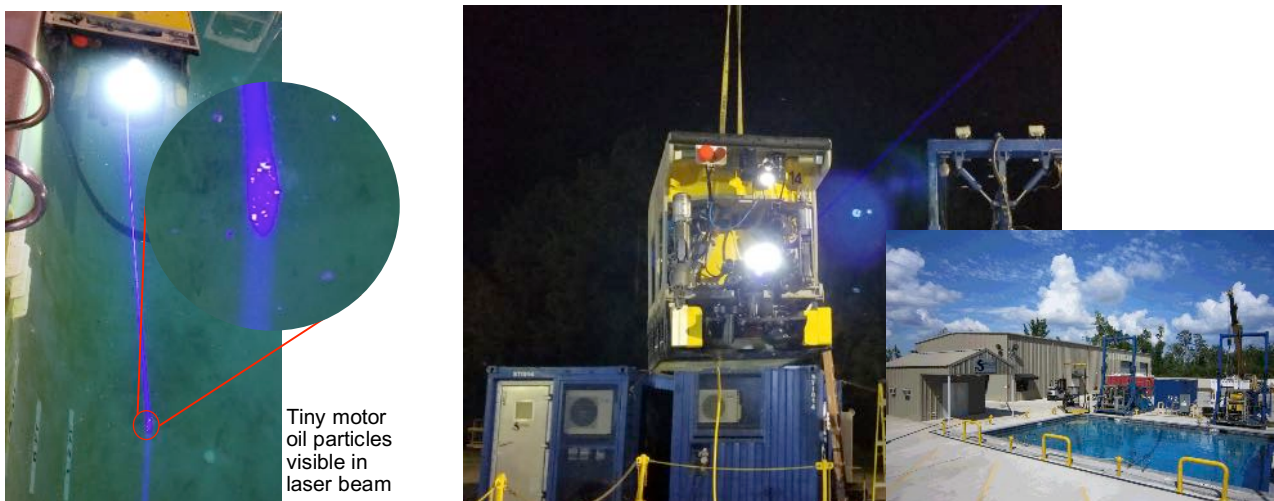
In the Fig. 5 below one can see the LIF laser beam bouncing off the water surface. It is interesting to zoom a little bit at the beam cross-section at the water surface to see some shining fluorescing particles of motor oil present in the test tank.

Fig. 5 ROV in the test tank (left), Lifting ROV off the test tank facility in Robert, LA (right)

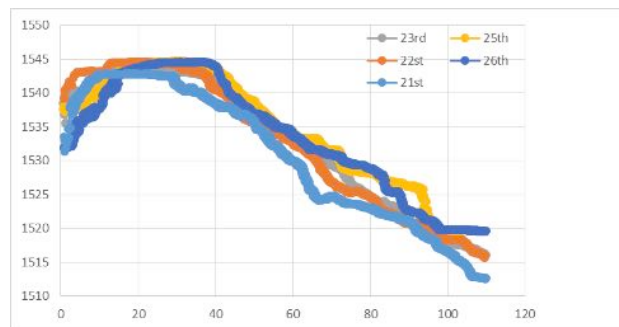
Every survey day began with a recording of the sound speed profile at or in close vicinity of the survey area. The data is presented in the graph below.

Fig. 10 The speed of sound profiles vs depth taken during the survey every morning.

The speed of sound profiles are used in both survey software and navigation system to compensate for refraction and improve the accuracy of the measurement.

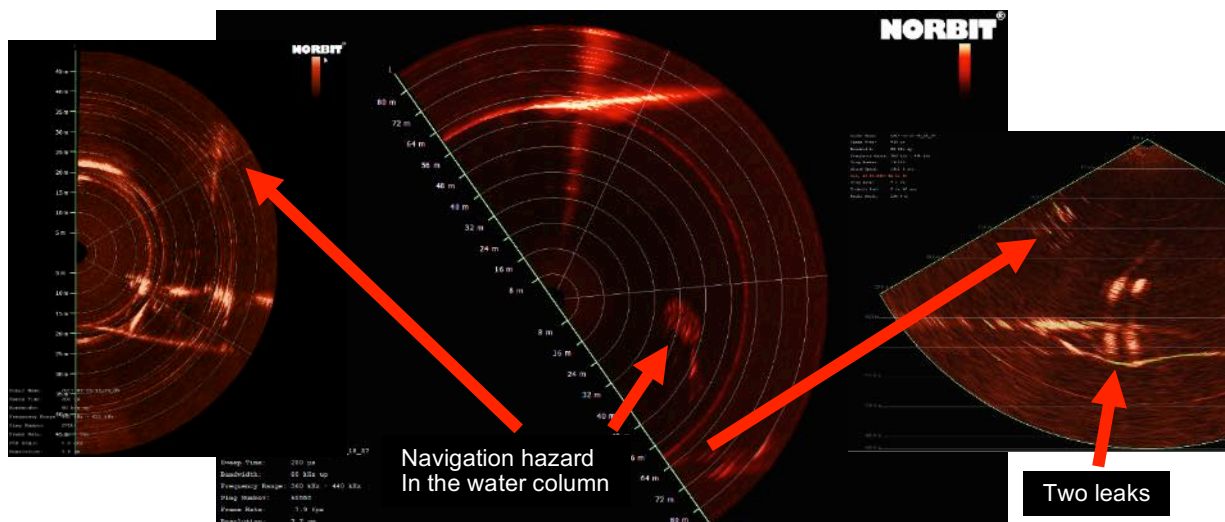
During the initial survey, it was also possible to see the hazard suspended roughly 35 m above the jacket (right-hand side of Fig. 14). Initially, it was not clear what this hazard was but then later using the forward looking sonars it was shown to be some sort of a structure attached to the jacket with metal rods (left two images in Fig. 14).

Fig. 14 Images showing the hazard located in the area of the main leak

The hazard is believed to be a collapsed collector dome structure left from the past. The remains are located at roughly 80m below the surface and do not pose a danger to general navigation, but it may cause trouble for any towed objects such as fishnets if they happen to be in that area.

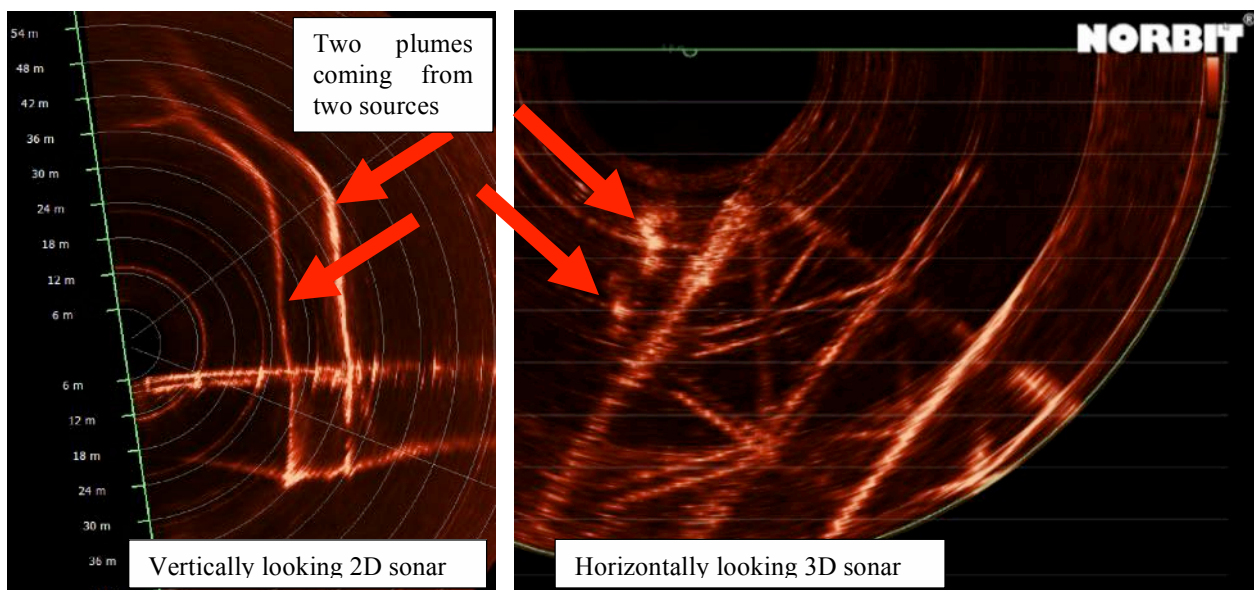
The combination of the two sonars has proven to be very efficient in navigating the ROV and visualizing the plume. With the horizontally looking sonar it was easy to instruct the ROV navigator to perform the ROV positioning in the required manner, and with the vertical sonar, it was possible to lower the ROV to the a safe altitude without the risk of hitting any objects.

Fig. 22 Two plumes coming from two sources visible on vertical (left) 2D and horizontal (right) 3D-FLS sonar imagery

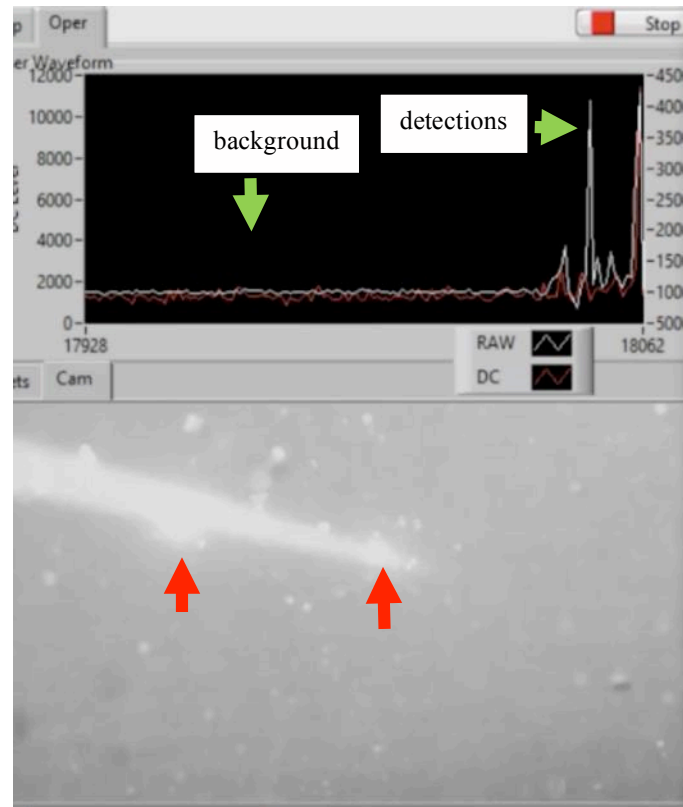
Fig. 25 LIF classification of the plume (top) and video camera (bottom) showing shining fluorescent particles passing by the laser beam

The LIF operates using laser light and as such is subject to the law of physics of optical light. That means its range will depend on the turbidity of the medium. However, provided it gets to the detection range, which in this case we found to be 2-4m, it offers unique classification capabilities by being able to distinguish between a gas leak and an oil leak.

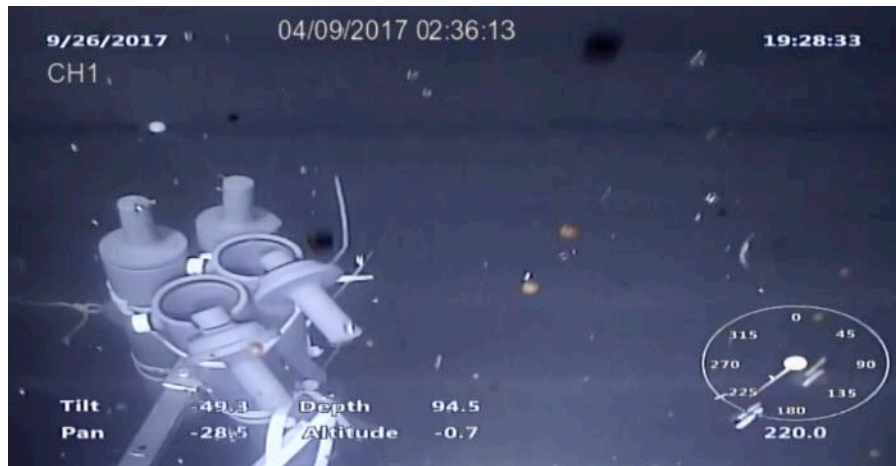
After the leak was recognized oil sampling was completed using 4 Niskin bottles, see Fig. 26.

Fig. 26 Oil samples collection using Niskin bottle and robotic arms to release the lock-in mechanism.

With the help of the FLS sonars (as before) the bottles have been positioned as close to the source as possible to capture samples of the oil. The bottles were closed using the robotic arms on the ROV and securely delivered to US Coast Guard personnel after returning to the surface.
