Influence of electroplated coatings on Hydrogen Embrittlement of low-alloy steel for subsea applications. Electrochemical and Mechanical analysis.

Doxsteel Fasteners

2018 Exploration and Production Winter Standards Meeting
San Antonio, TX, January 23, 2018

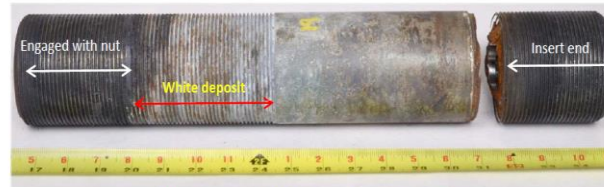
(A) Before cleaning at SES. Major scale divisions are in inches.

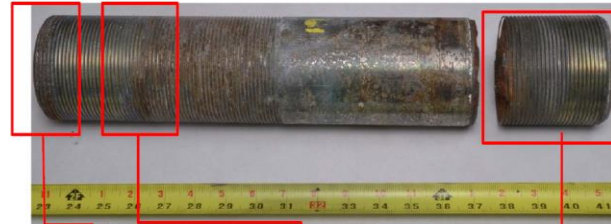
(B) After ultrasonic cleaning in an Alconox® solution. Major scale divisions are in inches.

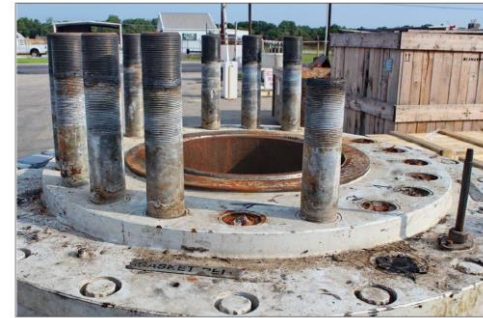
Figure 4: Hydraulic connector flange/fasteners showing failures and first engaged threads

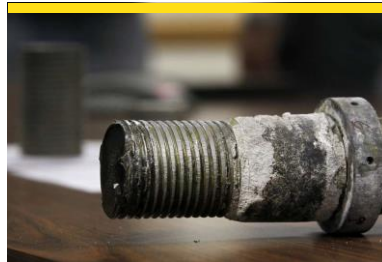
Failure 4: Bay Bridge Failure

- San Francisco Bay Area Bridge Failure
- High strength bolting
 - (ASTM A490 39 HRC Maximum)
- Hot Dip Galvanized Zinc
- Bridge closed for repairs
- Long and costly repairs
- Offshore and on land

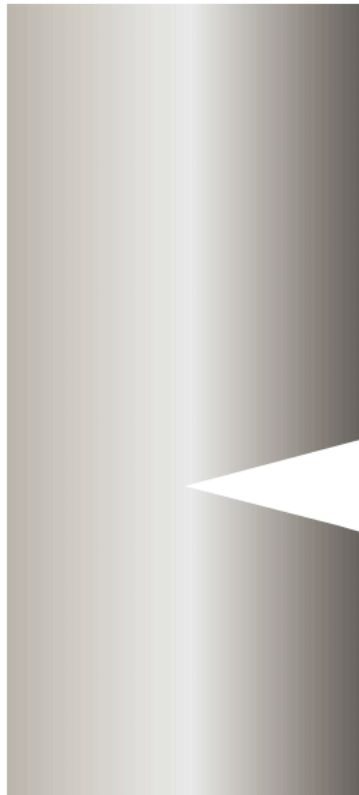
Hydrogen Embrittlement in Action

- Positively-charged hydrogen breaks out of water molecules and is attracted to metal
- Hydrogen atoms enter the metal through high-stress areas
- Hydrogen interacts with iron atoms to weaken and embrittle the metal

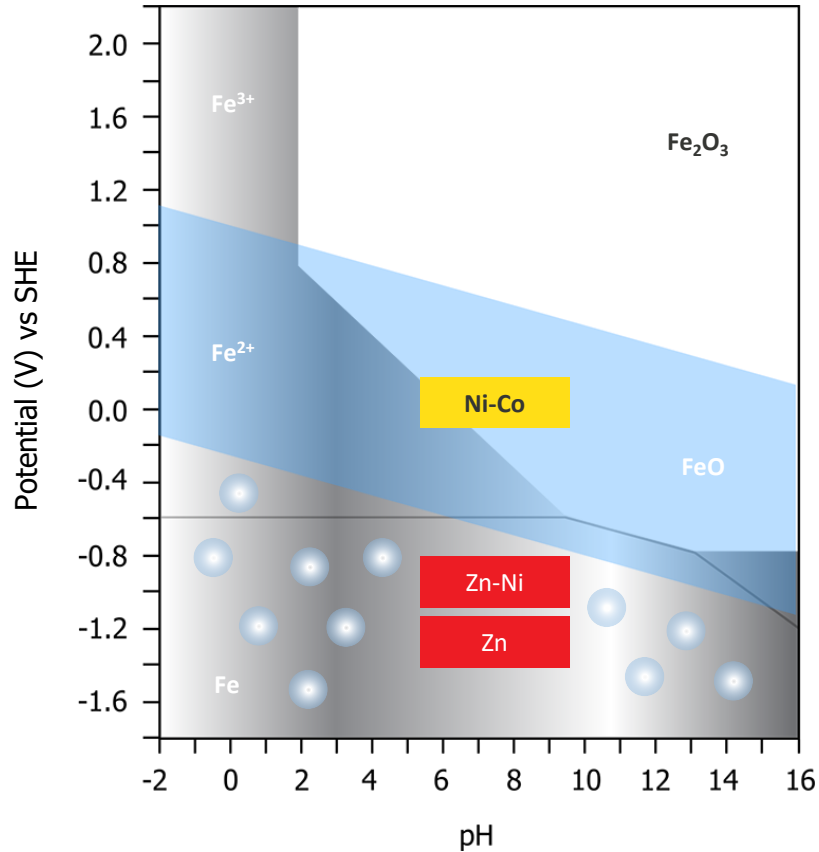
Thermodynamics of Hydrogen Production

- More negative potential increases the risk of hydrogen embrittlement.
- Below the water stability region, hydrogen is produced
- Nickel-Cobalt will not cause hydrogen embrittlement. Zinc does.
- Zinc will produce hydrogen gas and atomic hydrogen.

Water Stability Region

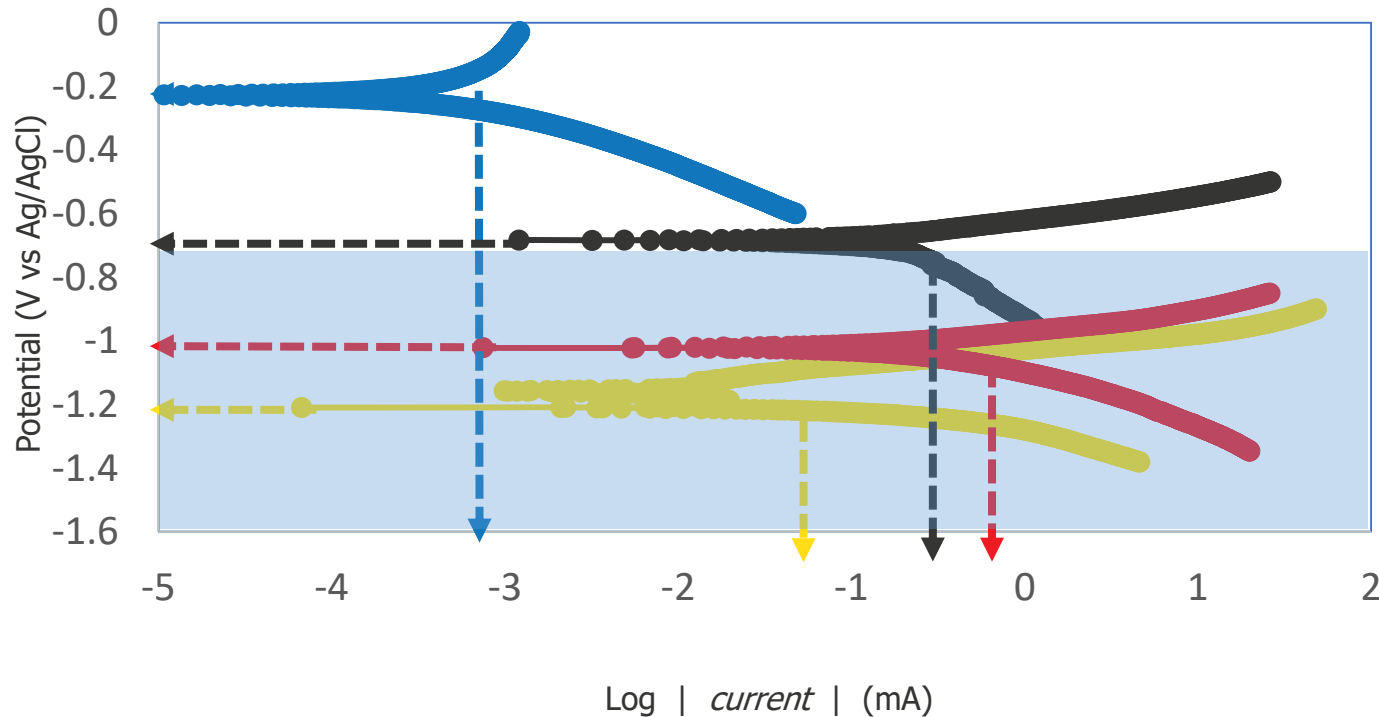
Electrochemical Performance of Different Metallic Coatings

- As negative potentials decrease more hydrogen is produced
- A higher current creates more hydrogen discharge

Potential	Current	Corrosion resistance	Hydrogen production
Zinc	↓	↑	↓	↑
Zinc-Nickel	↓	↑	↓	↑
Nickel-Cobalt	↑	↓	↑	↓

- Zinc and Zinc-Nickel have a very low potential and delivers a very high current, so it is very reactive and its cathodic current will produce hydrogen.
- Nickel-Cobalt has a high potential and delivers a very low current, so it reacts very slowly and is resistant to corrosion.

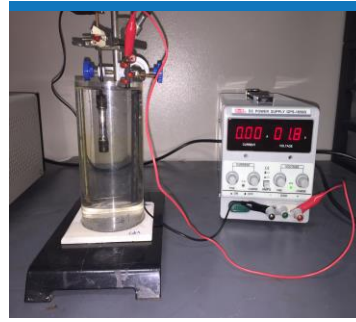
Nickel-Cobalt: Hydrogen Embrittlement Test for Cathodic Protection

- Notched tensile samples (49 HRC) were subject to cathodic overprotection of -1.0 V vs Ag/AgCl in 3.5%wt NaCl.
- Tensile tests to break the samples were performed after 30 days of polarization.

Bare Steel

Zinc coating

Nickel-Cobalt

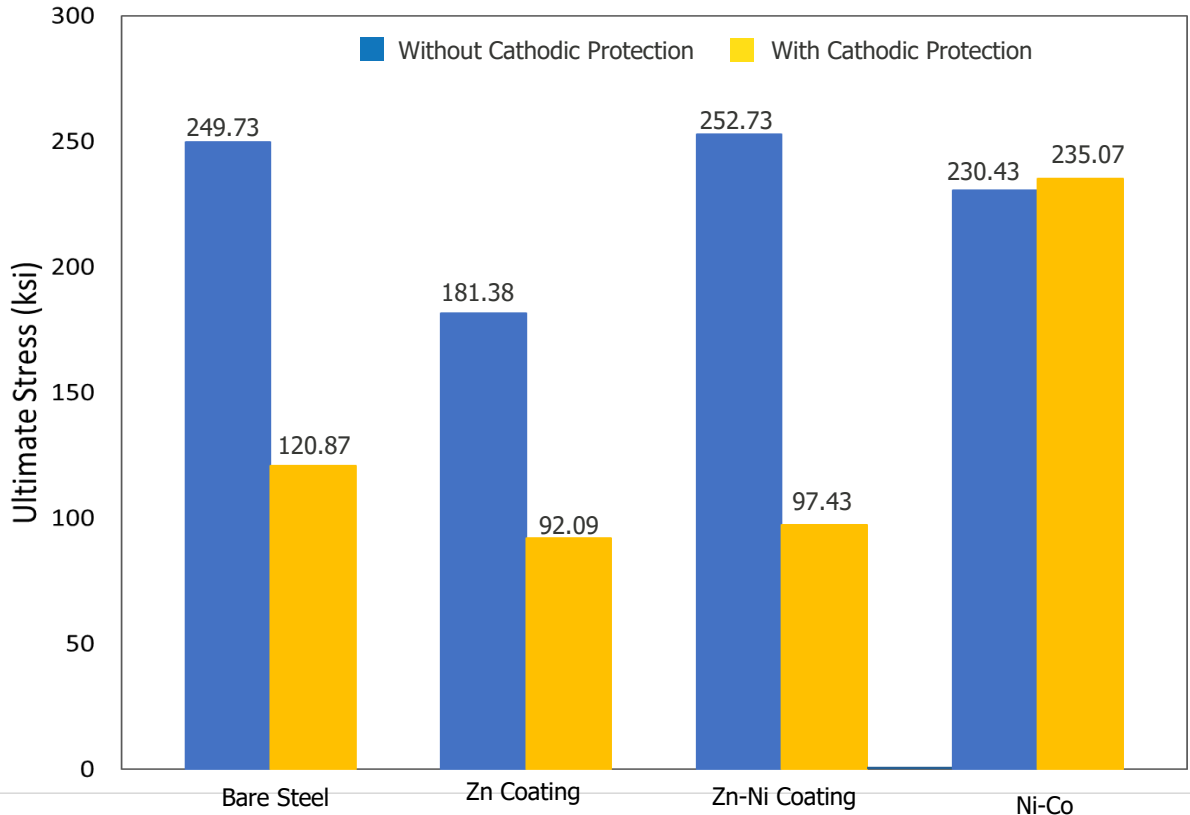
Tensile Tests with Cathodic Protection

- Nickel-Cobalt plating has a minimal effect on a fastener's mechanical performance.
- Cathodic overprotection has no effect on mechanical performance with Nickel-Cobalt plating.
- Nickel-Cobalt protects fasteners under stress from hydrogen.

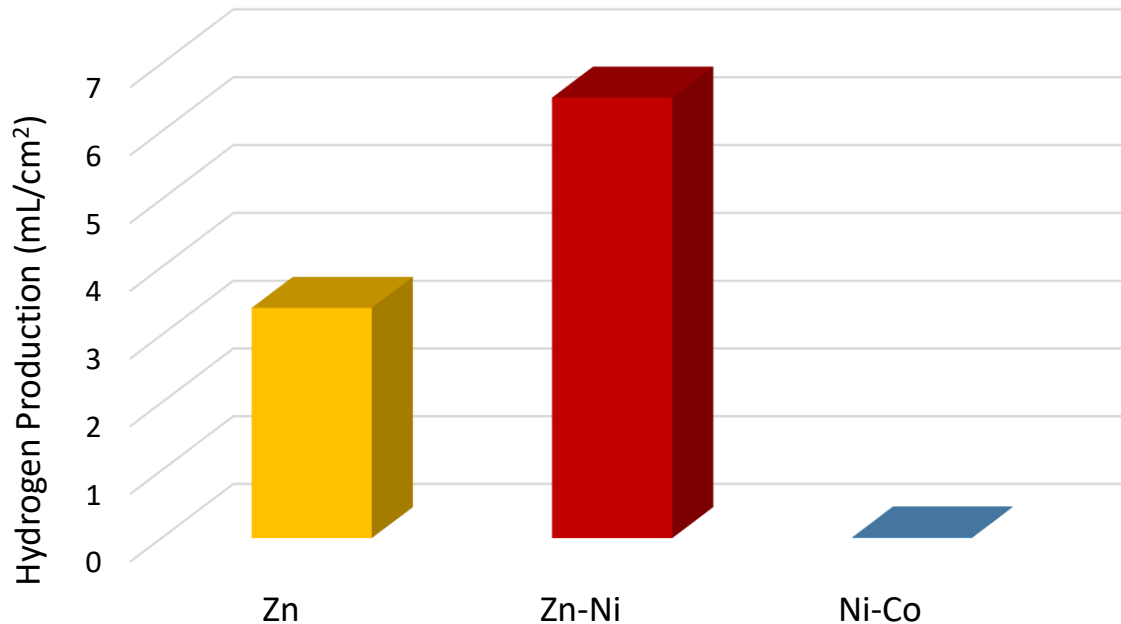
Hydrogen Production on different coatings

- 1 mA/cm² was applied during 12 hours in a 3.5wt% NaCl acidified to pH=3
- Hydrogen was collected and quantified
- Nickel-Cobalt produced the least amount of hydrogen compared to the other coatings.

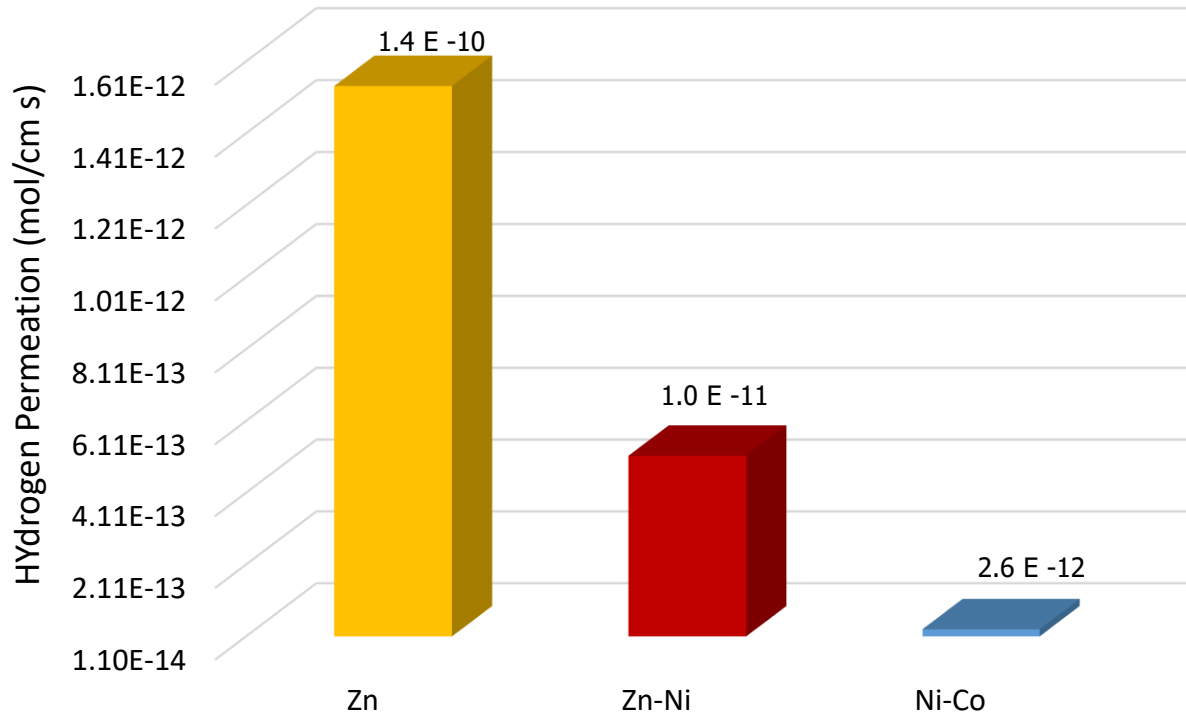
Hydrogen Permeation Cell Testing: Results ASTM G148

- Zn showed the highest hydrogen permeation
- Ni-Co exhibited the lowest hydrogen permeation, one order of magnitude less than Zn-Ni and two orders of magnitude of Zn
- Despite the high hydrogen production on the Zn-Ni, Zn had a higher permeation.
