# DATA SUMMARY

Active Ice Management System (AIMS) Testing  
Task Order # 140E0120F0013

Prepared by:  
Ohmsett - The National Oil Spill Response Research  
& Renewable Energy Test Facility

Active Ice Management System (AIMS) Test

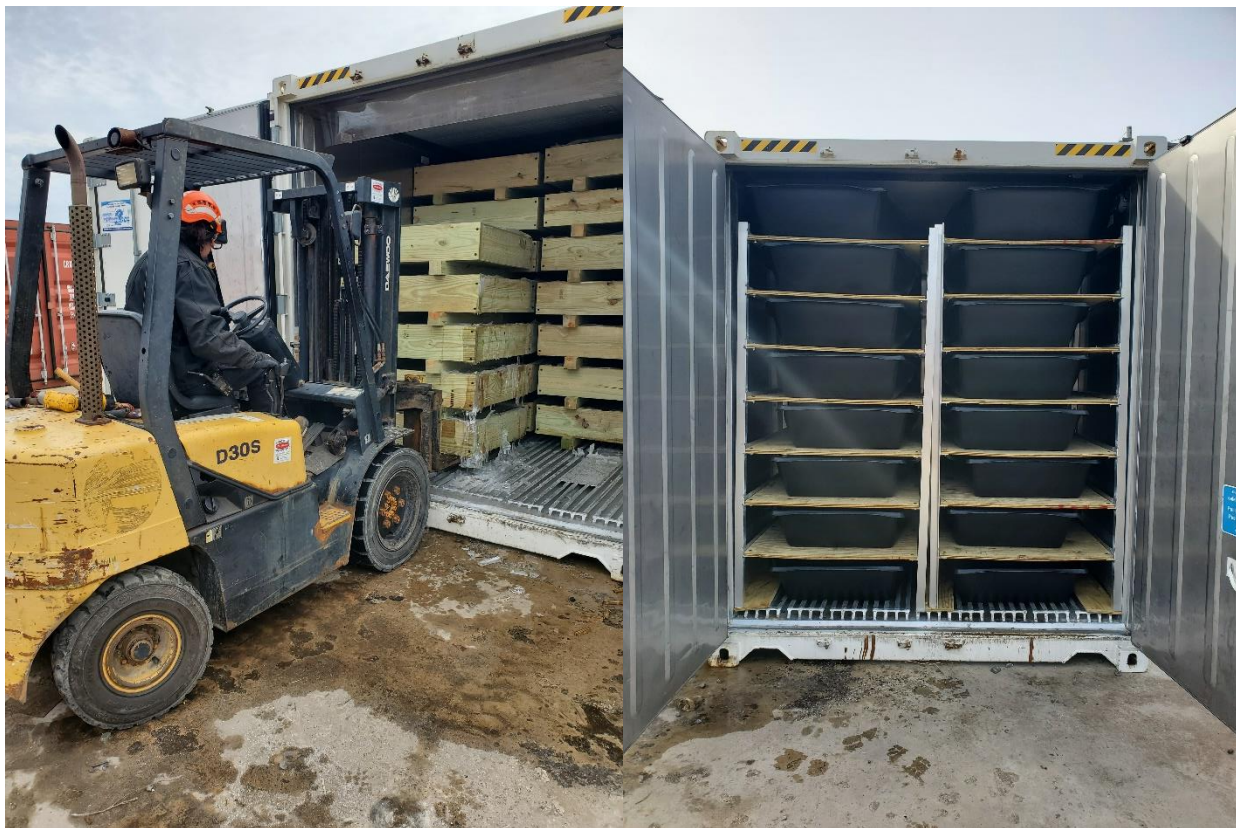
**Figure 1: On the left, wooden ice forms in reefer. On the right, plastic ice forms in reefer.**

Initially, two refrigeration units (reefers) were rented and delivered to Ohmsett for the freezing and storage of ice. Wooden ice forms were stacked within the first unit, and filled with water. Plastic ice forms were loaded onto the custom storage racks and placed within the second unit (see Figure 1). As the complete count of plastic trays could not be contained within a single unit, the preliminary plan was to form the ice in batches. The first round of ice was to be stored under heavy insulated blankets prior to testing. As the blocks were intended to be of small and varied sizes, minimal expected shrinkage was acceptable.

The temperature inside the two reefer units were set to just above freezing at 0.5°C (33°F), in order to allow the contained water to release its latent heat and allow the reefers to handle the humidity. The first reefer was found to be cooling at an unexpectedly slow rate with regular defrost cycles. This slow cooling rate was attributed to the effects of water in the reefer air intake channels due to spillage and leaking wooden ice forms. Unusually warm winter weather further called into question the ability to store ice blocks outside of the reefers. With successful ice generation in jeopardy, a third reefer unit was rented and delivered to Ohmsett to allow for a restart and redistribution of ice forms. The complete load of wooden forms was removed from the first reefer. At that time it was found that 15% (18 out of

120) of the plastic liners had completely failed and leaked. It was concluded that the 1000-gallon leakage, combined with the slight forward slope of the reefer unit floor, flooded and subsequently froze the cold air recirculation vents. The vendor service technician advised Ohmsett that this impacted the refrigeration system performance and caused the increased defrost cycling in the unit.

The failed wooden forms were re-lined, and the frozen forms were relocated to the third reefer. The remaining wooden and plastic forms were placed in the first reefer following a complete defrost and drying cycle. Subsequent freezing proceeded successfully in all three reefers. Of the re-lined wooden forms, ~15% (3 out of 18) were once again found to have failed. However the impact on ice formation was negligible since the newly re-lined wooden forms were intentionally staged on the opposite end of the reefers away from the recirculation vents, in order to minimize the impact of the water leaks. Leakage was believed to be the result of tiny imperfections or punctures to the plastic liner sheets. Shrinkage in the wood resultant from steady moisture removal conflicted with the natural expansion of freezing water, potentially providing puncture opportunities against the imperfect wooden surfaces.

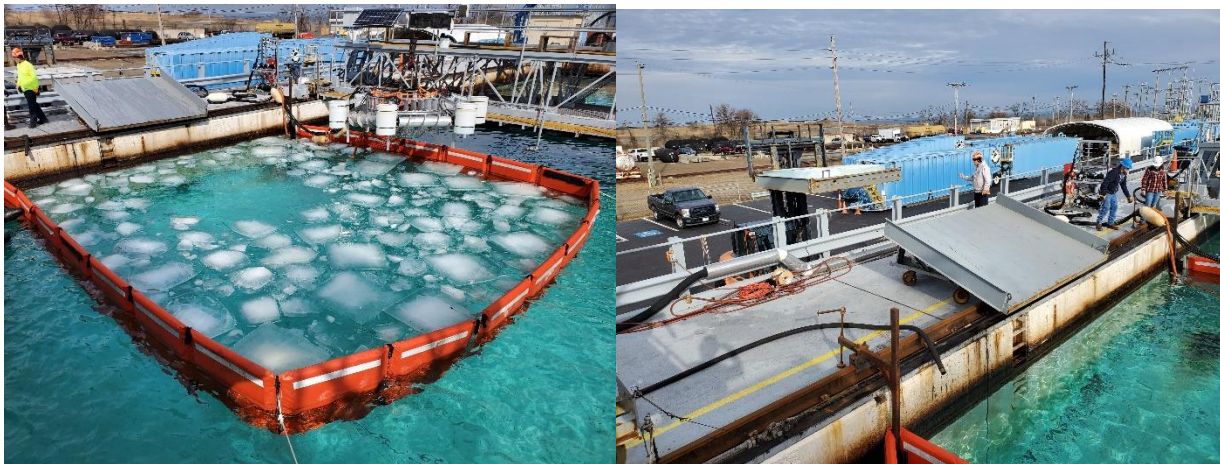
**Figure 2: On the left, 70% ice field. On the right, ice delivery slide.**

A 9.1 m x 9.1 m (30-foot x 30-foot) square area was formed by boom within the Ohmsett test basin. The Ohmsett team, with the assistance of the CRREL team, removed the requisite ice forms from each of the three reefer units and delivered them to the test area by way of a custom “slide” (see Figure 2). Upon visual observation of the simulated ice field by BSEE personnel, it was determined that the optimal number of ice blocks was to be comprised from 30 wooden forms and 40 plastic forms. After the test area was populated with the requisite concentration of ice, Hydrocal 300 was distributed to each corner

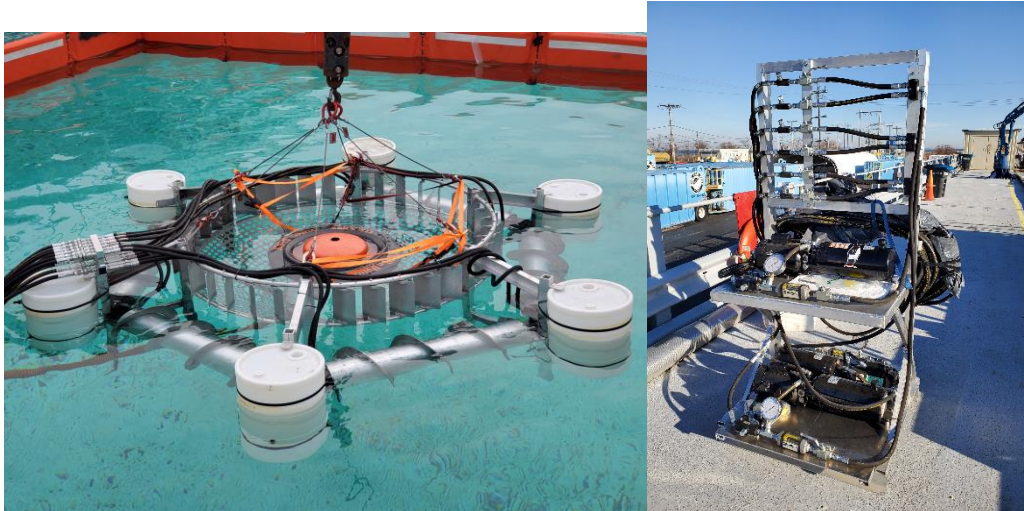
**Figure 3: On the left, AIMS auger configuration. On the right, AIMS hydraulic power control system.**

The Active Ice Management System (AIMS) arrived with the CRREL team. The system and hydraulic motor control unit were deployed on the tank deck. The system arrived with the rotating drums installed in an auger configuration (see Figure 3).

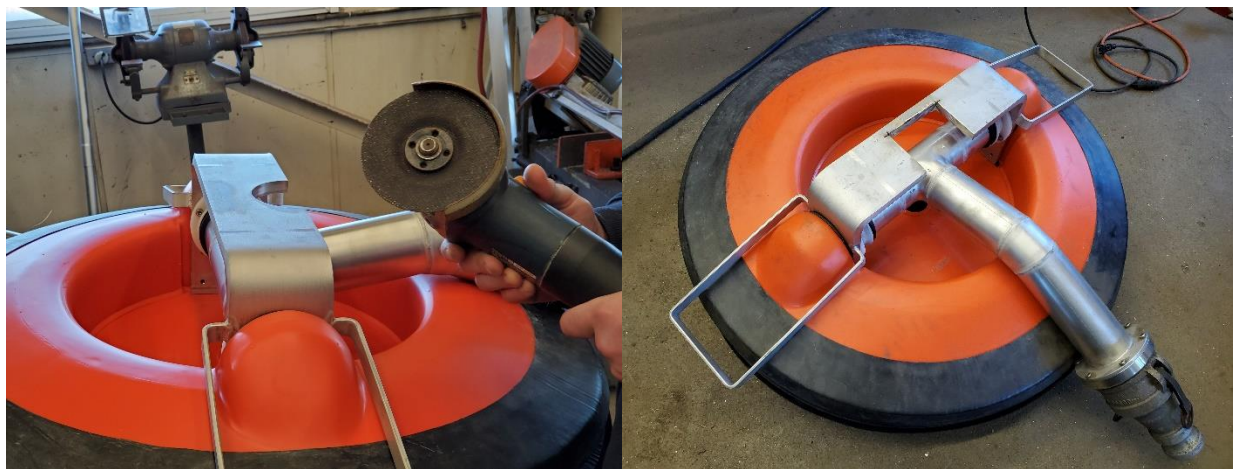
**Figure 6: On the left, DESMI Minimax prior to modification. On the right, DESMI Minimax after modification to allow further angular rotation.**

While the Desmi Minimax skimmer was new and the AIMS system was designed to integrate to the skimmer, there were several on-site modification were needed to allow testing to commence. The Desmi Minimax features a pivoting angled discharge line for use with long hoses in open water. Due to size constraints within the AIMS, the angle of the discharge line was not able to accommodate access to a hose through either the top or the bottom of the system. The Ohmsett team made a modification to the skimmer in order to allow the discharge hose to pass through the bottom of the AIMS without disturbing the level orientation of the skimmer (see Figure 6).

Additionally, the gasket seal within the rotatable discharge line was found to be inadequately sealed by the manufacturer. The Ohmsett team was able to insert additional gasket material and provide a successful seal. As Ohmsett did not possess a comparable replacement skimmer, these modifications

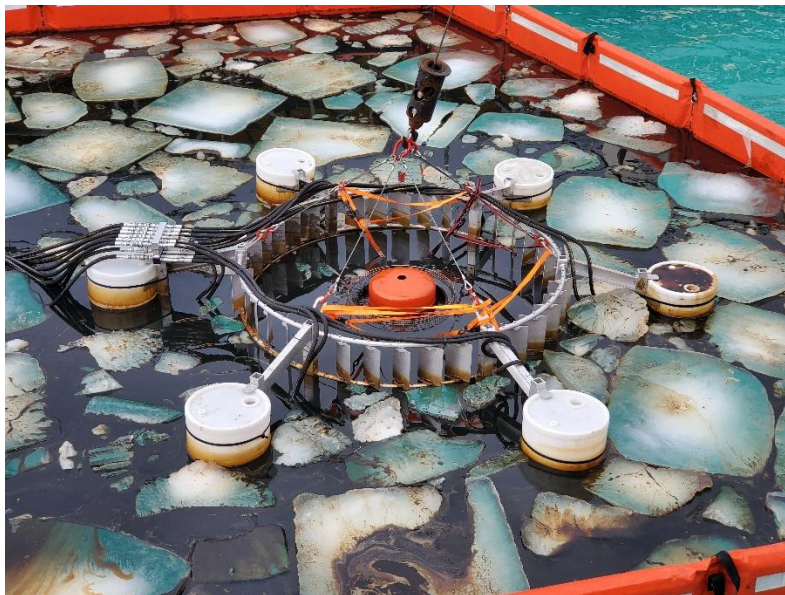
**Figure 7: AIMS deployed in ice field with 1-inch oil slick.**

While initiating daily testing, a barrier was encountered during the deployment of the AIMS and skimmer combo into the ice field. As the delivery of ice to the tank basin carried momentum, potentially damaging to the equipment, the system had to remain elevated above the water until the 70% coverage of ice in the oil/ice field was achieved. Additionally, deploying the system into a semi rigid field of ice highlighted the potential difficulties likely to be achieved in a real world arctic scenario. To overcome this barrier, team members manually maneuvered an opening within the ice field as the crane operator lowered the system into the water. Once in the water, the AIMS operator activated the hydraulic rotating drums, and any ice jammed within the system were manually cleared away with poles prior to initiating testing (see Figure 6).
