ICE ENCROACHMENT
IN THE ALASKAN BEAUFORT SEA

FINAL REPORT

Prepared for:
Shell Exploration and Production Company
Houston, Texas

April 2012

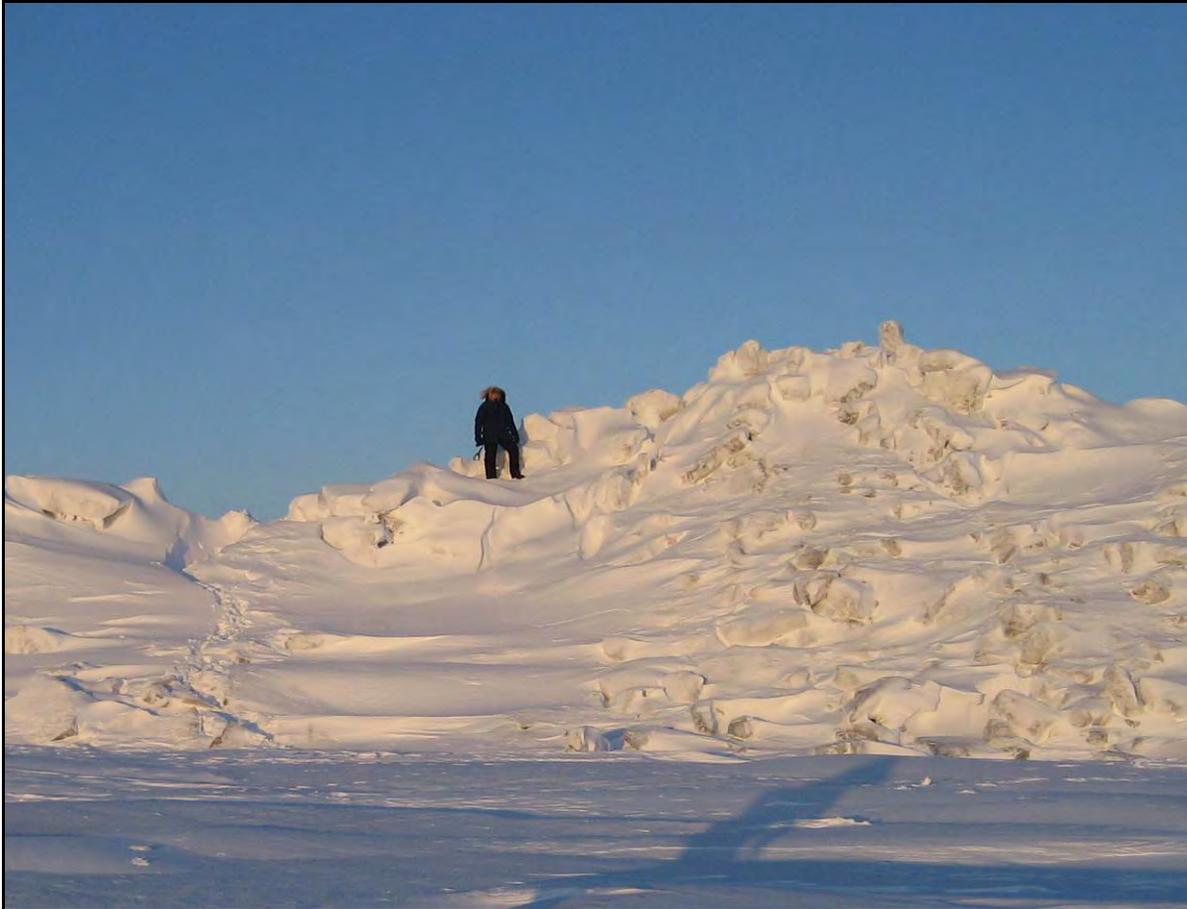
7.6-m Ice Pile-Up that Encroached 20 m on Narwhal Island in November 2011

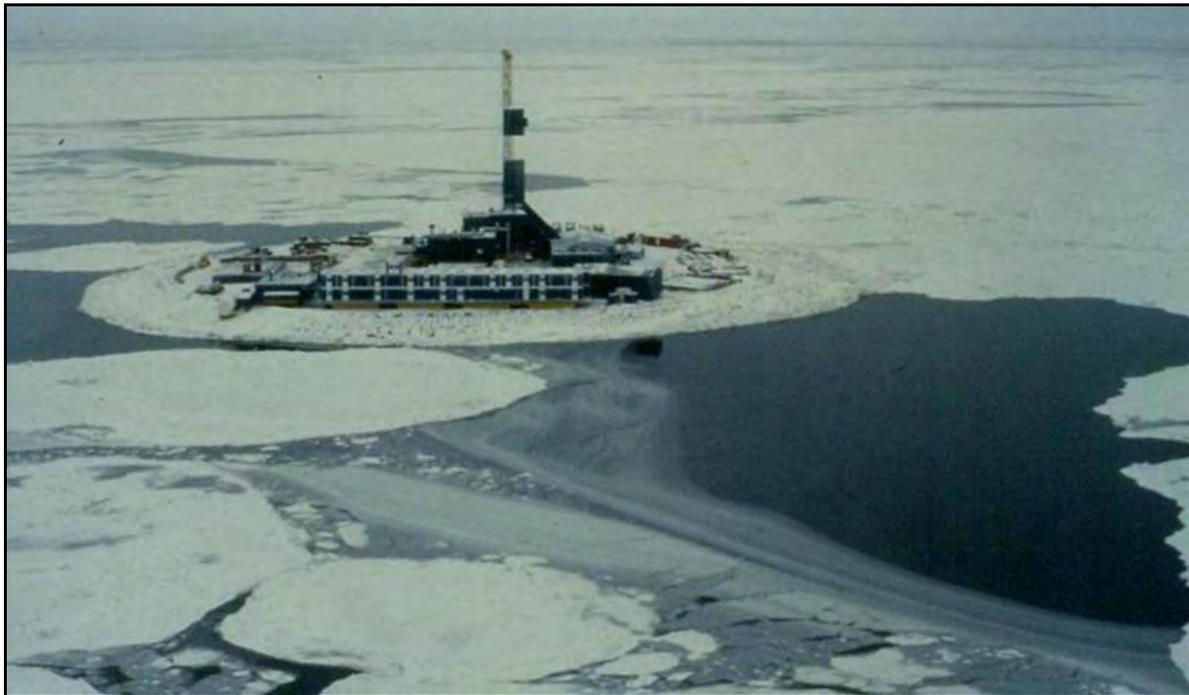
Plate 1. First Stages of Freeze-Up at BF-37 Exploration Island (October 1981)

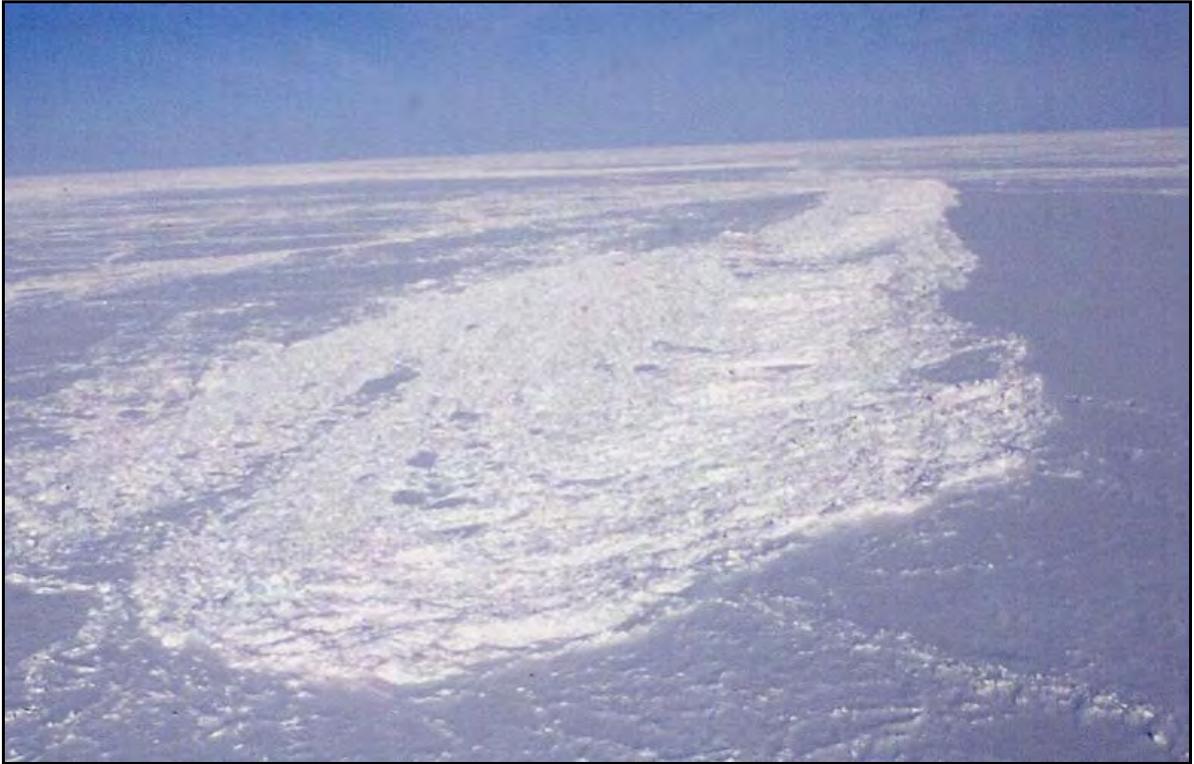
Plate 2. Typical Rubble Formation on Weller Bank (May 1989)

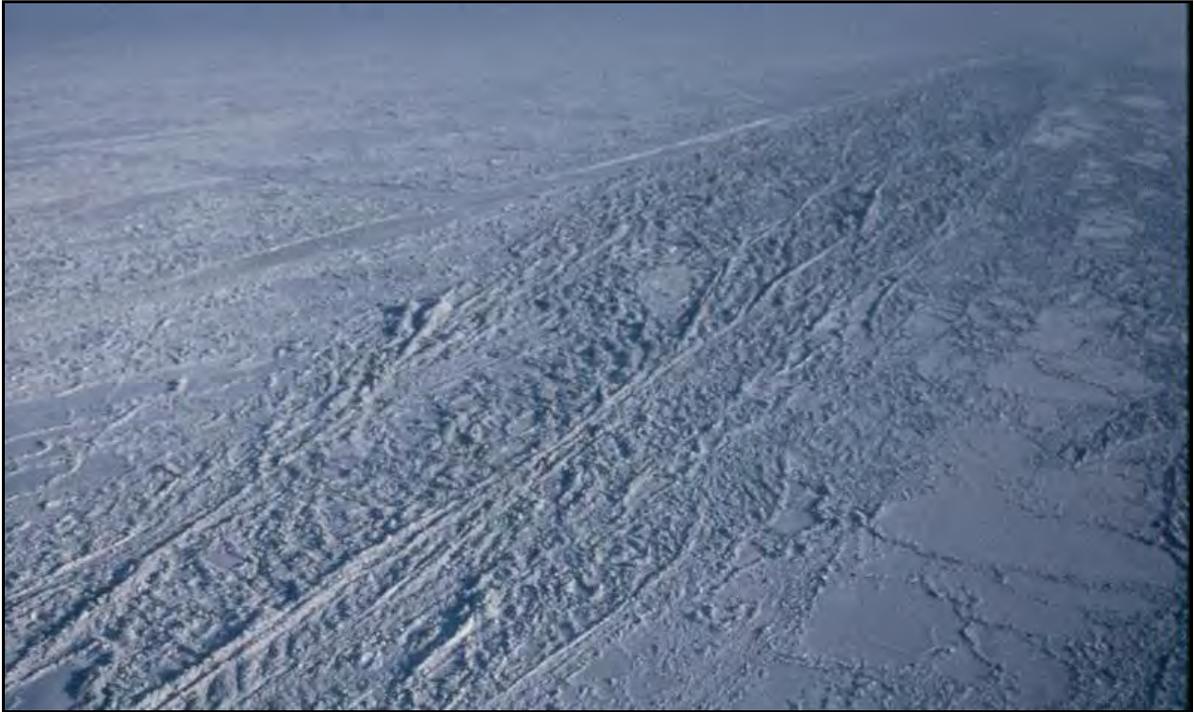
Plate 3. Shear Zone Formation in Outer Camden Bay (March 1987)

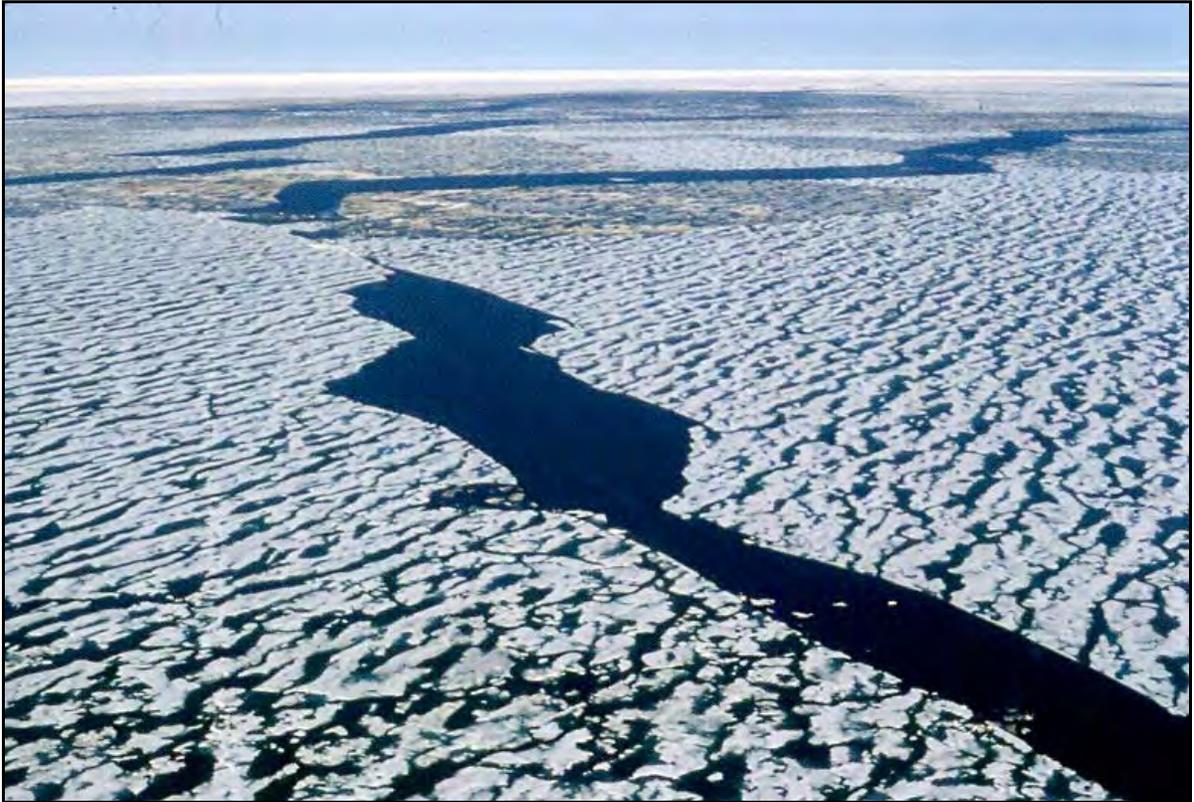
Plate 4. Break-Up of Landfast Ice in Stefansson Sound (early July 1983)

By mid- to late June, about two to three weeks after the flooding has ceased, most of the ice within the overflow zone has melted in place from a combination of the fresh, relatively warm, river water and the increased heat absorption by the ice surface, which is covered with a thin layer of silt deposited by the flood water. This decay, along with the ensuing loss of confinement, promotes break-up of the nearshore landfast ice (Plate 4) about three to four weeks after the conclusion of the overflow period.

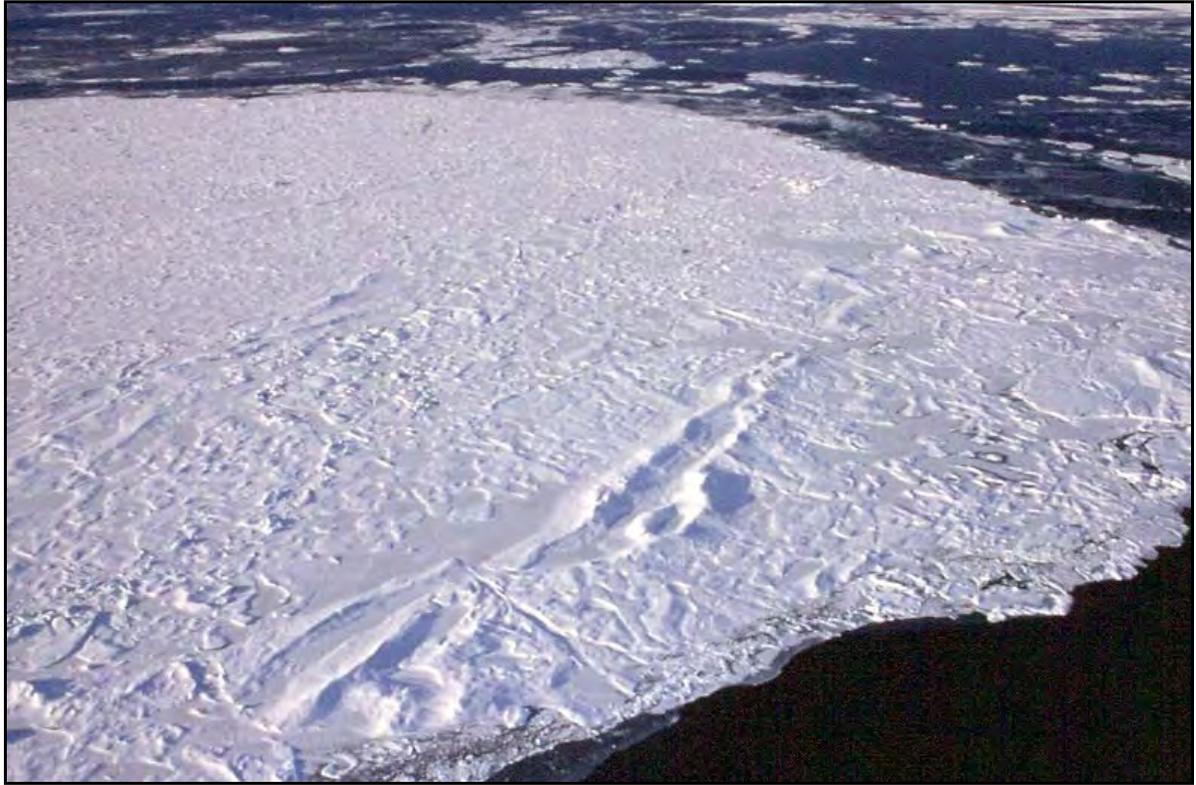
Plate 7. 1000-m Diameter Multi-Year Ice Floe in Camden Bay (October 1985)

Multi-Year Ice: Multi-year ice is sea ice that has survived at least one melt season. During freeze-up, multi-year ice floes (Plate 7) can invade the nearshore region of the Beaufort Sea north of the barrier island chain and typically seaward of the 12-m isobath. However, small multi-year fragments (up to 30 m across) can enter the shallow waters adjacent to the coast. During the 2010-11 freeze-up season, for example, such fragments were observed on the seaward shorelines of many of the barrier islands between Harrison and Camden Bays (Coastal Frontiers and Vaudrey & Associates, 2011). Most multi-year ice invasions occur during freeze-up, because pack ice confinement and the landfast ice zone tend to preclude such events in mid-winter.

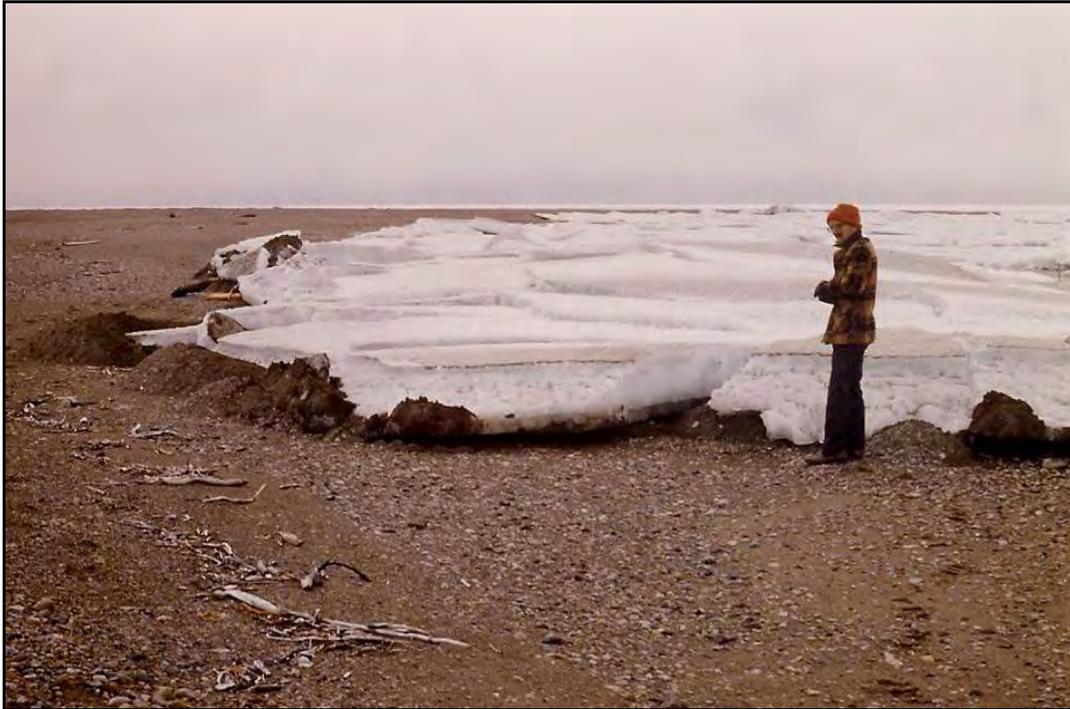
Plate 8. Ice Ride-Up on Pole Island in late June 1981 (60-75 cm thick sheet ice encroached 15 m onto beach during 20-kt westerly wind.)

An example of an ice ride-up event without significant pile-up occurred in late June 1981 (Vaudrey, 1982) when a 15-20 kt (8-10 m/s) westerly wind drove the 60-75 cm thick ice sheet onto the gently-sloping beach of Pole Island. (Plate 8). The ice encroached up to 15 m over an alongshore distance of roughly 300 m. Ice ride-up events also can occur during early freeze-up, when the young, pliable sheet ice can conform to minor changes in slope and move onshore if suitable storm conditions exist.

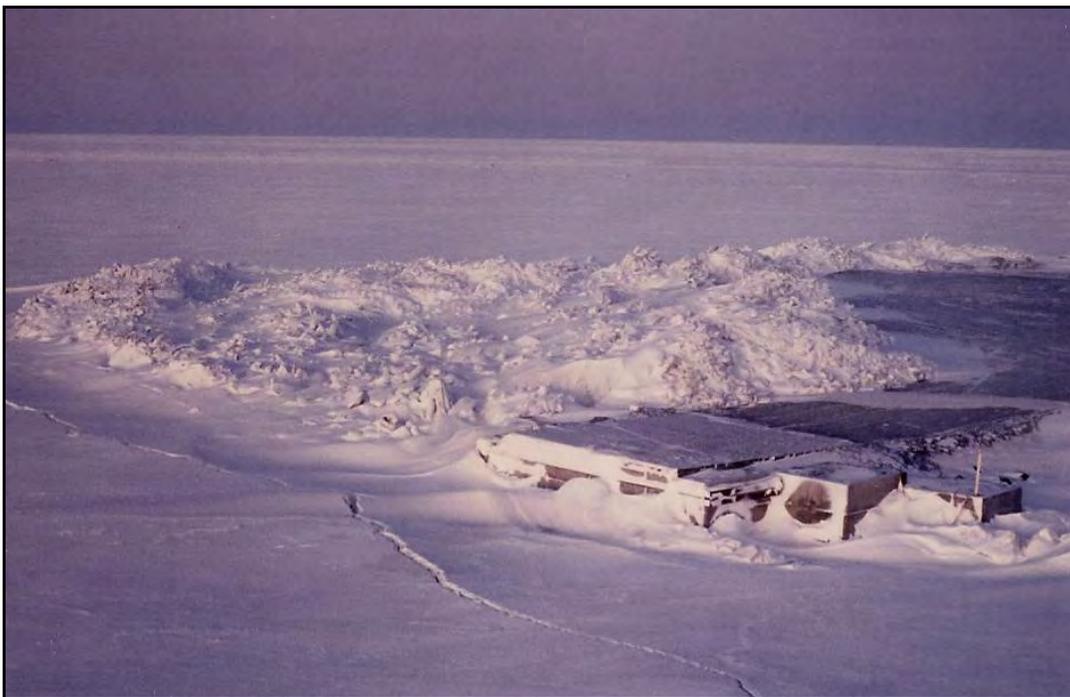
Plate 9. 7.6-m High Ice Pile-Up on Endeavor Island in Mid-October 1982 (20-cm blocks encroached 5 m onto work surface during 40-kt SW storm.)

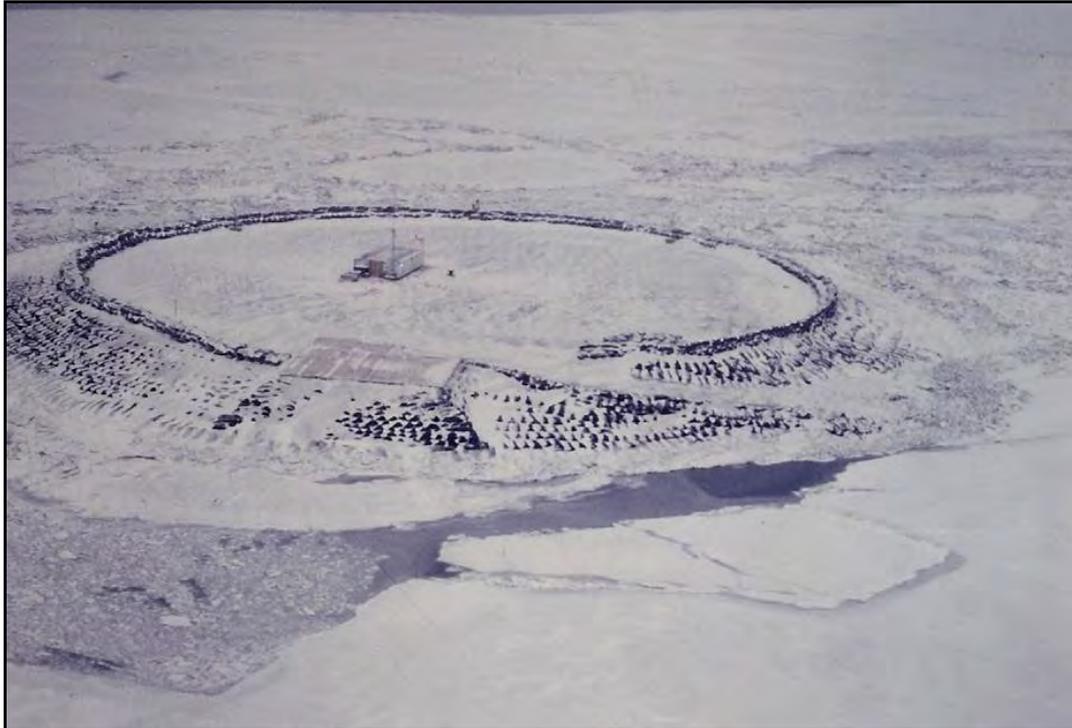
Plate 10. Broken Ice and Open Water around Seal Island on October 18, 1982 after Easterly Storm

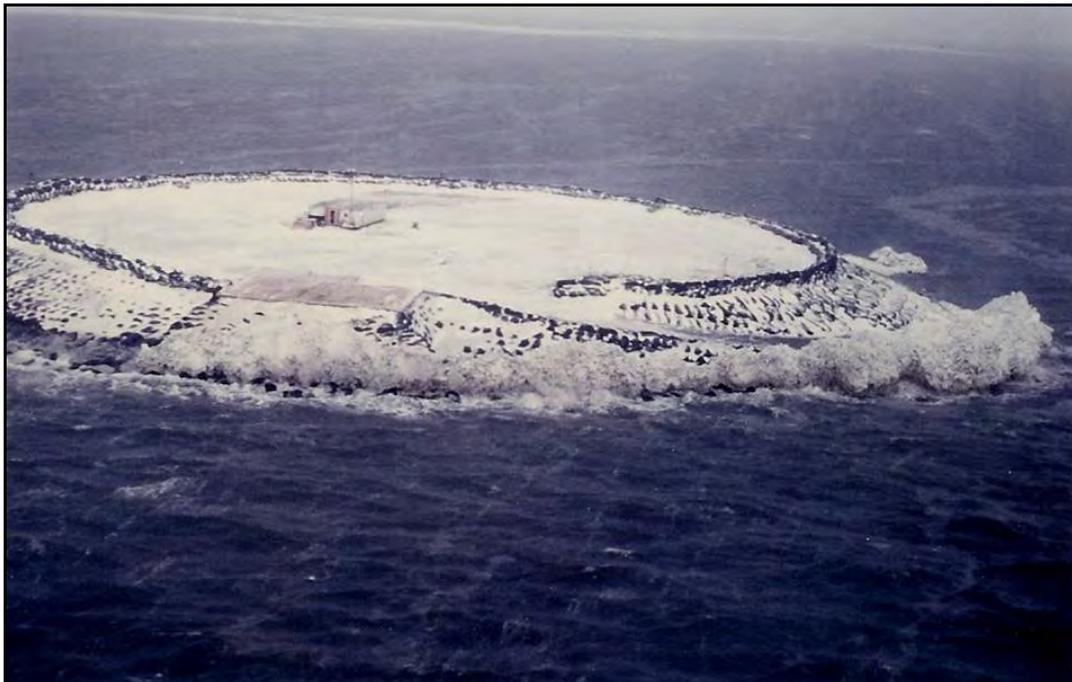
Plate 11. 6.1-m High Ice Pile-Up on Seal Island that Resulted from SW Storm on October 19, 1982.

As indicated in Section 2, ice motion is governed primarily by wind stress acting on the ice surface. Although factors that include astronomical tide, storm surge, and waves can contribute to the initiation of ride-up and pile-up, the single most important factor is the loss of confinement of the sheet ice. This phenomenon typically results from a reversal in the wind direction, due to the presence of cracks or small leads in the nearshore ice. For instance, an easterly wind may produce the cracks or leads, which subsequently allow the ice to begin moving when the wind direction shifts to westerly. Such was the case during the aforementioned storm in October 1982. As illustrated in Plates 10 and 11, the easterly winds on October 16 and 17 produced broken ice and open water around Shell's Seal Island (an exploratory island in a water depth of 12 m at the site of the present Northstar Production Island). The southwesterly winds that followed on the 19th drove the 20-cm thick ice onto the island side slope, creating a 6.1-m high pile-up on the west side.

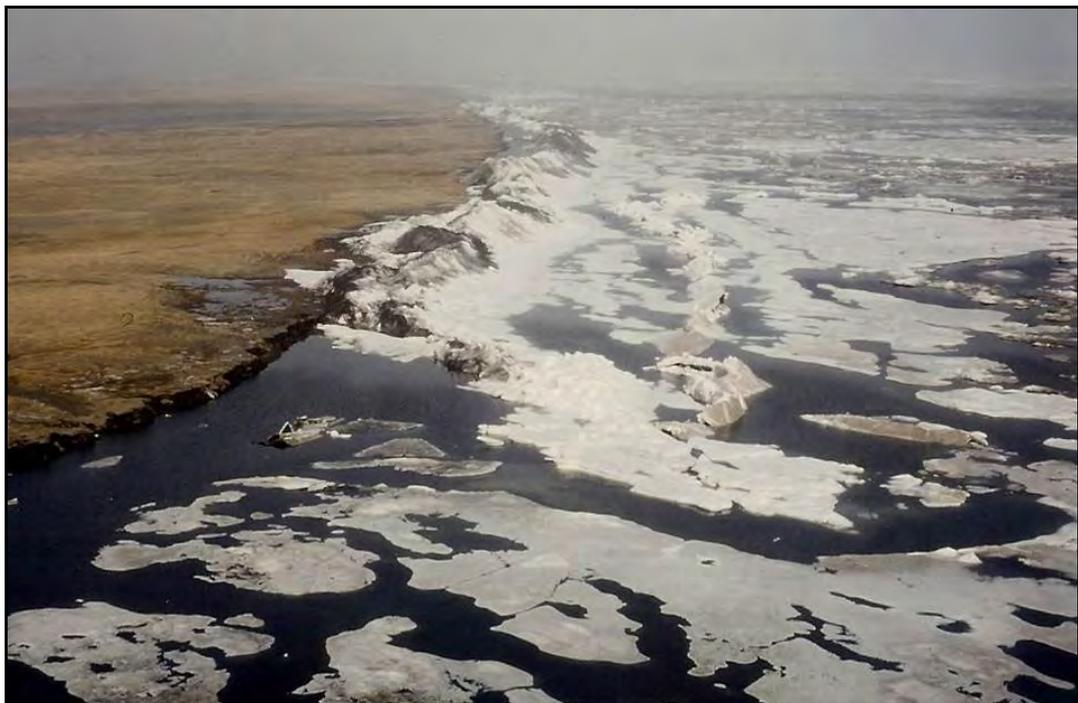
Plate 13. Ice Pile-Up that Overtopped 2-m High Bluff on Pingok Island in Early December 1982 (Note: photo taken during 1983 break-up.)

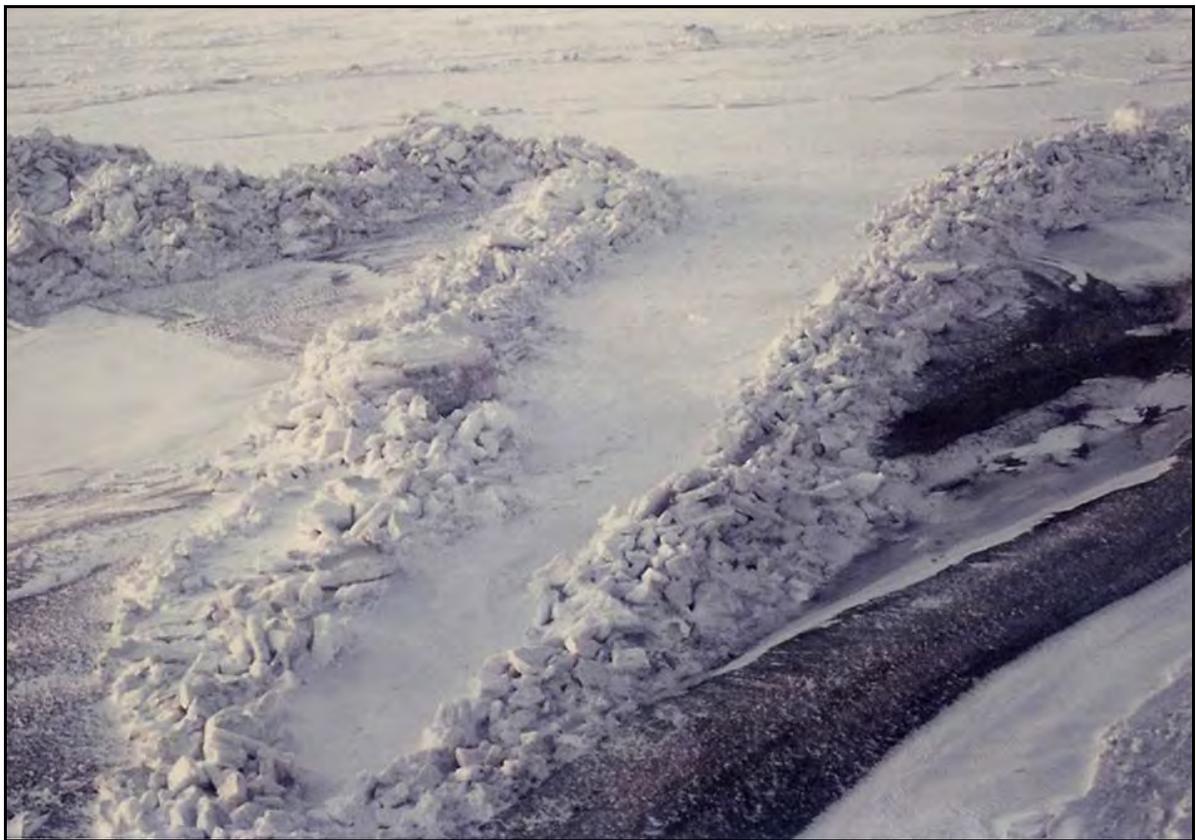
Plate 14. 3.7-m High Pile-Up/Ride-Up that Occurred on Jeanette Is. in Mid-October 1982 (10-m wide finger of 20-cm thick ice rode 76 m onto south-facing beach.)

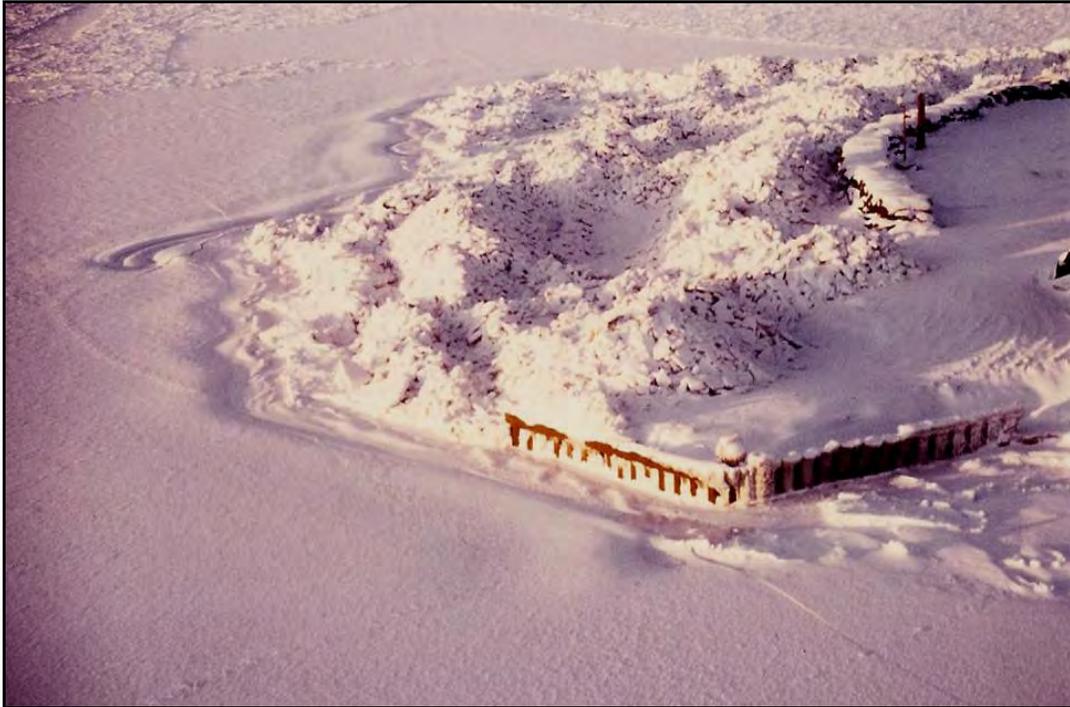
Plate 15. 7.6-m Pile-Up on Tern Island in mid-October 1984 (8-15 cm thick ice blocks encroached 12 m past waterline during 15-25 kt southwesterly storm.)

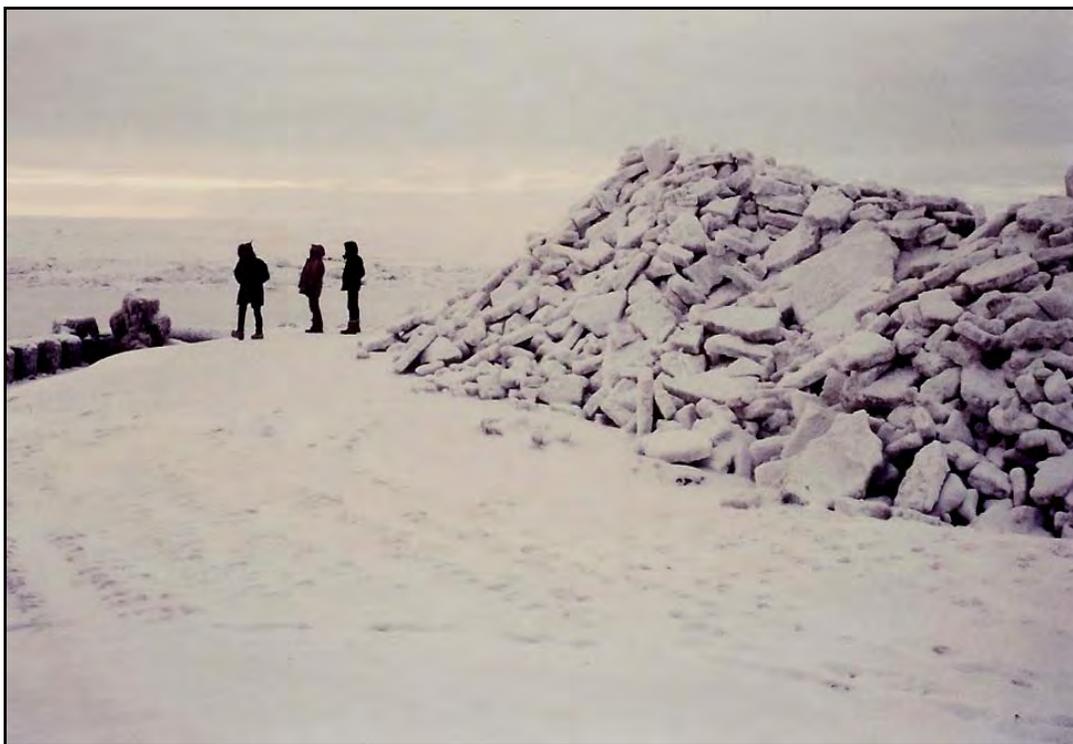
Plate 16. Work Surface Encroachment of 6 m on Tern Island in Mid-October 1984

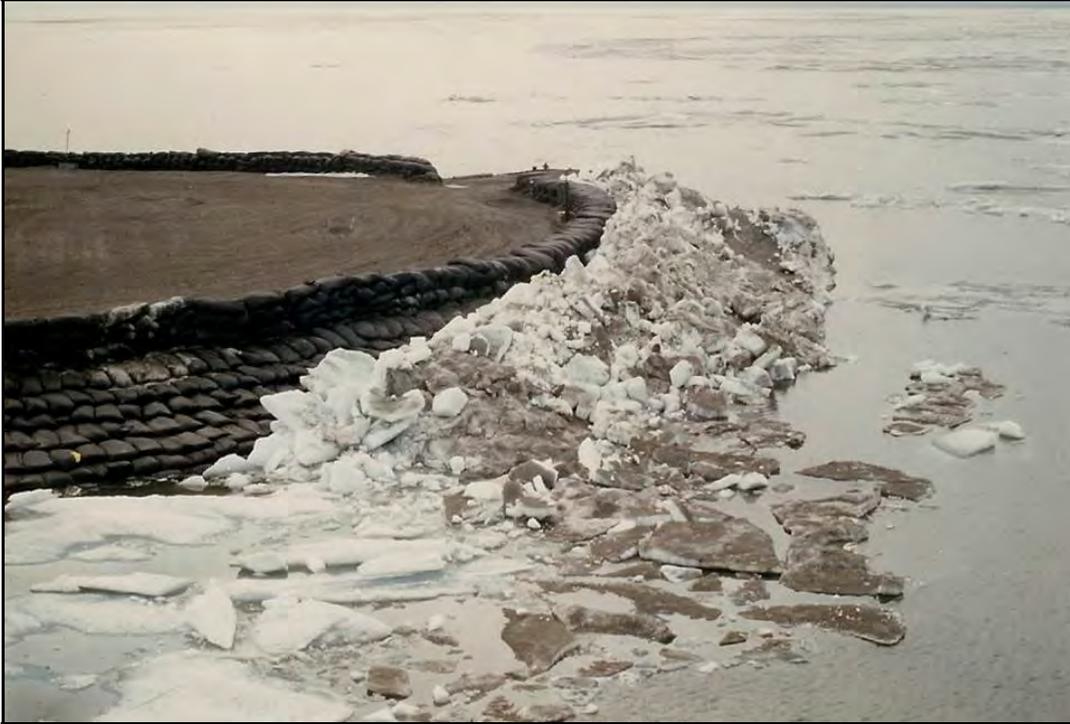
Plate 17. 6.9-m Pile-Up on Tern Island in Early July 1984 (60-120 cm thick ice blocks encroached 14 m onto gravel bag armor during 20- to 25-kt westerly storm.)

8 m. In all cases, the pile-up failed to reach the facility work surface. The 6.9-m pile-up that encroached 14-m onto Tern Island in early July 1984, is shown in Plates 17 and 18.

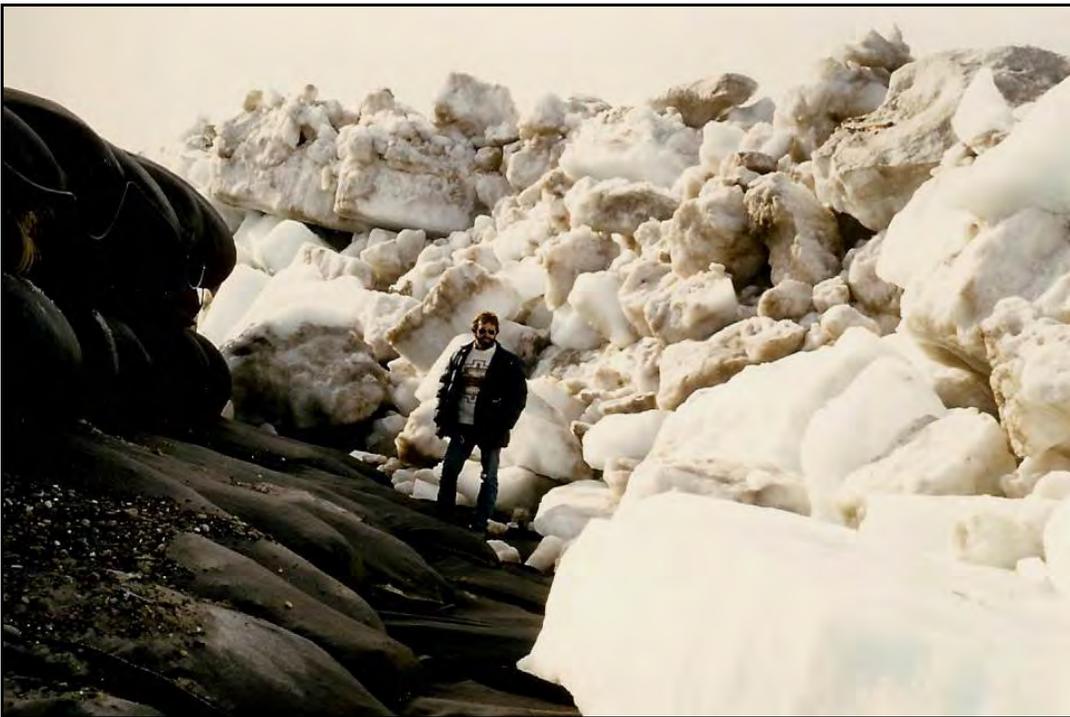
Plate 18. Detailed View of 6.9-m Pile-Up on Tern Island in Early July 1984

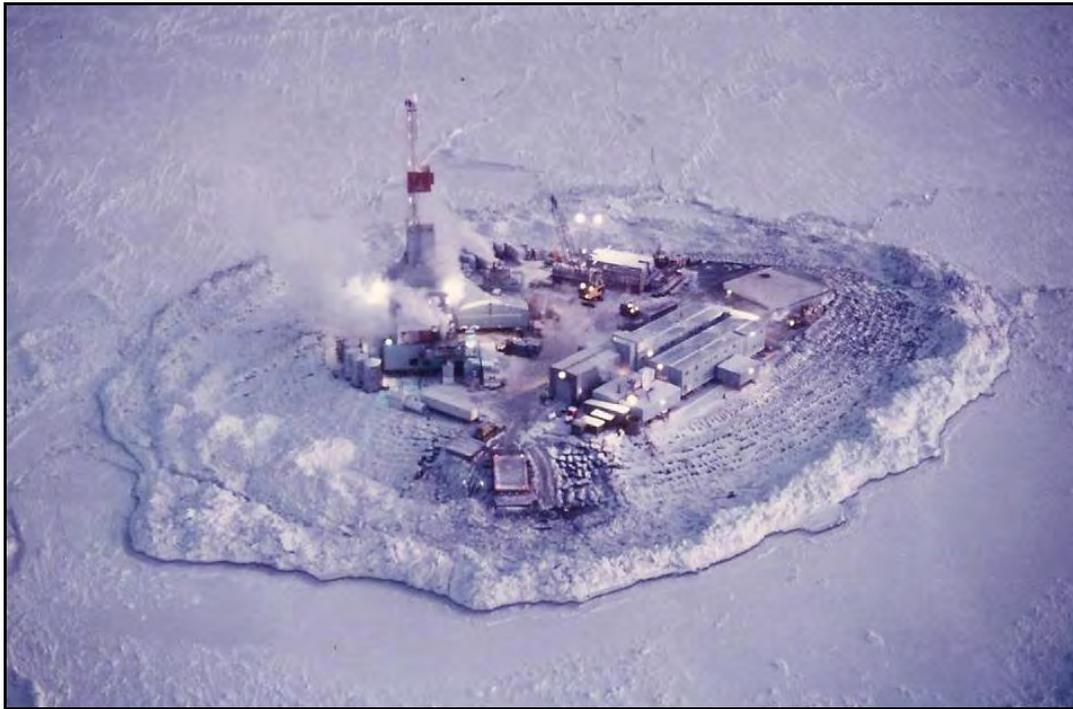
Plate 19. 7.6-m Pile-Up on Mukluk Island in Late November 1983 (60-65 cm thick ice blocks piled up at waterline during 30- to 35-kt easterly storm.)

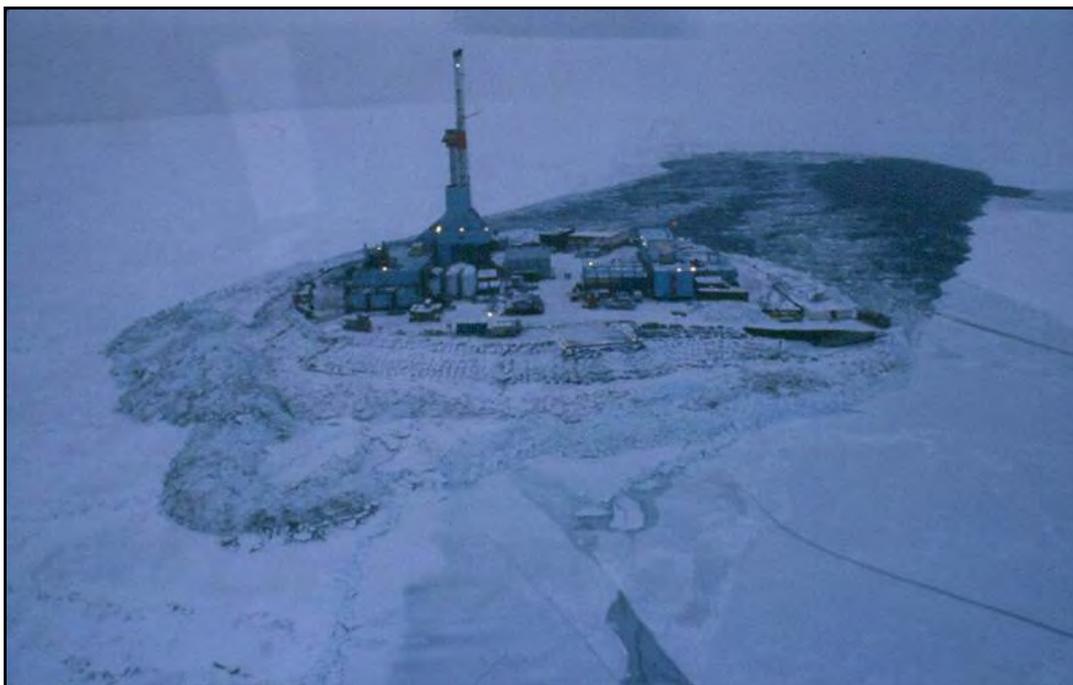
Plate 20. 11.5-m Pile-Up on Sandpiper Island in Mid-November 1985 (50-cm thick ice blocks encroached 5 m onto gravel bag armor during 30- to 40-kt westerly storm.)

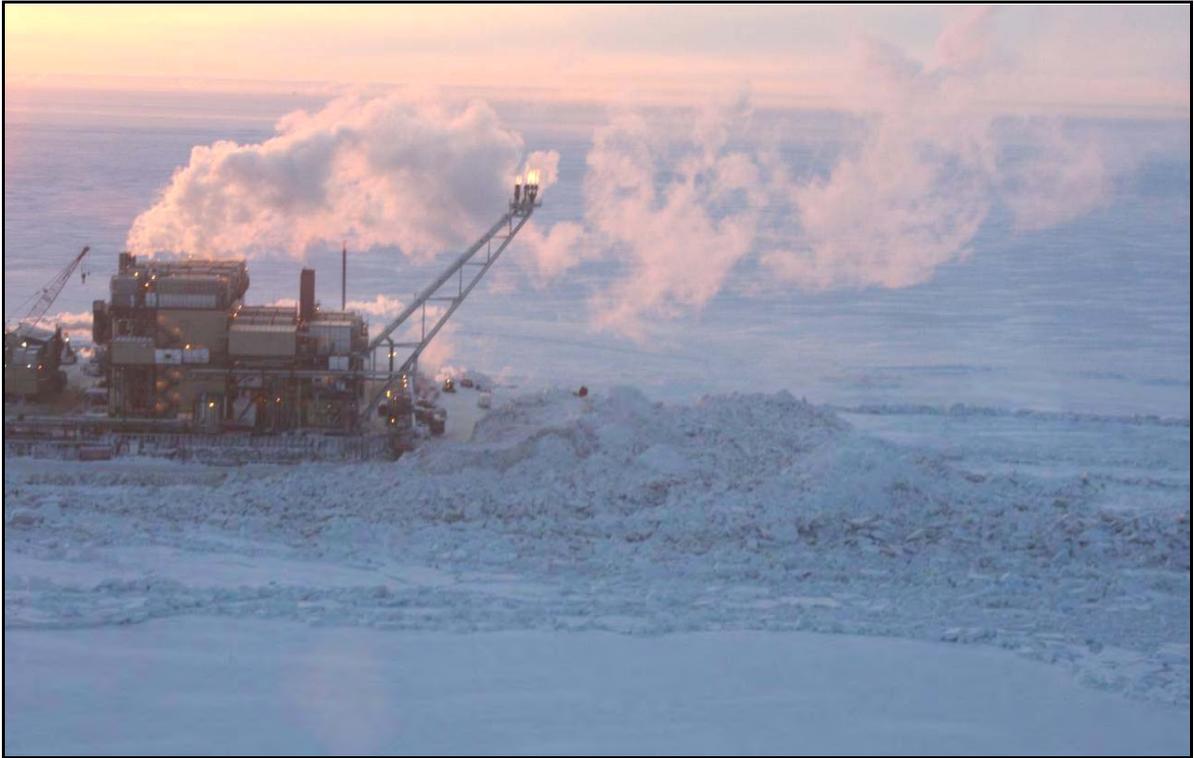
Plate 21. 14.3-m Pile-Up on Northstar Production Island in Late January 2008 (60-90 cm thick ice blocks encroached 27 m onto concrete mat during 30- to 40-kt westerly storm; Coastal Frontiers, 2009.)

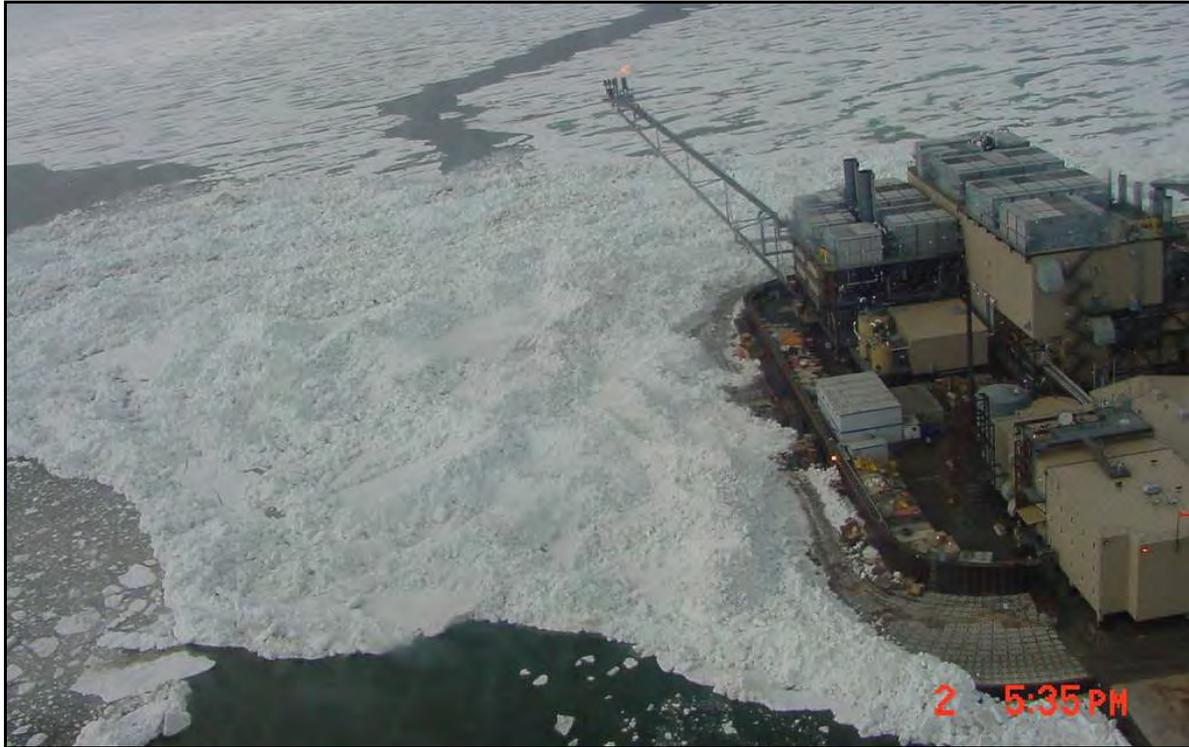
Plate 22. 9.1-m Pile-Up on Northstar Prod. Is. in Early July 2002 (1.0-1.5 m thick ice blocks encroached 27 m onto concrete mat during 10- to 20-kt westerly wind.)

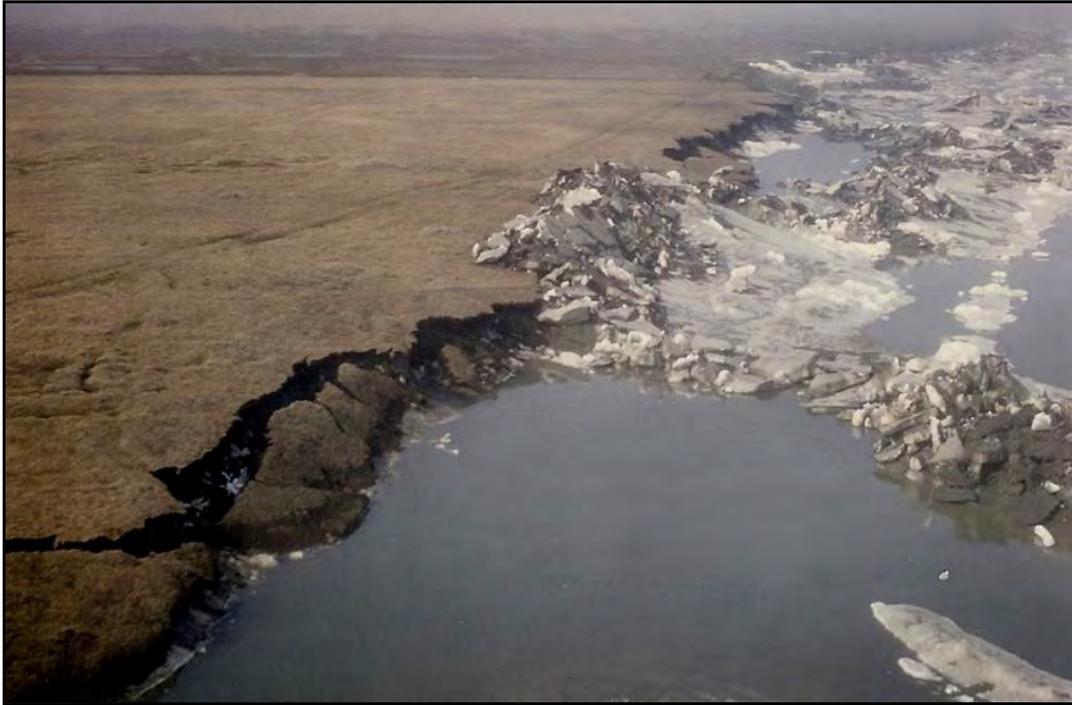
Plate 23. 3-m Pile-Up near Pogik Bay in Late June 1983 (45-75cm thick ice blocks overtopped 2-m bluff and encroached 12 m onto tundra during a 15- to 20-kt westerly storm.)

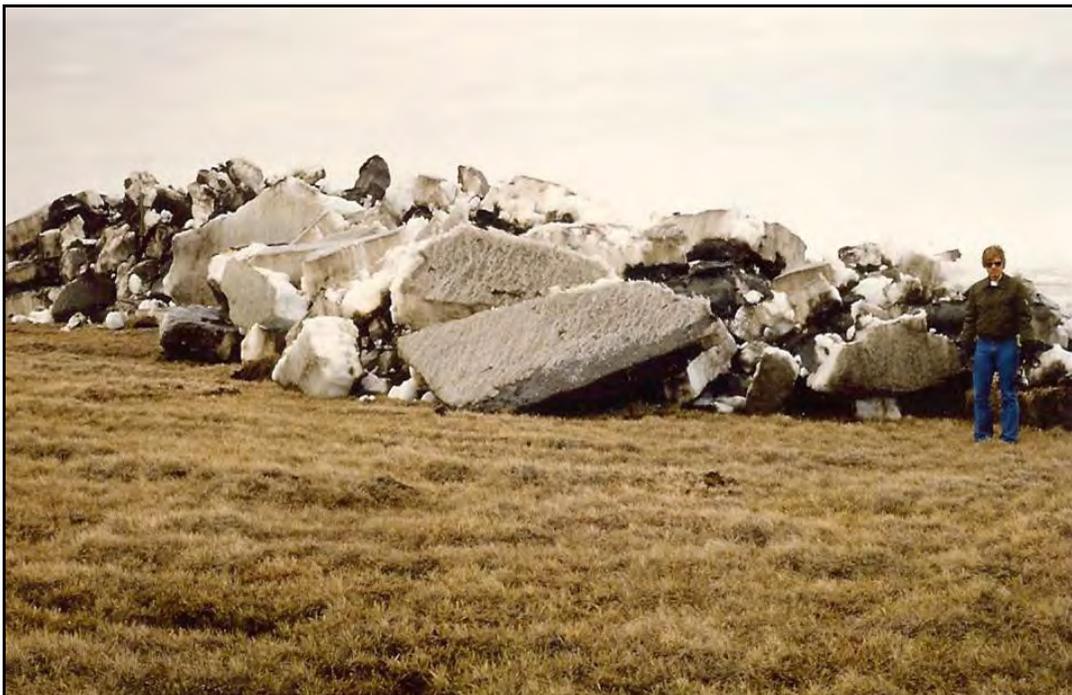
Plate 24. Detailed View of 3-m Pile-Up near Pogik Bay in Late June 1983

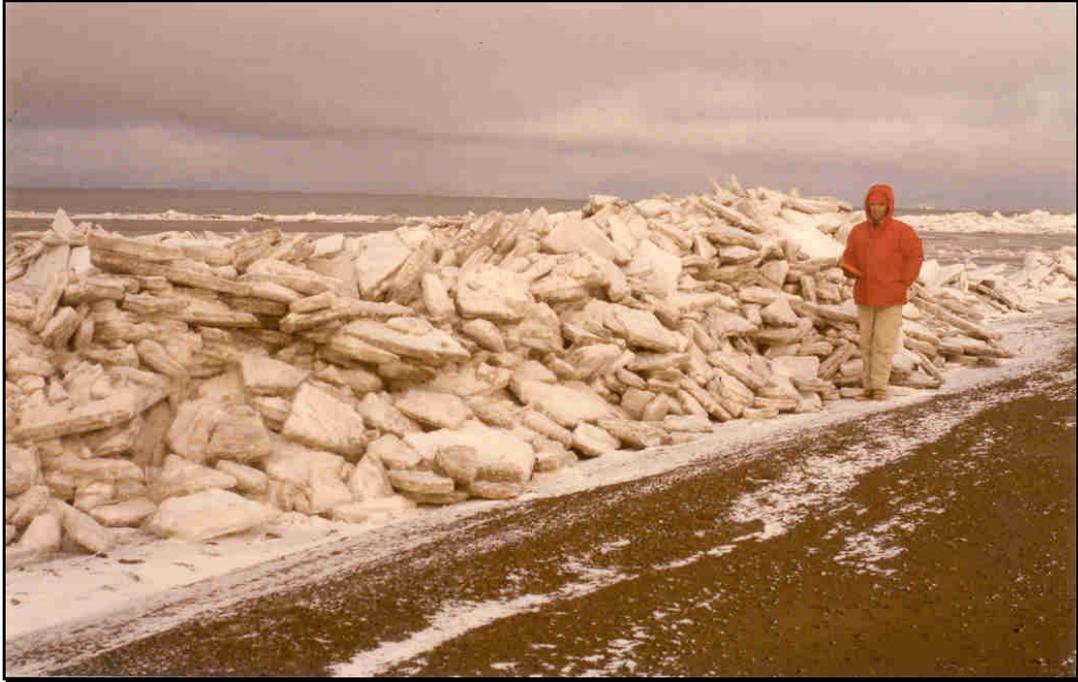
Plate 25. 1.7-m Shoreline Pile-Up on Thetis Island in Late September 1980 (8-10 cm thick ice blocks encroached 6 m onto beach during 15- to 20-kt westerly storm.)

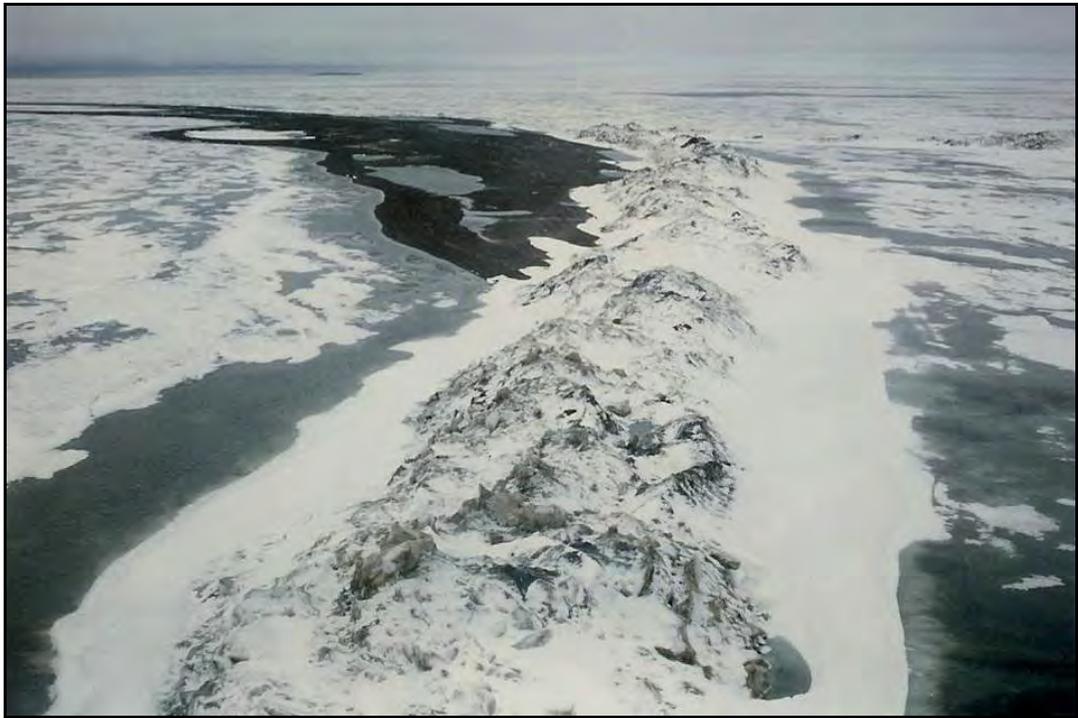
Plate 26. 10.6-m Pile-Up on Spy Island in Early December 1982 (60-90 cm thick ice blocks encroached 36 m across full width of island during 20- to 25-kt easterly storm.)

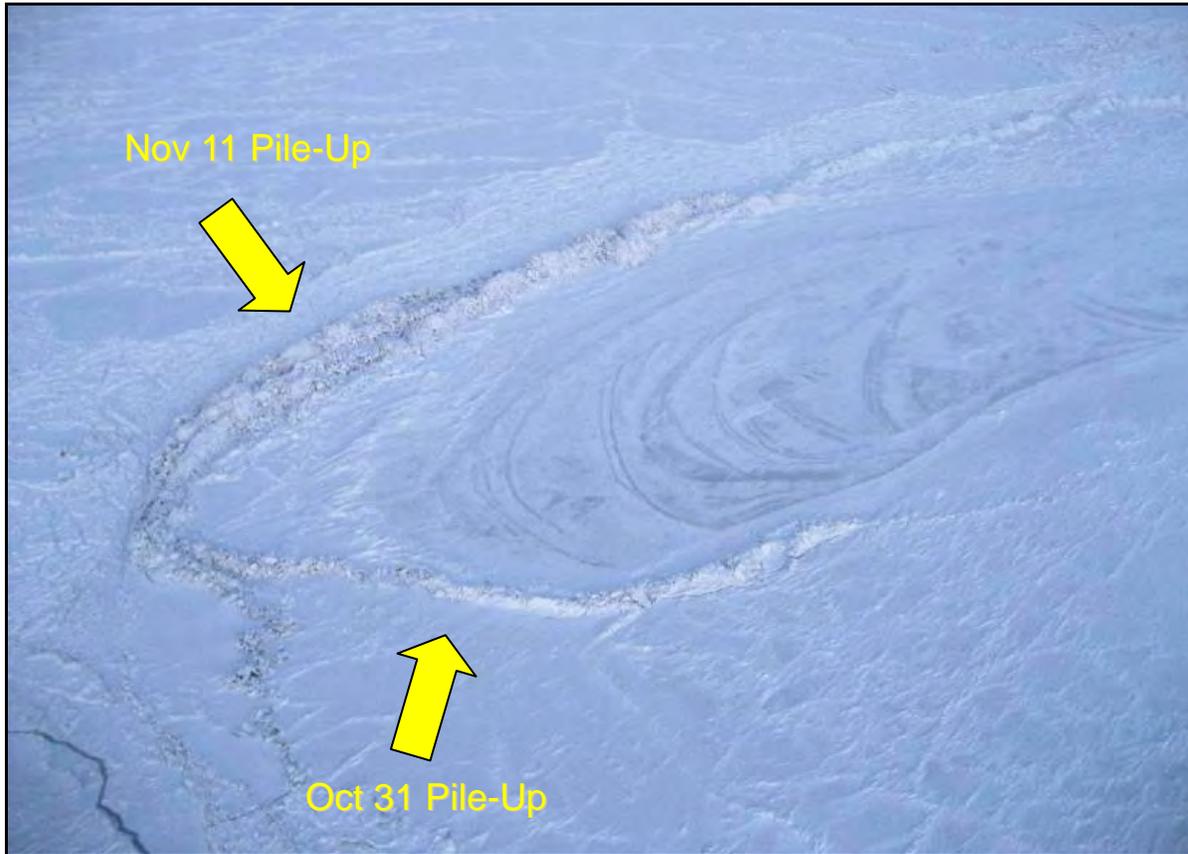
Plate 27. 4-m Pile-Up that Formed on Southwest Side of Narwhal Is. on Oct. 31, 2011, and 7.6-m Pile-Up that Formed on Northwest Side on Nov. 13, 2011 (20-cm thick ice blocks encroached 4 m during 20- to 25-kt southwesterly storm in October; 30-cm thick ice blocks encroached 20 m during 15- to 25-kt westerly storm in November.)

Two recent pile-ups observed on the west end of Narwhal Island during the 2011 freeze-up season are illustrated in Plate 27. The first, which formed on October 31 in response to a 20- to 25-kt (10- to 13-m/s) southwesterly storm, attained a height of 4 m and encroached 5 m onto the beach. The second, which followed on November 13 during a 15-to 25-kt (8 to 13-m/s) westerly storm, was characterized by a height of 7.6 m and encroachment distance of 20 m.
