ICE ENCROACHMENT
IN THE ALASKAN BEAUFORT SEA

FINAL REPORT

Prepared for:
Shell Exploration and Production Company
Houston, Texas

April 2012

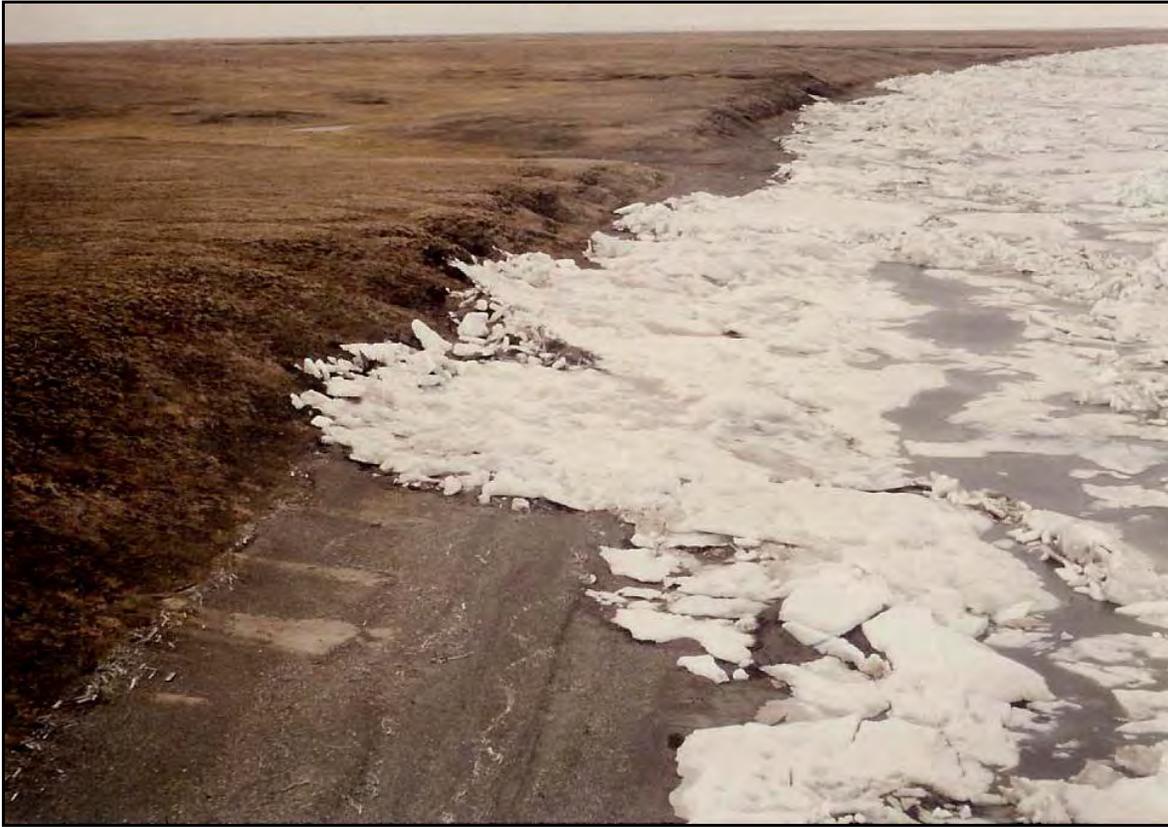
Plate 28. Ride-Up in Camden Bay in Late June 1983 (60-90 cm thick ice sheet encroached 43 m onto beach along 2-nm stretch during 15- to 20-kt easterly storm.)

The break-up events produced encroachments that varied from 3 to 45 m. The average value was 15 m. The ice thickness ranged from 30 cm to 1.5 m. An extensive ride-up that extended 2 nm (3.7 km) along the shoreline of Camden Bay is shown in Plate 28. The ride-up occurred on June 27, 1983, in response to a 15- to 20-kt easterly storm. The maximum encroachment was 43 m.

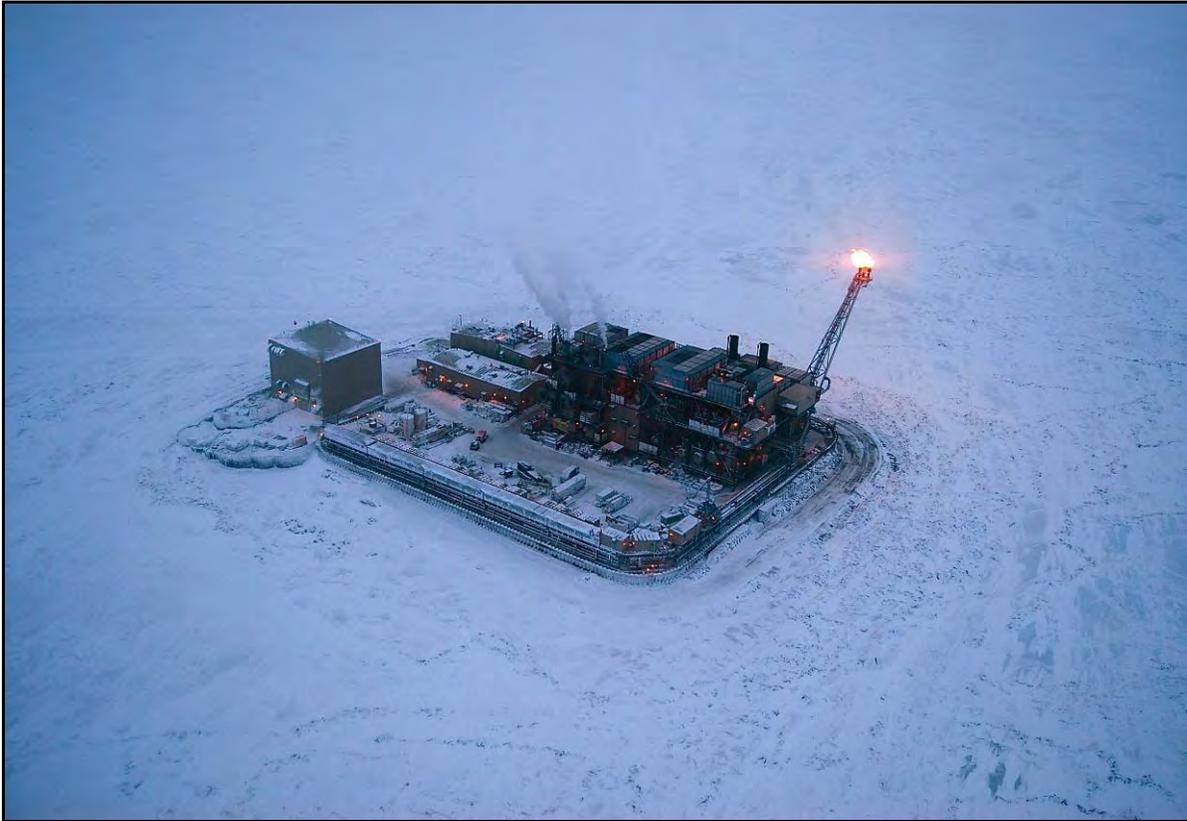
Plate 29. 4-m Pile-Up on Northstar Production Island in mid-November 2011 (30-cm thick ice blocks encroached 5 m onto concrete mat during 15- to 25-kt westerly storm)

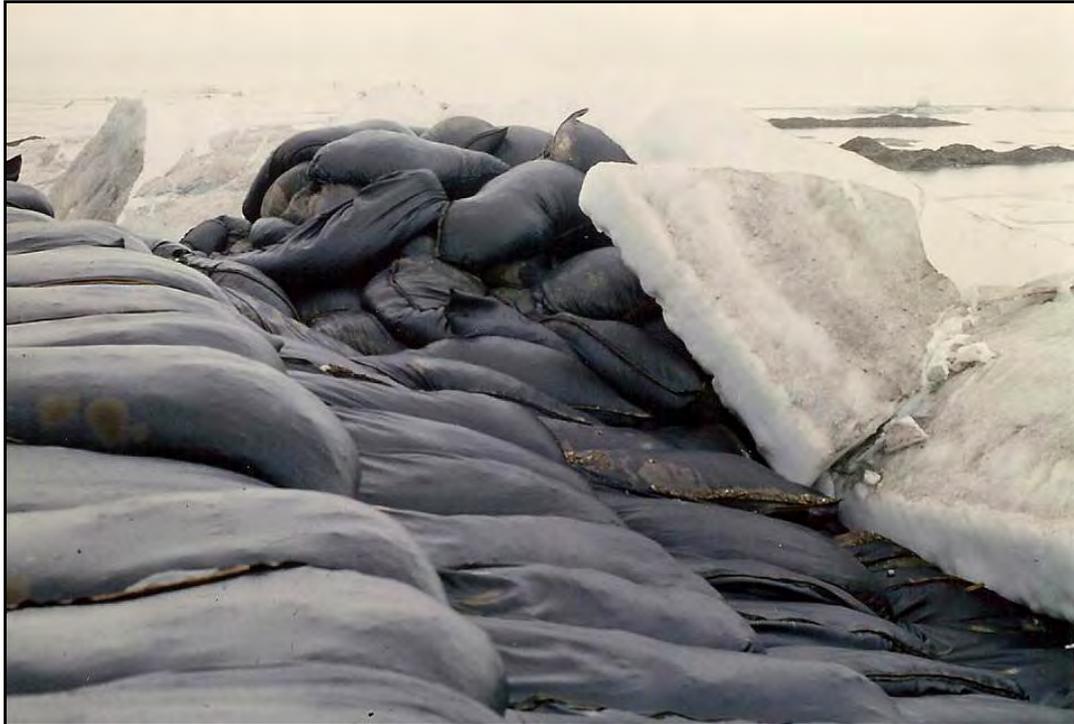
Plate 30. Gravel Bags at Waterline of Tern Island Damaged by Ice Encroachment on June 30, 1982

12. Even if ice does not encroach onto the work surface of a man-made facility, it can damage the armor that protects the side slope. Such damage tends to be most severe during break-up, when the ice is thicker than during freeze-up. In the event of a significant encroachment event on a man-made facility with armored side slopes, the impacted area should be inspected immediately after break-up to ensure that the slope protection system has not been compromised.

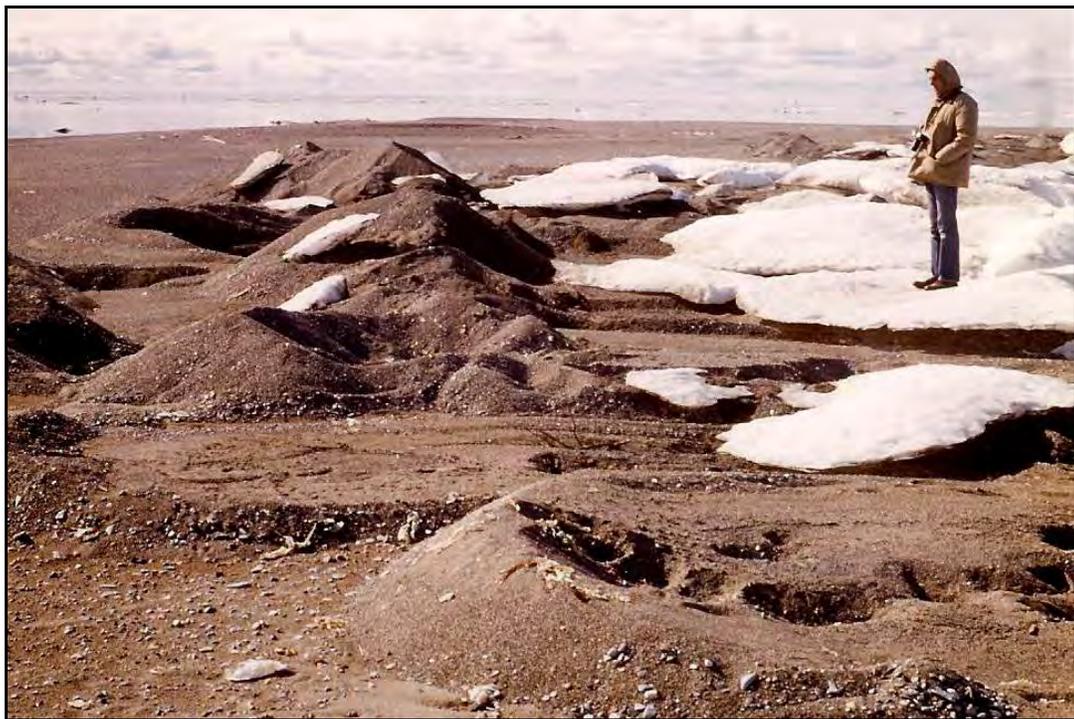
Plate 31. Gravel Beach on Karluk Island Bulldozed by Ice Ride-Up on June 27, 1981
