**STUDYING “FITNESS FOR SERVICE” OF THE SEALING ASSEMBLIES  
AND CEMENT SYSTEM IN SHALLOW WELL DESIGNS BY  
CONDUCTING SCALED LABORATORY TESTING, LEAKAGE  
MODELLING AND RISK ASSESSMENT**

**FINAL REPORT**

**Prepared under BSEE Project NO: E17PC00005**

**THE UNIVERSITY OF OKLAHOMA**

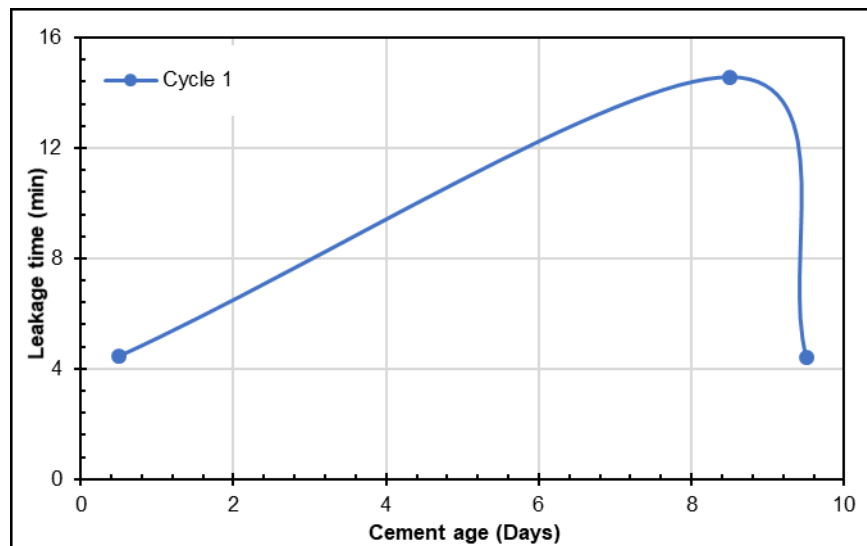
Figure 2.4: Leakage time versus cement age for 60 psig cycle in experiment 2 (neat Class H, WOC: 12 hours)

The major difference between experiment 1 and 2 (using big setup I) was the WOC time. The first test was performed after 12 hours WOC and the first bubble was detected approximately after 5 minutes. Figure 2.4 shows the leakage time versus the cement age for only one cycle. The second test was performed 8 days after the first test and the “self-sealing” phenomenon was observed with an increase in cement age. The combined permeability values were estimated using the three methods. Figure 2.5 shows that all the calculated permeability values fall between 0.001 mD and 0.045 mD, except the value calculated from the Darcy’s method in test 1. The values from the Forchheimer and pulse-decay methods were 0.002 mD and 0.003 mD respectively.

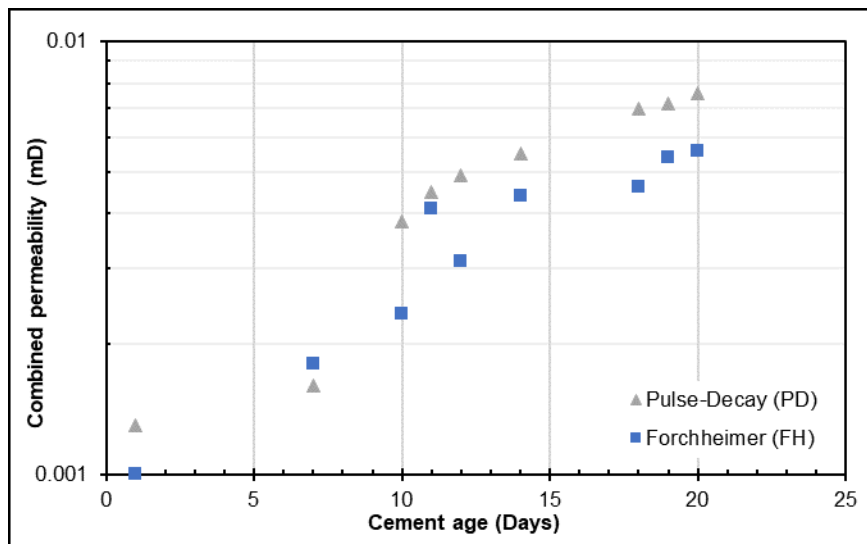
Figure 2.10: Combined permeability versus cement age for experiment 4 (neat Class G, WOC: 24 hours)

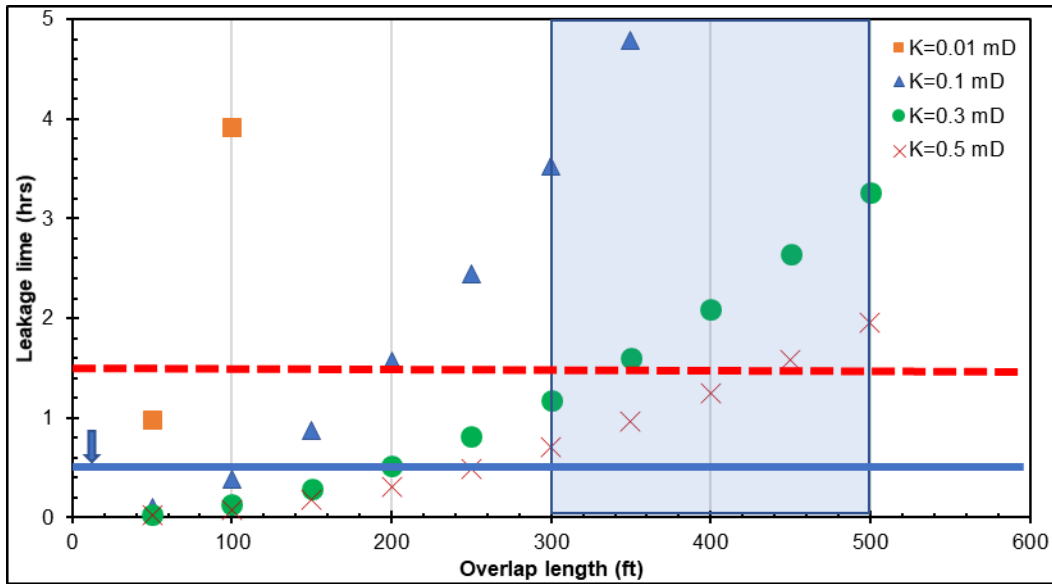
Figure 2.14: Leakage time versus liner-casing overlap for 1000 psi pressure differential across the cement.

The third and fourth leakage scenarios assumed differential pressures of 1000 psi and 1500 psi respectively across the cement column behind the liner-casing overlap. Figure 2.14 and Figure 2.15 show the leakage time versus the overlap length for 1000 psi and 1500 psi differential pressures respectively. It can be observed that the 50 ft overlap has the shortest leakage time especially for permeability values ranging from 0.1 to 0.5 mD.

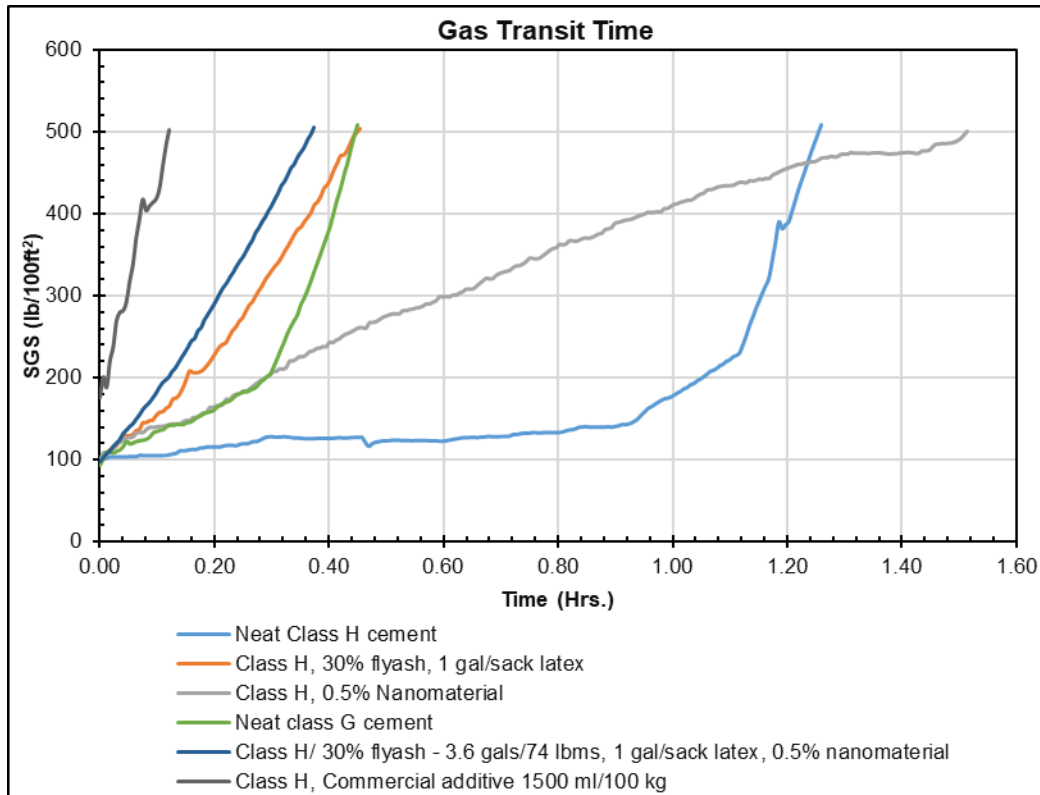
**Figure 2.26: Gas transit time for various cement slurry samples.**

The gas transit time of the slurry designs are displayed in Figure 2.26. The shorter gas transit times in the new slurry mixtures show higher potential for mitigating gas flow through the cement slurry. With the addition of 30% flyash and 1 gal/sack latex, the gas transit time was reduced by almost 1 hour, making the new slurry design desirable. The new slurry design with 30% flyash and 1 gal/sack latex proved to be a better substitute to neat Class H. It had a leak time of 21 minutes and 26 seconds in a 2-inch pipe, while neat Class H proved to prevent gas flow for only 5 minutes.

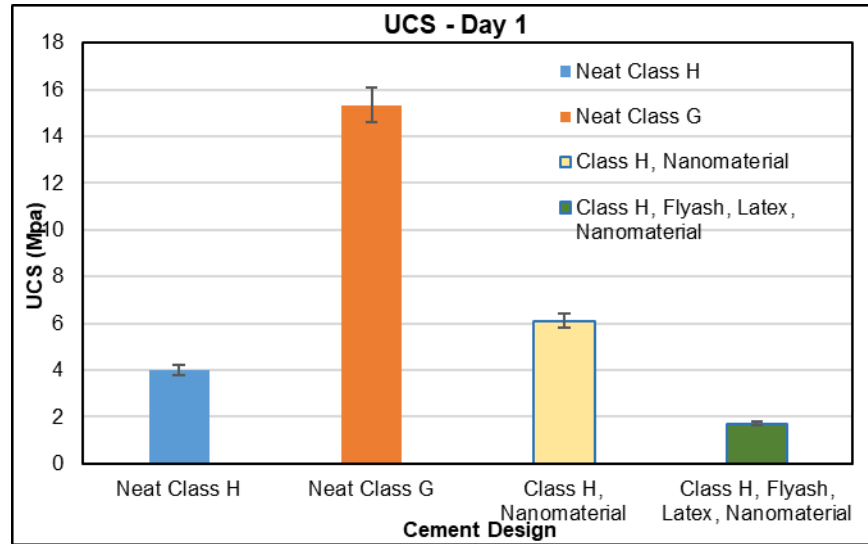
**Figure 2.29: Day 1 results for unconfined compressive strength (UCS) tests.**

From Figure 2.29, it can be observed that adding 0.5% nanomaterial to the slurry design improved the initial compressive strength of the new slurry. A 52.3% increase in compressive strength after 1 day was recorded. However, Figure 2.30 shows that the late time effect of nanomaterial is not as significant as the early time improvement. A 28% increase in UCS was recorded for the nanomaterial cement slurry design after 3 days. This increase is related to the neat Class H cement slurry after the third day of UCS test. The combination of latex, nanomaterial, and fly ash did not improve the UCS test values. The light weight of fly ash and latex are plausible factors that impeded compressive strength development. Apart from the recorded decrease in density, this slurry design showed a decrease in compressive strength by 57.75% on the first day and 58.27% on the third day of testing. Comparing Class H and Class G cement samples, Class G revealed better compressive strength development in both the first and third day of UCS test. A 283.5% increase in UCS was recorded in the first day.

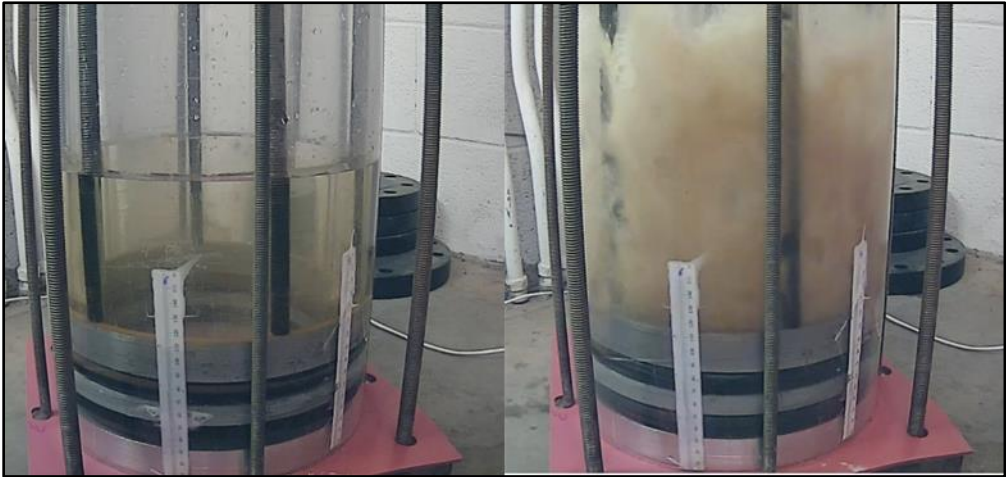
(a) (b)

Figure 4.5: NBR before (a) and after (b) failure during pressure cycling

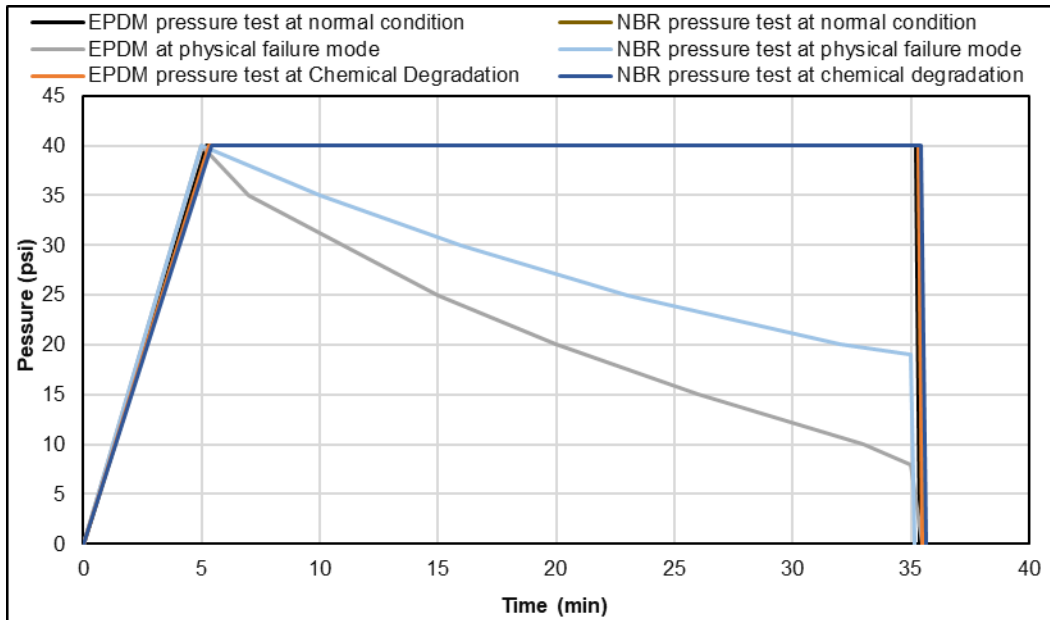
**Figure 4.16: Comparison of EPDM and NBR 40 psig pressure test performances at different conditions (normal, surfactant degradation, and physical defect) at 180 in-lbf.**

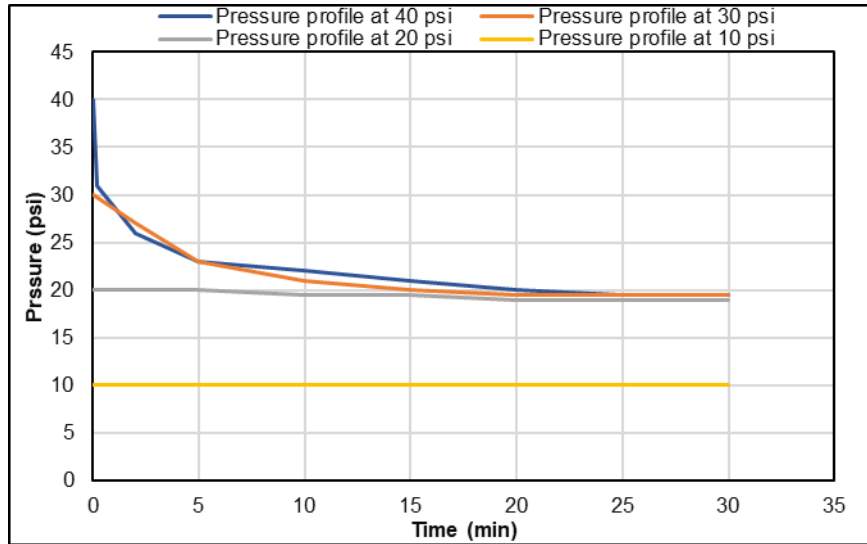
Figure 4.20: Faulty EPDM and neat Class H cement pressure decline after 48 hours WOC.
