SAFETY ALERT

Safety Alert No. 413
February 24, 2021

Hazards Identified in Level I Surveys not Communicated to Affected Personnel

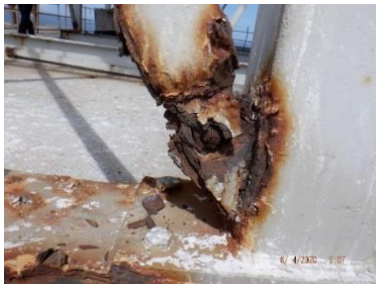
Figure 1 - Helideck structural support bracings in poor condition

That same month, BSEE inspectors found multiple unbarricaded corrosion issues throughout the facility, including helideck structural support bracings in poor condition (*figure 1*). The inspectors requested the previously completed Level I Surveys and found that the surveys from the prior two years described the helicopter bracing in poor structural condition and listed other hazards throughout the facility. These findings had not been addressed or even communicated to the personnel regularly boarding the platform. The helideck was put OOS and a NOTAM was issued.

- Incorporate a system for disseminating any findings stemming from Level I Surveys or similar reviews to personnel who visit those facilities.
- Review every completed Level I Survey and address all issues noted. Prioritize and track structural concerns to closure via a Quality Assurance/Mechanical Integrity work order system.
- Clearly mark boat landings and helidecks OOS if the Level I Survey identifies these areas to have compromised structural integrity.
- Properly barricade all hazards identified in the Level I survey, such as corroded grating, handrails, stairways, etc., if repairs cannot be completed immediately.

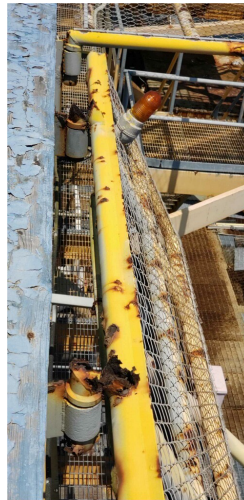
Figure 2 - Collapsed helideck skirting

In April 2020, during a BSEE inspection, a section of helideck skirting collapsed onto the handrail of the walkway leading to the helideck (*figure 2*). There were no injuries. The loss of integrity of the safety net attachment points was identified in a 2019 Level I Survey. However, platform personnel were not informed of the results of the survey, which put them in a potentially hazardous situation. The helideck was put out-of-service (OOS), and a Notice to Airmen (NOTAM) was issued.
