**Category: Grating/Open Holes**

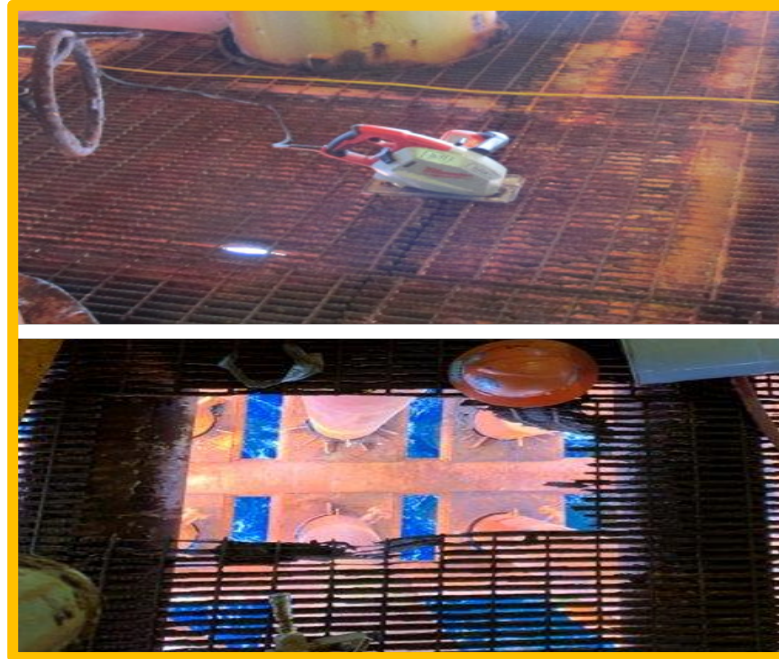
- A fatality incident occurred when grating gave way (bottom image) as personnel stood on grating after it had been ripped (top image) and chisel gunned.
- A man overboard incident occurred when grating shifted as personnel walked on the grating after the welds holding the grating to the structure were removed.
- A near-miss incident occurred when a worker walked over severely deteriorated grating, but caught himself before falling completely through.

When replacing grating, demolition operations such as ripping grating (cutting the crossbars along a sheet), needle or chisel gunning, and removing anchor welds can affect a section of grating's ability to hold personnel or equipment. The ability of deteriorated grating to hold weight cannot be determined visually or by prior experience, especially after demolition operations have begun.

- Train personnel on the dangers of insufficient grating.
  - Physical alterations to grating such as ripping, needle or chisel gunning, and/or removing anchor welds or clips will decrease the load capacity possibly causing grating that held persons before these actions to become unsafe.

- When replacing deteriorated grating, personnel should assume the grating to be unsafe to walk on without fall protection.
    - The integrity of deteriorated grating cannot be judged visually.

- Walking on deteriorated grating previously without incident does not ensure an incident will not occur.
  - Modifications to a sheet of grating can affect the rated load capacity.

- Create or revise procedures for the removal and replacement of grating to ensure removal preparations do not create a more hazardous walking and working surface, specifically for work on large areas or entire decks.

- Procedures should provide orderly steps conducive to working on small areas of affected grating at a time and identify safe working practices.
- Practice preventative maintenance rather than reactive maintenance where possible. Replace grating before it is deemed hazardous.
