SAFETY ALERT

Safety Alert No. 347
8 March 2019

Dropped Riser Joint Nearly Crushes Floorhand

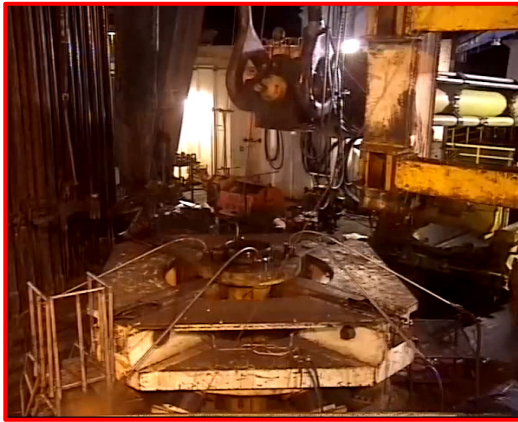
Drilling riser being lifted with hydraulic running tool

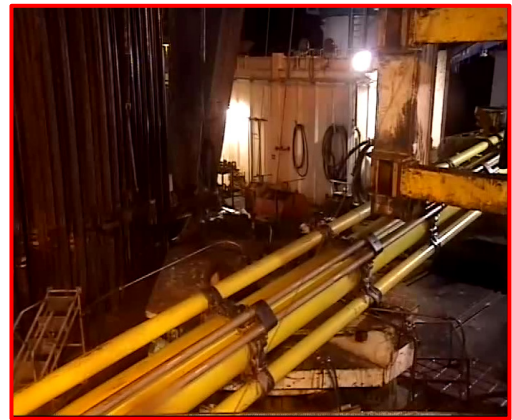
Riser after falling from hydraulic running tool

On 9 January 2019, a drilling contractor working on a rig in the Gulf of Mexico was lifting a riser joint with a Hydraulic Running Tool (HRT) and travel block. The riser joint disengaged from the HRT and fell to the drillfloor. Another floorhand noticed the riser falling and was able to evacuate the area prior to impact. There were no injuries to personnel reported. Damage assessment to equipment is currently ongoing.

The HRT initially appeared to lock in place above the riser joints locking profile. The HRT lock dogs were undamaged, and no shearing appears to have occurred. However, the lock dogs appear to have disengaged from the riser locking profile, or were never engaged into the locking profile, at the time of the incident. After further investigation, the lockout ring was found in the “unlocked” position, indicating the lock dogs were not fully engaged, and it was determined that the indicator rods prevented the lockout ring from moving into the locked position.

The HRT likely was not inserted into the riser joint at the required depth and the lock dogs did not engage the riser joint’s locking profile. The preliminary inquiry shows the indicator rods likely were not checked for full travel to the locked state and no confirmed attempt was made to move the lockout ring to the locked position to verify proper connection.

- Ensure all personnel involved in riser installations review all manufacturer's recommended attaching and running procedures for HRTs and risers.
- Ensure designated personnel confirm that the hydraulic locking function has fully actuated with visual verification of indicator rods and manual lockout.
- Ensure the JSA, or procedure for the task of lifting the riser joint, effectively captures all applicable hazards and mitigation measures, including the confirmation that the locking function has successfully activated before continuing with the job.
- Prior to any lifts made by an HRT, all personnel on the rig floor, including the auxiliary floor, should clear the floor area.
