SAFETY ALERT

Safety Alert No. 373
December 10, 2019

Lightning Strikes Threaten Aircraft on Helidecks

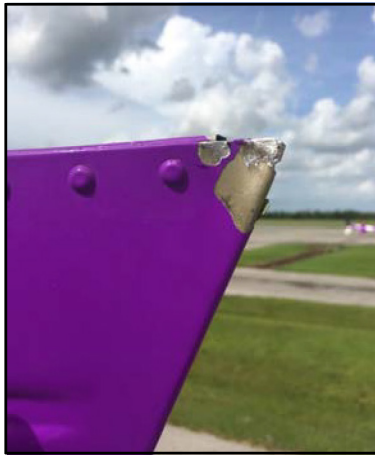
Figure 1. Lightning damage to the top of the vertical fin

- Ensure pilots closely inspect critical flying components of an aircraft, such as the vertical fin, rotor blades and landing gear, after it is exposed to a storm;
- Complete required inspections and notifications prior to further flights after an aircraft is exposed to lightning; and,
- Brief passengers about actions taken to inspect an aircraft prior to transporting passengers.

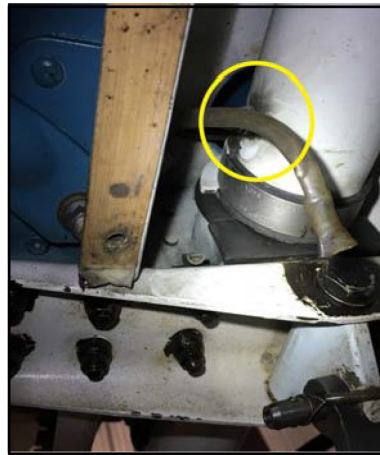
Figure 2. Lightning arcing on the aft strut

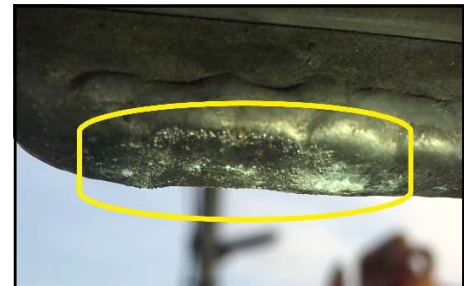
Figure 3. Lightning damage to the bottom of the skid
