SAFETY ALERT

Safety Alert No. 378
February 28, 2020

Unsecured Trough Drain Grating Poses Tripping Hazard

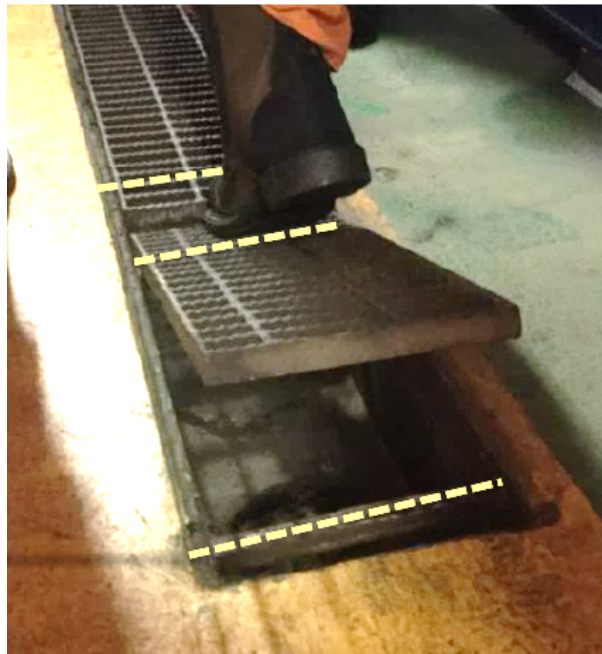
Reenactment of a grating pivoting under force.

The first incident occurred on December 6th when an employee was walking across the main production deck and stepped on a section of grating covering a trough drain. The grating shifted under his weight causing him to injure his back.

On December 28th, an employee walking behind the drawworks stepped on an unsupported section of grating, it pivoted under the employee's weight causing him to lose balance and twist his right knee.

- Inspect all grating covers to ensure no hazards exist, such as pivoting;
- Where applicable, weld shorter drain grating sections together to eliminate the risk of the grating pivoting under an applied force;

- Consider adding end caps to prevent grating sections from sliding;
- Emphasize the importance of situational awareness for reducing injury risks to crew members; and,
- Ensure lighting near grating is sufficient to make grating sections more visible.
