SAFETY ALERT

Safety Alert No. 397
October 2, 2020

Fire Tube Hazards Increase Risk of Flame Migration

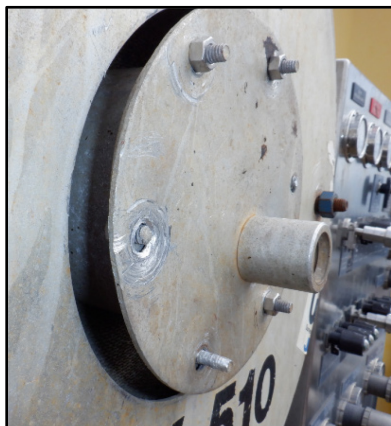
Improper bolts on a Glycol Reboiler

The fire tubes for both the Heater Treater and Glycol Reboiler units were removed, inspected, and reinstalled a month prior to the arrival of BSEE inspectors. The fasteners (i.e. nuts and bolts) used for the reinstallation in September 2019 were not Original Equipment Manufacturer (OEM) parts and therefore, not compatible with the vessels. Despite the improper reinstallation, the vessels were brought back online and production continued.

- Create a fit for purpose Pre-Startup Review when disassembling equipment for routine maintenance to verify that proper reinstallation procedures are implemented

appropriately prior to returning equipment online;

- Ensure only OEM recommended parts are applied to their associated equipment rated for a specific service;
- Increase visual inspection frequencies of flame arrestors to ensure an adequate flange face seal is intact;
- Examine the fit and make-up of all parts around the flame arrestor housing during any maintenance that disturbs OEM connections in order to eliminate any flow path around the fired component that would negate its efficacy; and,
- Review this Safety Alert in conjunction with [Safety Bulletin No. 012](#) to prevent gaps in a flange face.

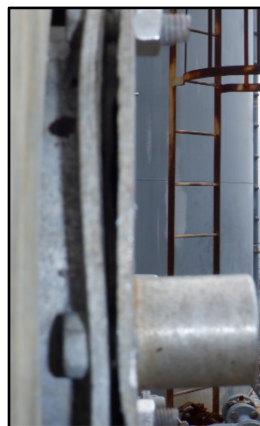
A warped Reboiler flange

At the time of BSEE's inspection, the flange faces were visibly warped and a gap in the flange created a path for flame migration due to the insufficient fastener assembly.

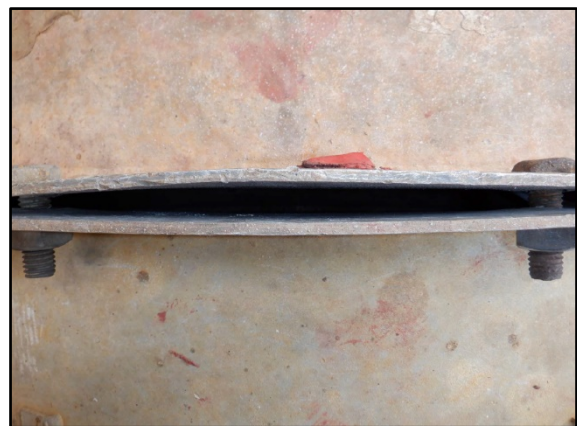
A gap in a Heater Treater flange is shown with no Gasket

The failures occurred because the flange faces of the flame arrestor housings were not flush, which is essential to its function. The resulting gap allowed the potential for flame migration to occur from the firing chamber to the Class I Division 2 Hazardous environment directly outside the process component.
