SAFETY ALERT

Safety Alert No. 417

Inadequate Operation of Circuit Breakers

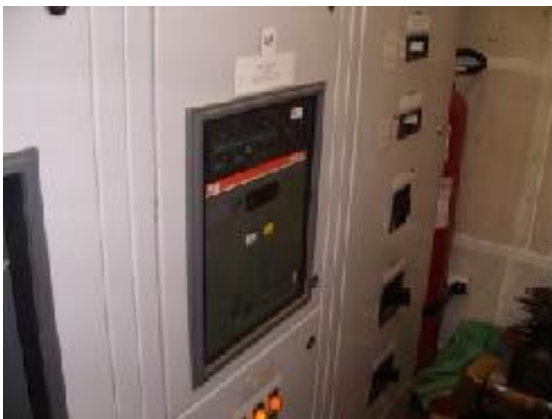
An incident took place onboard a production facility where a critical circuit breaker was disengaged. During an annual inspection, a maintenance worker was instructed to check the compressor #2 breaker's status in the Motor Control Center (MCC) building. In reviewing the #2 compressor breaker status, the individual pressed the switchboard command buttons that disengage the circuit breaker that supplies power to the compressor. This action resulted in the main circuit breaker losing power, causing the Public /General and Emergency Alarms activation. This incident caused no injuries or equipment damage but resulted in a significant loss in facility downtime and project delays.

Figure 1 - Compressor #2 breaker

BSEE recommends that operators and contractors, for those individuals working in or around the MCC building, consider ensuring:

- Personnel (electrical or general) are trained to recognize and understand the equipment's operation within the MCC building and on the switchboards.
- Those working on electrical equipment and on unrelated tasks (e.g., maintenance), but in the proximity to electrical equipment, are trained on electrical safety, and the training is documented.

- Installation of protective hinged coverings to prevent accidental activation of critical electrical command buttons.

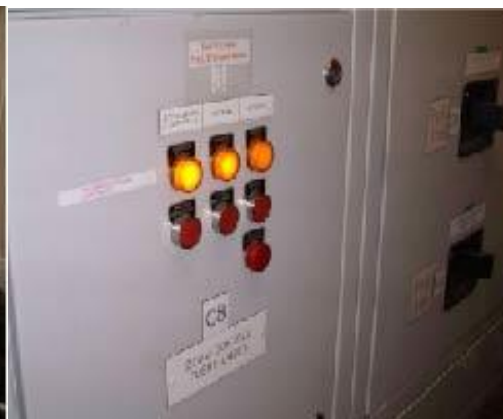
Figure 2 - Switchboard open/reset command buttons

- The individual went beyond checking the status and disengaged the breaker.
- Labels explaining the function of the breaker command buttons (i.e., open/reset) on the switchboard were not self-explanatory and were free to interpretation.
- The indicator lights on the outside of the cabinet showed "yellowish-brown" (see picture) as the normal operating condition. The indicator lights' position could have been potentially confusing due to the lack of a policy/procedure addressing the color scheme for the breaker's operation status.
- There was no procedure or work instruction to control entry to the MCC building or operation of the breakers.

- Instruction/operation manuals and documentation are current, available, and pertinent (e.g., circuit breaker diagrams) and is clearly posted on circuit breaker cabinets.
